## Post-flood field investigation in the Lower Chao Phraya River Basin 23 - 27 January 2012 Findings of the Thai - Dutch Reconnaissance Team

# **Post-flood field investigation in the Lower Chao Phraya River Basin 23 - 27 January 2012**

## **Findings of the Thai - Dutch Reconnaissance Team**

Organized by ENW: the Dutch Expertise Network for Flood Protection

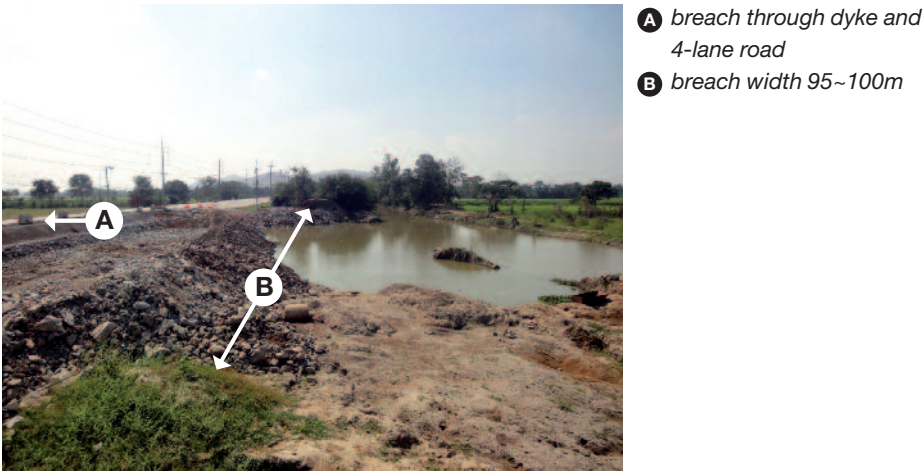
Figure 3.4  
Breach in the Manorum dyke near Chainat (location km 2 +650)
