QUANTITATIVE ANALYSES OF AGING STATUS OF DAM CONCRETE FOR A 25-YEAR-OLD DAM

Abstract

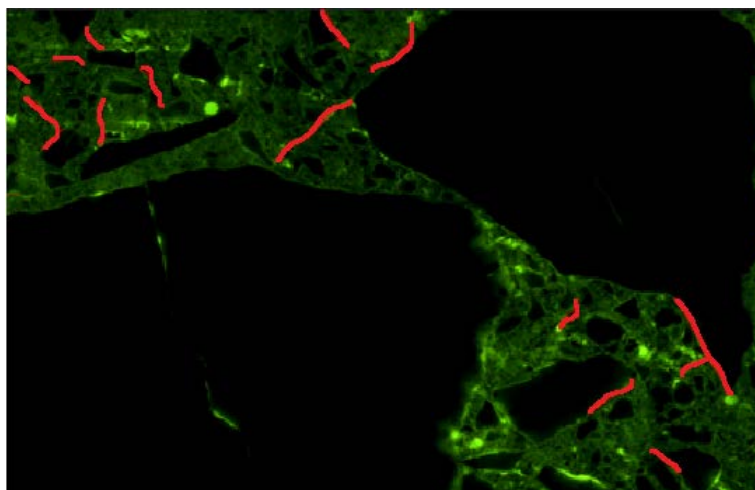
Figure 4: Microscopic image of core from the gallery (2cm*2cm in dimension, microcracks are highlighted by red lines)

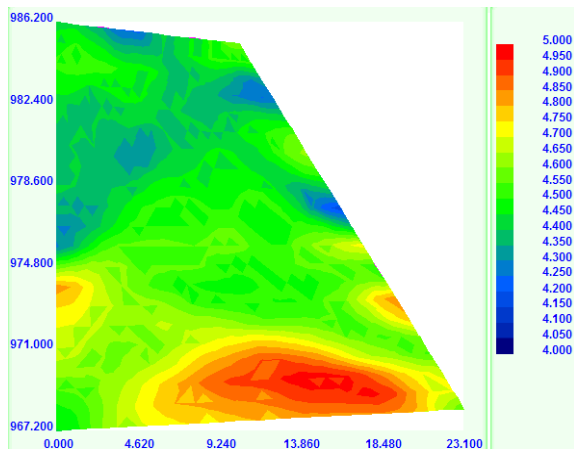
Figure 5: Elastic wave velocity distribution in dam blocks

For concrete with good quality, the P-wave velocity is between 3600 m/s and 4500 m/s [1]. As seen from Figure 5, the velocity in each dam section is around 4400~4500m/s and the minimum value is greater than 4023 m/s. It indicated that the dam concrete in these two blocks are in good quality and no defects could be found.

(a) #3 dam block, P-wave velocity: average value 4541 m/s, maximum value 4983 m/s, minimum value 4172 m/s

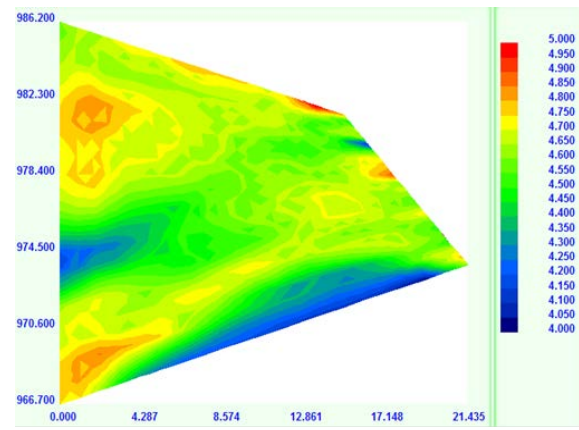
(b) #16 dam block, P-wave velocity: average value 4596 m/s, maximum value 4974 m/s, minimum value 4023 m/s

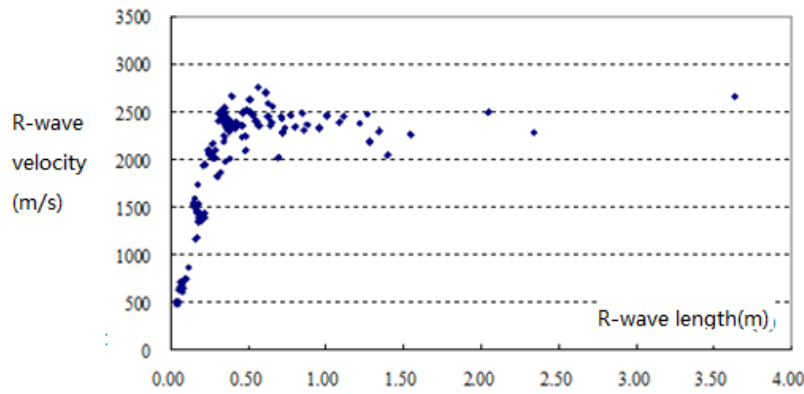
Figure 6: R-wave frequency dispersion curve

(a) Location 1 (#18 dam block)

As seen from Figure 6, the variation of the R-wave frequency dispersion curve is similar. When the wave length is greater than 50cm, the velocity is fluctuating around 2500m/s. The velocity decreases as the wave length decreases when the wave length is smaller than 50cm. It indicated that the superficial layer (about 25cm thick) of the concrete in the upstream is weathered and aging, so it's not as dense as the concrete inside. According to the relationship between the P-wave velocity and the R-wave velocity^[1], the corresponding P-wave velocity is around 4500m/s and it is consistent with the testing results obtained by elastic wave CT. Also we can see from Figure 6 that the internal concrete whose depth is bigger than 2.0m is of good quality and no aging sign could be found.

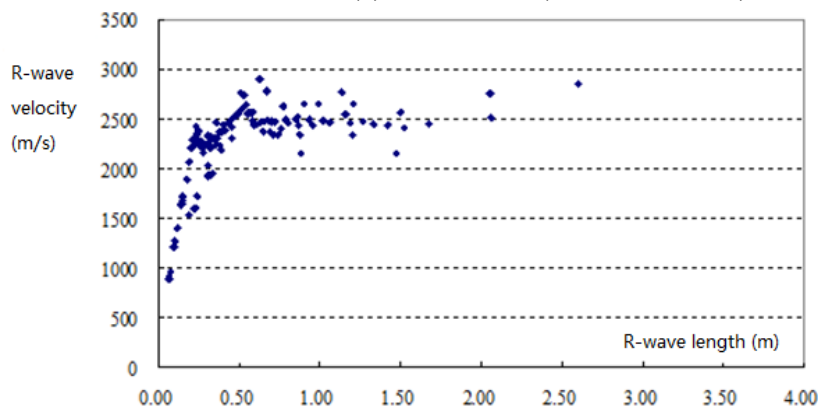
(b) Location 2 (#17 dam block)

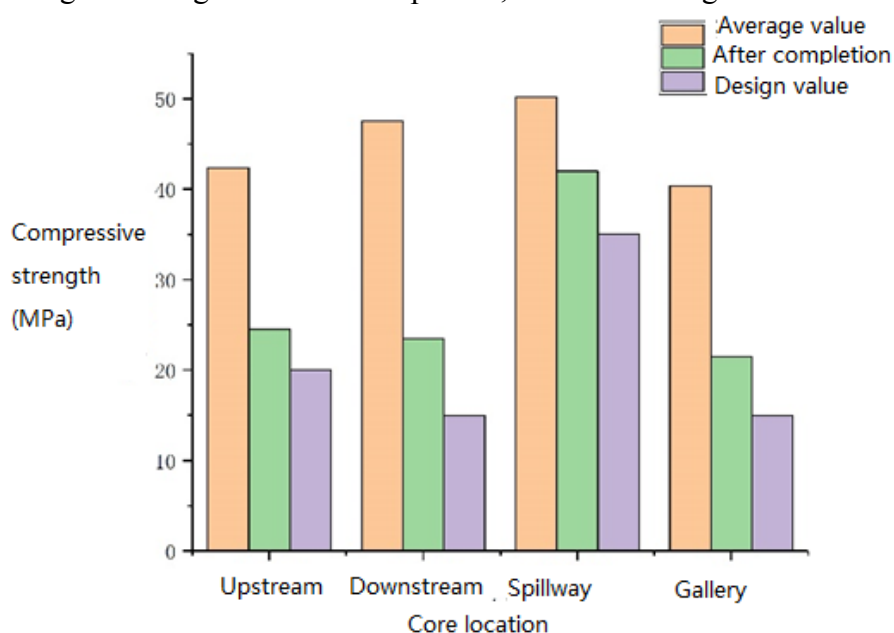
Figure 7: Comparison of the compressive strength of the dam concrete cores

As seen from Figure 7, the average compressive strength of the concrete cores from the upstream, the downstream, the spillway and the gallery is 42.3MPa, 47.5MPa, 50.2MPa and 40.4MPa, respectively. And the compressive strength values are all much higher than the design values as well as the values obtained right after the completion of the dam 25 years ago.
