**LABORATORY TESTS ORTHOTROPIC DECK
BASCULE BRIDGE VAN BRIENENOORD**

29 March 2000

M.H. Kolstein

Ministerie van Verkeer en Waterstaat - Bouwdienst Rijkswaterstaat
Nr.: BDN-3324
Projectcode: 3146
Datum: 19-12-97

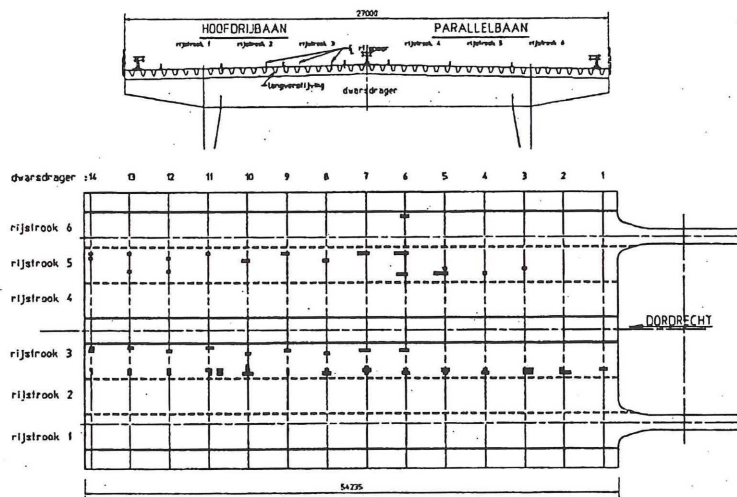
Figure 1.1 Locations of deck plate cracks

During visual examination of the condition of the surfacing of the bascule bridge Van Brienoord several longitudinal cracks were found in the slow lane. After detailed inspection by removing the surfacing from the steel plate, more cracks appeared to be present in the steel deck as shown in Figure 1.1. The crack length varied from small indications up to 600 mm. The cracks initiated at the root of the weld connecting the continuous longitudinal trough stiffener to the deck plate at the point where the crossbeam has been welded to the deck plate as shown in Figure 1.2. The cracks propagated through the total deck plate and surfacing and grow in longitudinal direction parallel to the stiffener to deck plate weld. Since the initiation of the crack was inside the trough no inspection from underneath was possible and they could also not be observed during regular visual inspection of the steel deck in the past. Since long adjacent parallel cracks could cause an unsafe traffic situation, preliminary repairs by grinding and filling the groove by a butt weld had to be carried out directly.

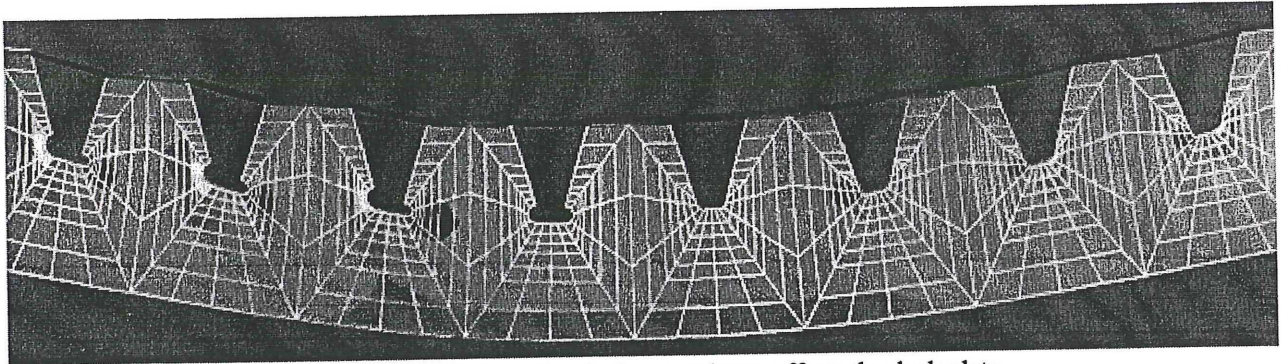
Figure 2.3 Shear deformation in the cross beam effects the deck plate

connection at locations which were not directly loaded in the previous and/or current tests. Probably these cracks have been initiated by the enforced shear deformations of the crossbeam which were present in the test specimen after the previous fatigue test for a period of 3.5 million cycles. From the finite element results as shown in Figure 2.3 it can be seen that the shear deformations in the cross beam also effects the shape of the deck plate. Additional finite element calculations showed that this behaviour results also in relative high peak stresses at the stiffener-deck plate-cross beam connection [4]. So the results of the static and fatigue tests on the "Birkhoff Panel" reported in this report can be affected by the previous ECSC tests on this panel.

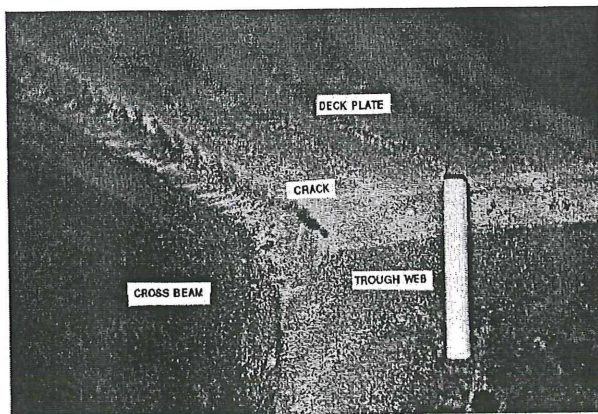
At the bottom side of the deck plate of the “Birkhoff Panel” small cracks were found at the point where the cross beam and trough-web are connected to the deck plate. These cracks located in the weld (see Figure 5.8) as well as at the weld toe (see Figure 5.9) did not grow after they had been observed.

Figure 5.8 Cracks were three welds meet

The crack growth of the cracks as found in the bottom side of the deck plate of the "Birkhoff Panel" (see Figure 5.8 and 5.9) during the fatigue test was neglectable. The crack growth of the cracks as found at the topside of the "Hollandia Panel" (see Figure 5.10) amounts about 1 mm/14.000 cycles. Typical data of these cracks is shown in the following table:

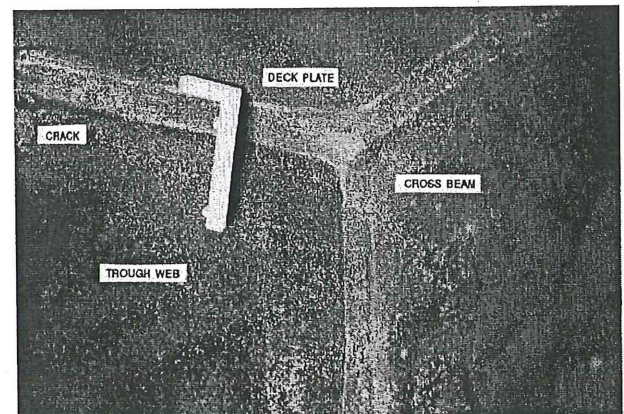
Figure 5.9 Crack at weld toe

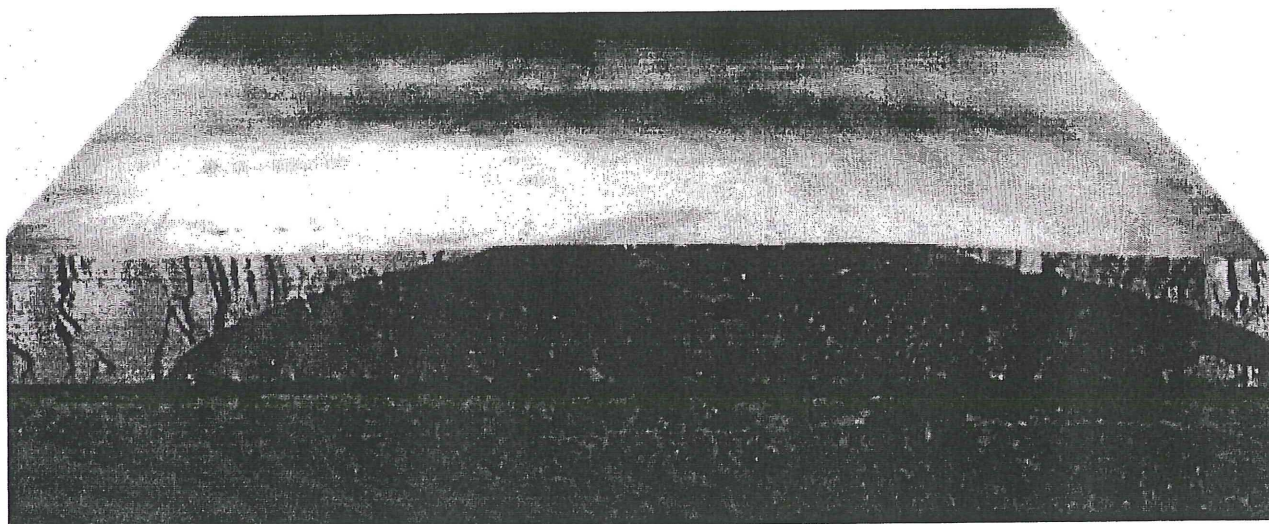
On the “Hollandia Panel” cracks have been found in the deck plate at a similar location as observed on the Van Brienoord Bridge [1] (see also Figure 5.10). These cracks initiated at the root of the weld at the bottom side of the deck plate at the point where the cross beam and trough-web are welded to the deck plate. They grow through the deck plate and developed along the deck plate weld at both sides of the cross beam.

Figure 5.10 Deck plate crack (see TNO rapport 97MI-00990/SCA/VIS)
