RESEARCH & ANALYSIS REPORT - TECHNICAL ANALYSIS

Manutenção Militar Complex - Lisbon, Portugal

STATE OF CONSERVATION

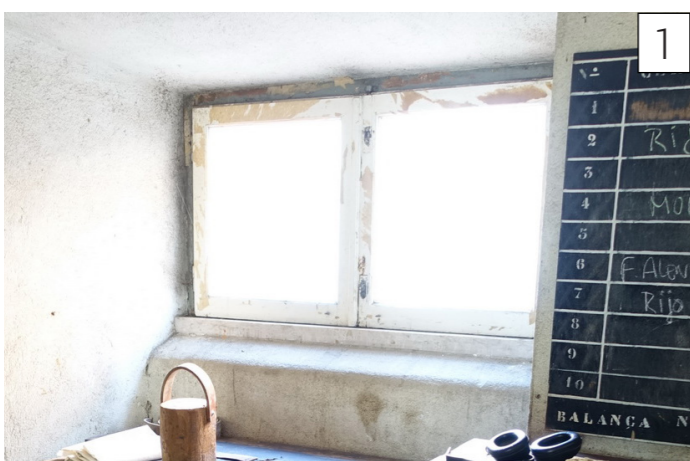
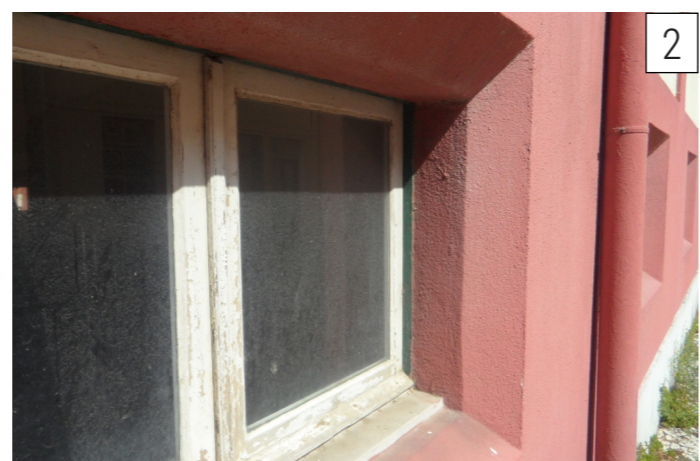
The wooden window frames need to be maintained, because the paint starts to peel and the wood begins to rot. It is plausible that this are the original frames, since there's no reason to think differently.

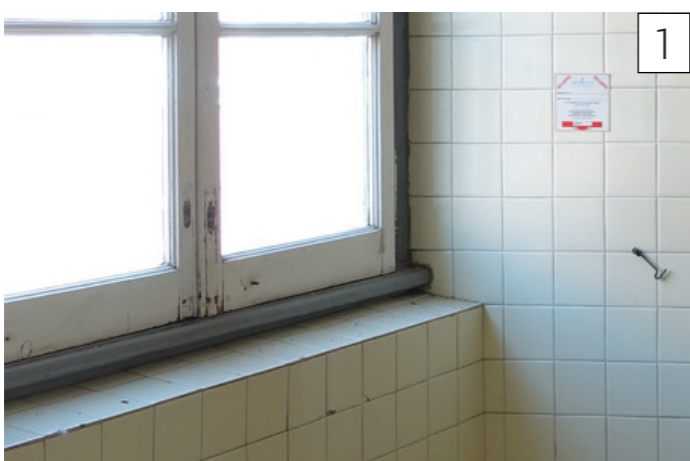
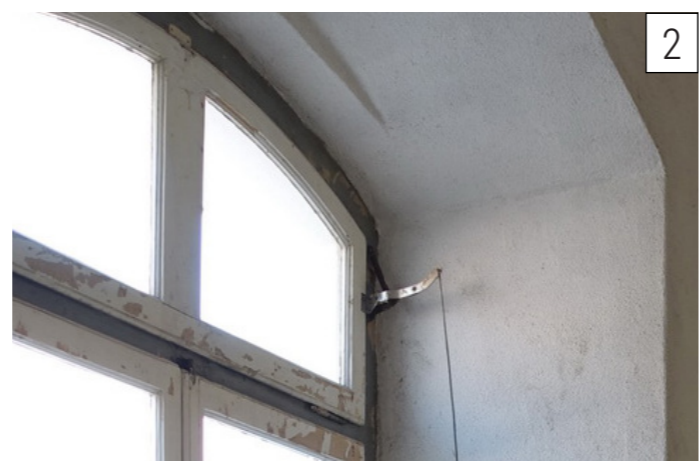
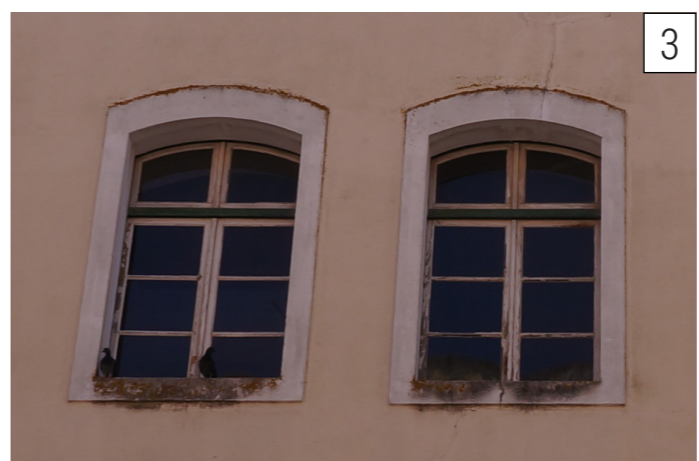
The wooden window frames need to be maintained, because the paint starts to peel and the wood begins to rot. Despite the internal changes in this part of the building during the 1970s, we assume that this are the original window frames: the detailing of it is comparable to the window frames on the ground of the silos in the mill building. Only the tiles on the inside date from the 1970s (p. 80).

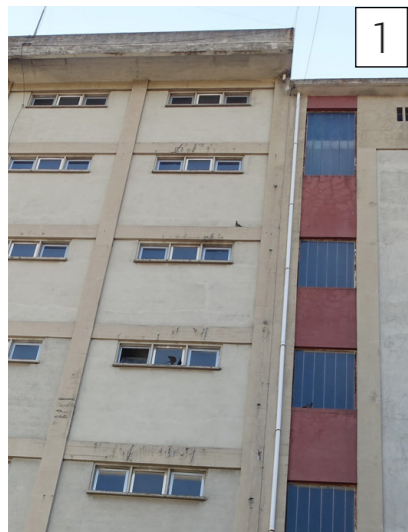
Building 20: part of the water pipe is missing causing leakage.

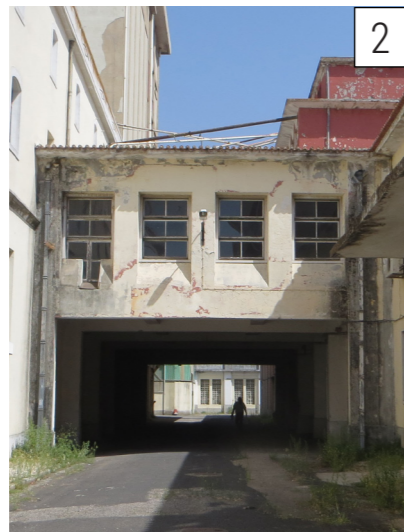
Building 16B: this building part causes water damage around the drainage system.

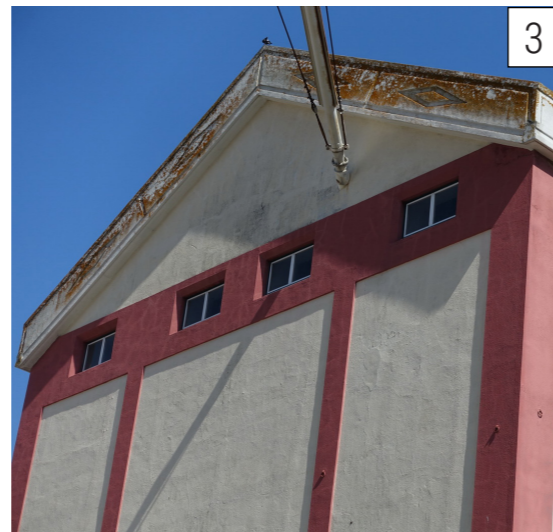
Building 18: the eaves are in a bad condition due to water damage (relief).

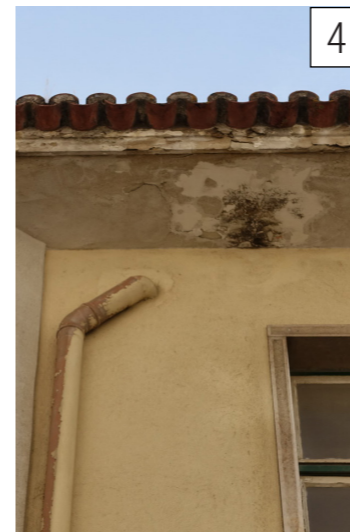
Building 16: the bakery has some drainage issues, resulting in leakages which are causing local water damage.

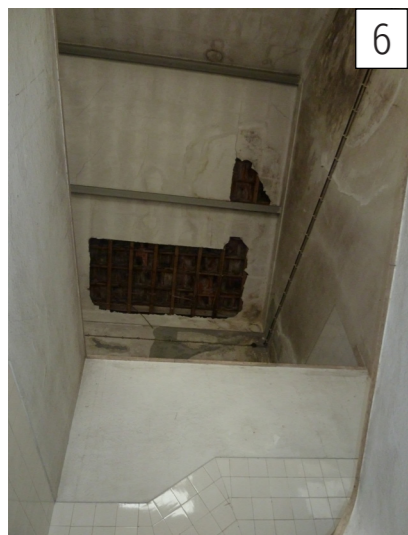
Building 16 and 16A: drainage problems at the connections between the buildings resulting in water damage on the inside of building 16, 16A and building 17.

On the left some examples of the water damage on both the exterior (image 1-5) and interior (image 6-10) of the ensemble are shown. When redeveloping the buildings it is important to think about the drainage system, especially between the different building components.

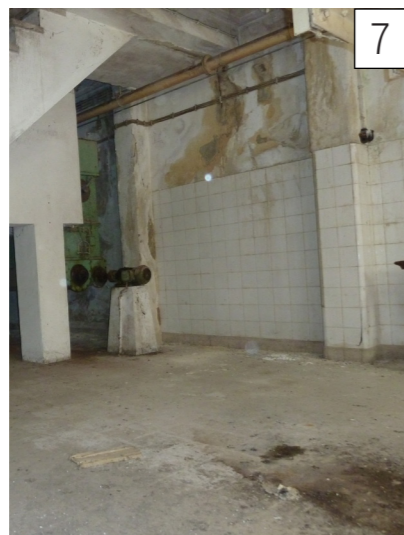
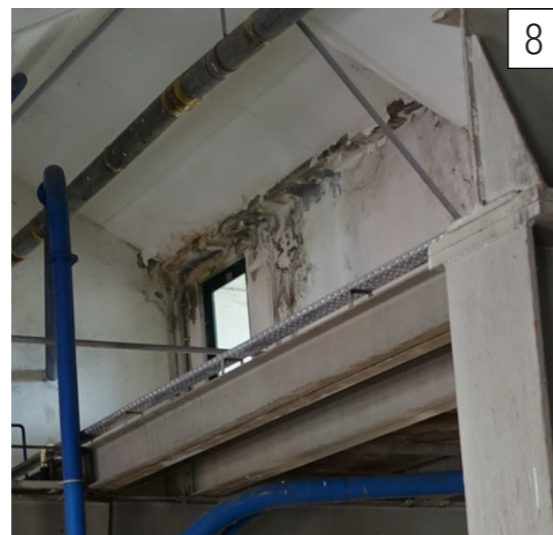
Building 18 and 19: water damage caused by leakages and badly detailed windows.

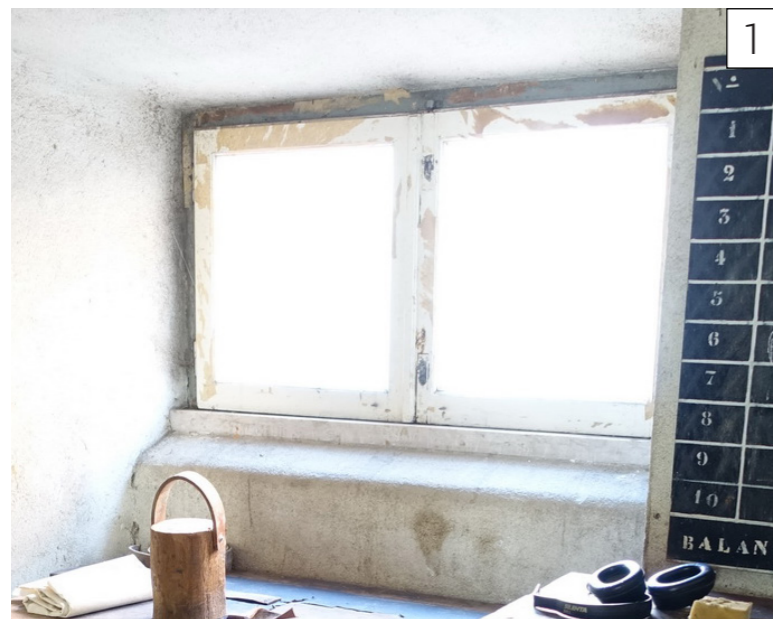
1. Building 18: damaged wooden window frame (photo by Hielkje Zijlstra, 04-09-2016)
 2, 3. Building 18: the trusses of the milling goes through the insulation causing a thermal bridge resulting in condensation (photos by Hielkje Zijlstra, 04-09-2016)

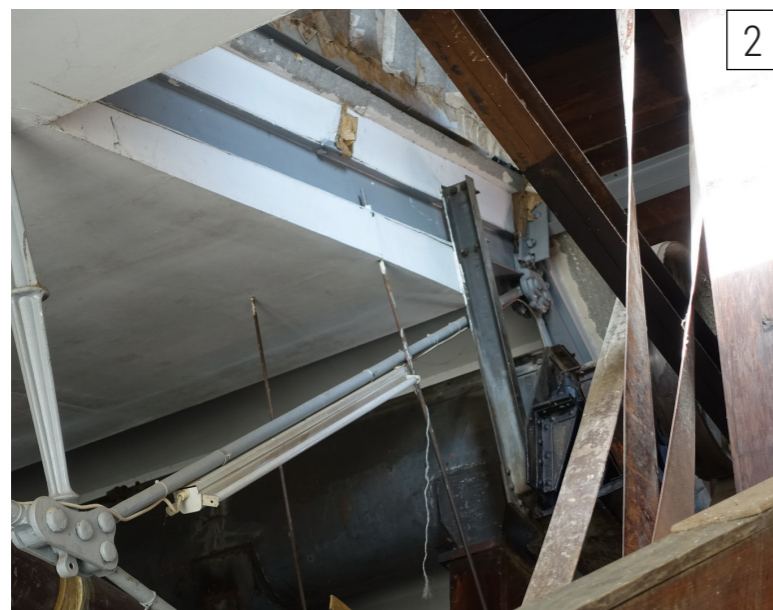
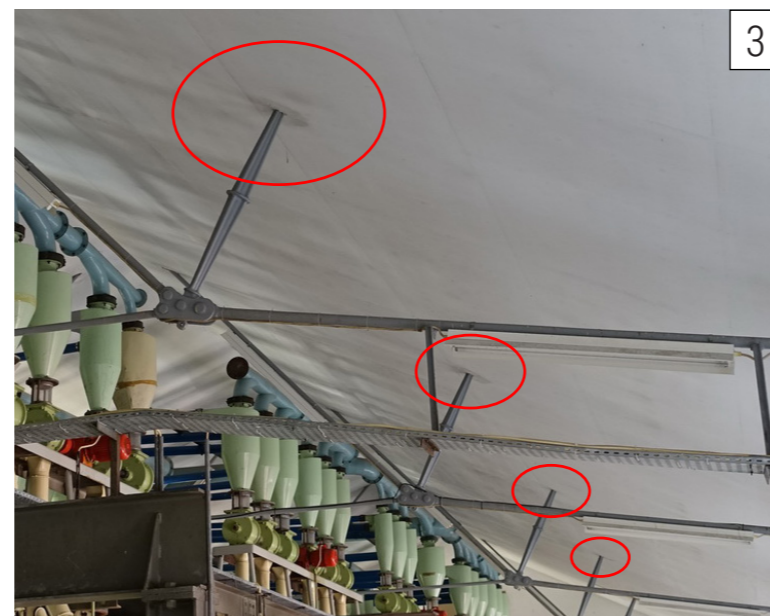
The milling (building 18) has some problems related to thermal bridges. As shown in the details, the walls of the milling are very thick (1100mm). This increases the risk of condensation near the window frames and the roof construction. Most of the wooden window frames are damaged (peeling of paint, rotting of wood, etc.) and the thermal bridges in the roofing show some condensation damages on the interior (image 3).

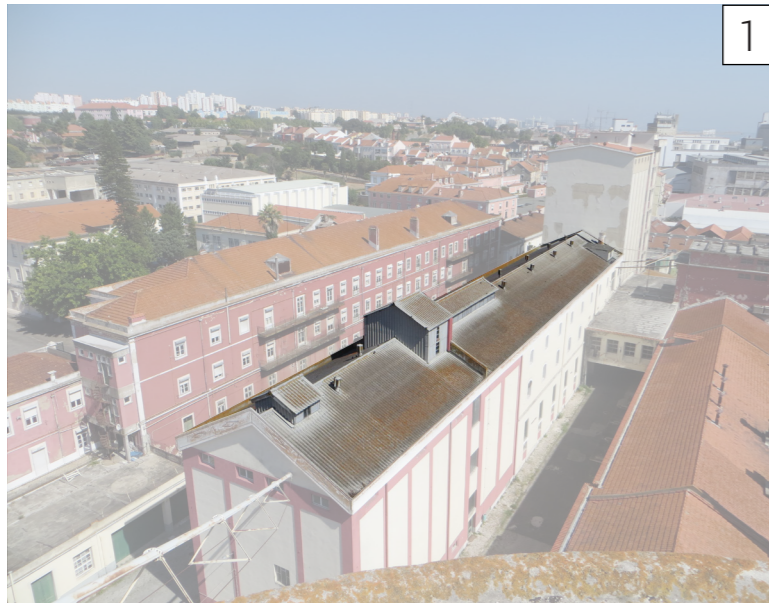
The roofing of the milling is covered with asbestos corrugated sheets, causing a serious health hazard when not removed. There are still a lot of buildings with asbestos in Portugal, even though a law on the removal of asbestos was pronounced in 2011 and the European Commission kept pressuring.¹ Despite the fact that the government couldn't finance the removal yet, the municipality of Lisbon wants to have asbestos removed from 42 municipal buildings before 2017.² When redeveloping the MMC, all the asbestos that is present have to be removed to secure a healthy living environment.

1. Building 18: the roofing is covered with asbestos corrugated sheets (photo by Noëlle Dooper, 01-09-2016)

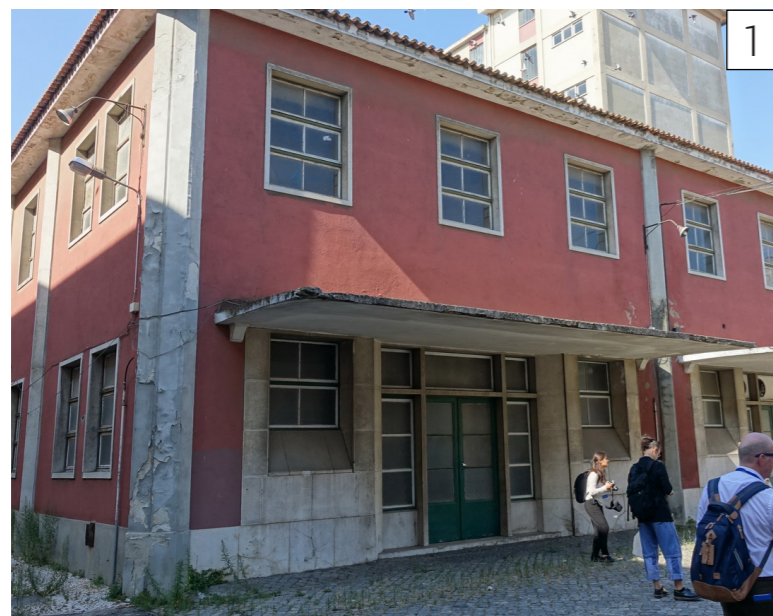
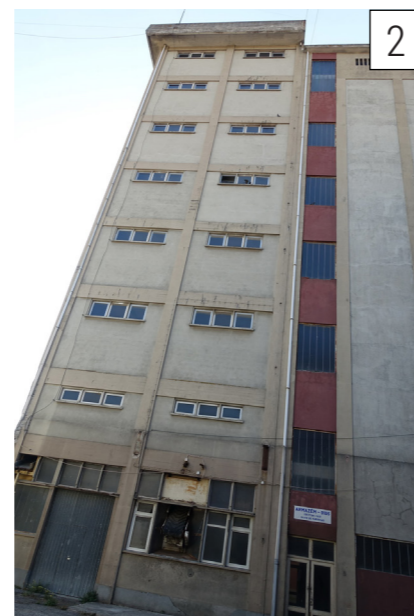
The ensemble show damages of corrosion, especially in the concrete building component of the 1980s (image 2) and the canopies of the cookie factory (image 1). The corrosion of the reinforcement is probably due to the thin concrete cover. Because the reinforced concrete is exposed to the weather, the majority of deterioration is caused by moisture. The issue is whether the existing material can be repaired or not. For this, the material must be investigated to determine their condition. Laboratory analysis of the concrete to be repaired is an important part of this investigation.¹ Since it is hardly impossible to do laboratory research during the graduation project, an assumption have to be made. Based on visual inspection we assume that the concrete structure of the storage (building 20) can be simply repaired. This does not apply to the canopies of the bakery, these are too badly damaged.

1. Building 17: corrosion of reinforcement of the thin concrete canopy (photo by Hielkje Zijlstra, 01-09-2016)
 2. Building 20: corrosion of reinforcement of the concrete (photo by Hielkje Zijlstra, 04-09-2016)

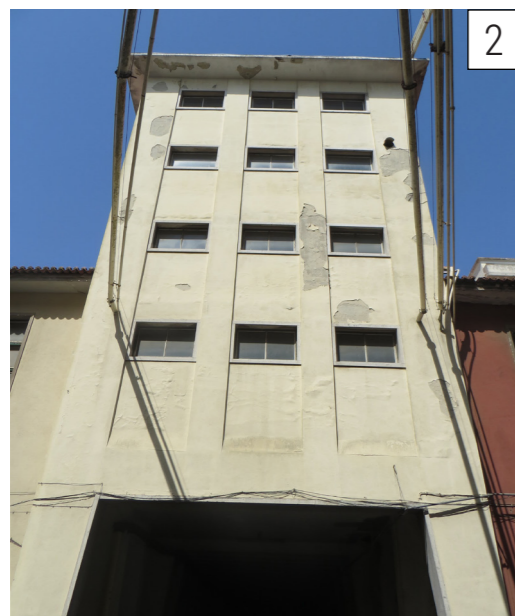
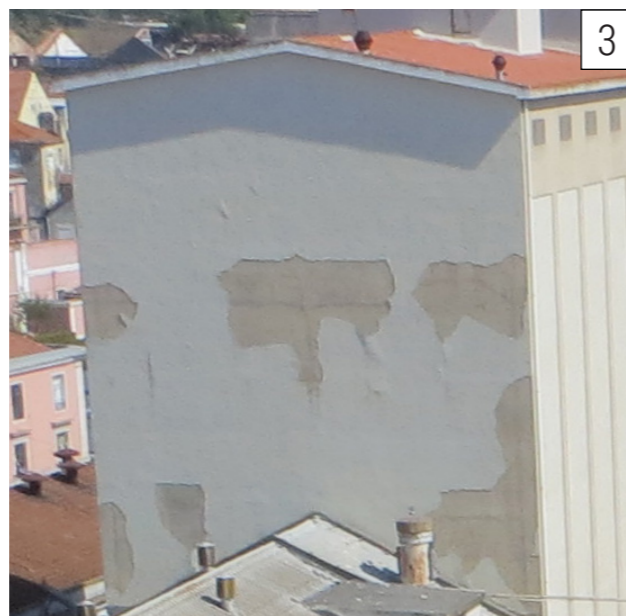
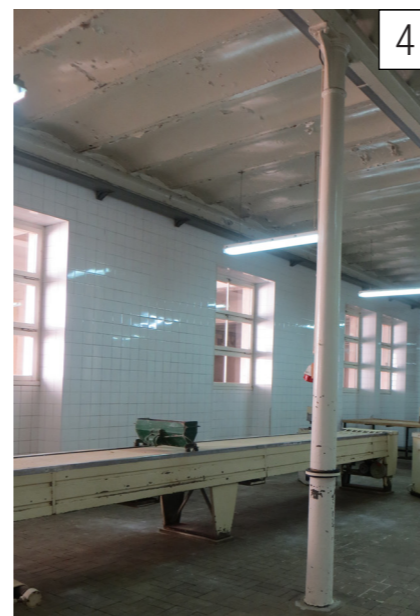
A lot of damages are visible in the plaster and paint of the buildings, sometimes due to water damage but also because of a lack of maintenance.

The façades of the ensemble show a lot of dirt and the formation of lichen and algae. The formations are not causing any harm right now, but the façades need to be cleaned to prevent future damage.

1. Building 18: forming of lichen, algae and dirt (photo by Hielkje Zijlstra, 04-09-2016)
2. Building 16A: detachment of render (photo by Noëlle Dooper, 01-09-2016)
3. Building 19: detachment of plaster (photo by Noëlle Dooper, 01-09-2016)
4. Building 17: peeling of paint (photo by Noëlle Dooper, 01-09-2016)

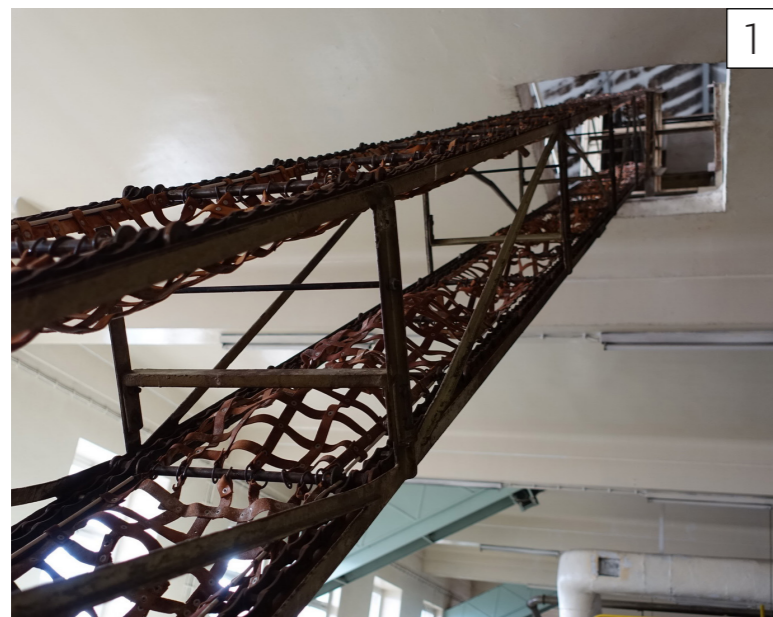
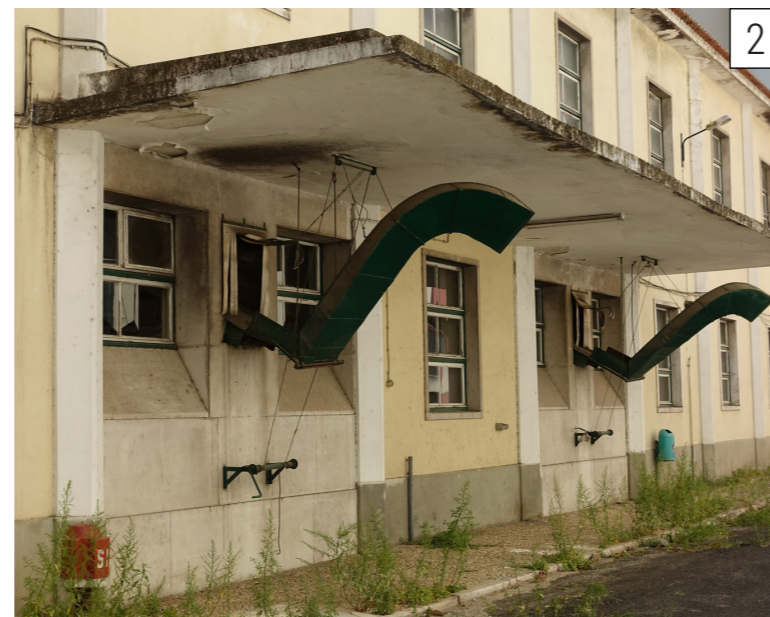
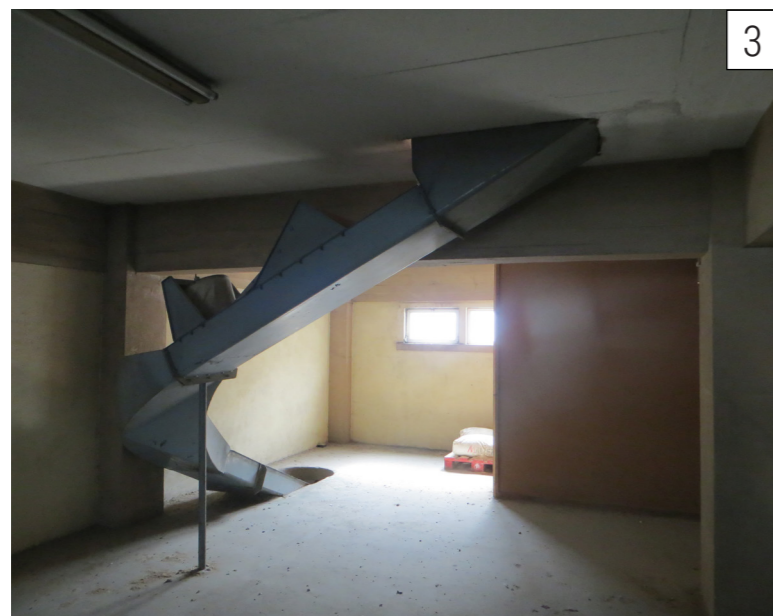
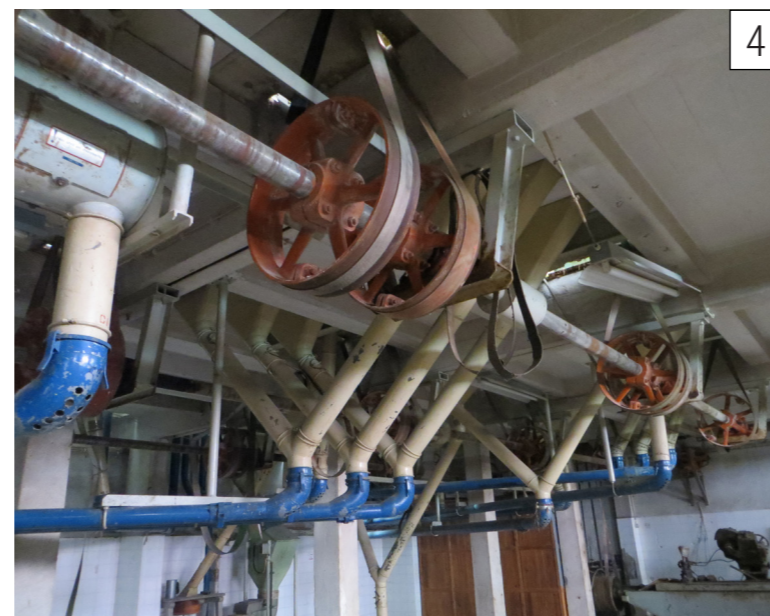
A lot of machinery is still present in the ensemble. The machines themselves are in a very good condition, but they are usually connected with each other through the flooring and/or outside walls. These connections are actually holes in the floor and exterior walls. When transforming the buildings, and probably removing the machines, it should thus be considered that a lot of holes will be left in the walls and flooring. These holes can cause future problems when not sealed.
