### **A case study**

# Wear Induced Failure of Automotive Disc Brakes—A Case Study

**Abstract:** This paper investigated a failure in a ventilated disc brake in an automobile. The failed brake disc had been in service for approximately 10 years. The observed failure was in the form of radial cracks that appeared to have initiated at the outer edge of the disc brake. The cracks were rather straight with no branching. Optical microscope, scanning electron microscope (SEM), and energy dispersive X-ray spectroscopy (EDS) were used to study the microstructure of the failed disc. Vickers microhardness test was also used to evaluate the hardness of the samples. Results showed that the root cause of crack formation, in this case, was related to the excessive wear in the brake disc. Different wear mechanisms, namely abrasive and adhesive wear, were recognized in the failed specimen. Moreover, the worn surface in some areas was covered with fine oxide particles. These particles appeared to have a significant contribution toward abrasion. To further understand the wear mechanisms, pin-on-disc experiments were also conducted on the samples. Results of the pin-on-disc experiments were compare

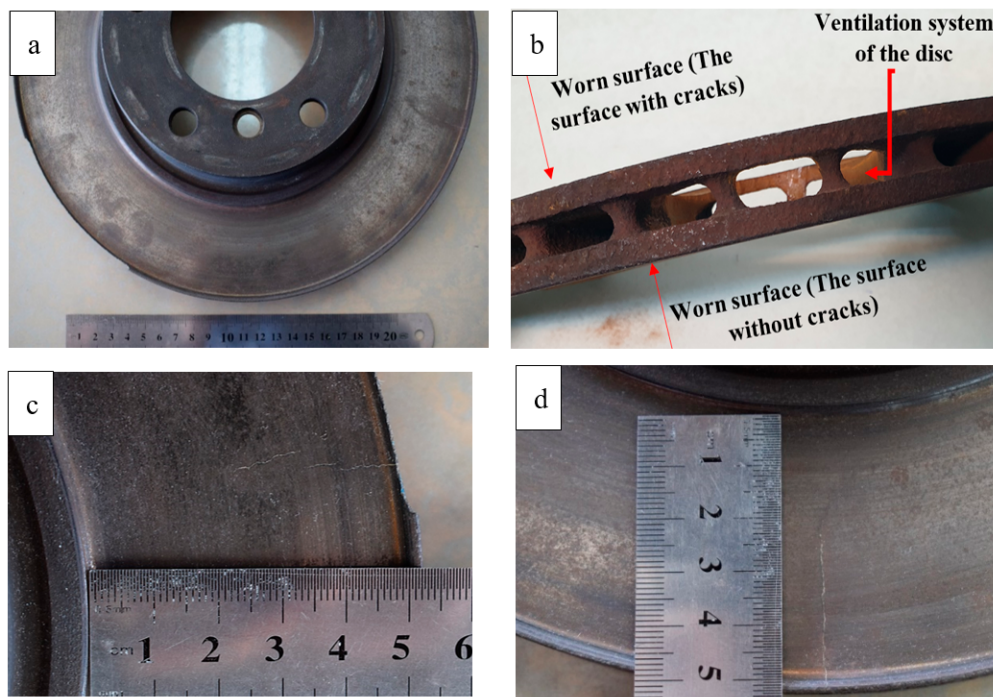
The failure, in this case, was related to the gray cast iron (Fe-3.3% C, 2.1%Si, 2.2% Mn, 0.2%P and 0.1%S, given by the supplier) disc brake in an automobile (see Figure 1a,b). The failed disc had been in service for approximately 10 years. The mileage when the failure was reported was 100,000 km (10 years of service). The disc had been in operation in temperature variations between  $-10^{\circ}\text{C}$  (in winter) to  $35^{\circ}\text{C}$  in summer in a rather dry atmosphere. The disc was a ventilated one and it was cast with two sides being in contact with the break-pad simultaneously. However, micro-cracks were formed only on one side. The observed failure was in the form of radial cracks, which appeared to be initiated at the outer edge of the brake disc. There were two rather large cracks, with one being approximately 30 mm and the other one being around 40 mm (see Figure 1c,d). The former crack was in fact two separated cracks, propagated in one direction, while the latter one was a straight continuous crack. There was no indication of the crack branching on the surface.

Figure 1. (a,b) Optical images of the disc and (c,d) images of the cracks at the surface of the brake disc.

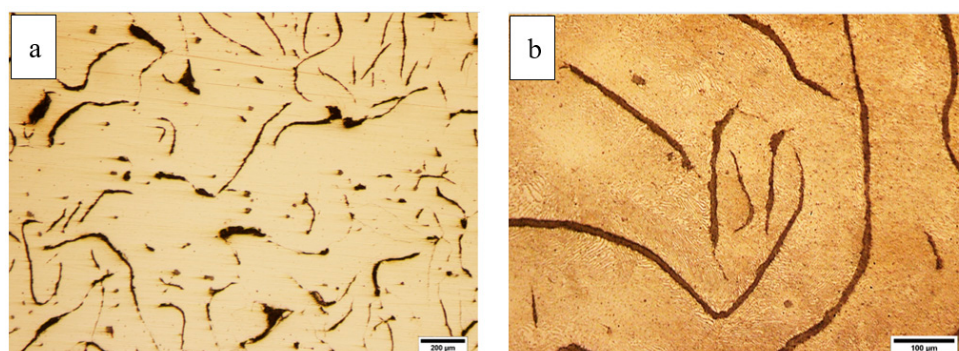
Figure 2 shows optical microscope images of the disc before and after etching. As shown, graphite flakes were distributed in a pearlite matrix. Graphite flakes are excellent thermal conductors, making gray irons good thermal conductors as well. This also has to do with the fact that graphite flakes form an interconnected network, forming an easy path for heat transfer. Moreover, graphite flakes are known to absorb sounds created by the brake pad-brake disc contacts [20]. Figure 3 shows the SEM images of cracks on the surface of the disc from the top view and from the cross-section. The former image shows that crack openings on the surface in some areas were as large as 200  $\mu\text{m}$ . It appeared that these large openings on the surface were formed due to the spallation of rather large chips from the surface. The remainder of these chip-like features were still visible inside the crack. Further away at the right side of the crack, there was a spot (roughly 200  $\mu\text{m} \times 100 \mu\text{m}$ ), which was seemingly the area from which a surface chip spallation had taken place. Figures 3b and 4 are images of the cross-section of the crack. There was no branching or any major deviation from the straight line. Figure 5 shows the laser profilometry of the surface topography in the vicinity of the crack. There were deep ups and downs parallel to each other [21]. Sharp edges on the surface were indications of surface cutting and abrasive wear on the surface.

Figure 2. Optical microscope images of the microstructure in (a) as-polished and (b) etched conditions.

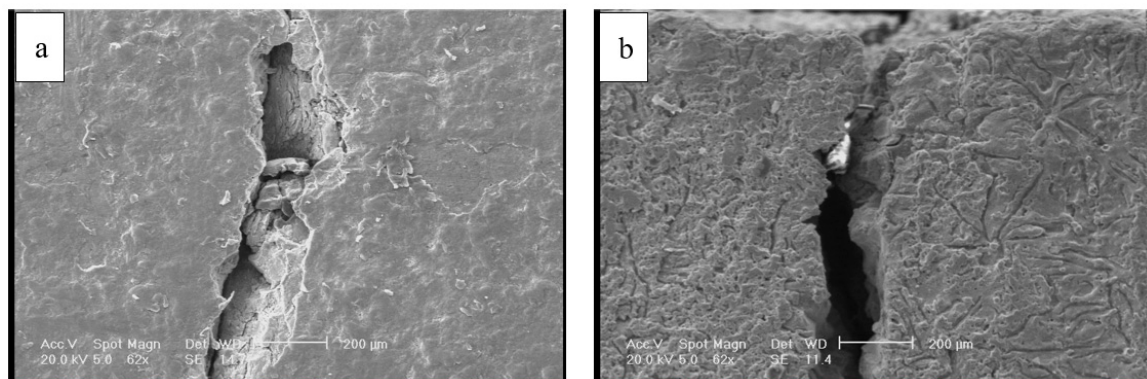
**Figure 3.** Scanning electron microscope (SEM) images of the crack, in (a) top view and (b) cross-section.

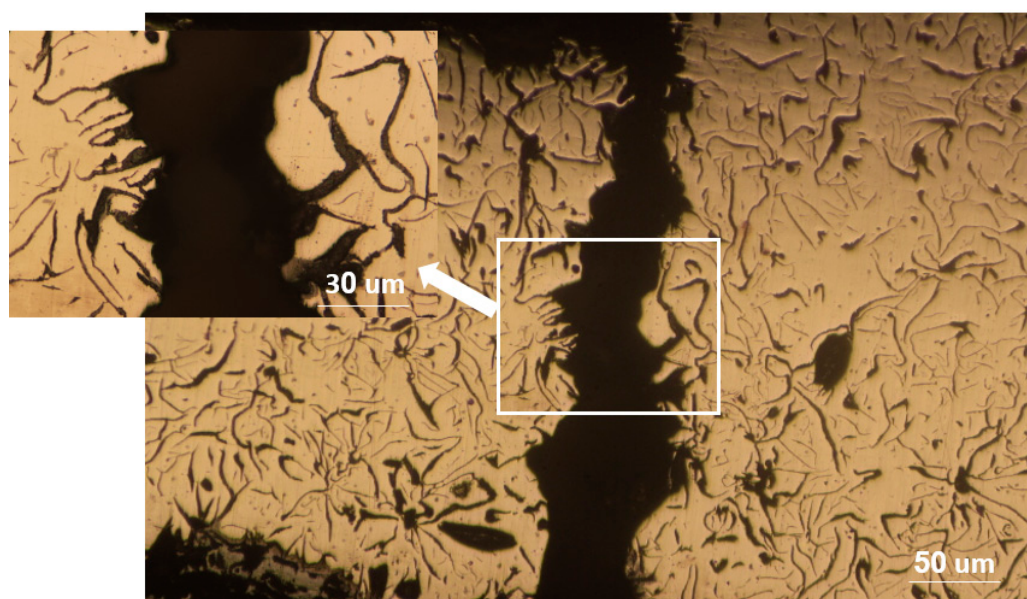
**Figure 4.** Optical microscope image of the cross-section of the crack.

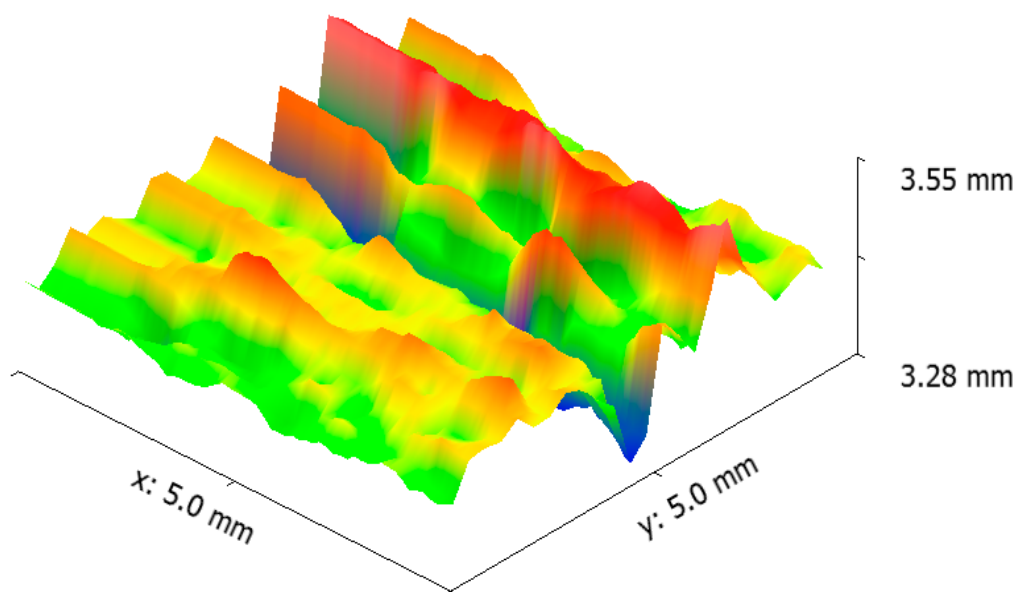
**Figure 5.** Laser profilometry of the disc brake surface in the vicinity of the crack.

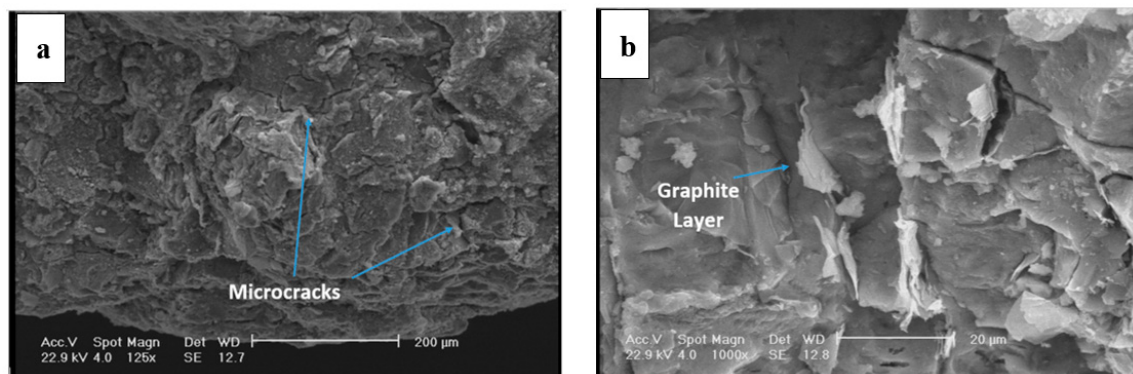
Figure 6 shows the fracture surface of the disc. Fracture is overall brittle with a layered structure (see Figure 6a). The fracture surface was covered with a network of fine microcracks. The interface of matrix-graphite, in which matrix is referred to pearlite, is a suitable place for crack initiation, given that the adhesion of graphite to the iron-based structure is rather weak. An example is depicted in Figure 6b. It appears that the fracture had mostly initiated from the graphite/matrix interface. Figure 7 shows that the fracture surface in some areas is covered with fine agglomerated particles. EDS results show that these particles were mostly Fe- and Si-containing oxide particles. These particles were formed during the wear of the surface and detachment of the particles. This is while the high temperature of the disc during the contact of the pad and the disc resulted in the diffusion of the oxygen atoms into the lattice and the oxidation of the particles. Fine oxide particles have relatively higher hardness compared to the matrix. These particles can cause severe abrasion in case they are entrapped between two moving components, which in this case for the brake pad and the disc. The formation of fine oxide particles between the brake pad and the disc had to do with localized temperature increase due to the excessive friction at local contact points between the pad and the disc.

Figure 6. (a,b) SEM images of the fracture surface in the brake disc.

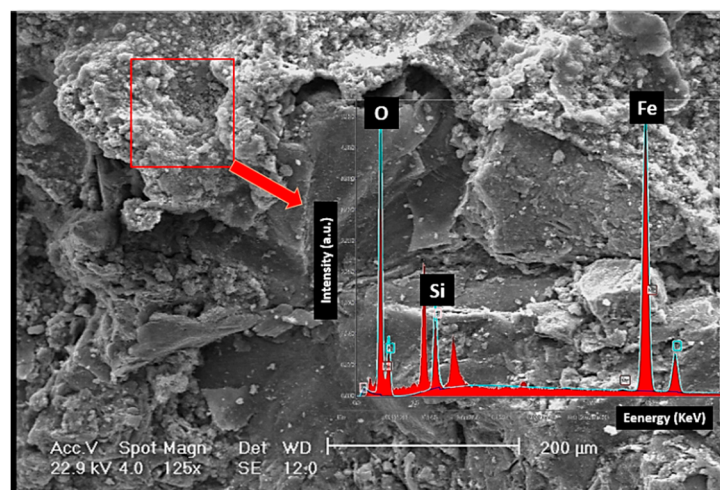
Figure 7. SEM/EDS analyses of the oxide particles.

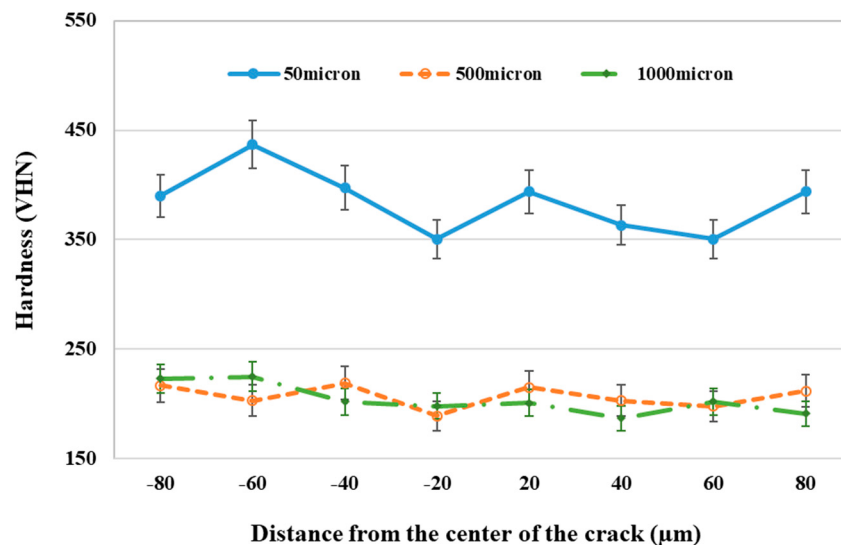
Results of microhardness profilometry across the crack at different depths from the surface are shown in Figure 8. Disc brakes experience large surface compression stresses due to exerted loads from the brake pad. This results in plastic deformation and work hardening at layers close to the surface. In this case, this resulted in an increase in the hardness from about 200 VHN at deep layers inside the brake disc to 400 VHN in layers close to the surface. This increase in the hardness confirmed the argument that the surface was heavily deformed and work-hardened during service. Prasad [4] also reported the occurrence of work hardening in gray cast iron discs during a wear test. The depth of the

work-hardened layer was dependent on the loading conditions, the sliding distance (service time), and the temperature increase at local contact points.

**Figure 8.** Hardness profilometry across the crack at different depths from the surface.

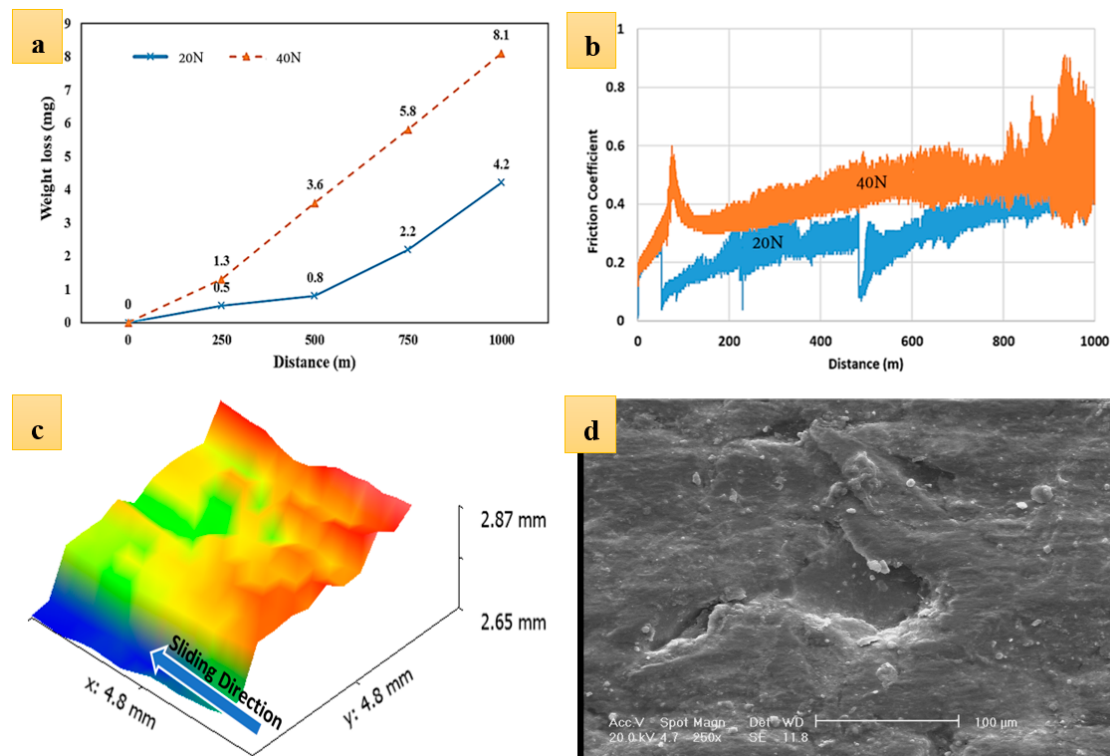
To further investigate wear mechanisms in gray cast iron, pin-on-disc wear tests were performed on discs of 50 mm diameter. The tests were conducted for 1000 m under 20 and 40 N loads. Figure 9 depicts the results of the wear tests. Figure 9a compares the weight loss during wear tests under 20 and 40 N loads. The higher the load, the higher the weight loss. In the case of a 40 N load, the weight loss linearly increased with the sliding distance. However, in the case of a 20 N load, it appeared that the weight loss had different kinetics during the test, in such a way that the kinetics of weight loss was much slower in the first 500 m of sliding. The kinetics of weight loss significantly increased from this point on. This could be due to the activation of a new wear mechanism. Given that oxide particles have a significant contribution to the wear [22], one can postulate that up to 500 m, not enough oxide particles were formed in between the pin and disc. This changed after 500 m of sliding. This argument follows the variation of the friction coefficient with sliding distance (see Figure 9b). We see that where the load was 20 N, the coefficient of friction increased with different kinetics after 500 m. Concerning the coefficient of friction, one can see that the coefficient of friction with a load of 40 N was comparatively larger than that with a load of 20 N. This had to do with the correlation of the applied load and the coefficient of friction. As the applied load increased during the wear test, the contact points between the asperities increased, which resulted in a higher coefficient of friction. The observed increase in the coefficient of friction with sliding distance in both cases could be attributed to the formation and fragmentation of oxide particles on the surface. More importantly, as the sliding distance increased, the chance of detachment and fragmentation of the graphite flakes increased. Given that graphite flakes have a self-lubricating effect, this detachment and fragmentation of graphite flakes can increase the coefficient of friction. Graphite detachment can also increase the surface roughness and this will have a negative implication on the coefficient of friction. Figure 9c,d show the laser profilometry of the surface topography and SEM image of the worn surface after 1000 m sliding under load 40 N. There were different features on the surface, with each being related to different wear mechanisms. First of all, there were some spots on the surface wherein the surface had clearly undergone severe plastic deformation. In some areas, this resulted in spallation on the surface (see Figure 9d). Other than that, there were some plowings on the surface related to the abrasion due to the relative movement of oxide particles on the surface. Moreover, some surface cutting was identified on the surface. Cutting was identified when there was material separating with negligible plastic deformation at the sides of the grooves.

**Figure 9.** Results of the wear test: (a) weight loss with sliding distance, (b) variation of friction coefficient with sliding distance, (c) laser profilometry of the sample after 1000 m wear test under 40 N load, and (d) SEM image of the same sample.
