# Independent root-cause analysis of contributing factors, including dismantling of 2 duodenoscopes, to investigate an outbreak of multidrug-resistant *Klebsiella pneumoniae*

Arjan W. Rauwers, MD,<sup>1</sup> Annet Troelstra, MD, PhD,<sup>2</sup> Ad C. Fluit, MD, PhD,<sup>2</sup> Camiel Wissink,<sup>2</sup> Arjo J. Loeve, PhD, Eng,<sup>3,4</sup> Frank P. Vleggaar, MD, PhD,<sup>5</sup> Marco J. Bruno, MD, PhD,<sup>1</sup> Margreet C. Vos, MD, PhD,<sup>6</sup> Lonneke G. Bode, MD, PhD,<sup>2,6</sup> Jan F. Monkelbaan, MD<sup>5</sup>

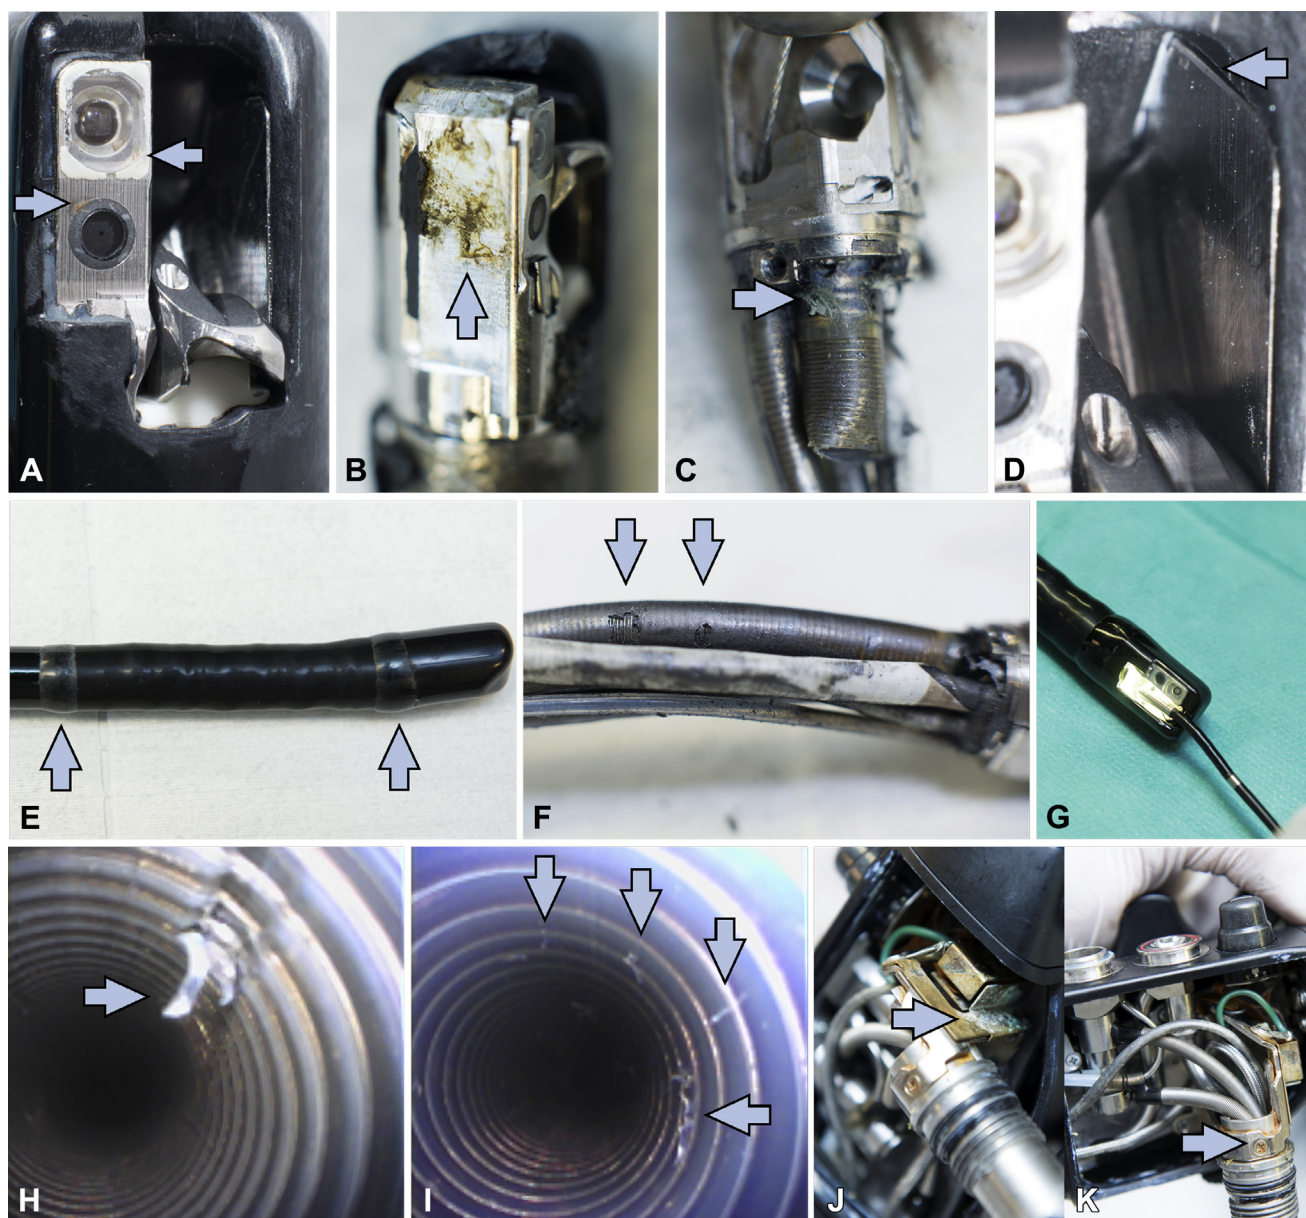
The following results are a summary of the original extensive investigation report.<sup>33</sup> On December 15 and 16, 2015, duodenoscopes A and B were dismantled. No MRKP isolates were found in the 15 and 16 samples taken from duodenoscopes A and B, respectively. Two microorganisms of concern were cultured from the instrumentation port of duodenoscope B: 10 colony-forming units/100 mL *S maltophilia* and 10 colony-forming units/100 mL *E cloacae*. In both duodenoscopes damage and improper repairs were observed: brown staining behind the glass covering the light-guide lens (Fig. 2A); brown scale on the distal tip frame underneath the protective cap (Fig. 2B); actuator area cover plates incorrectly reattached with too little glue, sealing it incompletely (Fig. 2B); and new biopsy channels attached to the tip in a manner that deferred from the prescriptions of the duodenoscope manufacturer (Fig. 2C). In duodenoscope B, the following additional damage was observed: brown staining behind the objective lens of duodenoscope B (Fig. 2A); inadequate connection of the replaced protective cap, leaving space between the cap and the tip frame (Fig. 2D); loosened bonding of the cardan rubber, which covers the distal 10 cm of the endoscope before the distal tip (Fig. 2E); insufficient lubricant powder underneath the cardan rubber, likely having been the cause of friction damage to the outside of the distal end of the biopsy channel (Fig. 2F); and heavily oxidized electric circuits and connecting parts of the signaling tube in the control section, indicating moist damage (Fig. 2J). In duodenoscope A, a crack at the distal end on the inside of the biopsy channel was observed with the borescope (Fig. 2H).

**Figure 2.** Dismantling of duodenoscopes A and B, showing damage, oxidation, and incorrect repairs (photos adapted with permission).<sup>33</sup> The observations as shown in photos **A** and **C** were present in both duodenoscope A and B. **A**, Duodenoscope B. Close-up of the distal tip showing the light-guide lens and objective lens. Sludge was observed behind the glass that covers both lenses (arrows). **B**, Duodenoscope B. Close-up of the dismantled distal tip showing a brown layer on the frame of the distal tip and the cover plate of the actuator area that was incorrectly reused and reattached by soldering after repairs. **C**, Duodenoscope B. Close-up of the dismantled distal tip showing the incorrect fastening of the biopsy channel to the distal tip. **D**, Duodenoscope B. Close-up of the distal tip showing unwanted space between the tip frame and the protective cap (arrow). **E**, Duodenoscope B. Cardan rubber at the distal 10 cm of the duodenoscope and the distal tip. At the arrows loosening of the cardan rubber bonding was observed. **F**, Duodenoscope B. Outside of the distal part of the biopsy channel with damaged parts caused by friction (arrows). **G**, Borescope investigation. Both duodenoscopes had replaced biopsy channels with a ribbed structure instead of the original smooth structure. **H**, Duodenoscope A. Borescope showing a crack at the distal end of the biopsy channel near the tip (arrow). The biopsy channel was used for 20 procedures in total. **I**, Duodenoscope B. Borescope showing fibers at the distal end of the biopsy channel near the tip (arrows). **J**, Duodenoscope B. Control section: oxidation of electric circuits (left) and **K**, the connecting parts of the signaling tube (right).

Institutions should be able to rely on repaired duodenoscopes being of similar quality as a new one, regardless if repairs are performed by the manufacturer or by ISOs. This investigation showed several inadequately conducted repairs, including incorrectly attached arm covers and biopsy channels of both duodenoscopes. In some cases, parts were reused or replaced with materials not originating from Olympus. In addition to aforementioned O-ring design issues, nearly all inadequate repairs could have contributed to the persistence of microorganisms. However, the investigation could not reconstruct the exact route of contamination. In 70% of Dutch centers, institutional technicians perform by Dutch guidelines required inspections of repaired endoscopes, often finding functional irregularities concerning the flexibility of the tip and the position of the spray nozzle.<sup>46,47</sup> However, institutional technicians may lack expertise or instruments such as borescopes for adequate assessment, and some inadequate repairs can only be revealed after dismantling. Although servicing of medical devices by ISOs is essential to the U.S. healthcare system,<sup>53</sup> the U.S. Food and Drug Administration and American Society for Gastrointestinal Endoscopy acknowledged concerns about the quality of servicing.<sup>53,54</sup> ISOs may experience difficulties in obtaining servicing manuals, technical specifications, training, and replacement parts from original manufacturers.<sup>53,54</sup> In the Netherlands, Olympus does not sell spare parts for the TJF-Q180V duodenoscopes; as a result, ISOs choose to use nonoriginal materials. Perhaps the repair quality could be improved if ISOs would service devices in agreement with manufacturers, the latter providing access to necessary materials and information.<sup>54</sup> Also, communication between all involved parties can be improved.<sup>1</sup> For example, U.S. manufacturers and institutions are not obligated to notify ISOs about adverse events related to servicing of the device.<sup>53</sup> A more transparent market would support reliable and affordable high-quality servicing.

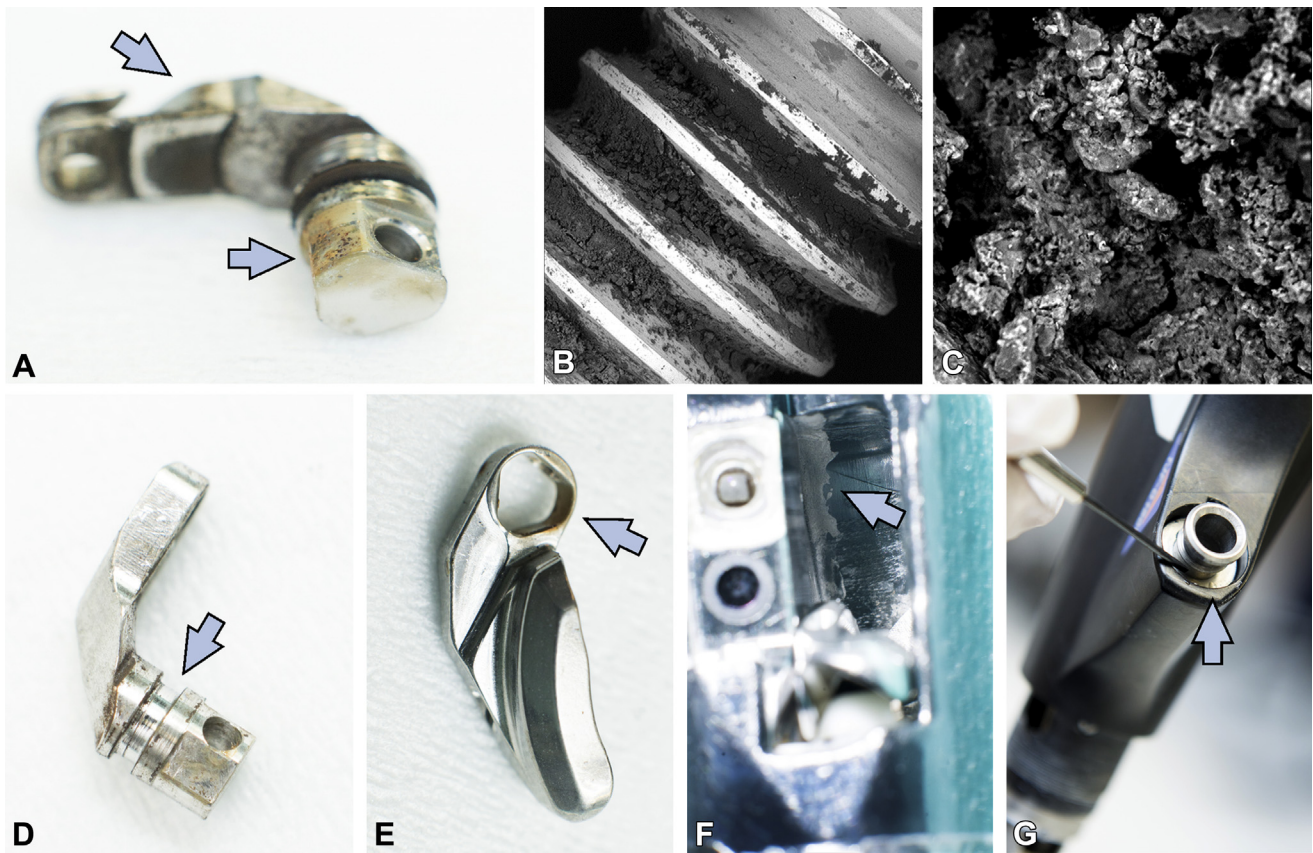
Three design-related abnormalities were observed (Fig. 3). First, in both duodenoscopes brown staining was observed on the distal tips in places on the patient

side that were not reachable for brushes and poorly accessible for rinsing or drying: on the internal channel port side and on the patient-sided axis of the elevator lever (Fig. 3A), on the screw fastening the forceps elevator to the lever axis (Fig. 3B), in the groove in which the O-ring is situated (Fig. 3C), and in the axis hole of the forceps elevator (Fig. 3D). Second, at several places surrounding the forceps elevator that were easily accessible for brushes, white and brown oxidation stains were observed (Fig. 3E). Finally, water droplets were observed under the instrumentation port's rubber sealing ring of duodenoscope B (Fig. 3F).

**Figure 3.** Dismantling of duodenoscopes A and B, showing residue resulting from design issues (photos adapted with permission).<sup>33</sup> The observations as shown in photos **A** to **D** were present in both duodenoscope A and B. **A**, Duodenoscope A. Elevator lever with a brown layer on both sides of the O-ring: axis side (patient side) and the channel port side (sealed off by O-ring). **B**, Duodenoscope A. Scanning electron microscopy photographs of the screw that fastens the lever axis to the forceps elevator with a powdery, brown layer with organic characteristics in the screw thread. Detail scans, 255× (*left*) and 3600× (*right*). **C**, Duodenoscope A. Elevator lever and axis with the O-ring removed. A brown layer is seen in the groove of the O-ring. **D**, Duodenoscope A. Forceps elevator with brown layer around the axis hole. **E**, Duodenoscope A. White, porous-looking layer in the recess for the forceps elevator. **F**, **G**, Duodenoscope B. Instrumentation port: water droplets under the rubber ring that seals the port were observed.
