MAISON DE LA MISERICORDE
RESTORATION BOOKLET

Florencia Marije Anna Visser
Student number: 4345053
Master track Architecture
Studio: Heritage and Architecture
Graduation tutors: prof. ir. Wessel de Jonge, ir. Lidy Meijers,
ir. Frank W.A. Koopman, ir. Bert van Bommel
Delft University of Technology
15-05-2017

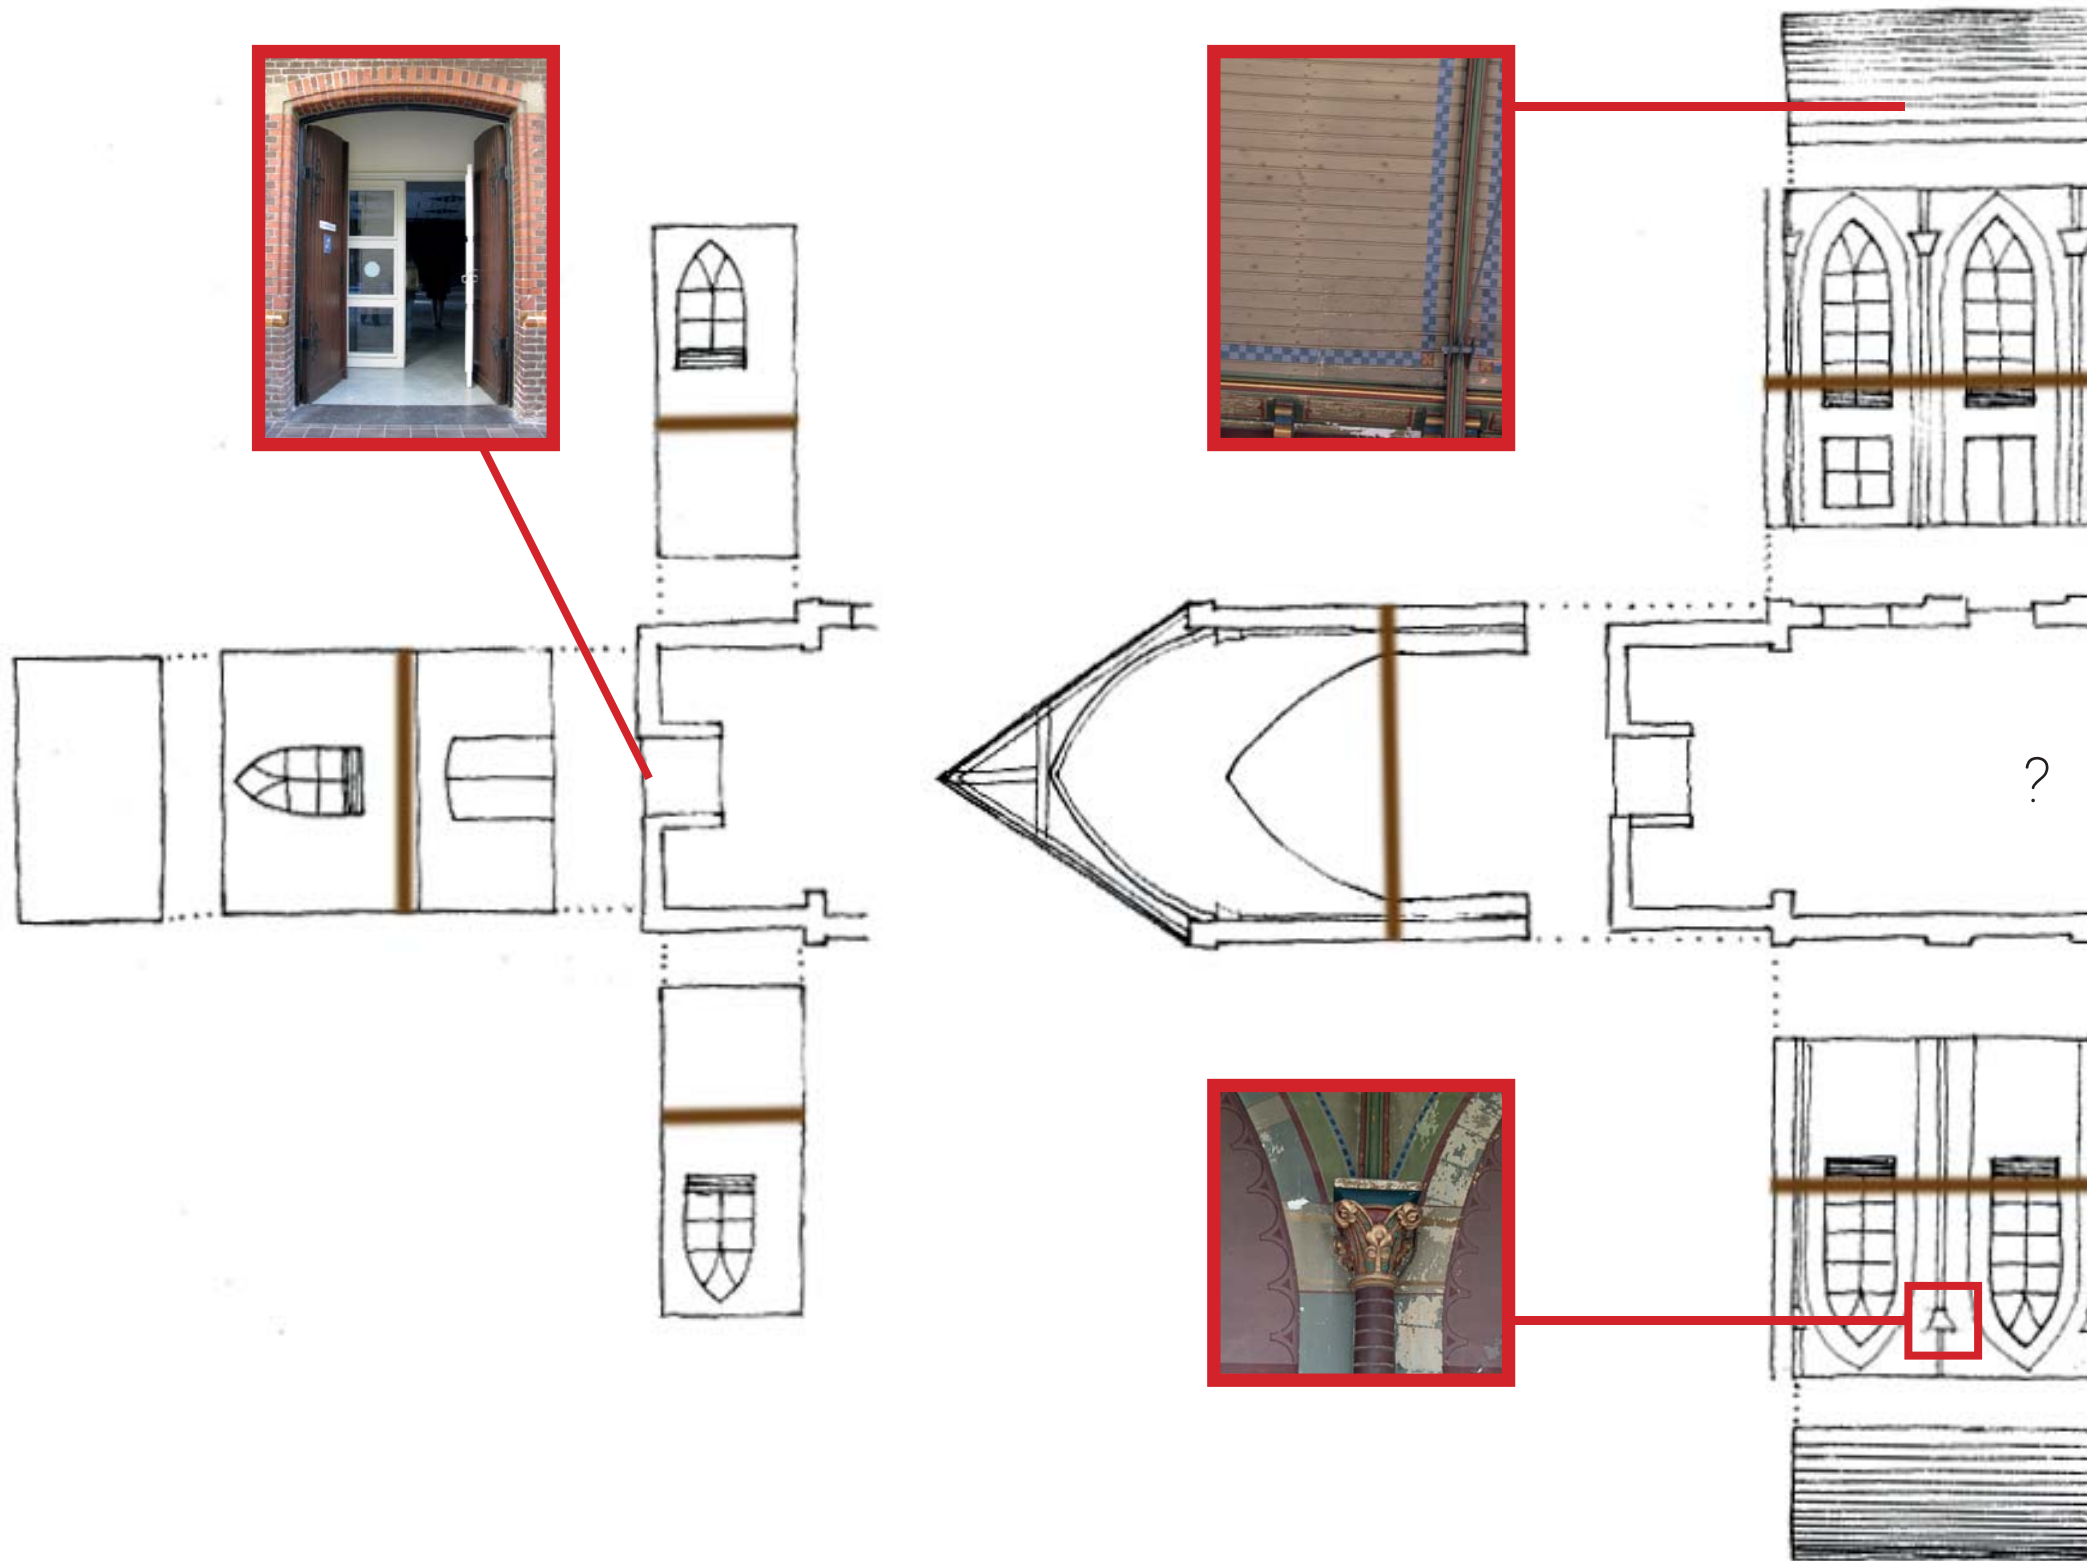
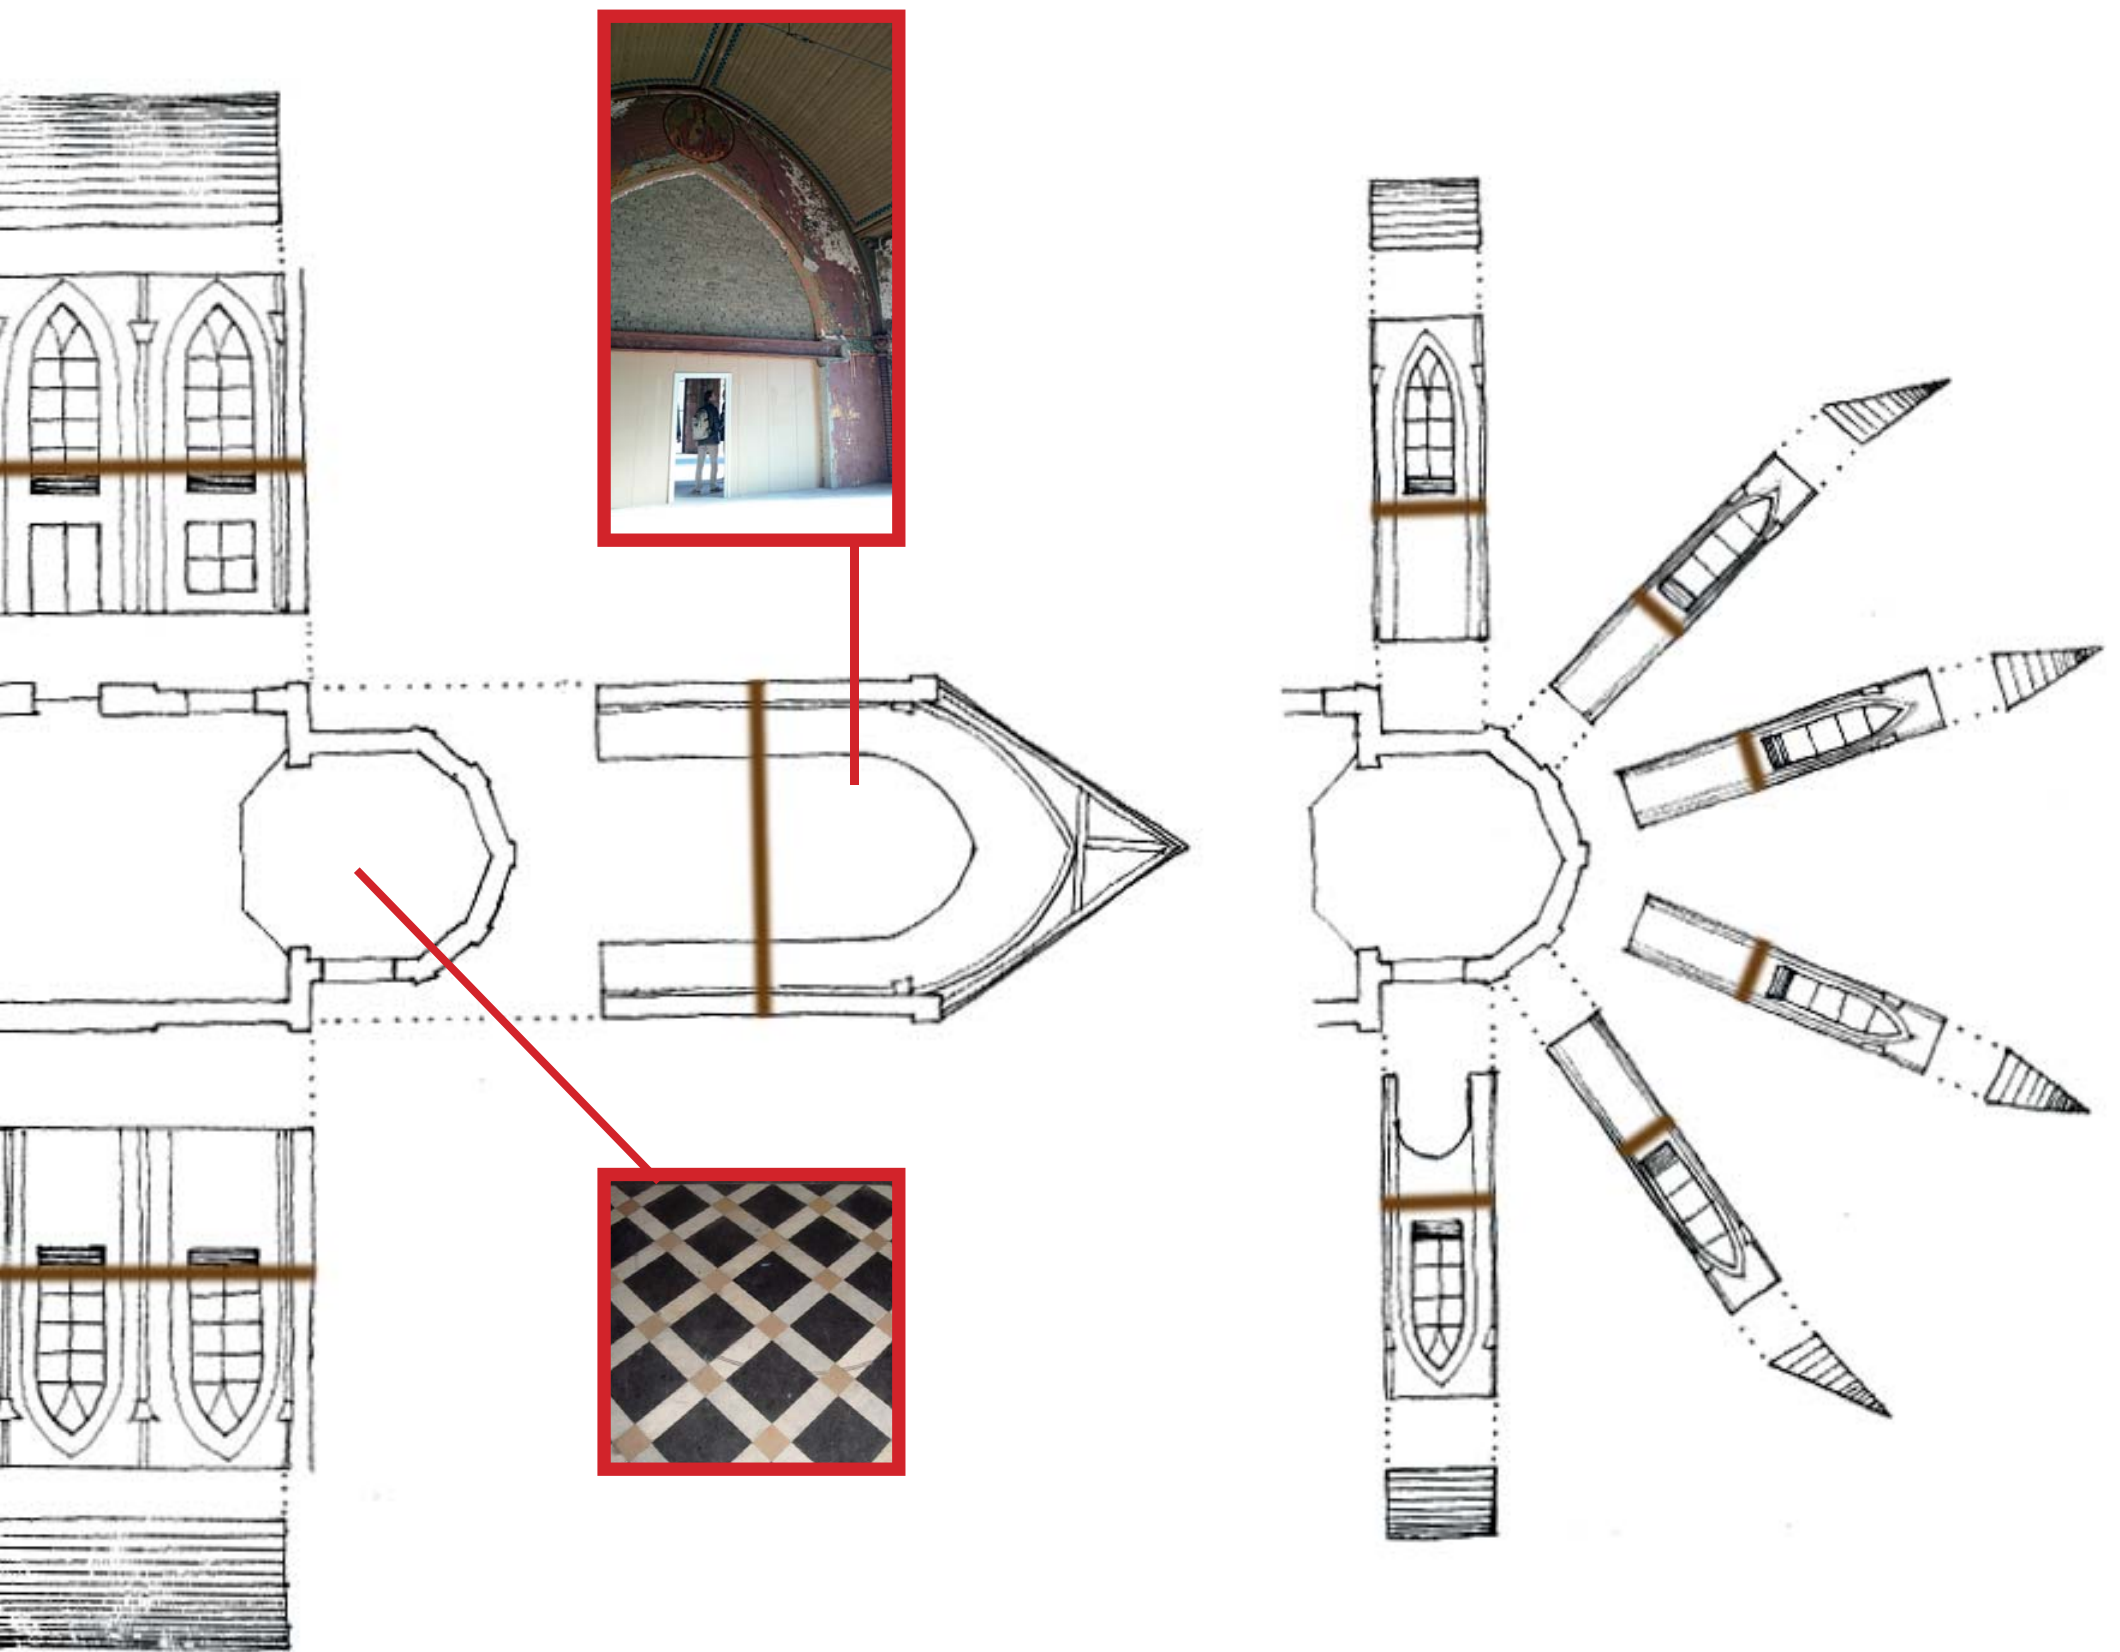
Figure 14. State of materials in the interior of the chapel
scale 1:200

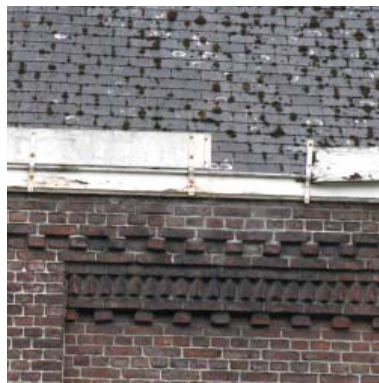
On the roof lie bitumious slates, these slates are full of asbestos.

Figure 17. Bitumious slates and wood gutter

When the structural problems have been solved the building has to be made waterproof. In case of the chapel this means that the gutters have to be replaced. Since there is extensive water-damage it can be assumed that the gutters are in such a bad condition they can't be repaired but have to be replaced.

To stabilize the temperature inside the chapel, necessary for the condition of the paintwork, the roof will be insulated and the roofing will be replaced. The roof is now covered in bituminous slates, this will be replaced for natural stone slates. Detail 1 on page 40 shows the technical solution that belongs to this method.

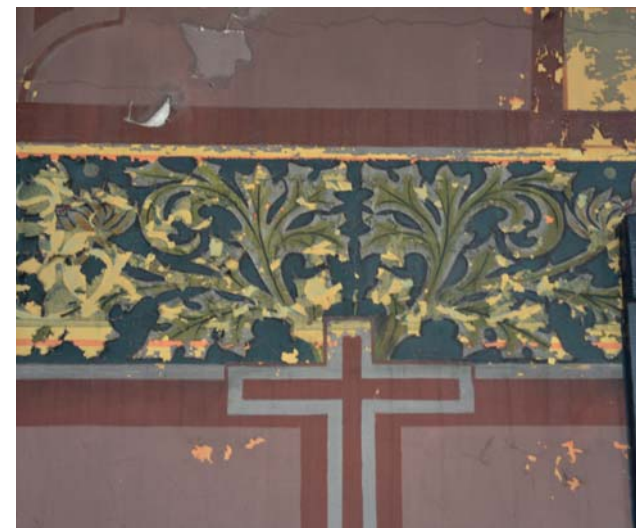
Figure 21. The strip, paintwork peeling and revealing

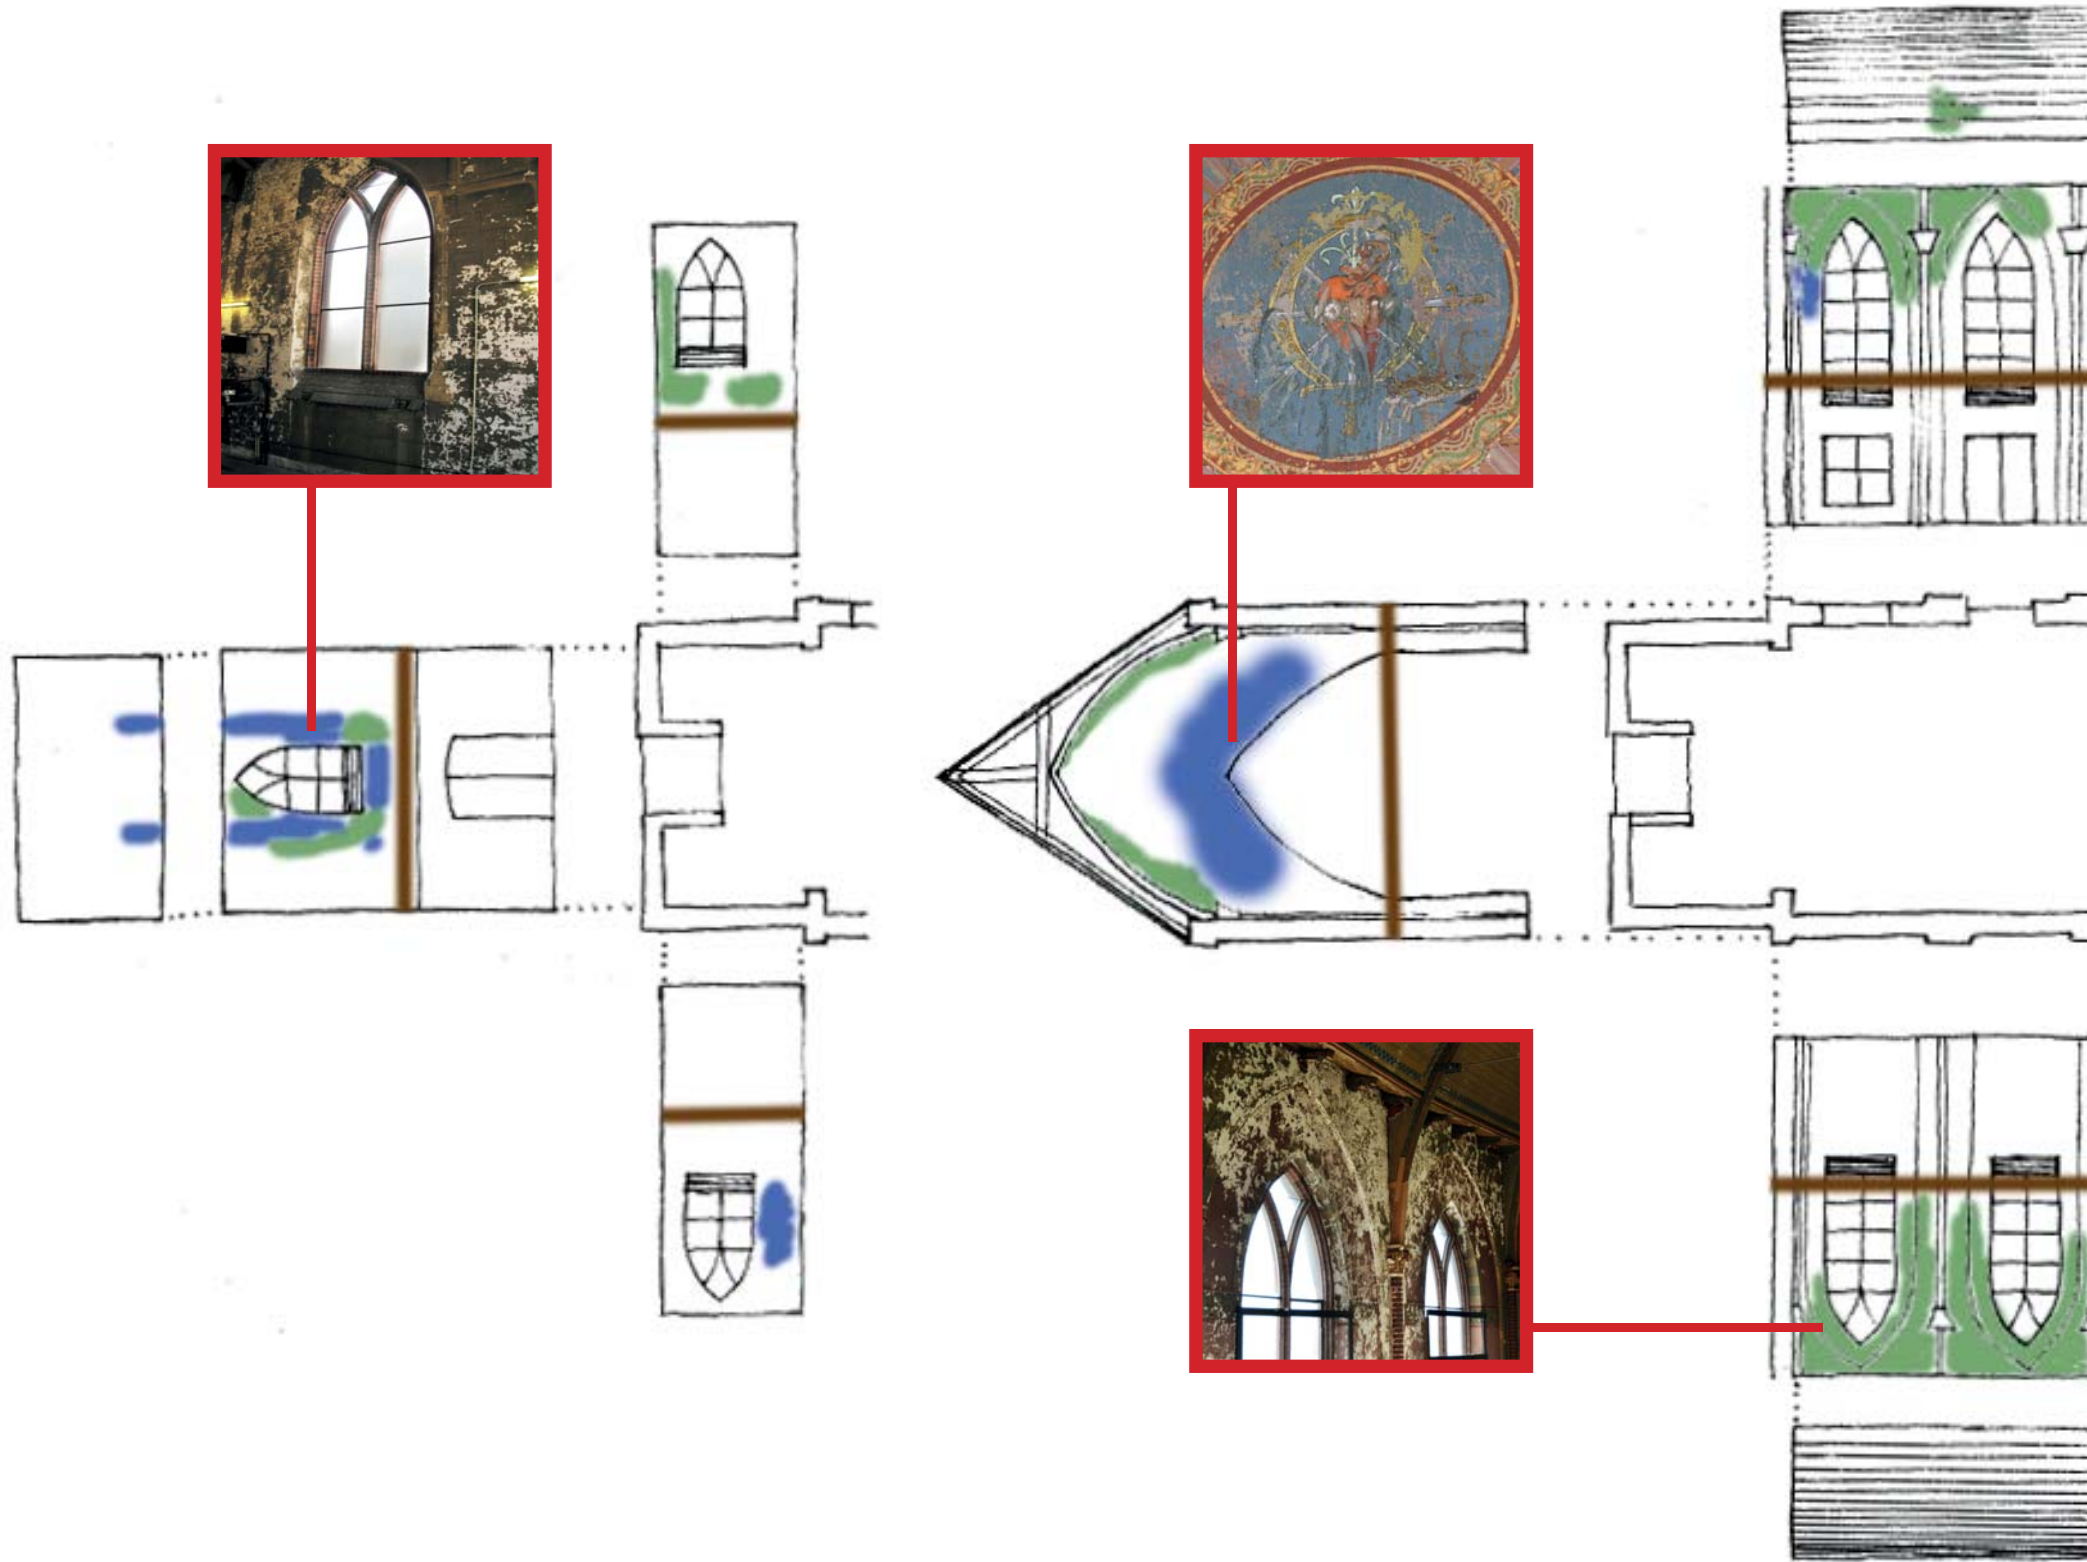
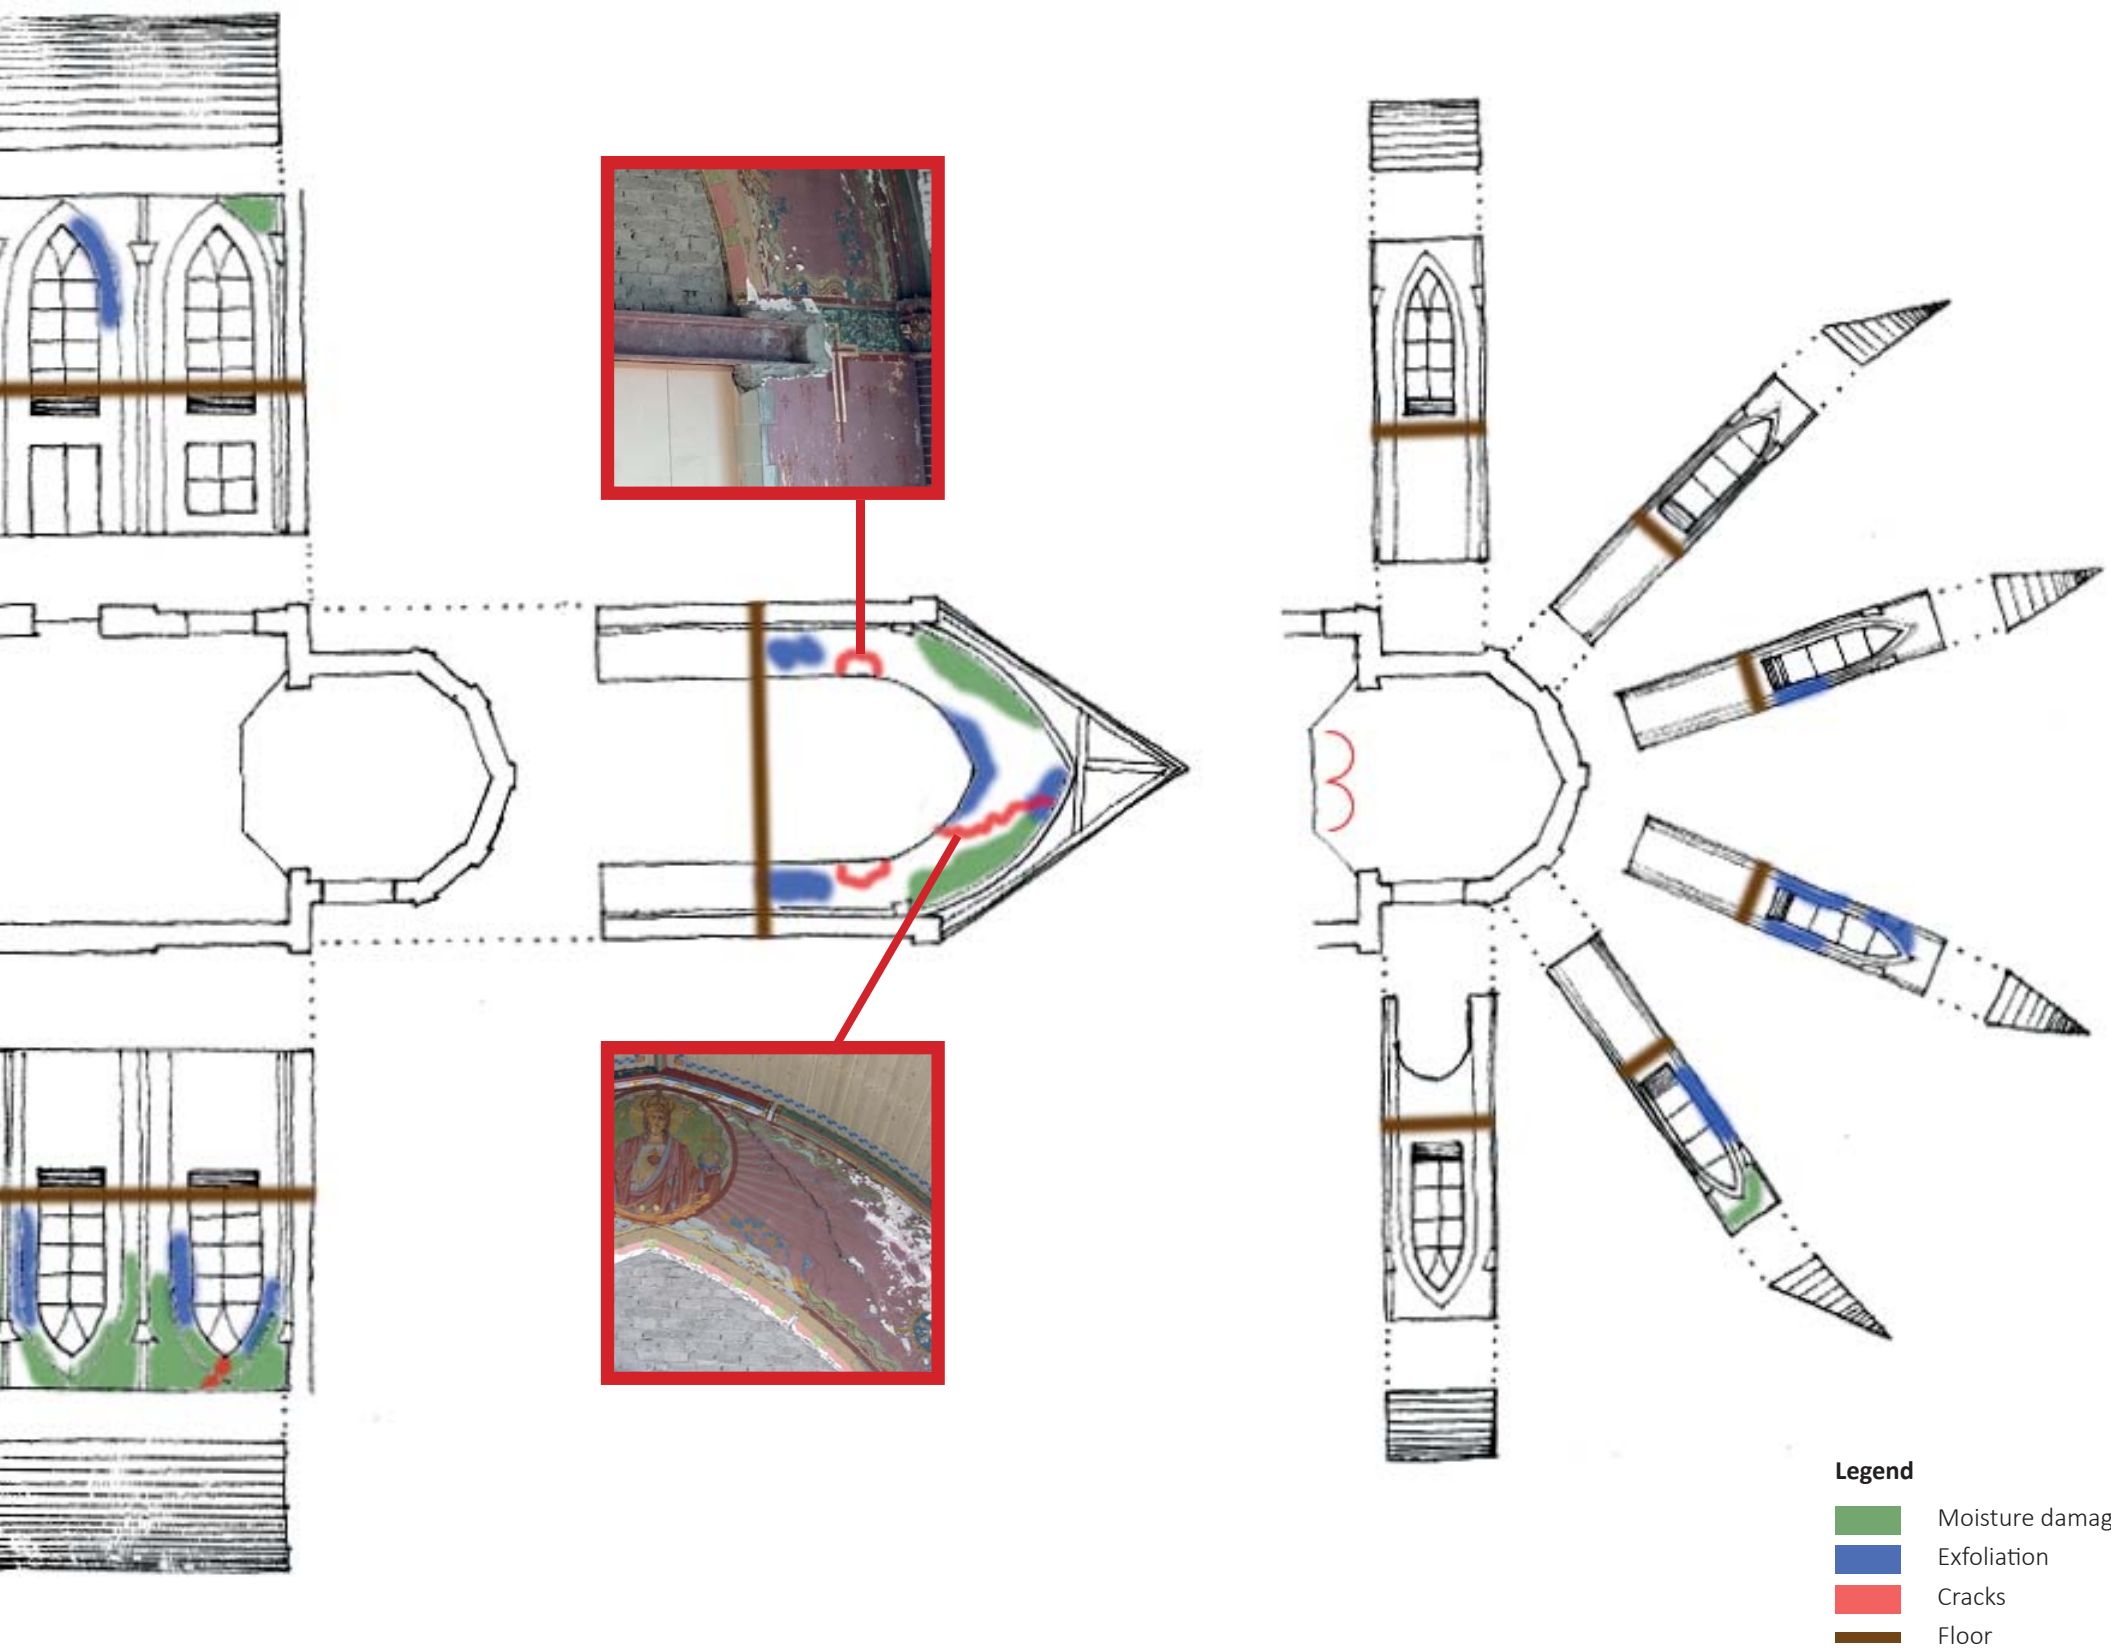
Figure 24. State of damages in the interior of the chapel
scale 1:200

Through the broken gutters water was able to leak into the walls which in turn caused a lot of damage to the paintwork inside the chapel. This damage is coloured green in figure 24 on the previous page. On these places everything has been pushed of the walls, leaving only the base layer whereupon the paintwork was made.

In some places the latest layer of paint has begun to peel of the walls, revealing the older layer of paint underneath. The places where this type of damage occurs is coloured blue in figure 24 on the previous page. This type of damage seems to occur on random spots in the chapel.

This damage comes from within the chapel, it is caused by how the chapel used to be heated. Due to peak hours that the chapel had to be warm the uppermost layer has begun to peel from its underground.

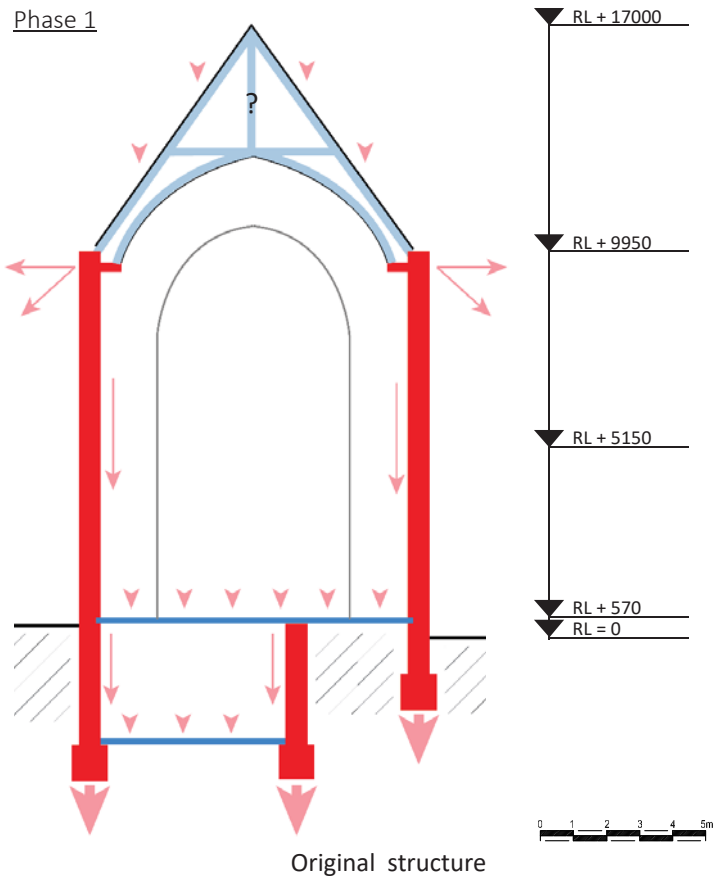
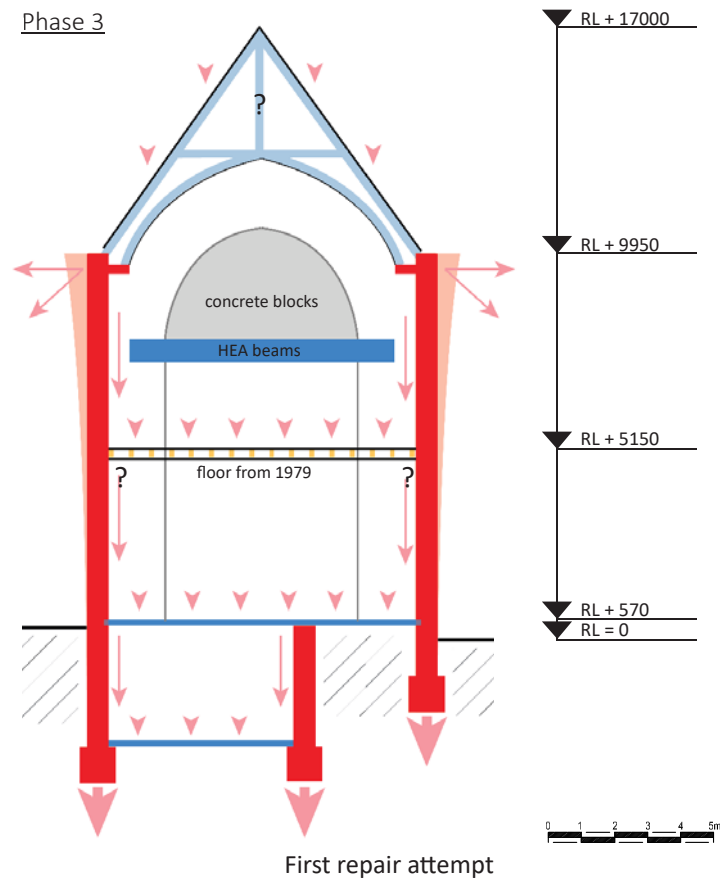
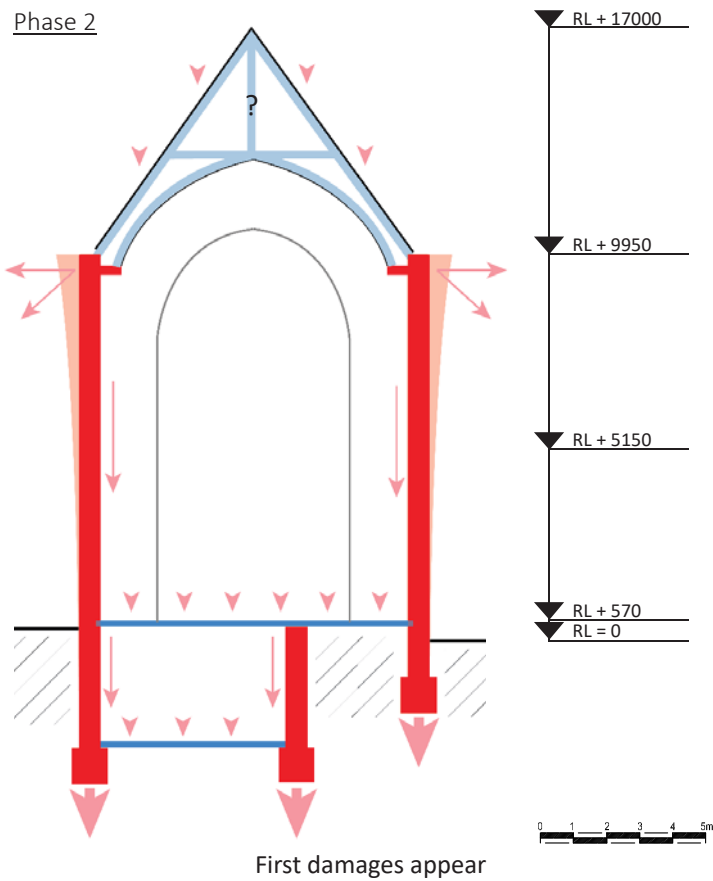
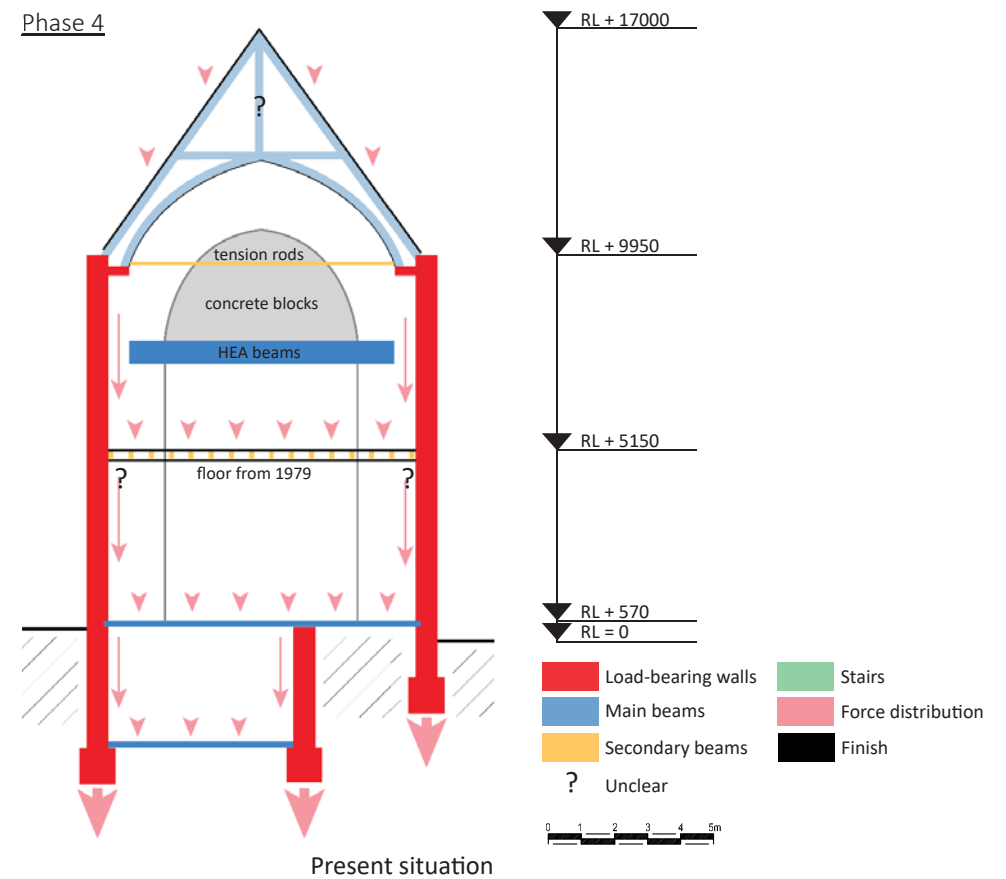
Figure 25. Structural damage

Phase 1 till phase 4 in figure 25 show why these damages appeared and where they came from.

Phase 1 shows the original structure of the Laymen's chapel. This section shows the load-bearing walls, the barrel vault and the force distribution in the building. In this first phase no horizontal connection was made between the two load-bearing walls.

Missing this vital connection, the walls of the chapel began to expand/bulge outward. This is shown in phase 2. The expansion/bulging of the walls caused the wall between the nave and choir to split in two and it caused the gutters to break.

Around the period of the redevelopment of the convent in 1979 the biggest damages in the chapel were strutted, visualized in phase 3. Two steel HEA beams were added under the arc in the wall between the nave and the choir. Later they filled the space between the beams and the masonry with concrete blocks, ensuring the wall wouldn't collapse.

The latest addition to the structure of the chapel are tension rods. These tension rods make the horizontal connection between the two load-bearing walls. In theory this would re-establish the balance of the force distribution of the walls.

However, it is worth to point out that only three of those tension rods were placed whereas there are five trusses (in Dutch: "kapsant").

The trusses next to the headboard walls did not receive tension rods, so the possibility remains that the crack is still growing.

The first thing that has to be done is controlling the damage. Crackmonitors will have to be placed on the crack between the nave and the choir to see if the crack is stabilized.

As stated earlier there remains a possibility that not enough tension rods were placed to provide a stable situation for the timber structure. One of the possibilities is to place the two extra tension rods connecting load-bearing walls on the trusses next to the headboard walls.
