Creep Failure of Reformer Tubes in a Petrochemical Plant

Abstract: This paper investigates a failure in HP-Mod radiant tubes in a petrochemical plant. Tubes fail after 90,000 h of working at 950 °C. Observed failure is in the form of excessive bulging and longitudinal cracking in reformer tubes. Cracks are also largely branched. The microstructure of service-exposed tubes was evaluated using optical and scanning electron microscopes (SEM). Energy-dispersive X-ray spectroscopy (EDS) was used to analyze and characterize different phases in the microstructure. The results of this study showed that carbides are coarsened at both the inner and the outer surface due to the long exposure to a carburizing environment. Metallography examinations also revealed that there are many creep voids that are nucleated on carbide phases and scattered in between dendrites. Cracks appeared to form as a result of creep void coalescence. Failure is therefore attributed to creep due to a long exposure to a high temperature.

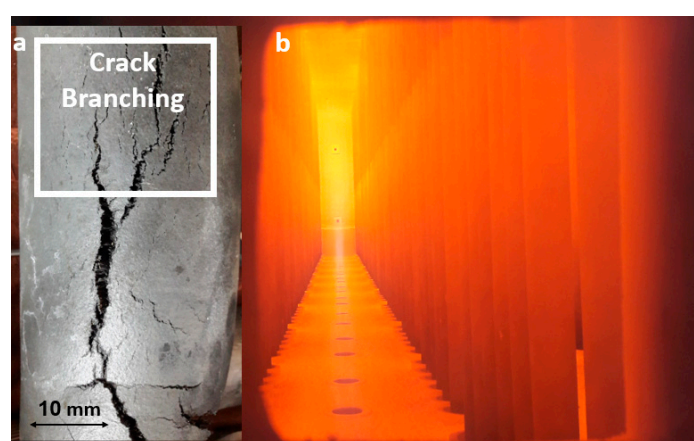
Figure 1 shows an example of failed reformer tubes together with an image, showing how tubes are installed in a reforming unit. As can be seen, cracks have propagated longitudinally. Extensive branching is also observed overall on the outer surface. It is also noticeable that in some parts tubes are largely deformed in such a way that a clear bulging is observed. Cracks are often seen in areas of localized deformation/bulging.

Figure 1. (a) Example of failed tubes and (b) an image of tubes in service.

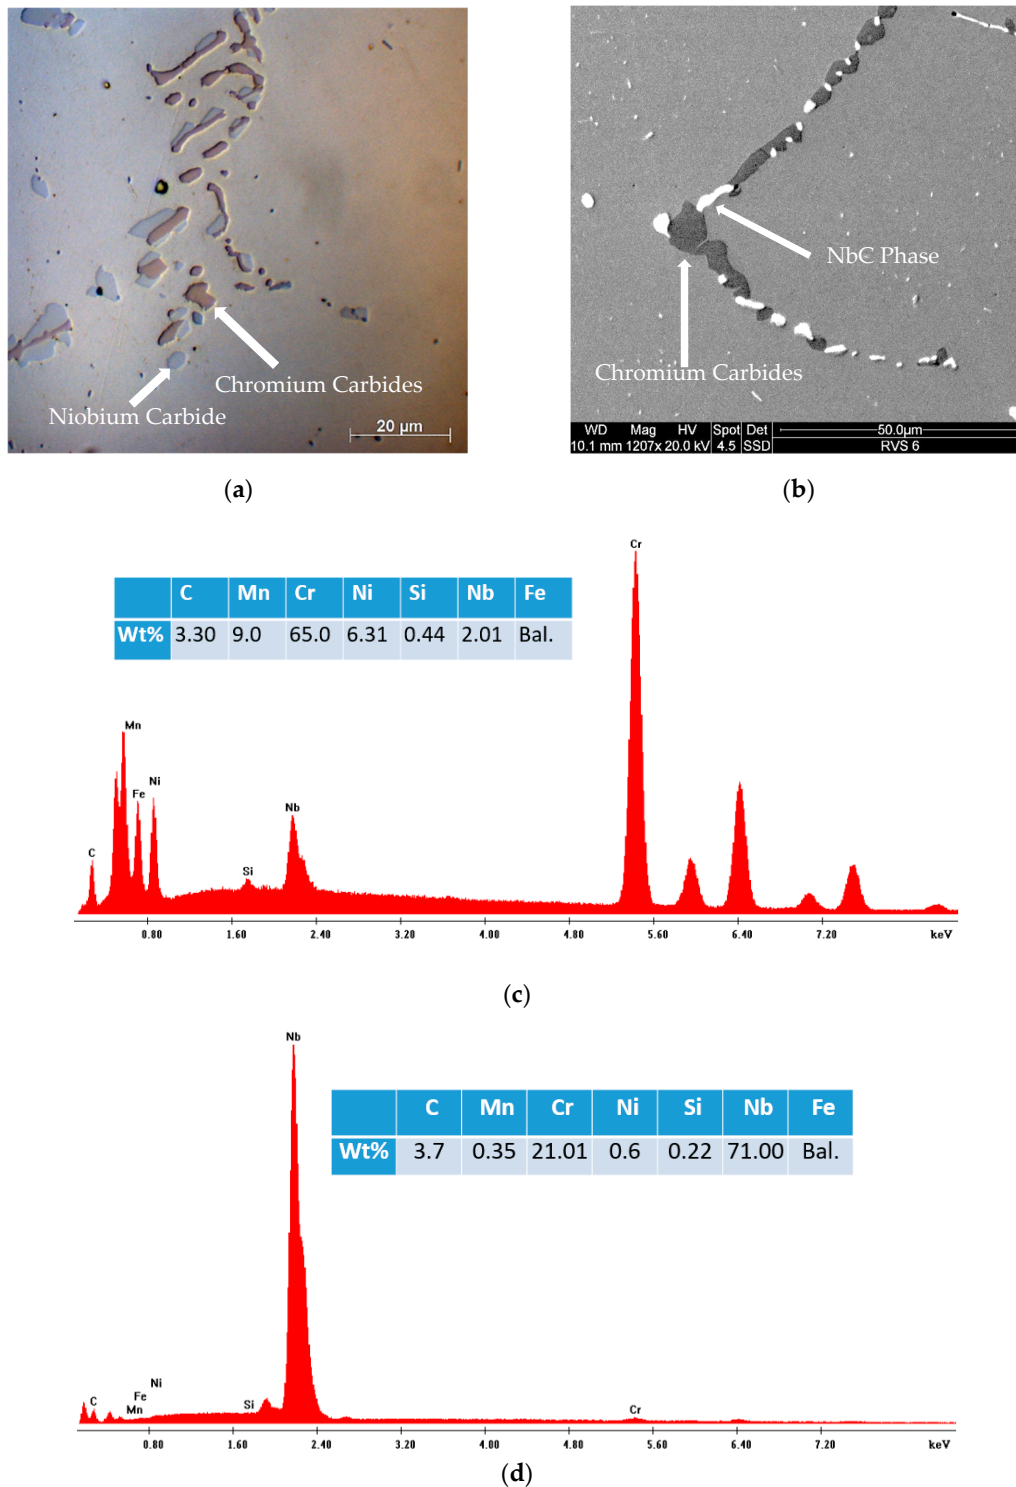
Optical and SEM micrographs of service-exposed tubes are shown in Figure 2. As can be seen, there are two types of morphologies for primary eutectic phases in the matrix. Primary eutectic phases can be categorized into “Chinese script” morphology (see Figure 2a) and a rather continuous grain boundary phase morphology (see Figure 2b). EDS analyses show that the eutectic phase is a mixture of dark and white phases, with the former ones being chromium carbides (Figure 2c), and more

specifically $M_{23}C_6$ and M_7C_3 carbides ($M = Fe, Cr$) ($M_{23}C_6$ carbides reportedly gradually transform to M_7C_3 carbides during the service due to carbon diffusion/carburization [6,7]), with the latter being niobium carbide (Figure 2d).

Figure 2. (a) Optical and (b) SEM images of the microstructure in failed tubes, together with EDS analyses of the (c) black phase (chromium carbide) and (d) white phase (NbC).

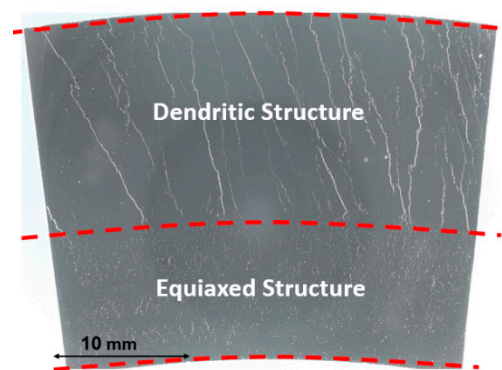
Figure 3. Stereomicroscope image of the cross section of the failed tube.

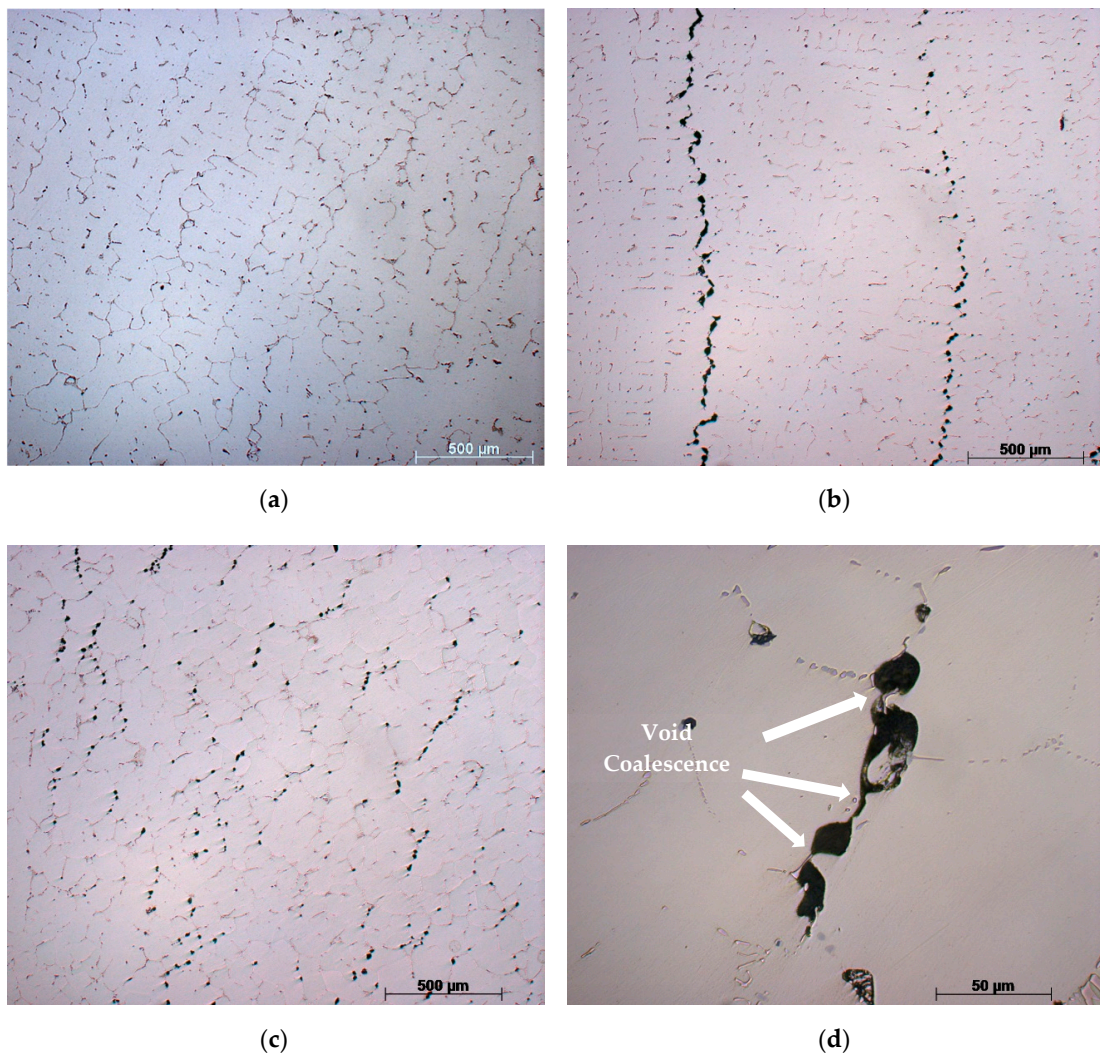
Figure 4. (a) The as-cast microstructure and voids in failed samples in (b) the dendritic structure region and (c,d) the equiaxed grain region.

- Creep voids were observed through the thickness of failed tubes. Voids in the dendritic structure region were oriented more alongside dendrites and were seen more often in the inter-dendritic regions. On the contrary, voids in the equiaxed grain structure were more randomly distributed without any directionality.

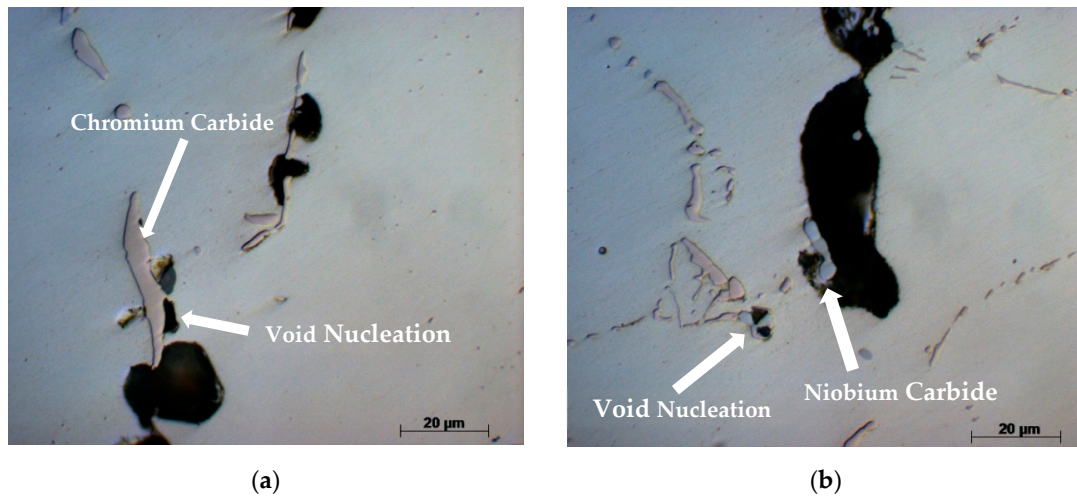
Figure 5. Void nucleation on (a) chromium carbide and (b) niobium carbide particles.

- Creep voids were nucleated on both chromium and niobium carbides. Cracks were formed due to the growth and coalescence of voids.
- The root cause analysis of the concerned failure showed that tubes failed due to creep failure.

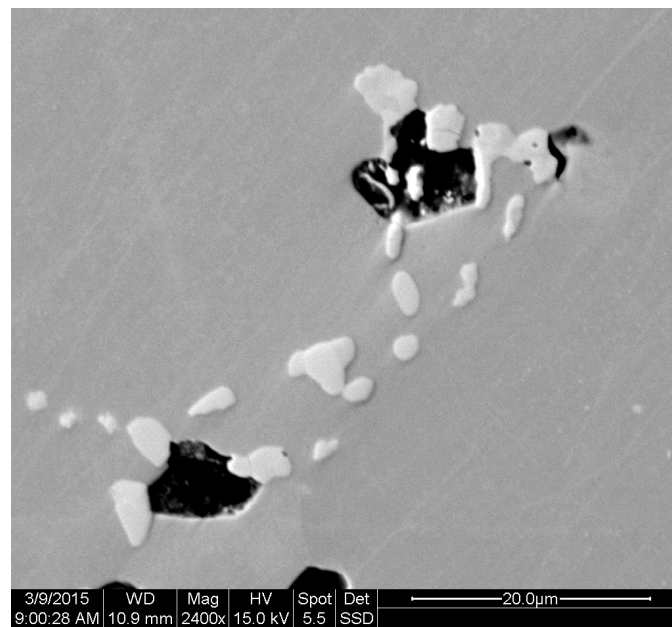
Figure 6. Creep voids are often nucleated in-between particles.

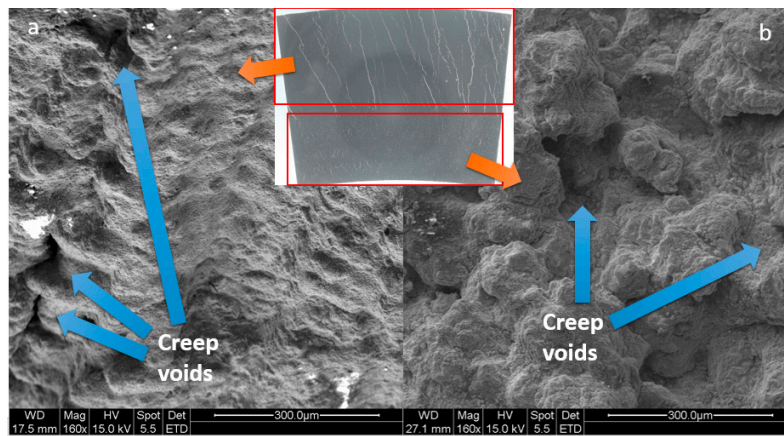
argument of creep-induced embrittlement in failed tubes [17]. However, the pictures do not show ordinary intergranular or interdendritic fractures. It is likely that the fracture surface was altered by the interaction with the steam/hydrocarbon/hydrogen atmosphere.

Figure 7. Fracture surface in (a) dendritic and (b) equiaxed grain regions.
