## A study on deterioration and residual service life of recovered azobé (*Lophira alata*) sheet piles

European Journal of Wood and Wood Products

# A study on deterioration and residual service life of recovered azobé (*Lophira alata*) sheet piles

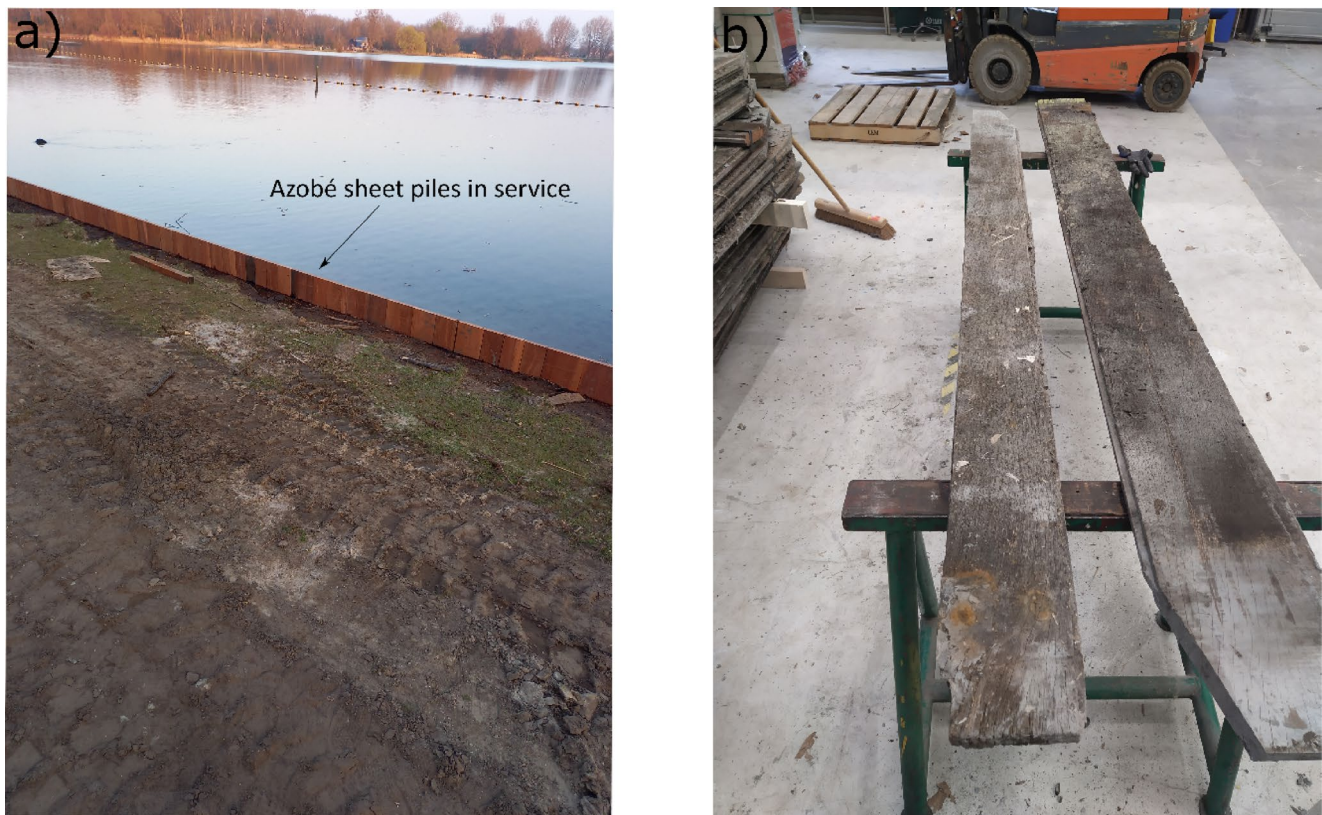
**Fig. 1** Full size azobé sheet piles (a) in service at Delftse hout, Delft, The Netherlands; (b) pulled out after 57 years of service from Medemblik, the Netherlands

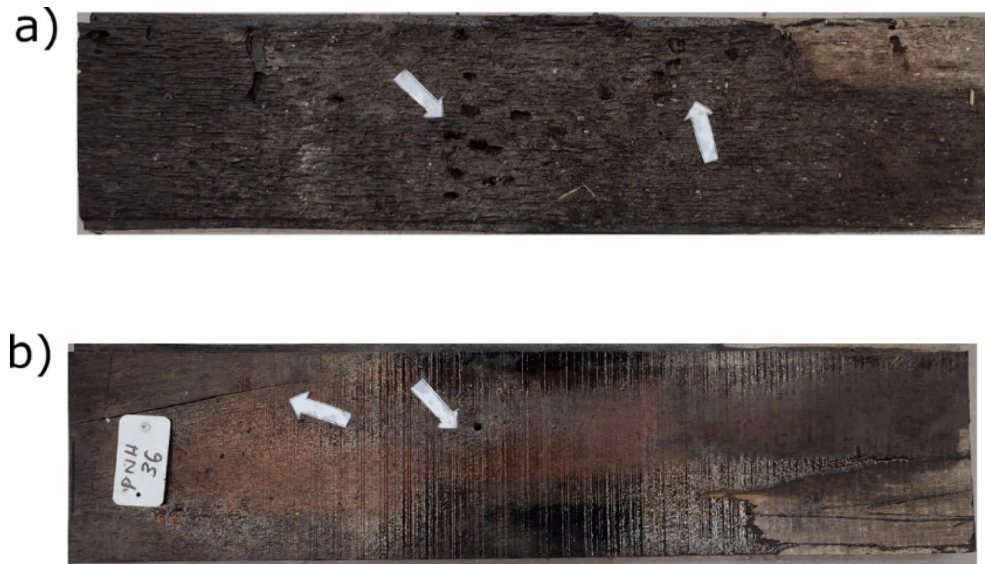
The deterioration of the recovered boards were seen to be non-uniform with respect to the face of the sheet pile. Sheet piles in service have a water-facing side and a soil-facing side. Erosion deterioration was observed in all boards throughout the length on the water side during visual assessment. Decay holes, resembling marine borer (*Teredo navalis*) attack passing through the full length of the sheet pile were observed in approximately 10% of the total boards analysed (Fig. 2). No visible deterioration was observed on the soil facing side. This outcome was also confirmed in

**Fig. 2** Detrimentation on water side (a) and earth side (b), with arrows highlighting the holes due to marine borer attack

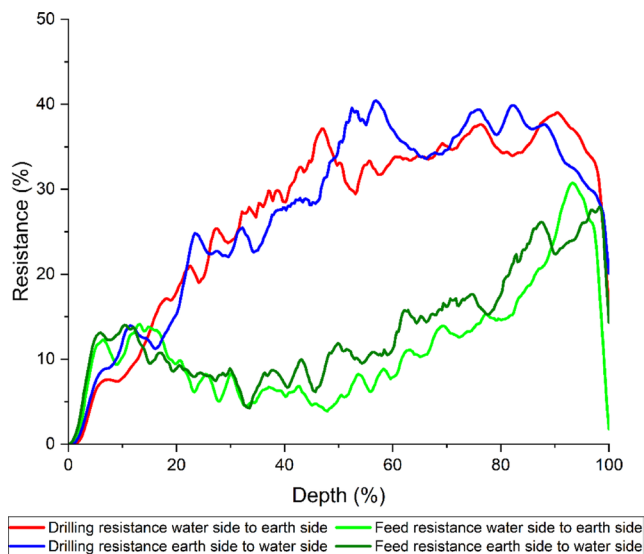
**Fig. 3** Drill and feed resistance from micro-drilling measurements executed from water side to earth side and vice versa

Resistance penetration drilling did not show any internal deterioration in the boards when drilled from earth side to water side and vice versa (Fig. 3). This proved to be true for both drilling and feed resistance (Fig. 3), with profiles very close to each other. Even though no direct comparison of micro-drilling measurements from new azobé boards was possible, those conducted at locations along the sheet piles which were embedded in soil with no deterioration, were similar to other parts of each board. Thus, the detected erosion on the boards, leading to a reduction in cross-sectional area, seemed to be limited only to their surface. Gard and van de Kuilen (2018) suggested that micro-drilling resistance testing on azobé can reveal not only defects like decay and cracks but also differences in density arising from slow growth and the presence of juvenile wood. They stressed that this detection capability is contingent upon precise calibration of the drilling, taking into account the depth, the wood's cross-sectional area, and the inherent characteristics of the wood species. Micro-drilling has been successfully used for assessing the decay in the outer layer of foundation piles in Amsterdam (Pagella et al. 2024) and proved to give useful insights into waterlogged piles (Humar et al. 2021). However, in this study no such decay or differences in density could be clearly detected, an outcome confirmed by the performed CT scans. Figure 4 shows an example of board featuring the aforementioned erosion in combination with marine borers attack, as well as an example of sound board. Interestingly, in spite of deterioration and long service life, the remaining cross section of the tested boards

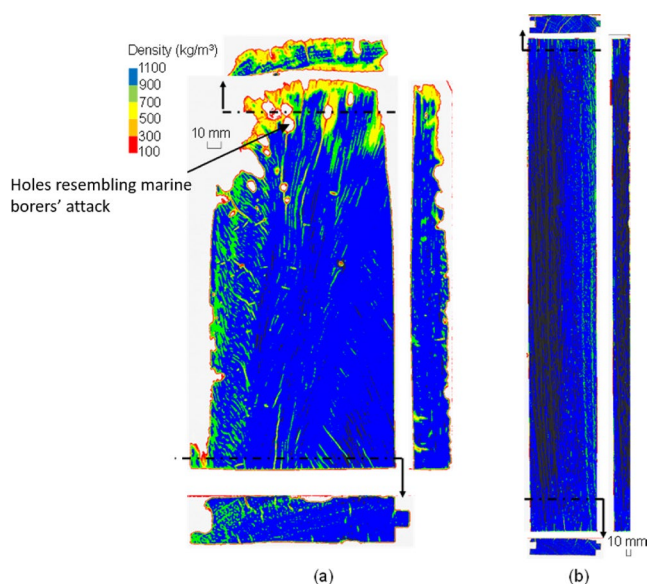
**Fig. 4** Results from CT scans on a decayed part of the board located on top water facing side (a) and sound part of the board located at bottom water facing side (b) Arrow indicates decay holes resembling marine borer attack

had densities comparable with those of fully sound azobé, underpinning the outcomes of micro-drilling measurements.

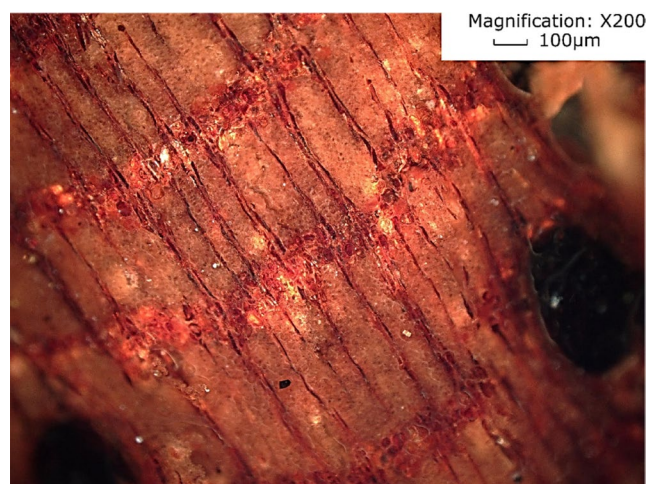
**Fig. 5** Example of radial section taken from the eroded portion of a board, with no apparent sign of severe degradation

Slices from intact and deteriorated parts showed a similar structure in microscopic analysis (Fig. 5). However, when the full boards were analysed on the water-facing side, fungi colonies resembling worm-spored wax cup (*Orbilbia aurantiorubra*) were detected, see Fig. 6. This may be an

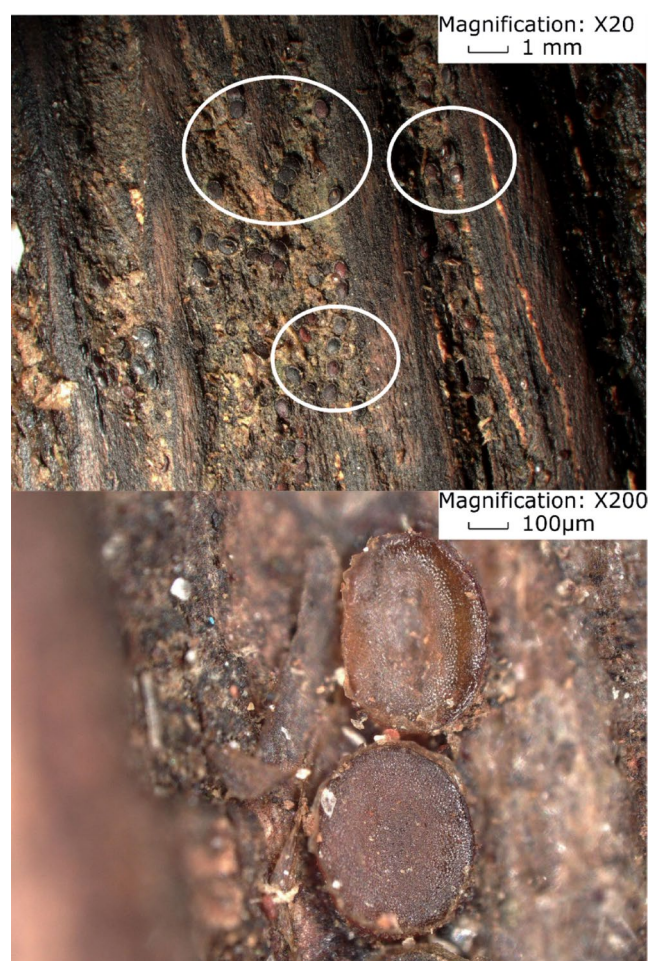
**Fig. 6** Fungi resembling worm-spored wax cup (*Orbilbia aurantiorubra*) detected under microscopic analysis on the water-facing surface of a board

indication of slow fungal decay process in progress, since the observed micro-organisms are known to be usually secondary colonisers found in hardwoods. While these fungi primarily thrive in moist, organic-rich environments, their specific effects on highly durable hardwoods like azobé remain less studied. Azobé's natural resistance to decay likely limits *Orbilbia*'s direct impact, although it may appear in later stages of degradation if the wood is compromised by more aggressive decay agents.

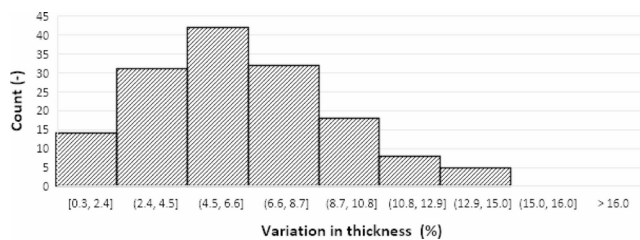
**Fig. 7** Distribution of variation in thickness obtained comparing most intact part of the sheet pile with least intact part of the sheet pile

non-parametric methods were 60 MPa and 58 MPa according to EN 384 (2016). The reduction in cross-sectional thickness was determined by measuring the most intact part of the sheet pile and least intact part of the sheet pile, see Fig. 7. Typically, bending loads govern the behavior of timber sheet piles used for bank protection; consequently, only bending test results were used in this study and the damage accumulation model.

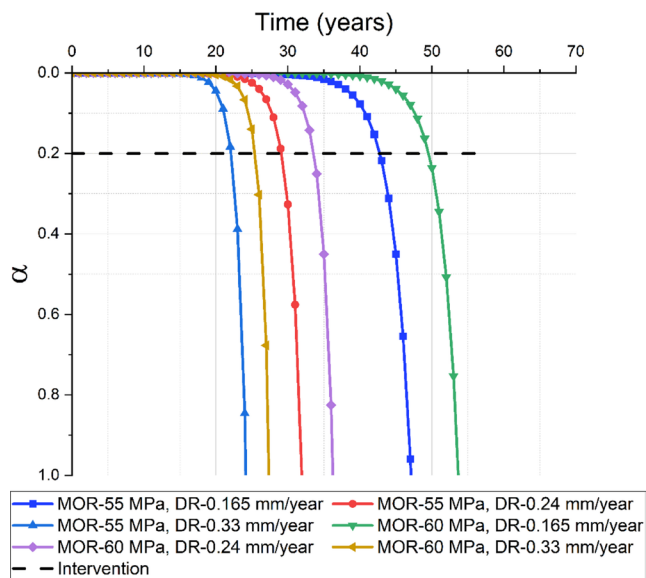
For predicting the future damage accumulation, azobé board strength corresponding to D55, D60 is considered. While full damage is accumulated when  $\alpha = 1$ , an interim value of alpha could be taken for planning any maintenance and intervention. A limit value of  $\alpha = 0.2$  is assumed as time for any intervention. The variation of damage accumulation on the sheet pile for D60 and D55 is shown in Fig. 9 for an acting bending moment of 5 kNm. It can be seen that an intervention would be required in 22 years, when a sheet pile strength D55 and a 1% decay rate (0.33 mm/year) is taken. The time for maintenance and intervention increases to 43 years when decay rate is 0.5% of the current thickness.

**Fig. 9** Damage accumulation with bending strength of 55 MPa and 60 MPa. DR- decay rate in mm/year

When the strength of the material is taken as D60 and a 0.33 mm/year, 0.24 mm/year, and 0.165 mm/year decay rate is considered, intervention would be necessary at 25, 34, and 49 years, respectively (Fig. 9).
