## Creep failure of reformer tubes in a petrochemical plant

# Creep Failure of Reformer Tubes in a Petrochemical Plant

**Abstract:** This paper investigates a failure in HP-Mod radiant tubes in a petrochemical plant. Tubes fail after 90,000 h of working at 950 °C. Observed failure is in the form of excessive bulging and longitudinal cracking in reformer tubes. Cracks are also largely branched. The microstructure of service-exposed tubes was evaluated using optical and scanning electron microscopes (SEM). Energy-dispersive X-ray spectroscopy (EDS) was used to analyze and characterize different phases in the microstructure. The results of this study showed that carbides are coarsened at both the inner and the outer surface due to the long exposure to a carburizing environment. Metallography examinations also revealed that there are many creep voids that are nucleated on carbide phases and scattered in between dendrites. Cracks appeared to form as a result of creep void coalescence. Failure is therefore attributed to creep due to a long exposure to a high temperature.

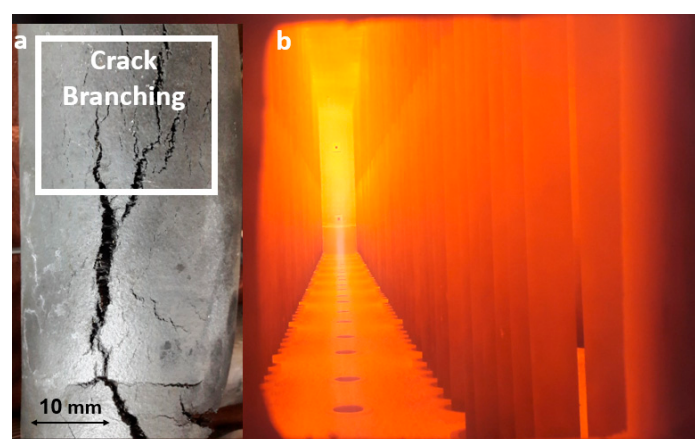
Figure 1 shows an example of failed reformer tubes together with an image, showing how tubes are installed in a reforming unit. As can be seen, cracks have propagated longitudinally. Extensive branching is also observed overall on the outer surface. It is also noticeable that in some parts tubes are largely deformed in such a way that a clear bulging is observed. Cracks are often seen in areas of localized deformation/bulging.

**Figure 1.** (a) Example of failed tubes and (b) an image of tubes in service.

- When it comes to creep failure, the most important factor that controls the lifetime of the components during a high temperature service is temperature. Improper control of temperature and overheating can dramatically decrease the creep lifetime of reformer tubes.

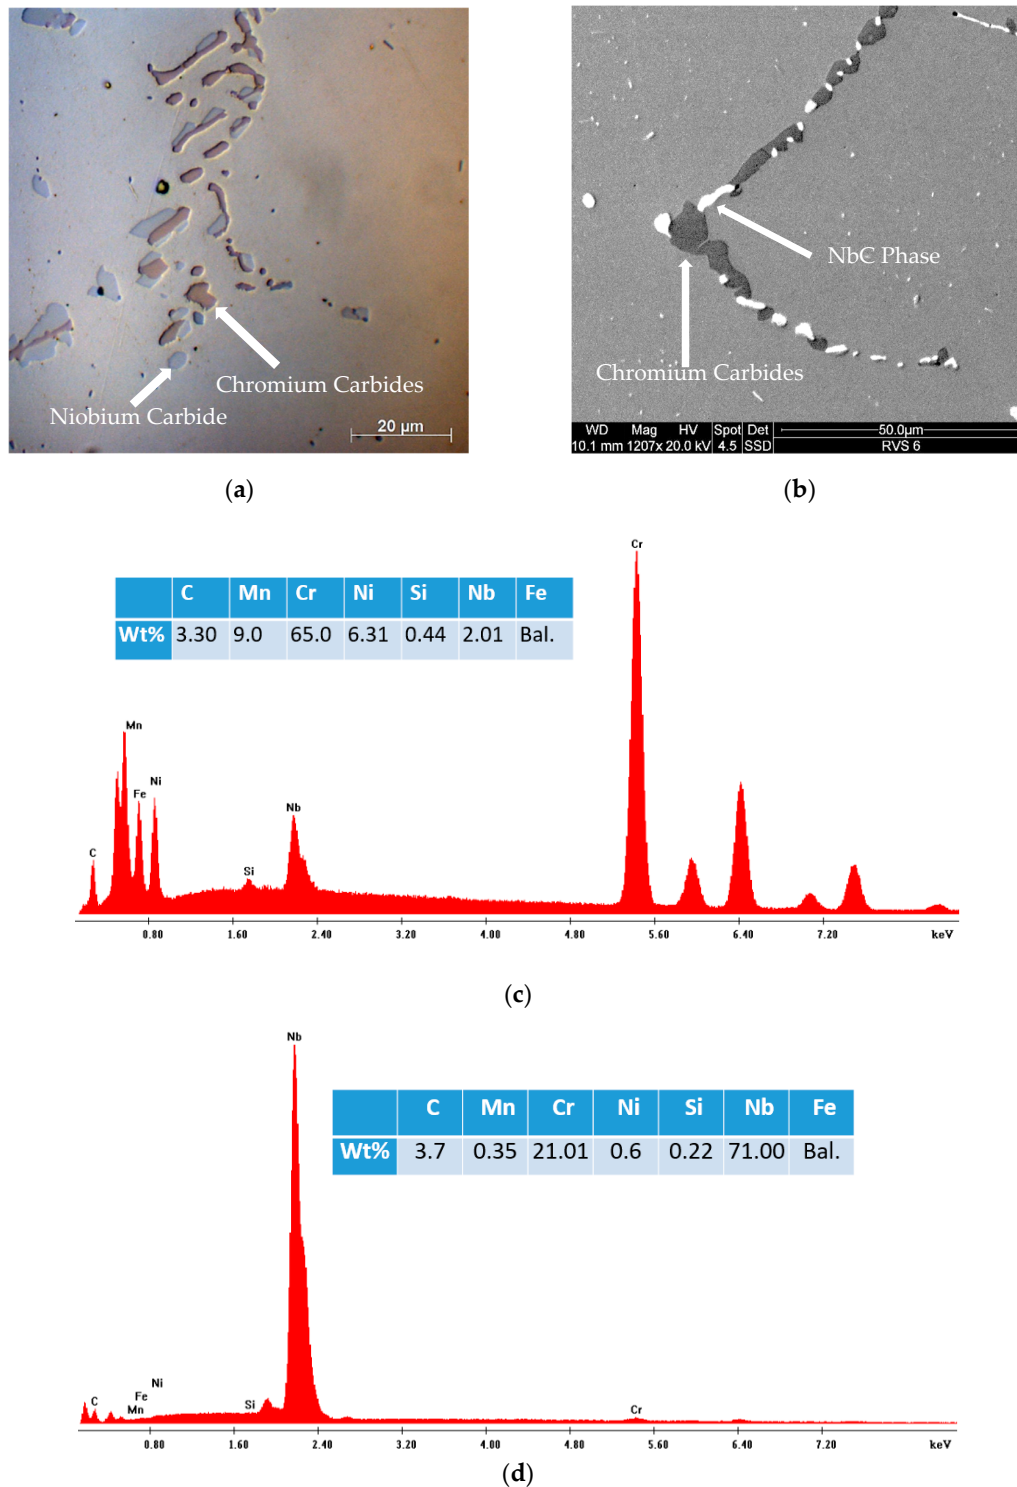
Optical and SEM micrographs of service-exposed tubes are shown in Figure 2. As can be seen, there are two types of morphologies for primary eutectic phases in the matrix. Primary eutectic phases can be categorized into “Chinese script” morphology (see Figure 2a) and a rather continuous grain boundary phase morphology (see Figure 2b). EDS analyses show that the eutectic phase is a mixture of dark and white phases, with the former ones being chromium carbides (Figure 2c), and more

specifically  $M_{23}C_6$  and  $M_7C_3$  carbides ( $M = Fe, Cr$ ) ( $M_{23}C_6$  carbides reportedly gradually transform to  $M_7C_3$  carbides during the service due to carbon diffusion/carburization [6,7]), with the latter being niobium carbide (Figure 2d).

**Figure 2.** (a) Optical and (b) SEM images of the microstructure in failed tubes, together with EDS analyses of the (c) black phase (chromium carbide) and (d) white phase (NbC).

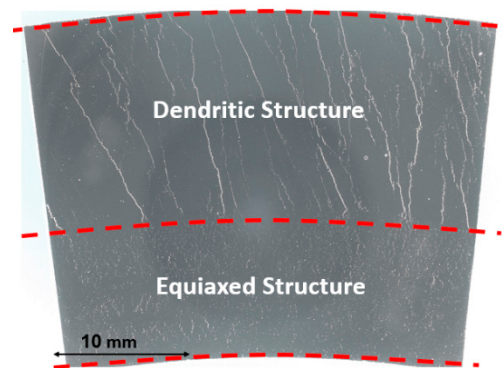
Figure 3. Stereomicroscope image of the cross section of the failed tube.

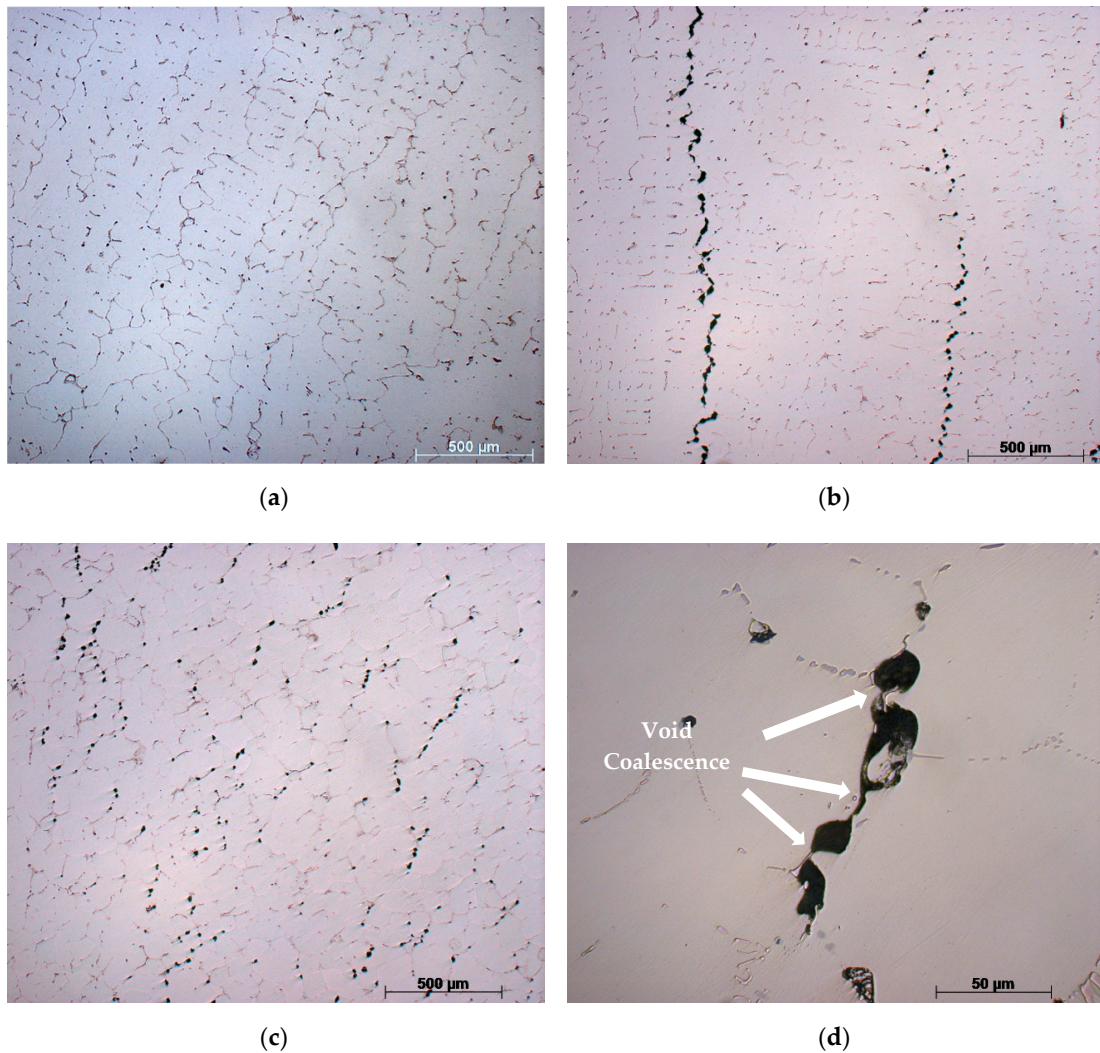
Figure 4. (a) The as-cast microstructure and voids in failed samples in (b) the dendritic structure region and (c,d) the equiaxed grain region.

- Creep voids were observed through the thickness of failed tubes. Voids in the dendritic structure region were oriented more alongside dendrites and were seen more often in the inter-dendritic regions. On the contrary, voids in the equiaxed grain structure were more randomly distributed without any directionality.

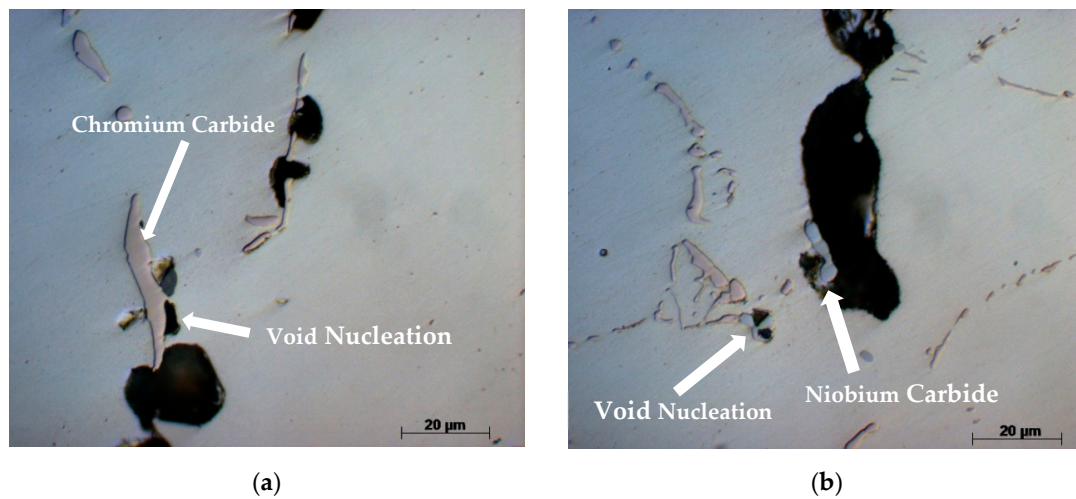
**Figure 5.** Void nucleation on (a) chromium carbide and (b) niobium carbide particles.

- Creep voids were nucleated on both chromium and niobium carbides. Cracks were formed due to the growth and coalescence of voids.
- The root cause analysis of the concerned failure showed that tubes failed due to creep failure.

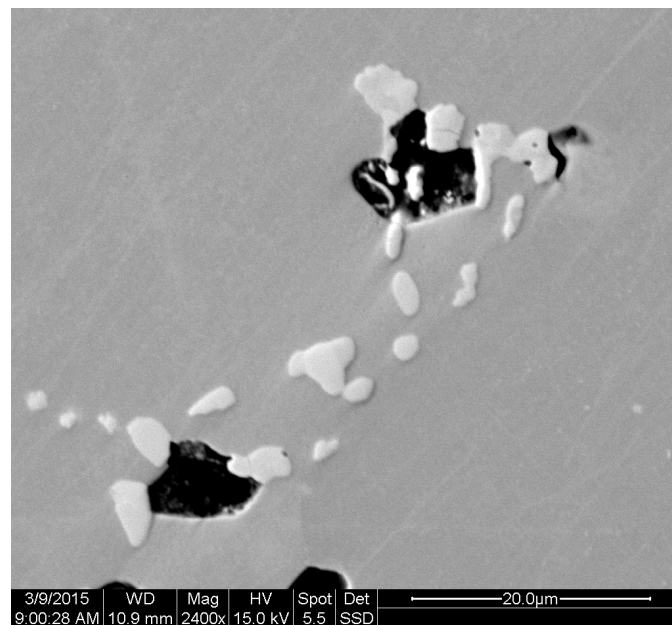
**Figure 6.** Creep voids are often nucleated in-between particles.

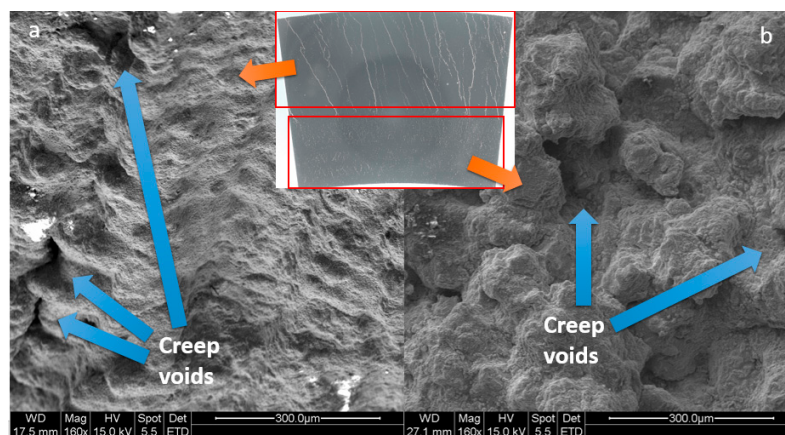
argument of creep-induced embrittlement in failed tubes [17]. However, the pictures do not show ordinary intergranular or interdendritic fractures. It is likely that the fracture surface was altered by the interaction with the steam/hydrocarbon/hydrogen atmosphere.

**Figure 7.** Fracture surface in (a) dendritic and (b) equiaxed grain regions.
