## Roof of FC Twente Stadium

Case Studies on Failure Investigations in Structural and Geotechnical Engineering

# Roof of FC Twente Stadium

*This chapter focuses on human and organizational factors that are usually behind the technical cause of failure. In this chapter the focus is on the collapse of the extension of the roof of the Football Club Twente stadium in Enschede (The Netherlands) during construction, resulting in two fatalities.*

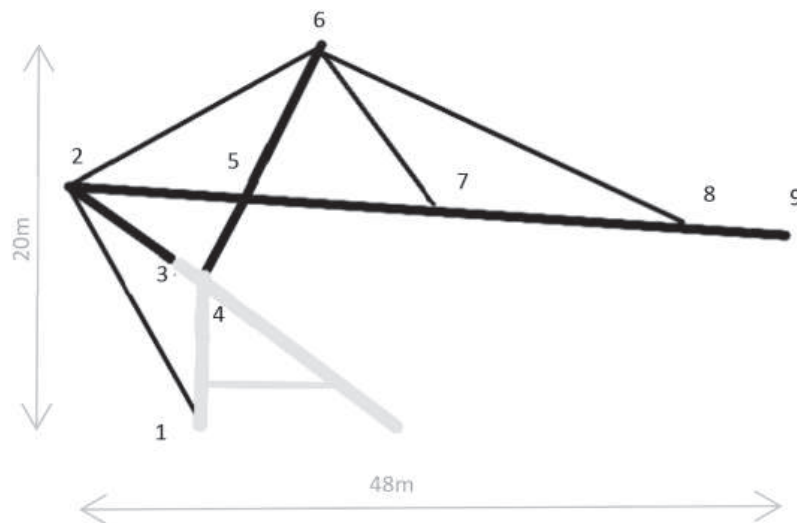
**Figure 8.1** Schematic overview of bearing frame (Based on [2]).

The structure for the extension of the roof in 2011 consisted of 11 bearing frames. Each bearing frame had a length of approximately 48 m and a height of approximately 20 m (see Figure 8.1). The bearing frame was constructed out of steel tubes. These were mounted on the concrete grandstand structure.

The engineers created stability out of plane by coupling bars and braces at the positions of 2, 5, 6, 7, and 8. The roof, a steel structure with steel sheeting, was positioned below position 2, 5, 7, 8, and 9. All frames were erected when the structure collapsed (Figure 8.2).

- the frame where the video-wall was connected collapsed first;
- the main cause of failure was out-of-plane buckling of the outer parts of two frames where the connecting bar at position 2 was missing.

Instability of the structure during construction can be regarded as a sufficient technical cause. TNO calculated a buckling factor  $n=1.67$  for the situation without coupling bars [2, p.74 and annex]. The buckling factor was calculated here as the ratio between the buckling capacity load (Euler's critical load of a perfect structure) over the actually applied load (no load factors used)[1]. If  $n>10$  no instability issues are to be expected. If  $n<1$  instability is to be expected. A factor of 1.67 means that the structure is very vulnerable for instability, although it will not necessarily result in a collapse if there is hidden capacity. TNO also calculated that without the loads of video-wall etc., the buckling factor of this structure still would be around 2.

In case the coupling bars would have been present, this would result in a buckling factor of  $n=12$ . Thus, the presence of these coupling bars would have significantly increased the capacity against buckling as the buckling length would have been reduced. The absence of these bars was therefore regarded to be a major contributing factor.

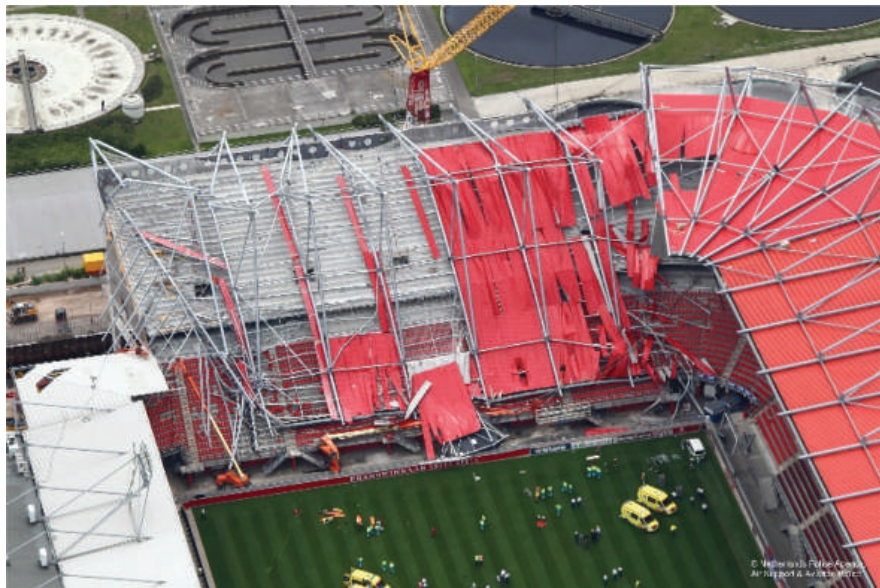
However, the structure appeared not to be fully assembled at the moment of collapse. One coupling bar between the nodes 6 of two frames was lacking. Furthermore, several

**Figure 8.2** Roof of FC Twente stadium after collapse. Reproduced by permission of Netherlands Police Agency, Air support and Aviation Police.

couplings between nodes 2 of various frames were missing to enable easier construction with the tower cranes. Temporary braces were removed to apply safety nets. Part of the steel roofing was already assembled.

Although the structure was not completed, it was already loaded in various ways. Roofing sheets were stacked on the roof waiting for assembly. Labourers were walking on the roof for assembly of the remaining structure. Furthermore, hanging bridges were connected to the roof for assembly, and several days before the collapse a video-wall of 8400 kg was installed at the position of node 9.
