# Quasi-static test on half-scale modern unreinforced masonry building with plan irregularity

Abide Aşıkoğlu<sup>1</sup> · Graça Vasconcelos<sup>2</sup> · Alberto Barontini<sup>2</sup> · Paulo B. Lourenço<sup>2</sup>

## Abstract

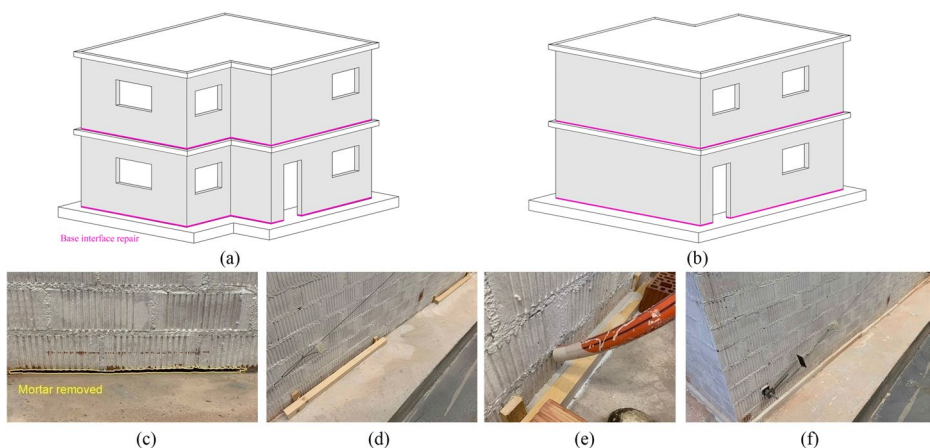
Following the completion of Test 1, minor damage was observed on the structural walls. However, the boundary interface of the walls was detached from the foundation, leading to detachment at the base. To ensure the specimen remains suitable for continued testing, lim-

ited modifications were carried out prior to Test 2. These modifications were guided by practical considerations and focused exclusively on restoring the original boundary conditions without altering the specimen's structural characteristics. Specifically, fluid mortar (Mape-Antique I) was used to re-establish the wall-foundation and wall-slab connections, ensuring continuity in load transfer and overall stability, see Table 4. The repair was carried out along the perimeter at the base interface of the walls on both floors, as shown in Fig. 9(a), and (b). The bed joint below the first course of bricks was carefully removed progressively, firstly on the first floor (Fig. 9(c) and (d)). A mould with a height of 70 mm was prepared to cast the new consolidation material. Before applying Mape-Antique I, the area was sprayed with water to prevent excessive absorption of water by the bricks and concrete. This cement-free hydraulic binder, with an 18 MPa compressive strength after 28 days, was selected for its superfluid consistency and a maximum aggregate size of 100  $\mu\text{m}$  to prevent the occurrence of voids (Fig. 9(e)). After repairing the first bed joint on the first floor, a 7-day curing period was considered before proceeding with the second floor (Fig. 9 (f)). No repairs were performed on the observed wall cracks, as introducing new materials and reinforcement could have influenced the structural behaviour.

**Fig. 9** Repair of the base interface along the perimeter (highlighted in pink) to restore the wall-foundation or slab connection after Test 1: **(a)** North-West façade, **(b)** South-East façade, **(c)** removal of the cement-based mortar, **(d)** preparation of the formwork, **(e)** filling in Mape-Antique I slurry, and **(f)** end of the application

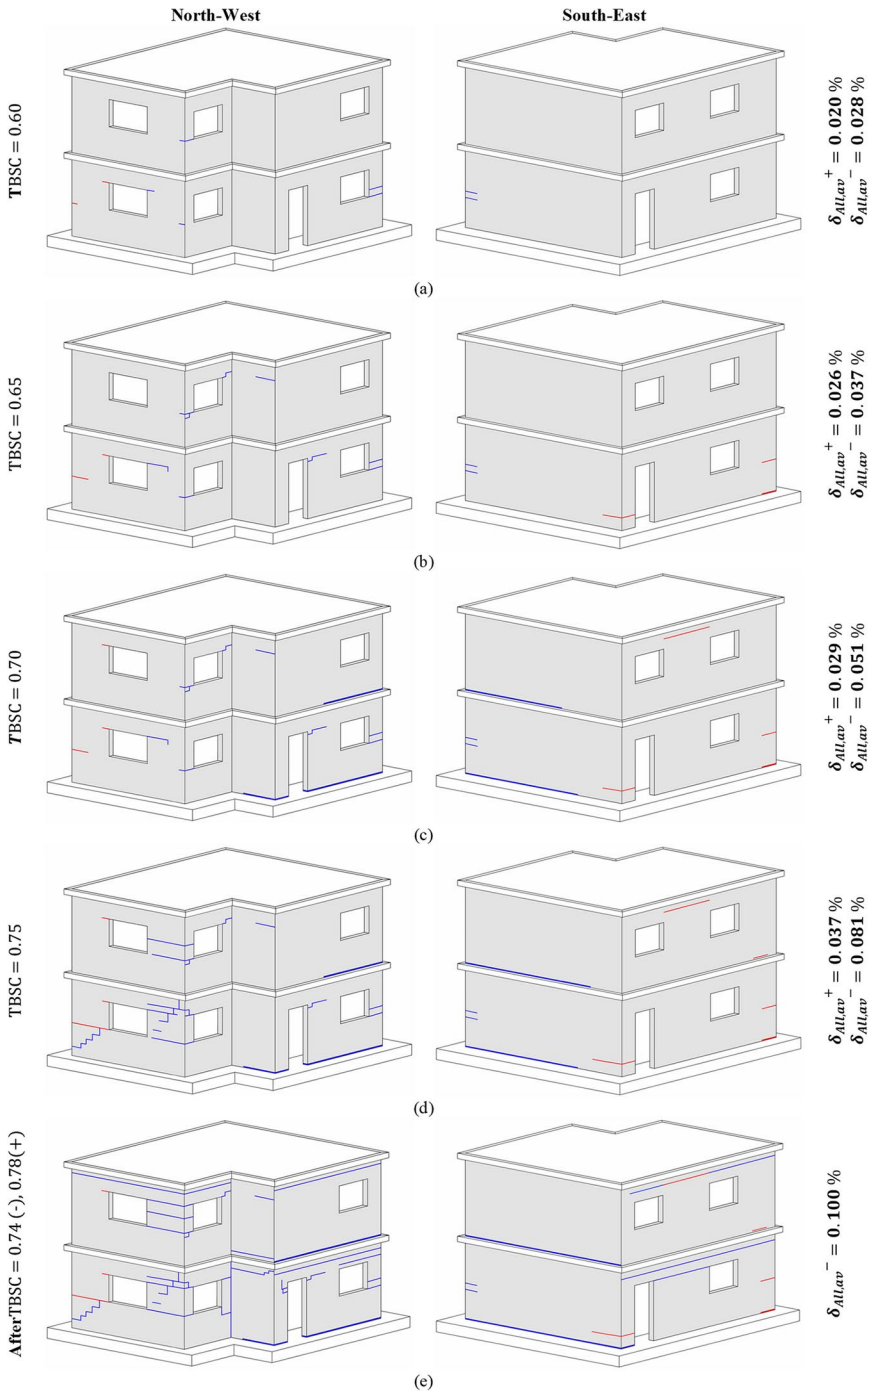
The damage analysis indicated no visible cracks until the applied lateral load reached 60% of the total weight of the structure (total BSC=0.60). The average drift ratio on the second floor ( $\delta_{All,ave}$ ) was measured at 0.020% (0.62 mm) in the positive direction and 0.028% (0.86 mm) in the negative direction (Fig. 14a). Crack initiation was identified at low drift values recorded on the first floor, with bed joint cracks appearing at the south-west corner at an inter-story drift ratio of 0.012% in the negative direction. see Fig. 15(c). Crack occurrence was primarily driven by the load applied in the negative direction. Signs

**Fig. 14** Evolution of damage throughout Test 1. The red colour refers to damage due to loading in the positive direction while the blue colour indicates cracks as a result of negative loading

of flexural tension cracks were detected on the North1 wall piers on the first floor. Initial cracks align with high-stress concentrations around window and door openings, as well as the corners (specifically, the southwest corner on the first floor and the northwest corner on the second floor). These cracks further expanded to perpendicular walls, highlighting the effectiveness of the flange, as shown in Fig. 17.

Following an increase in the lateral load of 5%, the average absolute drift on the second floor reached 0.026% (0.78 mm), resulting in the extension of flexural tension cracks at the North piers and further propagation to the orthogonal East wall under the loading in the positive direction (see Fig. 14b). The first evidence of uplift occurred at the base of the northeast corner (Total BSC=0.65 in the positive direction). In the negative direction, the applied lateral load resulted in an average absolute drift of 0.037% (1.11 mm) on the second floor, causing crack occurrences along the mortar and brick interface throughout the structure (Fig. 16). A considerable crack developed on the right side of the door opening on the West wall, which was in the perpendicular direction to the load application. This was a clear indication of the flange effect and the torsional rotation characterising the response of

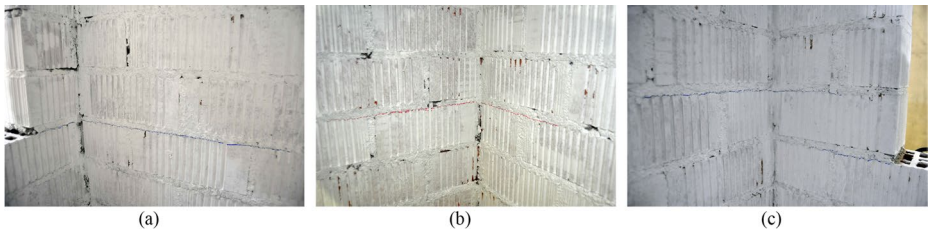
**Fig. 16** Horizontal cracks observed at the corners: (a) northwest corner, (b) northeast corner, (c) southwest corner

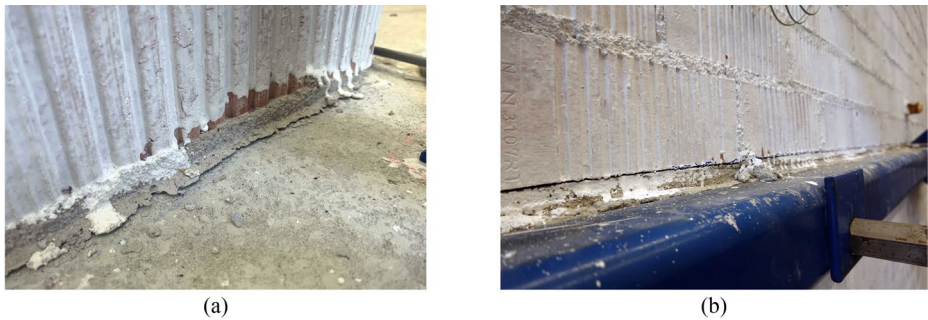
At a Total BSC of 0.70, crack progression under positive loading cycles was gradual compared to the negative cycles. Horizontal cracks formed primarily along bed joints, with one developing directly beneath the actuator on the second floor and another at the northeast corner (Fig. 14c). A critical shift in structural behaviour was observed at a total drift of 0.051% in the negative direction ( $u_{2,2}=1.52$  mm), when the southwest corner began

Fig. 18 Uplift deformations observed at the boundary of the: (a) Southwest corner on the first floor, (b) South wall on the second floor

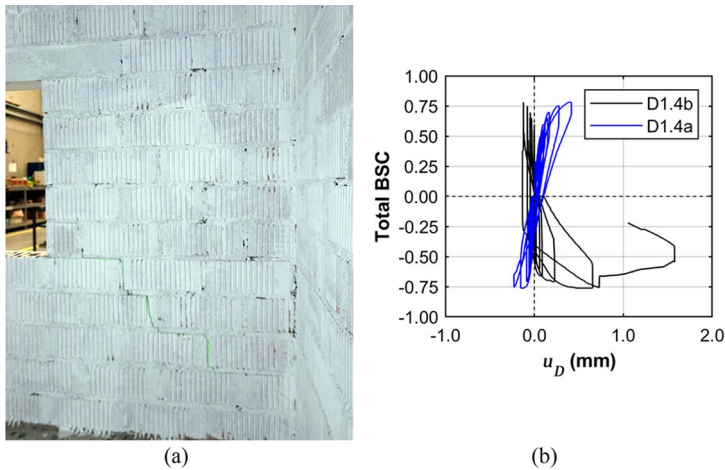
**Fig. 20** Diagonal shear crack on North1 wall: (a) green line, interior view, (b) diagonal crack opening by D1.4a and D1.4b

failed, see Fig. 20 (b). It is interesting to note that, in the case of North 1 wall, flexural cracks initiated on the left-hand pier at an inter-story drift ratio of 0.018%. In comparison, similar flexural cracks appeared on the right-hand pier under the same load applied in the negative direction, associated with a higher inter-story drift ratio of 0.028%. Up to a Total BSC of 0.75, the North1 wall's response was governed by flexure. Still, at this load level, the inter-story drift ratio on the first floor reached an average of 0.084% (based on L1.4X and L1.5X), and the wall developed a diagonal crack, exhibiting a combined flexural and diagonal shear mechanism. Notably, this drift value is significantly lower than those suggested for in-plane walls in the literature (EN 1998-1:2004, 2004; Morandi et al. 2018).

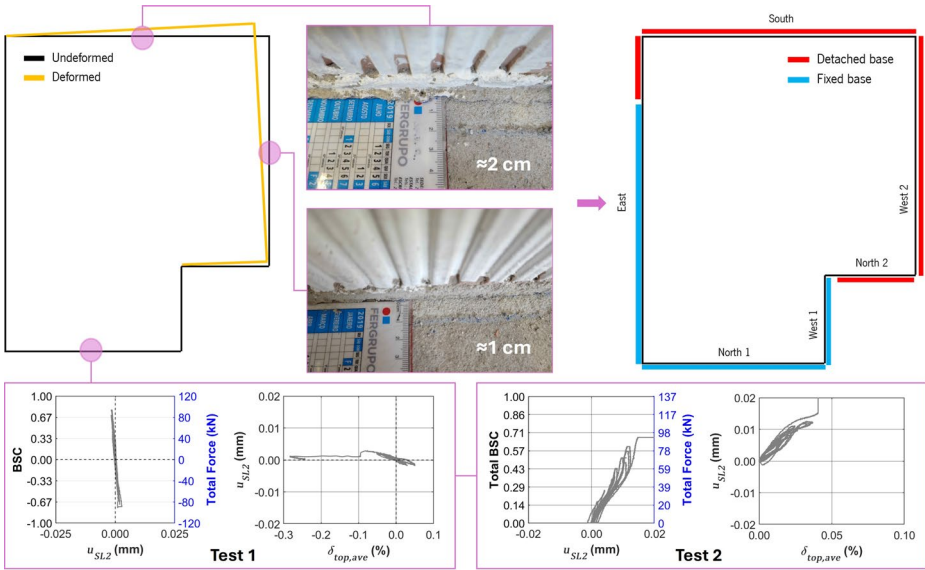
Overall, the structural response was characterised by a combined mechanism of flexural deformation and diagonal shear, with the predominant rocking behaviour of the entire structure. The maximum measured longitudinal displacement ( $u_Y$ ) was observed at L2.5Y. This could explain the occurrence of horizontal and diagonal shear cracks observed on West1 and West2 walls, respectively (see Figs. 15 and 17). With the sudden release of force at the rocking failure point, the structure slid nearly 10 mm and 20 mm from the base of the South and West2 walls, respectively (Fig. 21). The base of the South and West walls was utterly detached from the foundation and displayed significant deformations. However, it was concluded that the structure slid partially due to the deformation measured by LVDT

**Fig. 21** Visual representation and measurements of residual sliding displacement at the base of the structure after Test 1. Additionally, sliding displacements recorded during Test 2 are presented at their respective locations

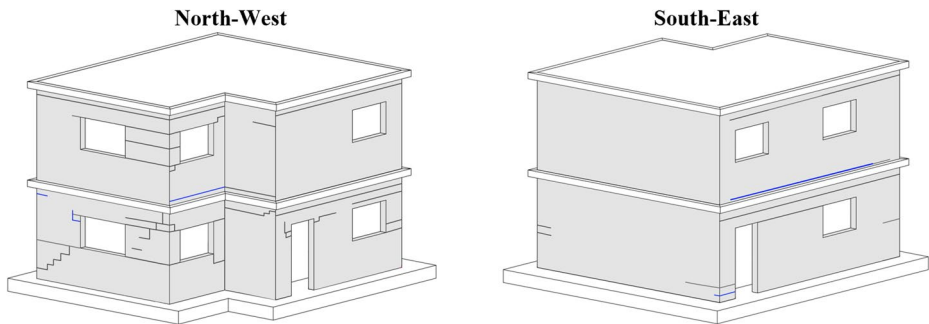
Figure 22 presents the progression of damage (indicated in blue) observed during Test 2, after boundary repair of the structure and more weight was added. Notably, no damage was recorded at the base of the structural walls, similar to uplift, highlighting the efficiency of the boundary interface repair conducted after Test 1. The observed damage, on the other hand, was predominantly linked to the activation of pre-existing cracks, which were observed to open and close during the test. Onset diagonal shear crack formed on the North1 wall, while horizontal cracks were observed at the base of West1 wall and the East wall on the second floor. It is stressed that the horizontal cracks transitioned directly above the first brick course rather than the repaired mortar layer, which suggests the efficiency of the repairing method. This implies that the repaired boundary interface contributed to the redistribution of the strains, thereby preventing damage along the boundary interfaces. This finding is consistent with the displacement measured on the South wall, which was relatively lower compared to other in-plane walls, as presented in Fig. 24. The maximum displacement recorded on the South wall was 1.0 mm, with less than 0.05 mm observed on the first and second floors, respectively.

**Fig. 22** Evolution of damage at the end of Test 2
