# The Stratified Significance of a Historic Façade as a Basis for a more Durable Conservation Approach

DOI 10.1515/rbm-2015-1004

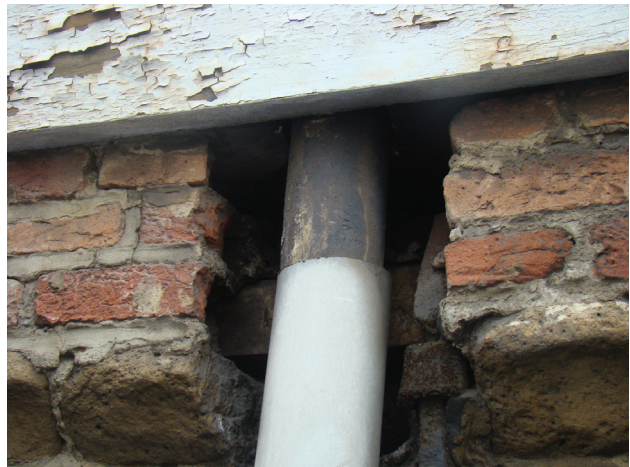
For the Shoemakers Chapel, the state of conservation of the drainpipes was rather good, but the connections between the gutter and the vertical drainpipes was a delicate point where water infiltrations were very likely (Figure 3). A proposal was made to attach the vertical drainpipe to the gutter and prevent the infiltration of rain water into the façade. It would be sufficient to introduce an end piece in metal that covers the hole and guarantees a smooth connection with the gutter.

**Figure 3:** This connection between the gutter and the vertical drainpipe is a delicate point where water infiltrations are likely.

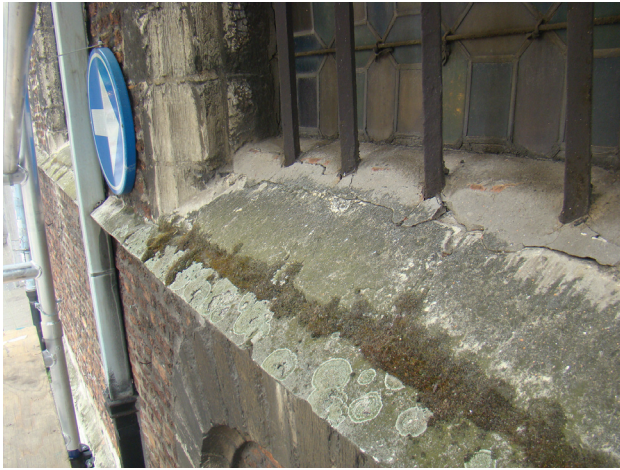
**Figure 4:** Windowsills in natural lime stone with an additional layer in cement mortar.

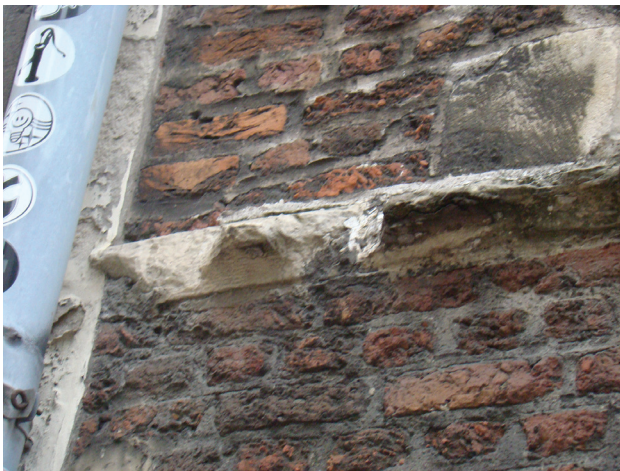
**Figure 5:** Some parts of the functional elements in limestone are strongly deteriorated.

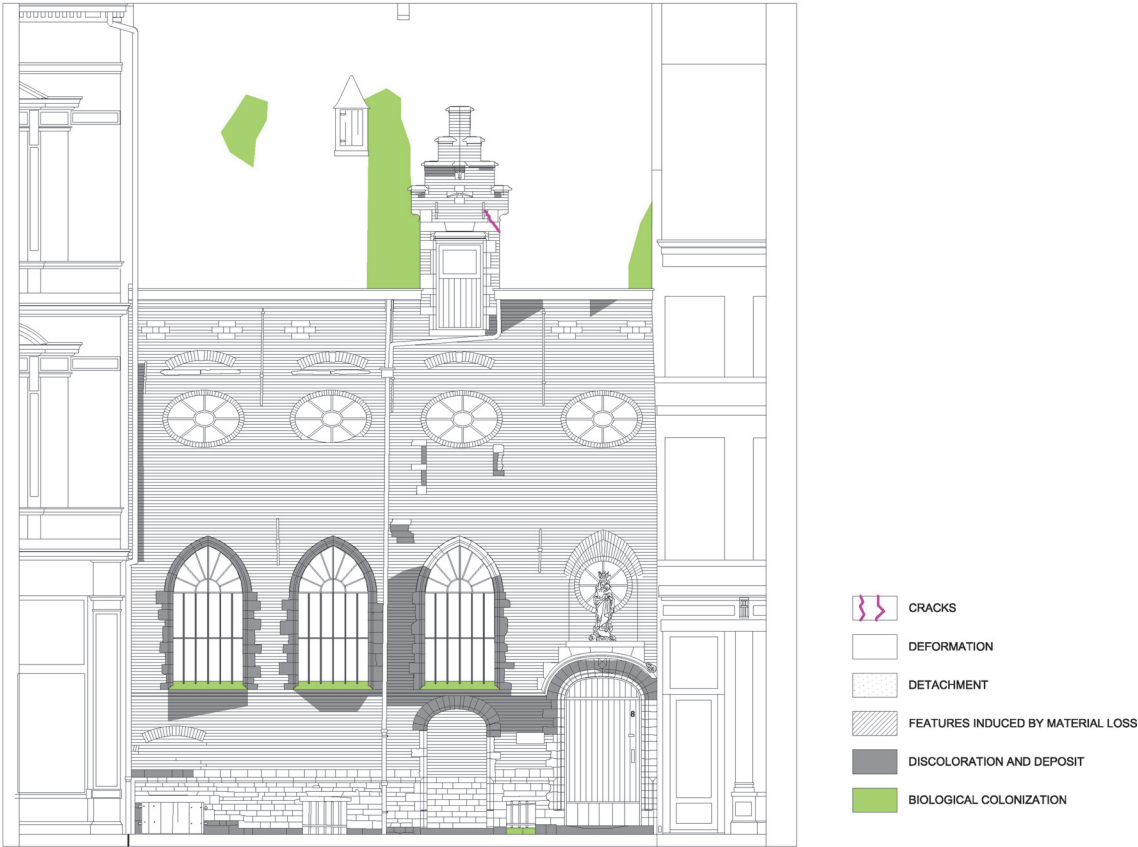
Figure 6: Map of state of conservation of applied materials, general assessment of the façade.

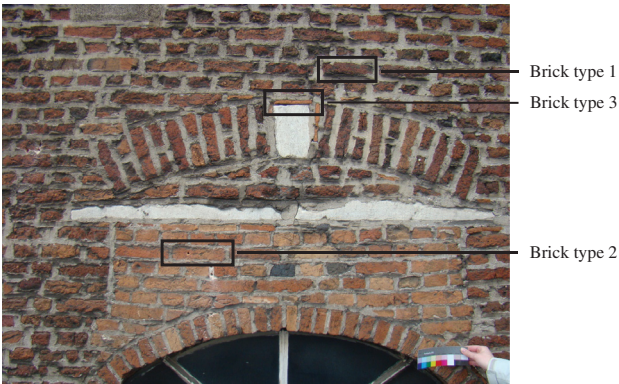
Figure 7: Inspection area B4.

The visual inspection and measurement of the bricks allowed to recognize three different types of bricks (Figure 7). The first type is the most occurring (type 1, Figure 7): it is a handmade brick of a dark red colour and an average size of 17 cm (length) by 4 cm (height). The second brick was found around the oculi (type 2, Figure 7). The brick has an orange colour, is also handmade and of similar size. The third type of brick (type 3,

Figure 7) was found locally, for example near the scaffolding holes. It is a very thin, orange brick that looks like terracotta. It was used to fill holes in places where elements were inserted when the spaces were too large to be merely filled with mortar. In Figure 7 some of these bricks can be seen around the key stone in natural limestone and below the lintel in natural limestone.

Figure 8: Detailed survey of brick M2 and surrounding pointing mortar within area B4.

The state of conservation of the bricks was generally good. A superficial deposit was found on most of the bricks, as well as signs of erosion.

For the façade of the Shoemakers Chapel, the pointing mortar was in most cases inaccurately applied, possibly in a recent intervention. It seems that the mortar was spread over an existing mortar that needed repair. Signs of small cracks were detected, which pointed at the need of further analysis. At some places, detachment of the pointing mortar was detected and the underlying lime-based bedding mortar showed crumbling.

pointing mortar after repairing the bedding mortar. However, for those parts where there is no detachment of the pointing mortar, removing it will cause damage to the bricks. Therefore, the state of conservation of the pointing mortar should be assessed on a regular basis and detached cement based pointing mortar should be removed, while locally repairing the bedding mortar and applying a compatible lime-based mortar.

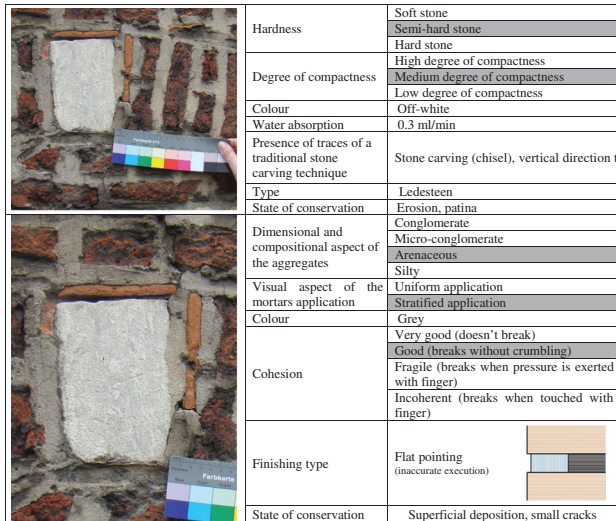
**Figure 9:** Detailed survey of stone P1 and surrounding pointing mortar within area B4.

In general, the state of conservation of most of the stone elements was quite good. Some showed a superficial deposit of dust and patina. The Lede stone, showed locally gypsum crusts (mainly at the dormer door and window frames on the ground floor), and crumbling, at some exposed locations.

For the consolidation of the stones with gypsum crusts, two possible approaches were formulated. The first approach, general practice in Flanders, consists of the mechanical removal of the crust and deteriorated material, after which the remaining stone is repaired with a compatible repair mortar, if necessary. The second approach consists of a chemical cleaning with ammonium bicarbonate. Ammonium bicarbonate in watery solutions transforms the calcium sulphate dehydrate into ammonium sulphate, a different type of salt that is however much more soluble in water. By applying the ammonium bicarbonate with poultices, the formed ammonium sulphate will migrate from the stone into the poultices and can be removed from the stone. This is a delicate operation that is not so often applied in Flanders. If it would be chosen, however, the intervention would be limited to a few stones only, and the conservation approach would imply a local application of the chemical cleaning, and less historic material will be lost.

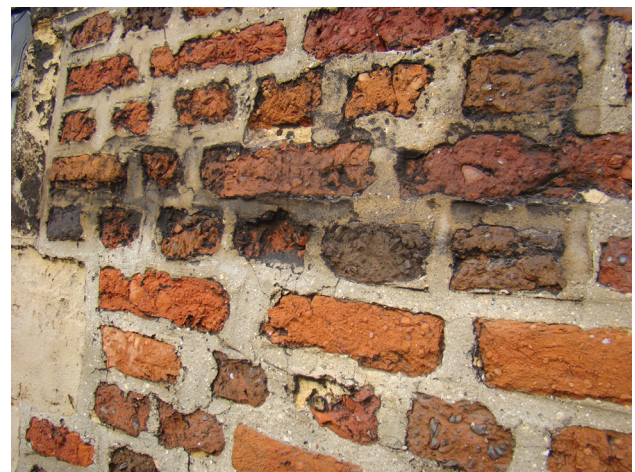
**Figure 12:** Upper part cleaned with steam cleaning, lower part cleaned with wet-jet abrasive cleaning.

the masonry. It is an industrial product that consists of a self-vulcanizing cleaning paste for the dry removal of the soiling. The paste was left on the surface for two days, but the soiling resulted to be too adherent or too much infiltrated into the pores of the materials to be removed with this technique.

Since it is difficult to remove the soiling without introducing further damage to the already eroded bricks, the conservation approach foresees a regular superficial cleaning of the façade by sponging of the dirt with water.
