Independent root-cause analysis of contributing factors, including dismantling of 2 duodenoscopes, to investigate an outbreak of multidrug-resistant *Klebsiella pneumoniae*

Gastrointestinal Endoscopy

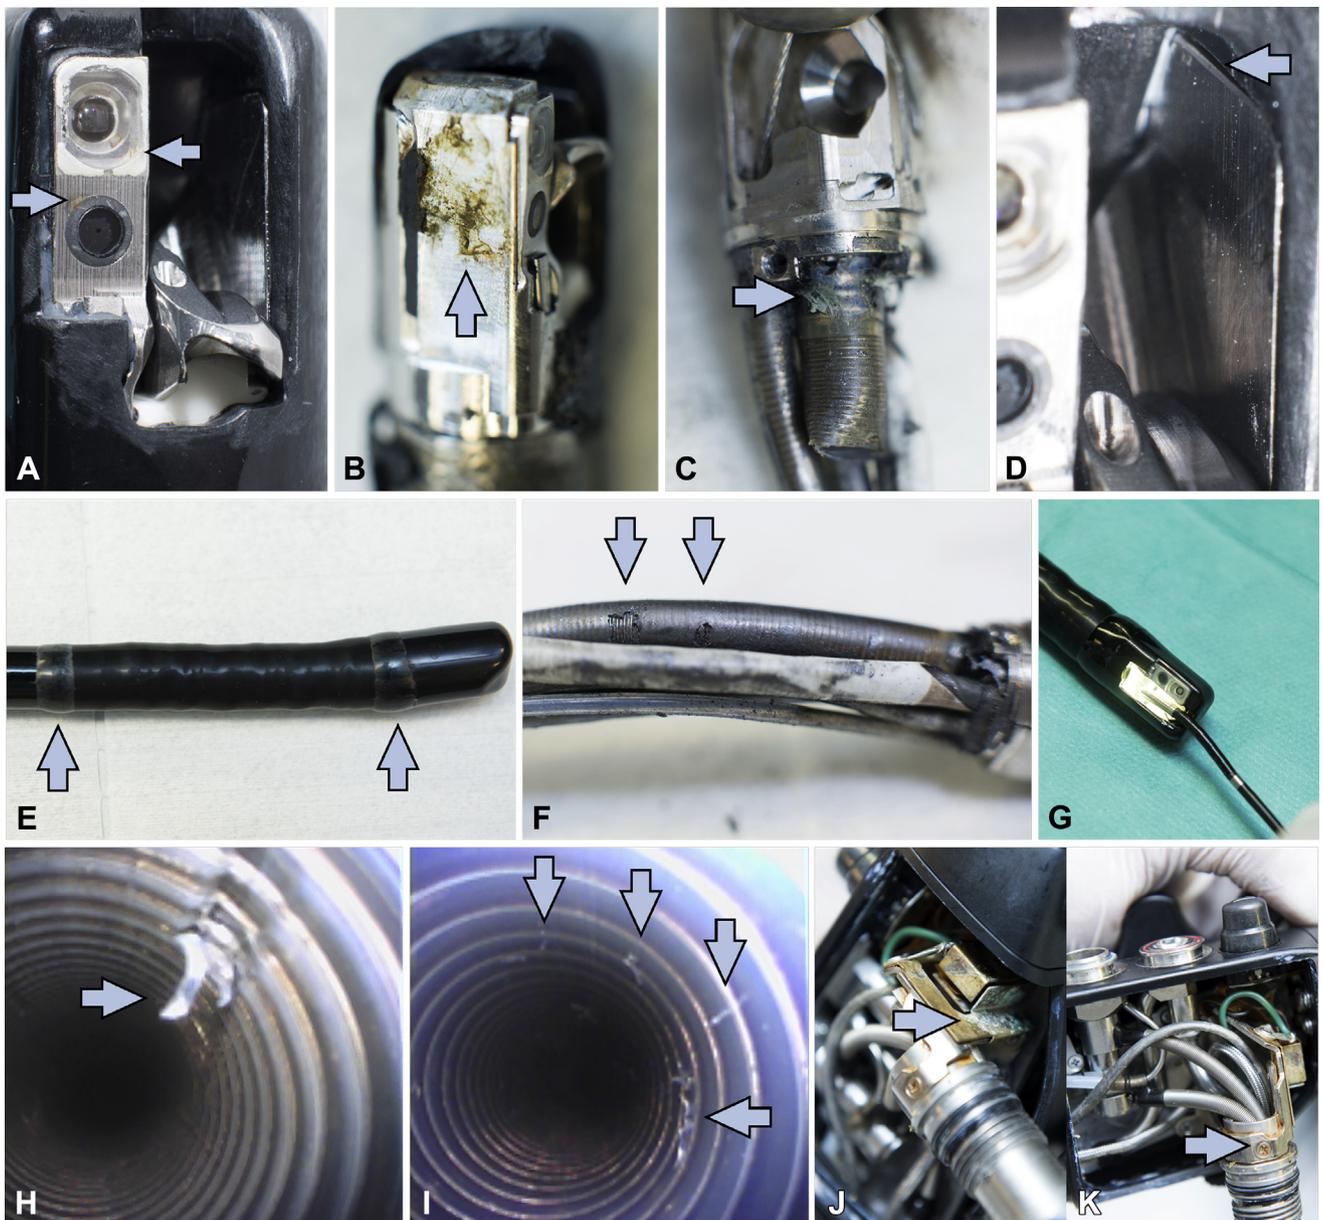
The following results are a summary of the original extensive investigation report.³³ On December 15 and 16, 2015, duodenoscopes A and B were dismantled. No MRKP isolates were found in the 15 and 16 samples taken from duodenoscopes A and B, respectively. Two microorganisms of concern were cultured from the instrumentation port of duodenoscope B: 10 colony-forming units/100 mL *S maltophilia* and 10 colony-forming units/100 mL *E cloacae*. In both duodenoscopes damage and improper repairs were observed: brown staining behind the glass covering the light-guide lens (Fig. 2A); brown scale on the distal tip frame underneath the protective cap (Fig. 2B); actuator area cover plates incorrectly reattached with too little glue, sealing it incompletely (Fig. 2B); and new biopsy channels attached to the tip in a manner that deferred from the prescriptions of the duodenoscope manufacturer (Fig. 2C). In duodenoscope B, the following additional damage was observed: brown staining behind the objective lens of duodenoscope B (Fig. 2A); inadequate connection of the replaced protective cap, leaving space between the cap and the tip frame (Fig. 2D); loosened bonding of the cardan rubber, which covers the distal 10 cm of the endoscope before the distal tip (Fig. 2E); insufficient lubricant powder underneath the cardan rubber, likely having been the cause of friction damage to the outside of the distal end of the biopsy channel (Fig. 2F); and heavily oxidized electric circuits and connecting parts of the signaling tube in the control section, indicating moist damage (Fig. 2J). In duodenoscope A, a crack at the distal end on the inside of the biopsy channel was observed with the borescope (Fig. 2H).

Figure 2. Dismantling of duodenoscopes A and B, showing damage, oxidation, and incorrect repairs (photos adapted with permission).³³ The observations as shown in photos **A** and **C** were present in both duodenoscope A and B. **A**, Duodenoscope B. Close-up of the distal tip showing the light-guide lens and objective lens. Sludge was observed behind the glass that covers both lenses (arrows). **B**, Duodenoscope B. Close-up of the dismantled distal tip showing a brown layer on the frame of the distal tip and the cover plate of the actuator area that was incorrectly reused and reattached by soldering after repairs. **C**, Duodenoscope B. Close-up of the dismantled distal tip showing the incorrect fastening of the biopsy channel to the distal tip. **D**, Duodenoscope B. Close-up of the distal tip showing unwanted space between the tip frame and the protective cap (arrow). **E**, Duodenoscope B. Cardan rubber at the distal 10 cm of the duodenoscope and the distal tip. At the arrows loosening of the cardan rubber bonding was observed. **F**, Duodenoscope B. Outside of the distal part of the biopsy channel with damaged parts caused by friction (arrows). **G**, Borescope investigation. Both duodenoscopes had replaced biopsy channels with a ribbed structure instead of the original smooth structure. **H**, Duodenoscope A. Borescope showing a crack at the distal end of the biopsy channel near the tip (arrow). The biopsy channel was used for 20 procedures in total. **I**, Duodenoscope B. Borescope showing fibers at the distal end of the biopsy channel near the tip (arrows). **J**, Duodenoscope B. Control section: oxidation of electric circuits (left) and **K**, the connecting parts of the signaling tube (right).

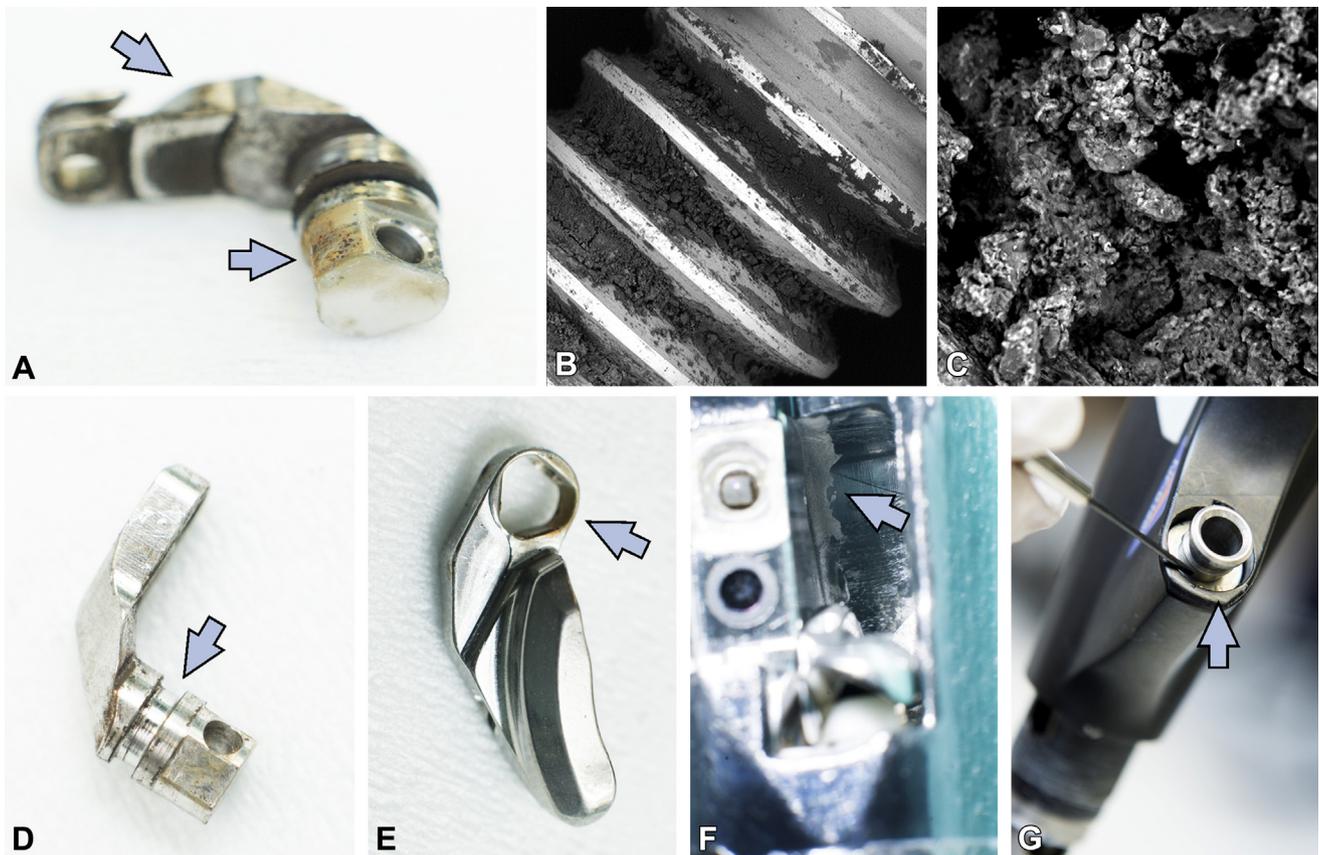
Three design-related abnormalities were observed (Fig. 3). First, in both duodenoscopes brown staining was observed on the distal tips in places on the patient

side that were not reachable for brushes and poorly accessible for rinsing or drying: on the internal channel port side and on the patient-sided axis of the elevator lever (Fig. 3A), on the screw fastening the forceps elevator to the lever axis (Fig. 3B), in the groove in which the O-ring is situated (Fig. 3C), and in the axis hole of the forceps elevator (Fig. 3D). Second, at several places surrounding the forceps elevator that were easily accessible for brushes, white and brown oxidation stains were observed (Fig. 3E). Finally, water droplets were observed under the instrumentation port's rubber sealing ring of duodenoscope B (Fig. 3F).

Figure 3. Dismantling of duodenoscopes A and B, showing residue resulting from design issues (photos adapted with permission).³³ The observations as shown in photos **A** to **D** were present in both duodenoscope A and B. **A**, Duodenoscope A. Elevator lever with a brown layer on both sides of the O-ring: axis side (patient side) and the channel port side (sealed off by O-ring). **B**, Duodenoscope A. Scanning electron microscopy photographs of the screw that fastens the lever axis to the forceps elevator with a powdery, brown layer with organic characteristics in the screw thread. Detail scans, 255× (left) and 3600× (right). **C**, Duodenoscope A. Elevator lever and axis with the O-ring removed. A brown layer is seen in the groove of the O-ring. **D**, Duodenoscope A. Forceps elevator with brown layer around the axis hole. **E**, Duodenoscope A. White, porous-looking layer in the recess for the forceps elevator. **F**, **G**, Duodenoscope B. Instrumentation port: water droplets under the rubber ring that seals the port were observed.
