# Surgical Quay-wall Renovation

Joost W. Bos Msc.  
Royal Haskoning  
E-mail: j.bos@royalhaskoning.com

Bastiaan Winde BBE  
Port of Rotterdam Authority  
E-mail: sc.winde@portofrotterdam.com

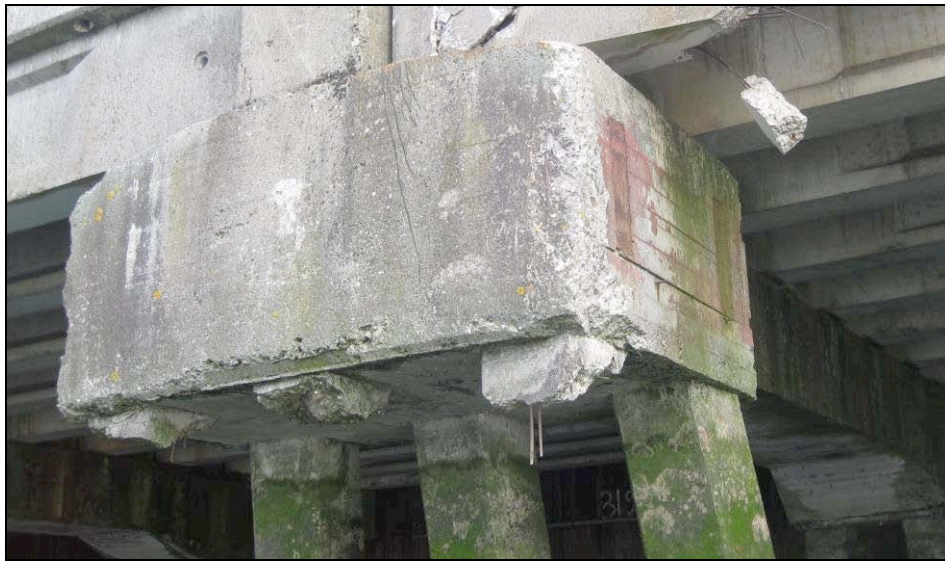
- At the South section, 13 foundation piles were found to be broken or completely missing, with another 9 piles damaged (of total 226 piles). 17 I-beams were broken or severely damaged, with another 6 damaged (of total 187 beams). The bituminous deck wear layer was severely damaged. The concrete underneath the wear layer however, was in good state. Chloride intrusion into the concrete was limited throughout the structure. Deck, I-beams, supports and piles generally were in good condition. No polycyclic aromatic hydrocarbons were found in the bituminous wear layer. The presence of asbestos was not suspected, after an inspection by others;

*Figure 5. Photo of south section, 3 piles missing underneath single trestle*

- Replace front I-beam over entire length with new beam, and repair deck behind it;
- Replace limited number of damaged I-beams in the deck, and repair deck around these;
- Add supports of steel tubular piles and bracings to the trestles with damaged/missing piles;
- Local concrete repairs after carbonatation / chloride initiated corrosion of reinforcement;
- Remove bituminous wear layer on deck. Apply antiskid epoxy coating directly on concrete.

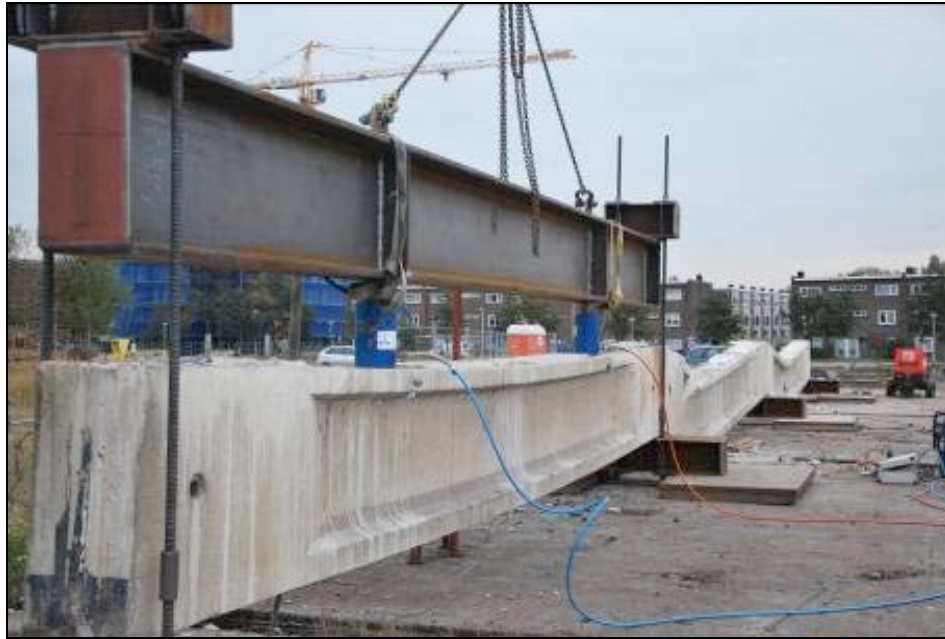
*Figure 6. Photo of field test*

The tests showed that indeed, the beams had been prestressed, and that no reinforcement for shear forces had been applied in the beams. Overall conclusion of the tests was that the bearing capacity of the I-beams was still there. In fact, in time due to continued curing of the

concrete, the capacity of the concrete had increased. The deck was suitable to cope with the required loads.

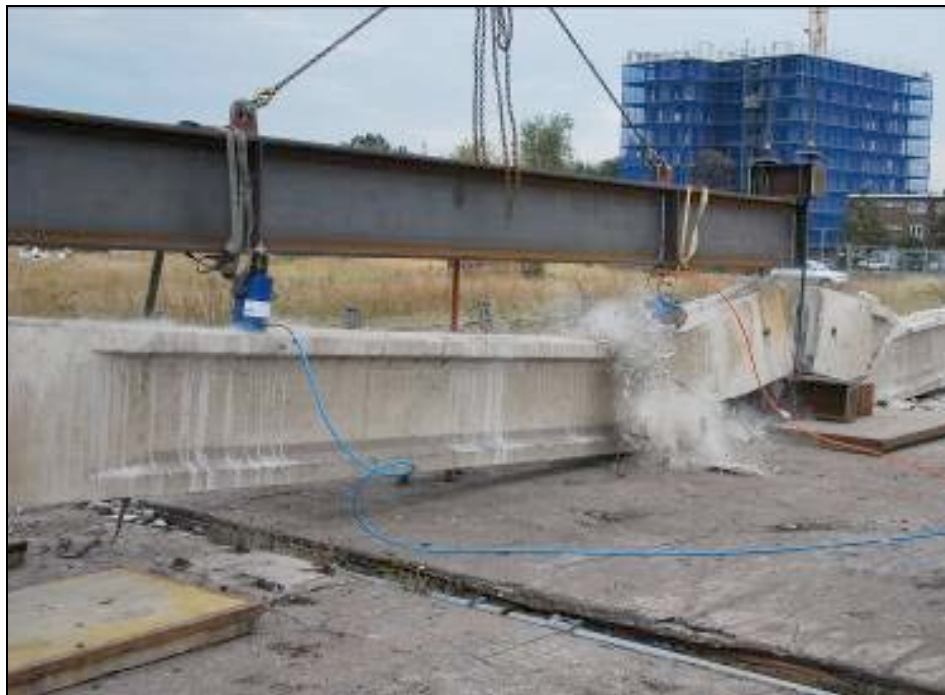
*Figure 7. Photo of field test*
