## Corrosion-Fatigue Failure of Gas-Turbine Blades in an Oil and Gas Production Plant

# Corrosion-Fatigue Failure of Gas-Turbine Blades in an Oil and Gas Production Plant

**Abstract:** This paper investigates the root cause of a failure in gas-turbine blades, made of Nimonic-105 nickel-based superalloy. The failure was reported in two blades in the second stage of a turbine-compressor of a gas turbine in the hot section. Two failed blades were broken from the root and from the airfoil. The failure took place after 20 k h of service exposure in the temperature range 700–850 °C, with the rotating speed being in the range 15,000–16,000 rpm. The microstructures of the failed blades were studied using optical/electron microscopes. Energy dispersive X-ray spectroscopy (EDS) was employed for phase identification. Results showed that failure first initiated from the root. The dominant failure mechanism in the root was concluded to be corrosion-fatigue. The failure scenario was suggested based on the results obtained.

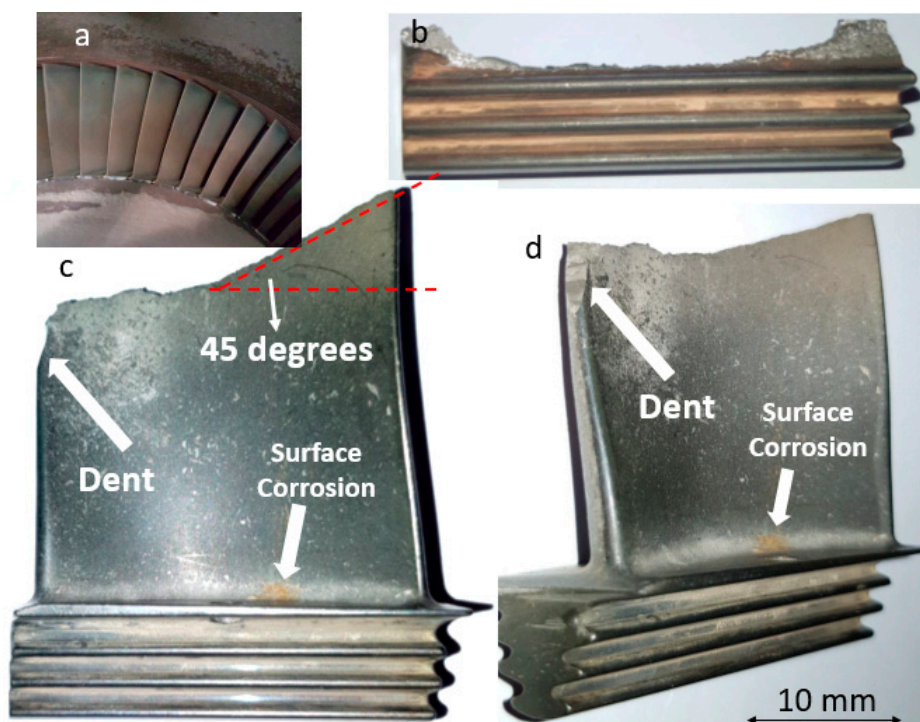
The reported failure in this case was related to two turbine blades as shown in Figure 1, with one failing from the root and the other from the airfoil. These two blades were located in the vicinity of each other. There are a few observations worth mentioning. First of all, there was no severe surface corrosion on either side of the blades, except for a brownish spot shown in Figure 1. This does not appear to be a severely corroded spot. Also, there was no excessive deformation (i.e., noticeable thinning or buckling) in the profile of the failed airfoil. One can also see that there was no surface irregularity observed in the failed blades. This includes surface cracking or pitting. In one edge of the failed airfoil, one can see a dent, which seems to be due to the collision of a high-energy flying object. The last important visual observation to mention is that the fracture in the airfoil has two areas: the flat surface and the part with 45-degree inclination. This is clearly shown in Figure 1c.

**Figure 1.** Visual observation of broken blade, (a) and overview of blades in the assembled condition, (b) failed blade from the root, and (c,d) broken blade from the airfoil.

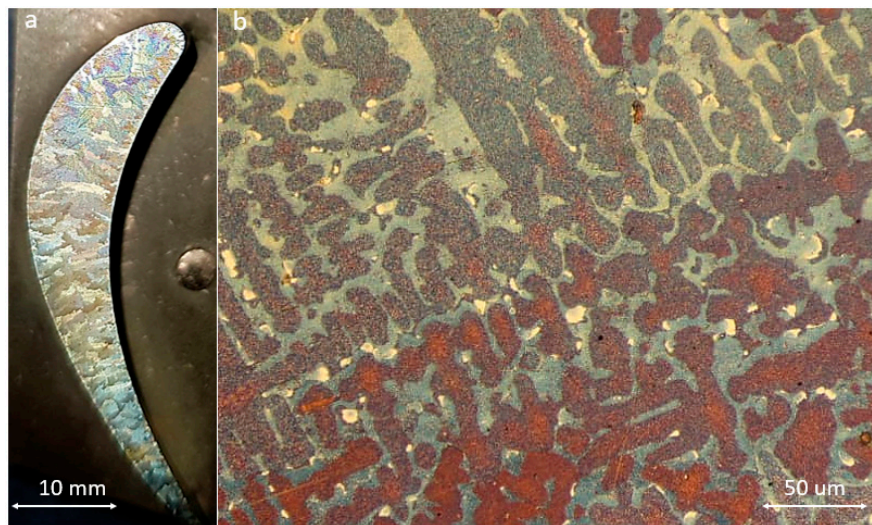
Figure 2 depicts the typical microstructure in the failed blades. The microstructure is a typical dendritic cast structure where dendrites have grown from two sides towards the centerline of the blade, as expected. Fine white particles in-between dendrites are carbide particles.

**Figure 2.** (a) Macro and (b) optical microscope images of failed blades.

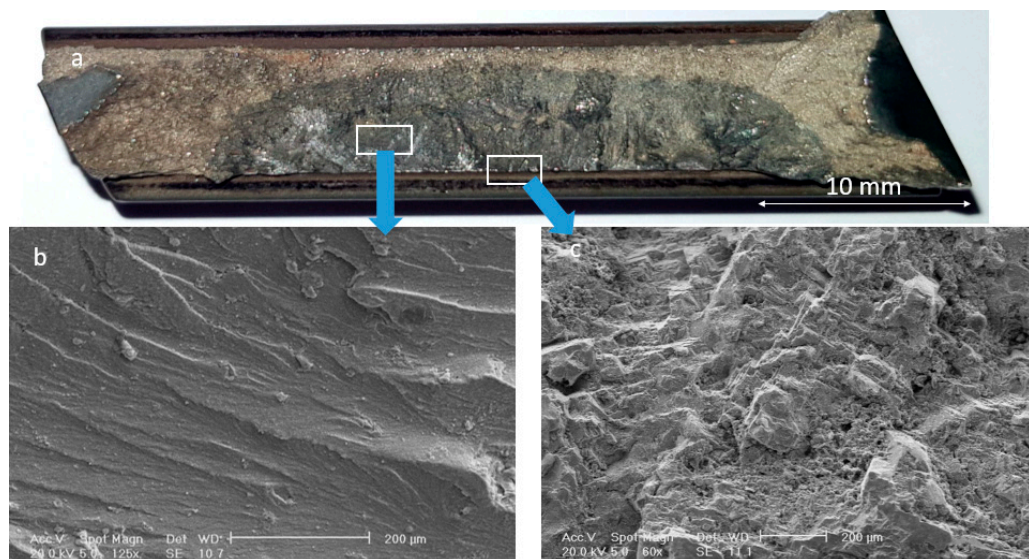
Figure 3 shows stereomicroscope and SEM micrographs of the fracture surface from the blade that failed from the root. As shown in Figure 3a, the fracture surface has two areas: the dominant grayish area and the rest of the surface. This is a typical fracture surface when fatigue is the governing damage mechanism. Figure 3b,c show SEM micrographs of two areas, highlighted in Figure 3a. The former image (Figure 3b) shows typical beach marks, indicating that fatigue is an active mechanism. Further down to the edge, there is a clear change in the fracture surface (Figure 3c). The surface at the edge of the failed blade is covered with some deposits, which were analyzed by EDS. Results of EDS analysis of the microstructure at the edge (presented in Figure 4) showed that surface deposits are rich in Cl, K, Na, and Ca. This, together with the fact that there is a high concentration of oxygen in the analysis, indicates that these deposits are in fact corrosion products. It is highly likely that the aforementioned elements come from the fuel/gas.

**Figure 3.** (a) Stereomicroscope and (b,c) scanning electron microscope (SEM) micrographs of the fracture surface of the blade, failed from the root.

From the results obtained, it can be concluded that the failure in the blade, broken from the root, was controlled by the simultaneous activation of corrosion and fatigue. Corrosion-fatigue is a common degradation mechanism in moving components exposed to high-temperature harsh working conditions [21]. Corrosion fatigue essentially takes place under the synergistic activation of corrosion and dynamic loading. This degradation mechanism is one of the most common reasons for the failure of turbine blades [22]. Corrosion fatigue is undoubtedly one of the most complex failure mechanisms. Both mechanical and chemical aspects of failure in this case are equally important. Any mitigation measure to avoid this failure necessitates a multi-disciplinary approach. Corrosion-fatigue failure of the blade root in this case has possibly originated from corrosion pits/products deposited at the root/airfoil interface. The results showed that corrosion products/deposits in this case mostly contained CaO, Na<sub>2</sub>O, KCl, and NaCl. The sensitivity of turbine blades to corrosion-fatigue initiation largely depends on the integrity of the passive film on the surface [22]. The breakdown of this passive film

- Given that both corrosion and fatigue mechanisms were involved in this failure, it is important to minimize mechanical vibrations and to reduce contaminants in the system. The latter necessitates further investigation on the origins of the Cl, Na, and Ca-containing residues and how they can be controlled/eliminated from the system.

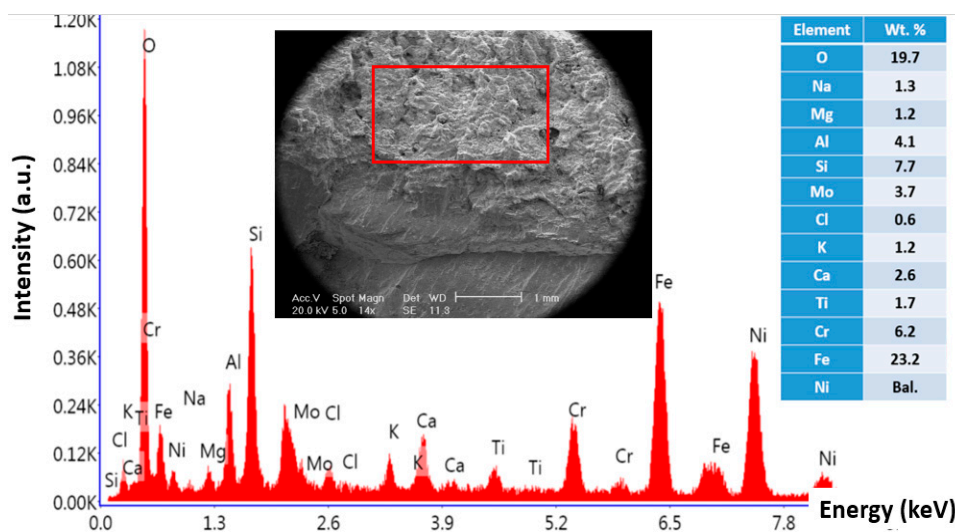
**Figure 4.** Energy dispersive X-ray spectroscopy (EDS) analysis of corrosion products at the edge of broken blade.

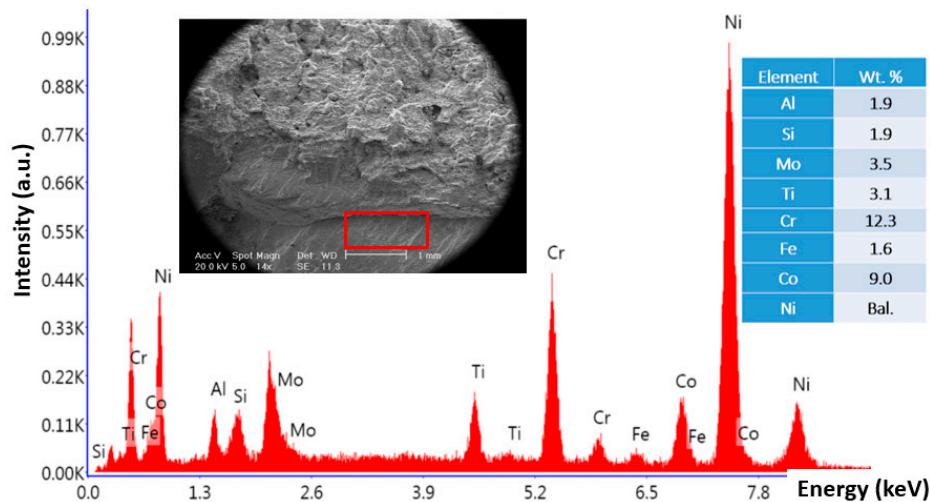
Results of EDS analysis of the microstructure further away from the edge is presented in Figure 5. There is hardly any oxygen, Na, Ca, K, and Cl in the analysis, inferring that the aforementioned corroded area is limited to few hundred micrometers from the edge.

**Figure 5.** EDS analysis of the area with beach marks in the failed blade, broken from the root.

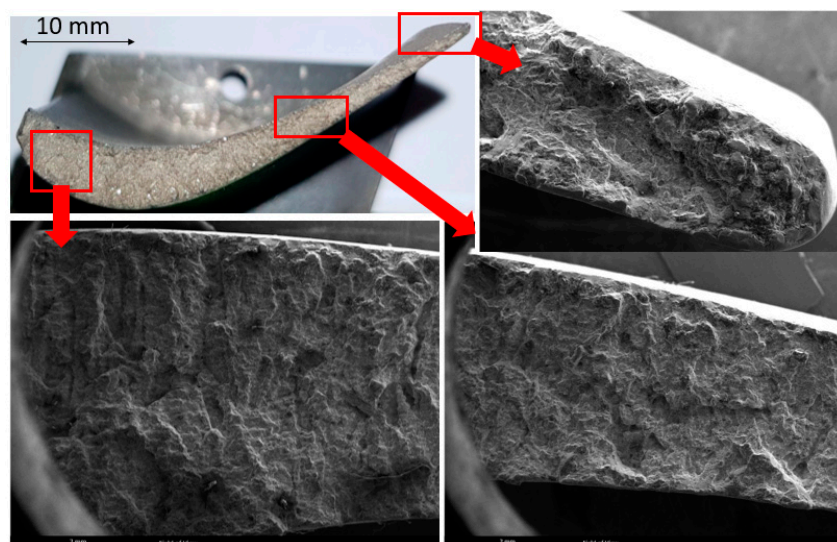
Figure 6 shows stereomicroscope/SEM micrographs of the fracture surface of the sample, failed from the airfoil (see Figure 1c,d). SEM micrographs, shown from different areas, indicate that there is hardly any difference between fracture modes in different areas. More importantly, there is absolutely no indication that fatigue has been an active mechanism in this blade, i.e., there is no beach mark on the fracture surface. Figure 7 shows SEM micrographs of the fracture surface with higher magnification, again confirming that there is no fatigue involved in this case. Fracture in this sample has elements of ductile and brittle fractures. There are some areas with colonies of dimples and some areas with cleavage fracture. The fact that there is no fatigue in this blade is indicative that this blade has fractured due to a sudden overloading and/or collision. The logical failure scenario is that the blade that failed from the root has first undergone a corrosion-fatigue failure. The broken piece has then hit the adjacent blade, causing the fracture of the blade from the airfoil. The dent observed at the edge of the airfoil (highlighted in Figure 1c,d) has possibly formed as a result of a collision between the flying broken piece and the airfoil.

**Figure 6.** Images of fracture surface of the blade, broken from the airfoil.

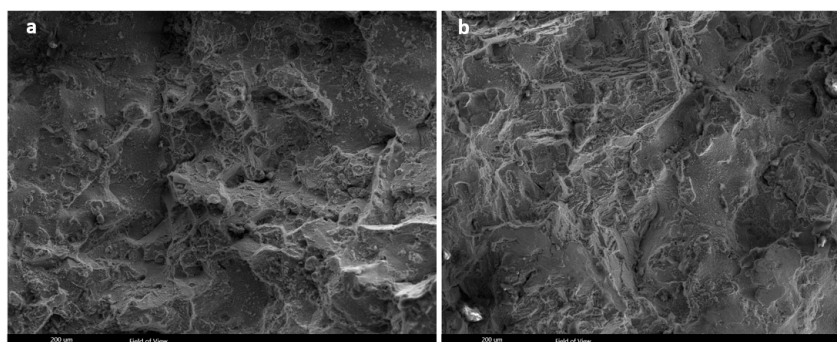
**Figure 7.** (a,b) SEM micrographs of fracture surface of the blade, broken from the airfoil.
