Preface

This analysis book is made during the graduation studio *AR3AR111 Zutphen Sustainable City*, in the academic year of 2017-2018. This studio is part of the Heritage & Architecture Master track of the TUDelft. This book is part of a series of analysis on several buildings in the the Nieuwstad, a neighbourhood in the city of Zutphen. The aim of this analysis is to grasp the identity and character of this area.

Technical Analysis

This part will focus on the technical aspects of the buildings. The structure, materials, damages and services will be analysed to get a grasp on the buildings structure and conditions for interventions in the future.

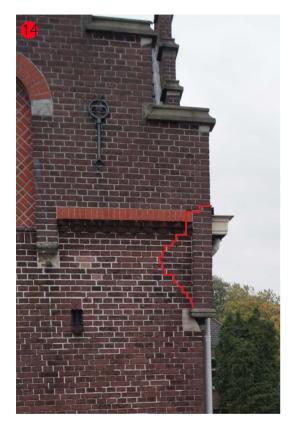
Here we find an extensive wall cracking presenting a V shaped pattern. Most likely scenario is that the cracking is result of a structural failure due to loads stressed by the pitched roof of the building at its façade. The exact location of the cracking is the point where the wooden rafter of the roof is resting on the front façade. As a result the façade structure failed to adequately support this lateral loads and lead to cracking. This potentially could be a serious damage since it may result in detachment of this part of the wall and cause roof structure instability.
