# White Etching Cracks in wind turbine bearings

## Department of Wind Energy Master Report

DTU Wind Energy-M-0131

August 2017

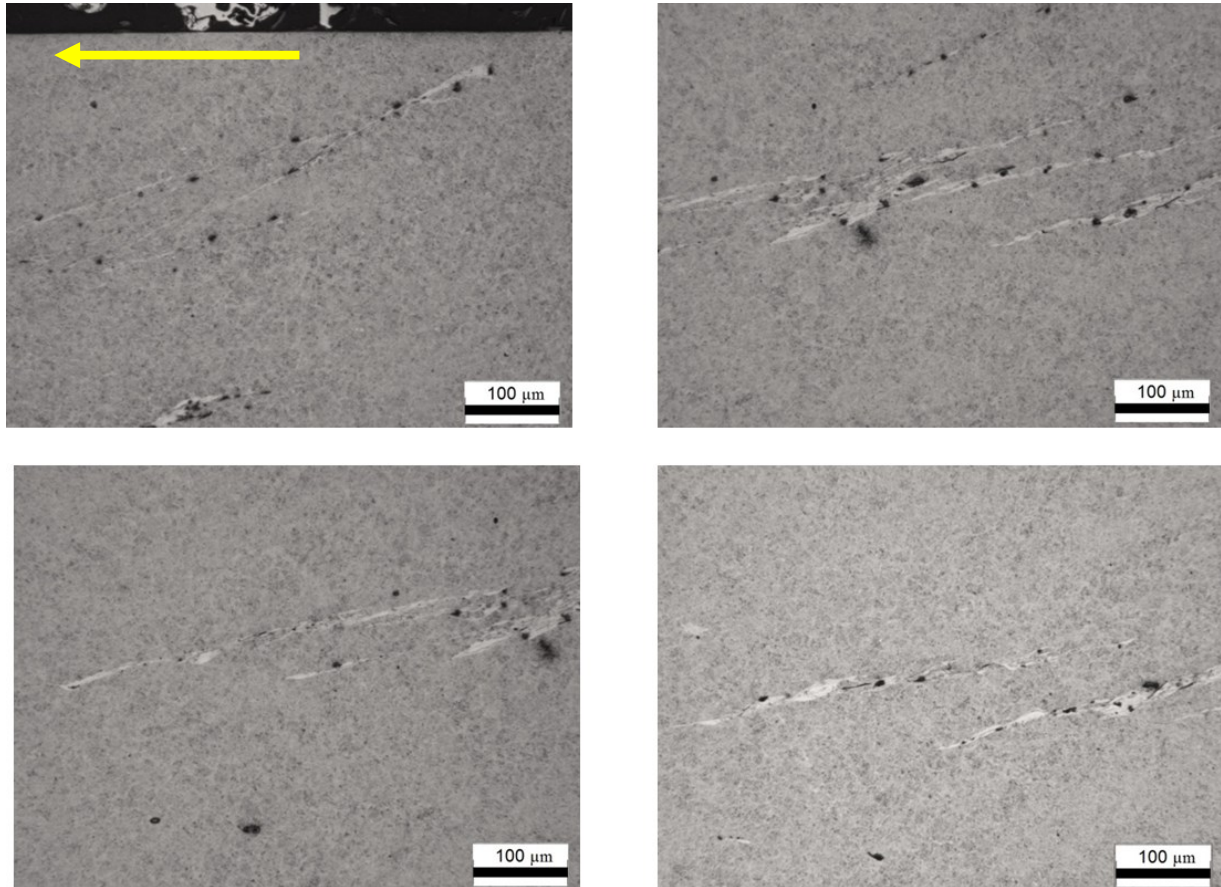
The investigation of this sample was extensive as it presented various visible butterfly-cracks with clear indication of WEAs; Figure 15 is shown as an overview of the extensive damage in the bearing, the black stains that appear to be inclusions are localized etching, the yellow arrow indicates assumed rolling direction based on literature for all images. Figure 16 is presented as a close-up to the regions of interest showing WECs. The images are oriented as to show the raceway on top, the revealed cross section is normal to the rolling of the bearings. Since the bearing was obtained from a wind turbine no information was provided regarding exact operational conditions.

**Figure 15 Overview of butterfly cracks in WT radial ball bearing**

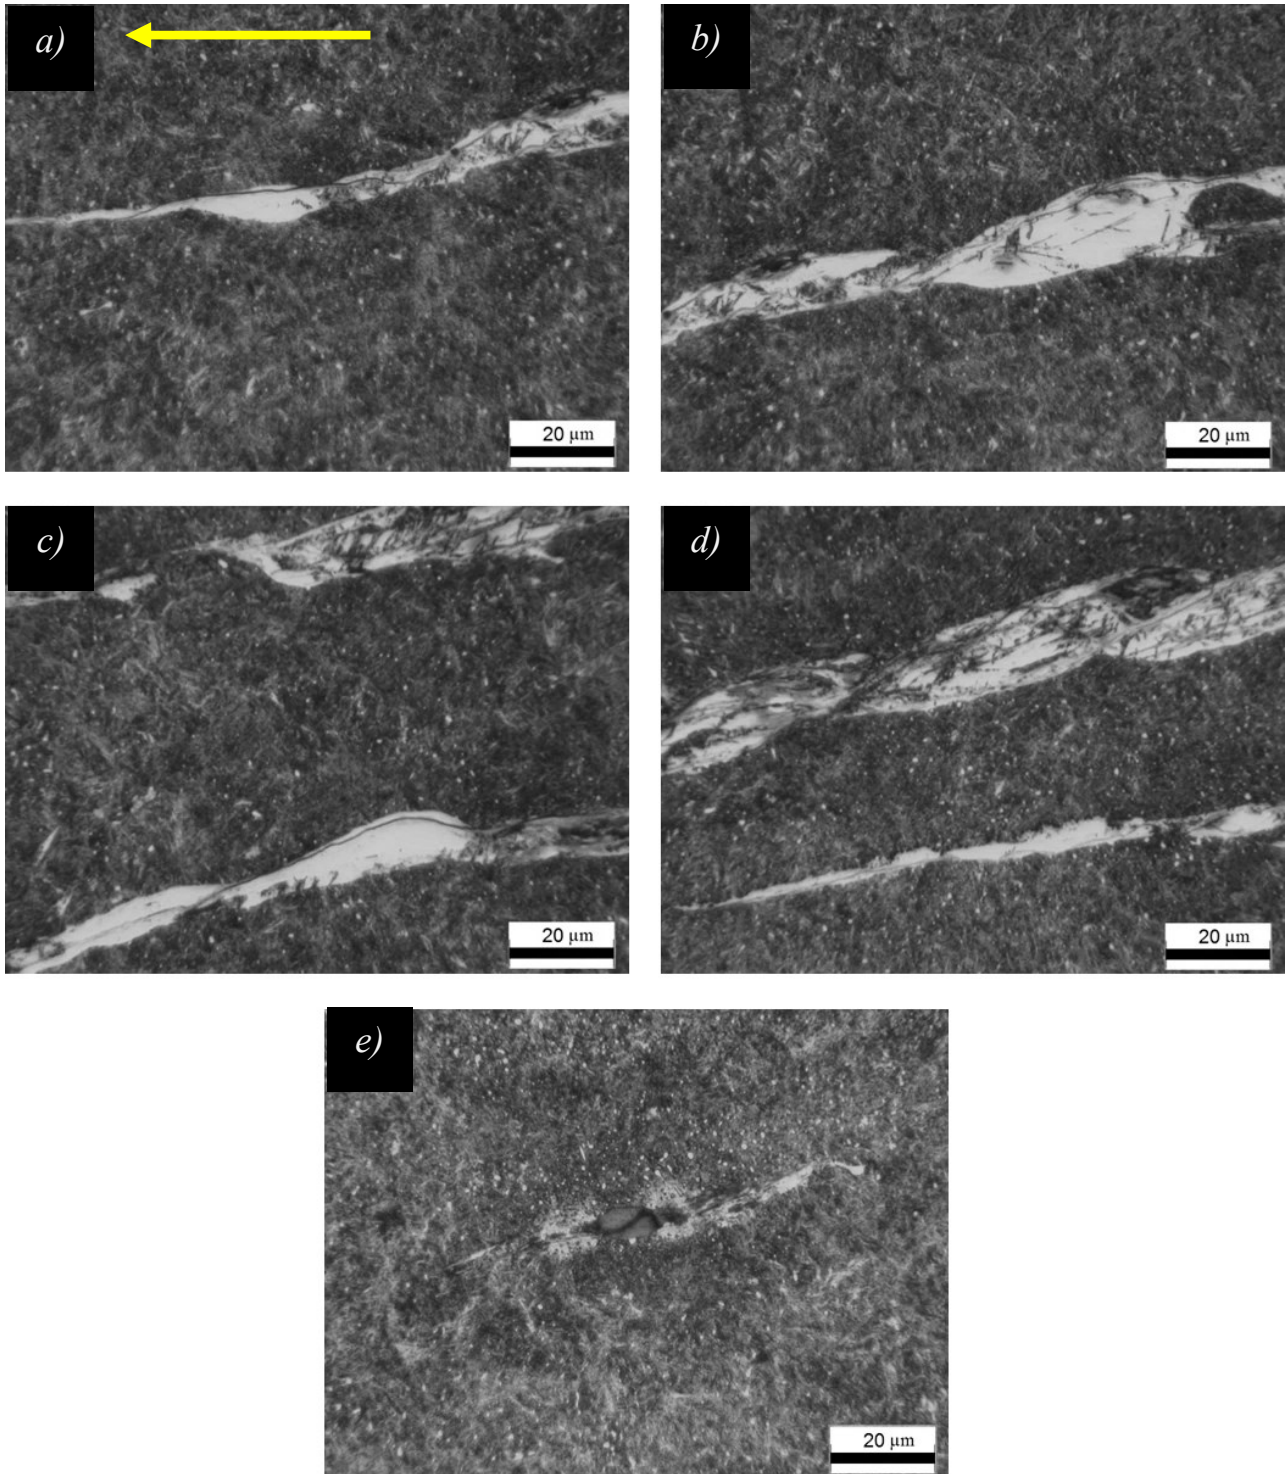
**Figure 16** Close-up to regions of interest from Figure 15

Figure 16 e) is of interest as it shows an inclusion with a crack going through it and a WEA around the crack. The black dots are the result of an aggressive etching, indicating a possible DER. A region with several cracks was chosen from the sample to perform a tomography scan as shown in Figure 17 where the yellow arrow shows the possible rolling direction and results are presented in Figure 18.

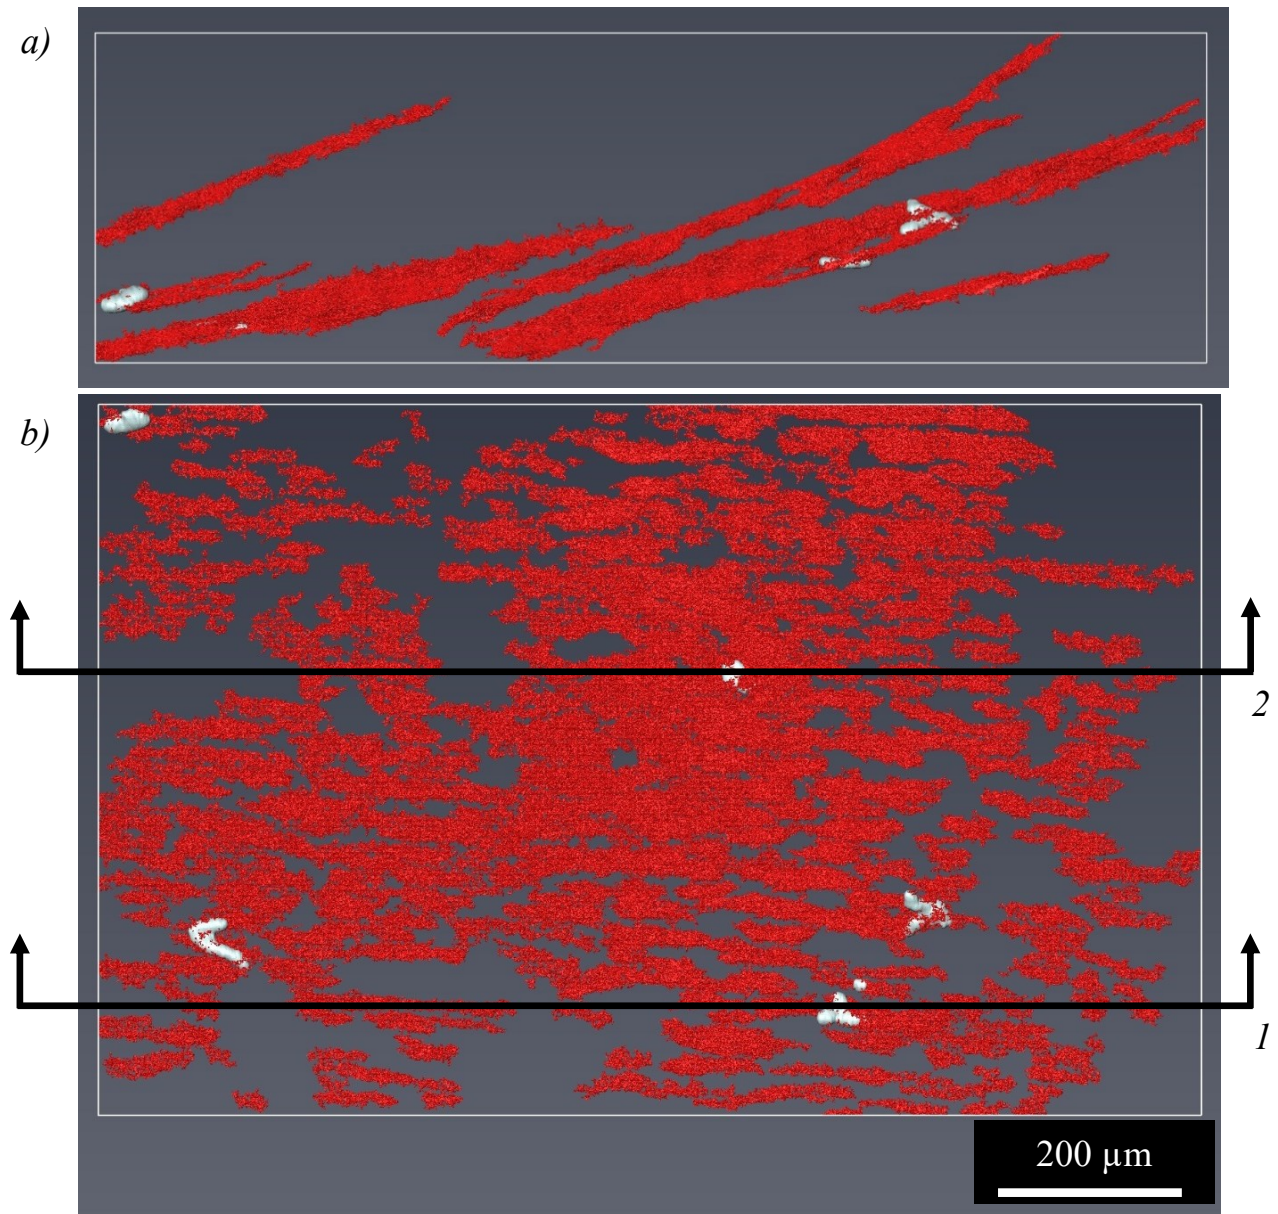
Figure 18 3D Tomography scan results from Figure 17, front view (a) and top view (b), inclusions-like regions and cracks are colored white and red respectively

Figure 18 *a)* shows the same view as presented in Figure 17 while Figure 18 *b)* shows the sample viewed from the raceway perspective (top view). It is noticeable that the scan shows the butterfly cracks running parallel to each other, this was later confirmed by serial sectioning. The angles at which they are propagating are well within the range described by other authors, 30° to 50°. The inclusions interacting with the cracks were colored white and artificially enlarged as to make them visible by the region growing segmentation method. Although the segmentation method could not catch all the details of the butterfly cracks, it showed characteristics that otherwise could not be observable. More importantly the results were used to reveal the enlarged inclusions and four regions of interest were identified for serial sectioning. The first revealed surface by optical microscopy shows a remarkable similarity compared to the tomography scan, marked (*I*) in Figure 18, and in the future referred as surface (*I*), the results are compared in Figure 19.

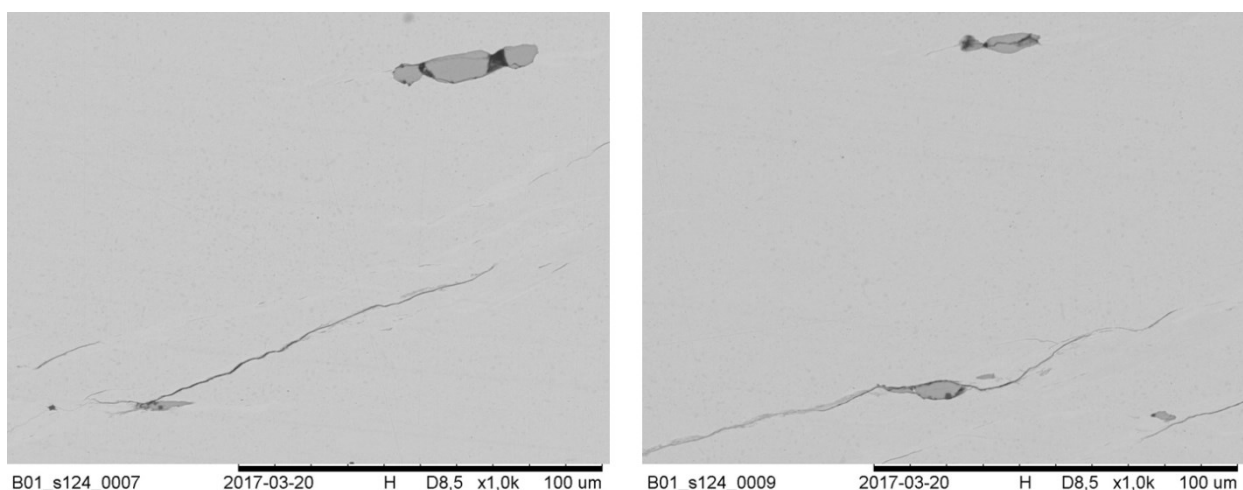
Figure 20 shows two SEM images from surface (*I*) at different depths, where a change in the shape of the inclusion and crack is visible.

**Figure 20 SEM results for revealed surface (*I*) as shown in Figure 19**

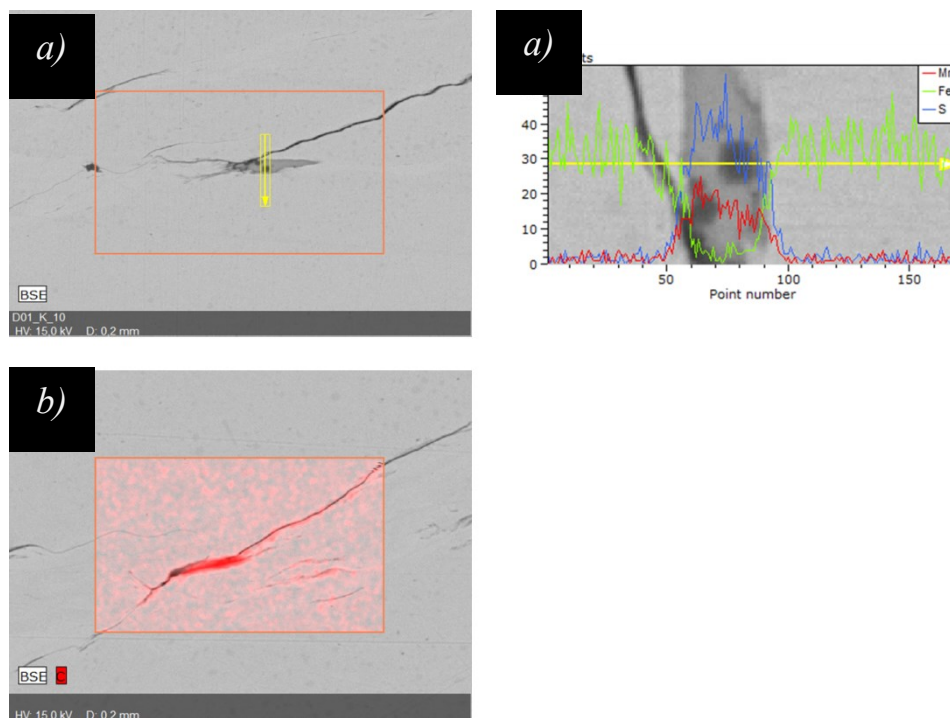
The EDS results for surface (1) showed two elements, manganese and sulfur, suggesting a manganese sulfate inclusion, on the other hand, results of surface (2) showed a high carbon content, suggesting a graphite inclusion or sample contamination from the epoxy used, the EDS results are shown in Figure 22.

**Figure 22 EDS results for surface 1 (a) as shown in Figure 20; Mn (red), Fe (green) and S (blue). Results for surface 2 (b) as shown in Figure 21; Carbon (red)**

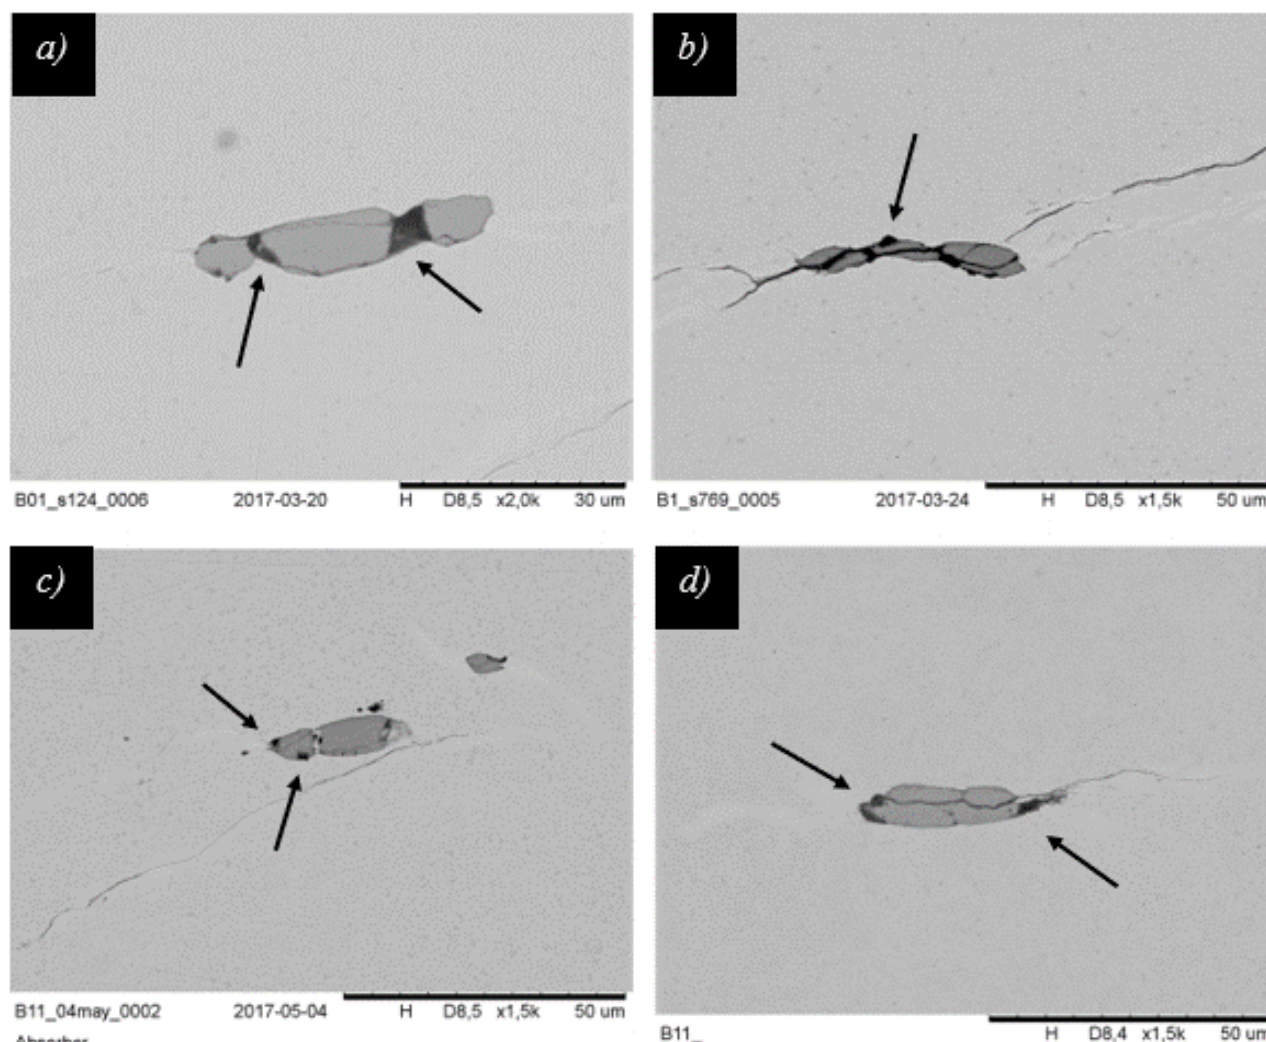
**Figure 23 SEM results showing inclusions with inner cracks**

EDS experimentation was performed to results in Figure 23, all of them were manganese sulfates nevertheless, sample a) showed the presence of carbon, pointed by the arrows, while samples b), c) and d) showed the presence of aluminum oxide, pointed by the arrows. Except for sample b), the inclusions were isolated from the main butterfly cracks. Although four regions were identified by the tomography scan with cracks-inclusions interactions, only two could be investigated. The main factors for this were near proximity between regions ( $<80\text{ }\mu\text{m}$ ), which resulted in over-polishing while trying to reveal one of the surfaces, also, limitations for samples with a thickness of less than  $50\text{ }\mu\text{m}$ , as the material falls from the holder resembling a metal foil.

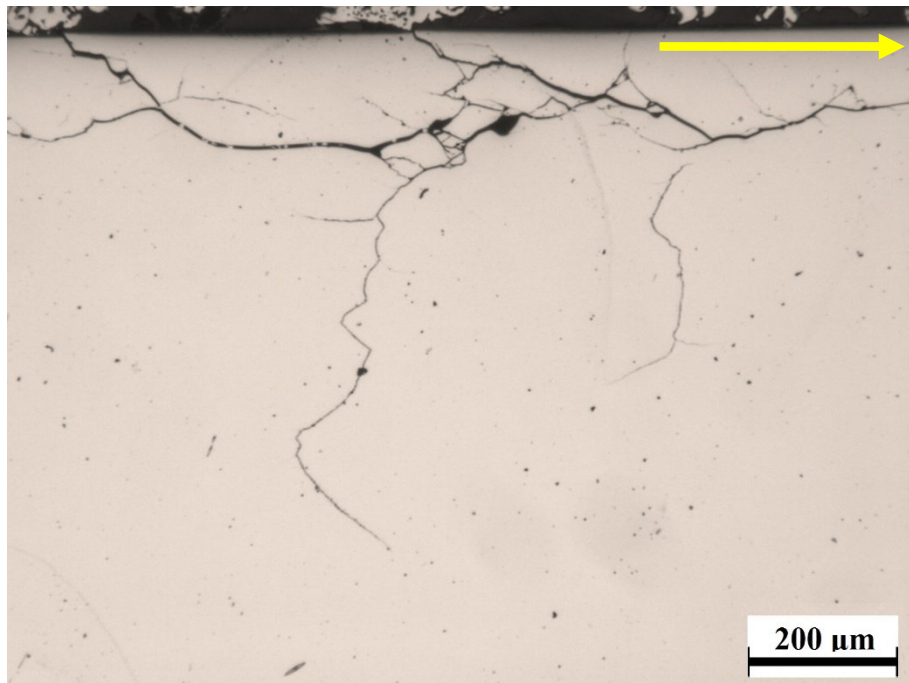
It was found that the sub-surface was heavily damaged and a crack network was visible, in some regions of the raceway the cracks already had reached the raceway surface and the width of the cracks were considerably large as shown in Figure 25, where the yellow arrows indicates the rolling direction.

**Figure 25 Region from axial bearing with extensive damage, sample obtained from bearing shown in Figure 24**

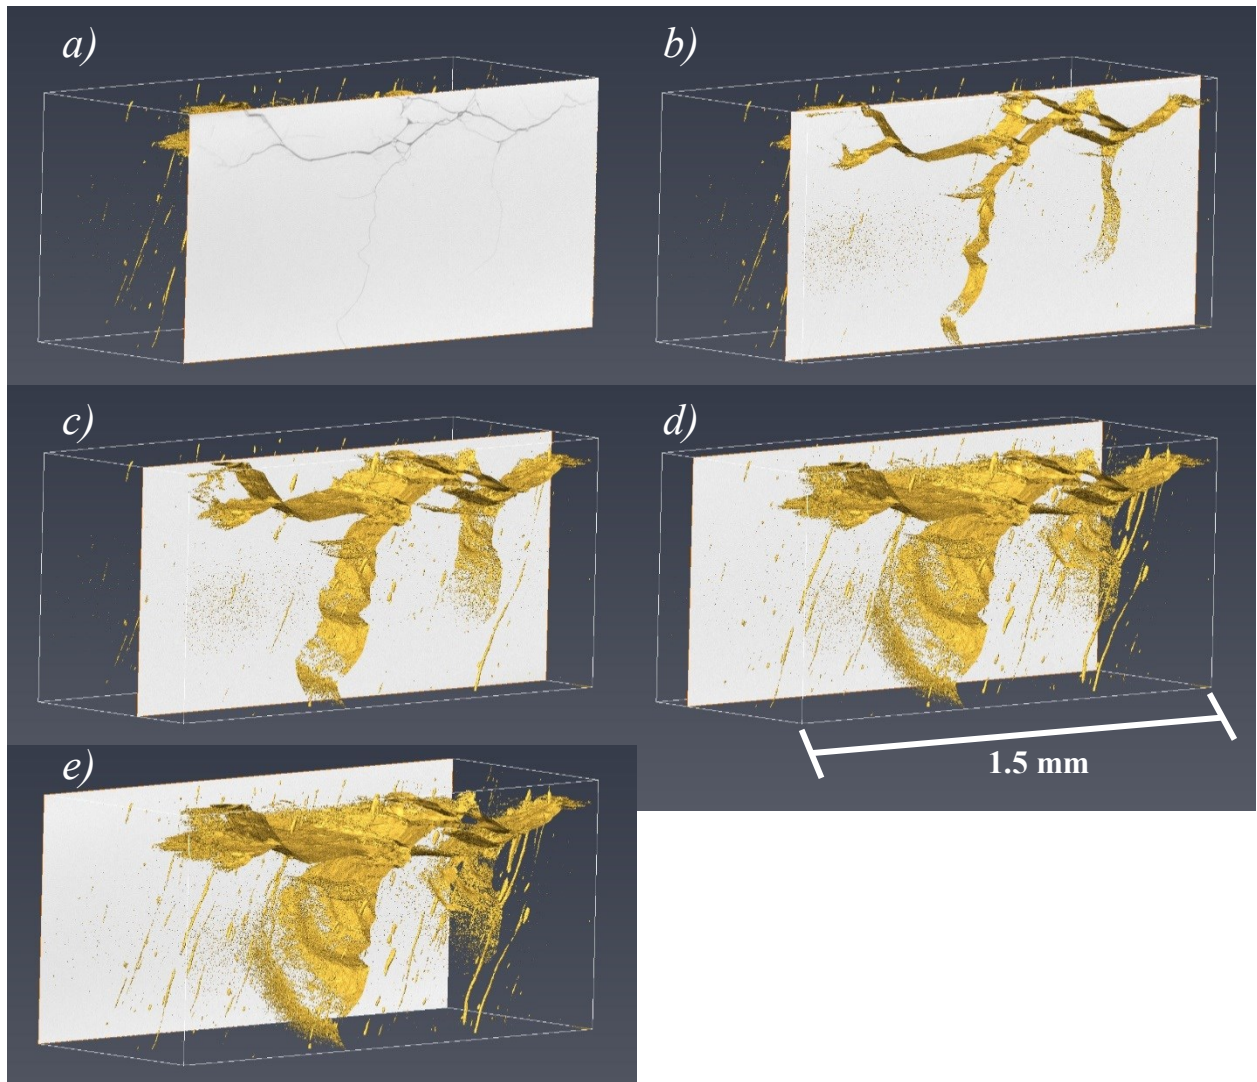
**Figure 26** Post processing of raw data and crack-inclusion mapping, results are from sample in **Figure 25**

Figure 26 shows the tomography results and how it mapped the crack; due to the crack width, it was possible to obtain a remarkable 3D reconstruction. The results were processed using the automated “Isosurface” command on Avizo. The inclusions are shown as elongated entities, nevertheless due to the heavy damage in the region the interaction between inclusions and cracks could not be observed in detail and no significant conclusion could be reached in this matter. A second sample was cut to observe a triple junction of the crack to investigate the propagation direction and whether grain boundaries have any influence on its path. The analyzed region is shown in Figure 27 where the yellow arrow indicates the rolling direction. The results of the EBSD is shown in Figure 28 which was conducted with a step size of  $0.05\ \mu\text{m}$ .

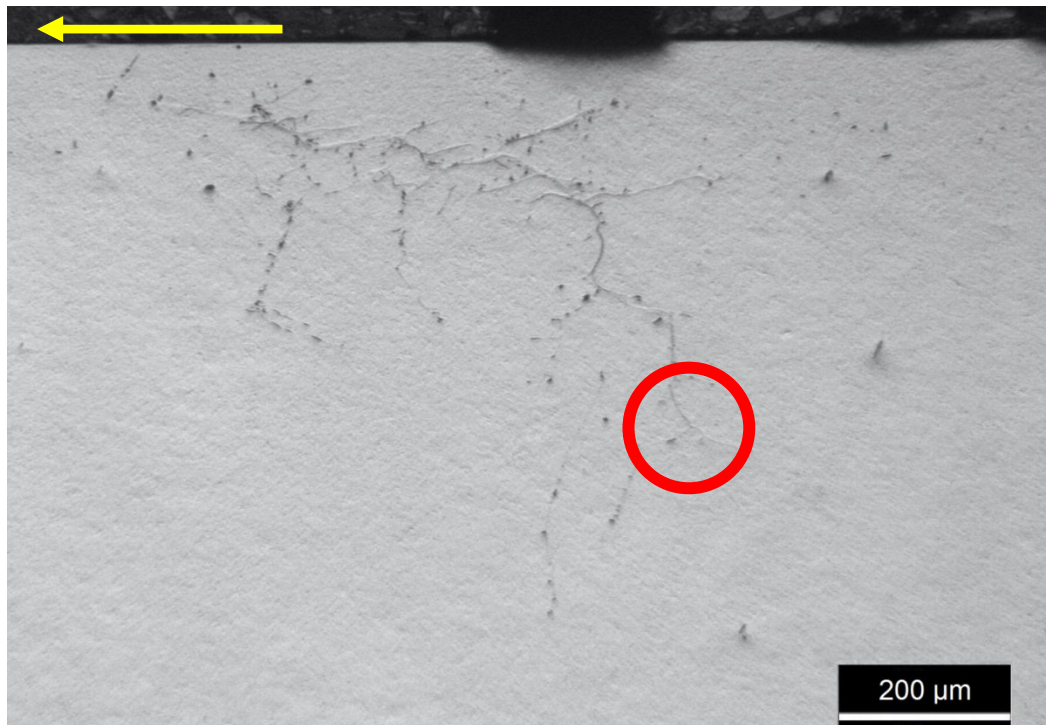
**Figure 27 Triple junction of crack and region of interest for EBSD**

As it can be observed from Figure 27 the width of the crack network is thinner compared to the one presented in Figure 25, nevertheless the cracks are already approaching the surface and propagating inside the material. The EBSD study demonstrates that the crack is propagating through prior austenite grain boundary (PAGB) highlighted by a white contour. A reduction in grain size is observed near the cracks or in the WEAs, these regions are colored in black in Figure 28 and are undistinguishable from the crack. Both regions cannot be indexed due to the

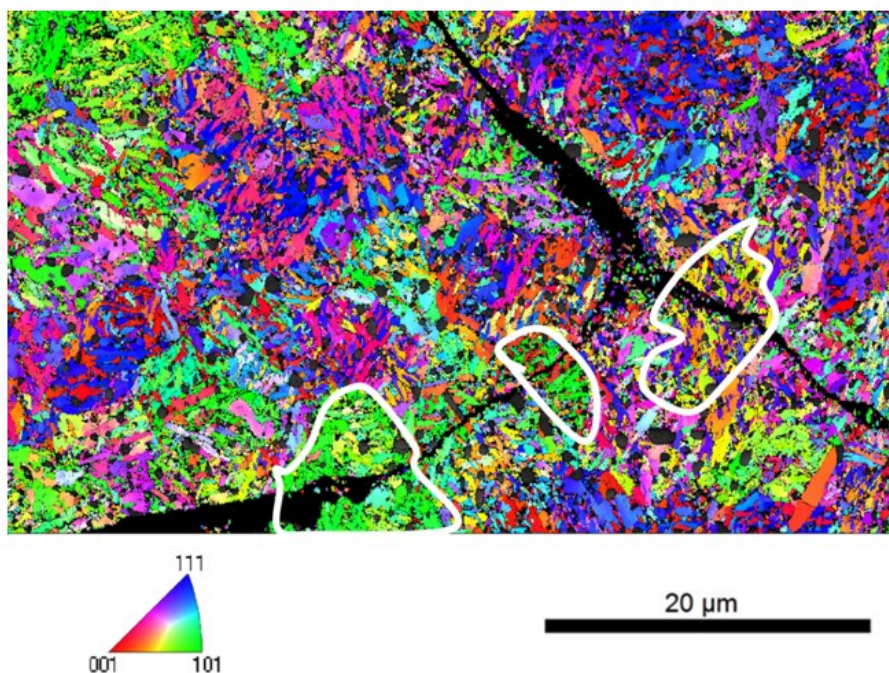
**Figure 28 EBSD results from region highlighted in red in Figure 27 (iron BCC matrix)**

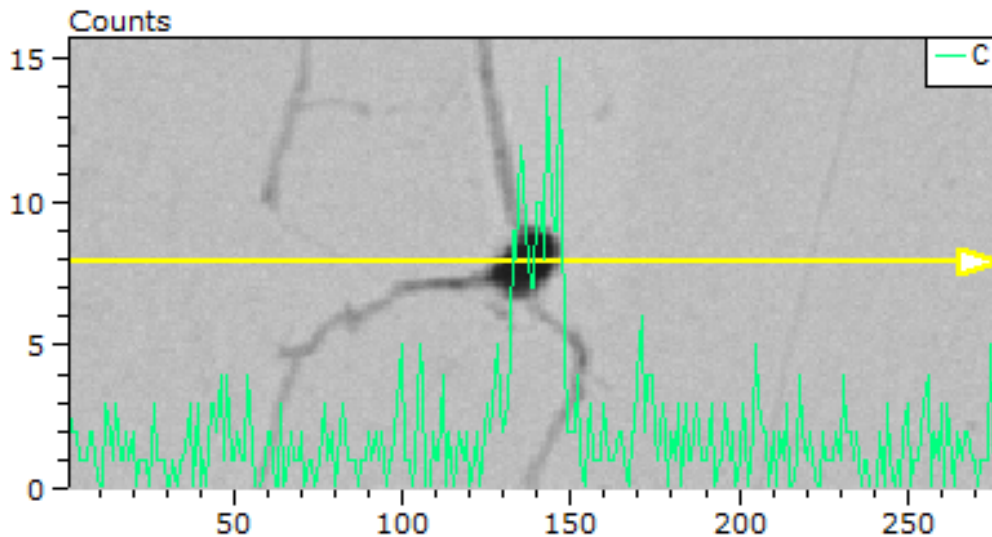
**Figure 31 Carbon results in EDS experiment from triple junction crack shown in Figure 30**

It thus can be concluded that the inclusion in this region is either graphite or sample contamination from the holder and due to time constraints only one surface was investigated, but the tomography scan showed various regions with similar interactions between cracks and inclusion-like particles. Overall, less damage was observed in the outer contact surface between the raceway and the roller as predicted by [35] and shown in Figure 24. Although only one triple junction was observed under the EBSD as seen in Figure 28, it was possible to conclude that the crack propagated over what seems to be a PAGB.

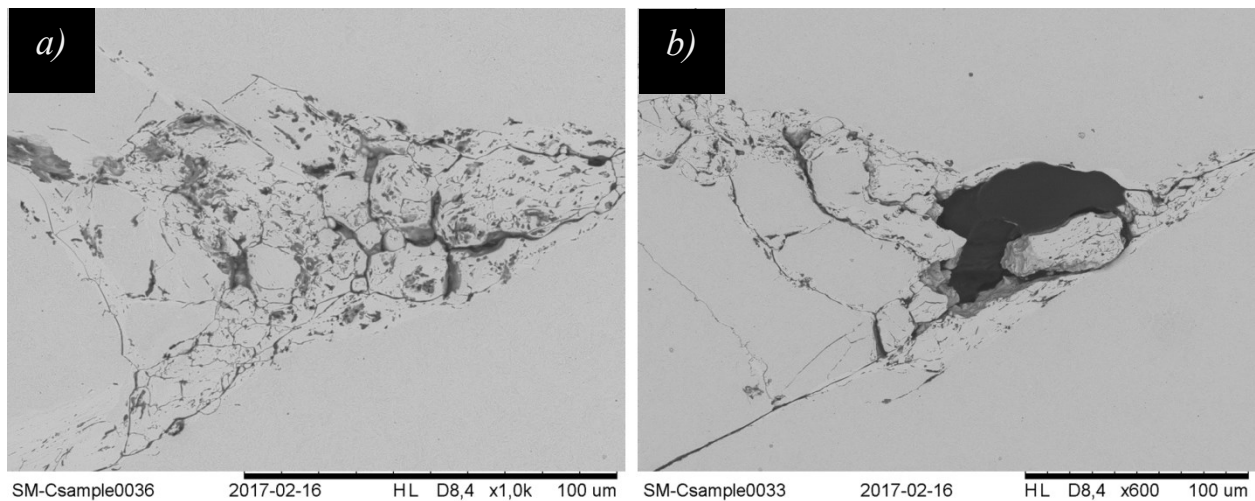
**Figure 32 Regions of interest in WT main bearing regions *a*) and *b*) are highlighted by a black and red circle respectively in Figure 34**

The pattern on the crack shown in Figure 32 *a*) might had been an indication that the crack was extending along prior austenite grain boundaries, thus an EBSD test was conducted with a step size of 0.05 μm, however no significant results were obtained due to heavy plastic deformations and a considerable decrease in grain size as shown in Figure 33.

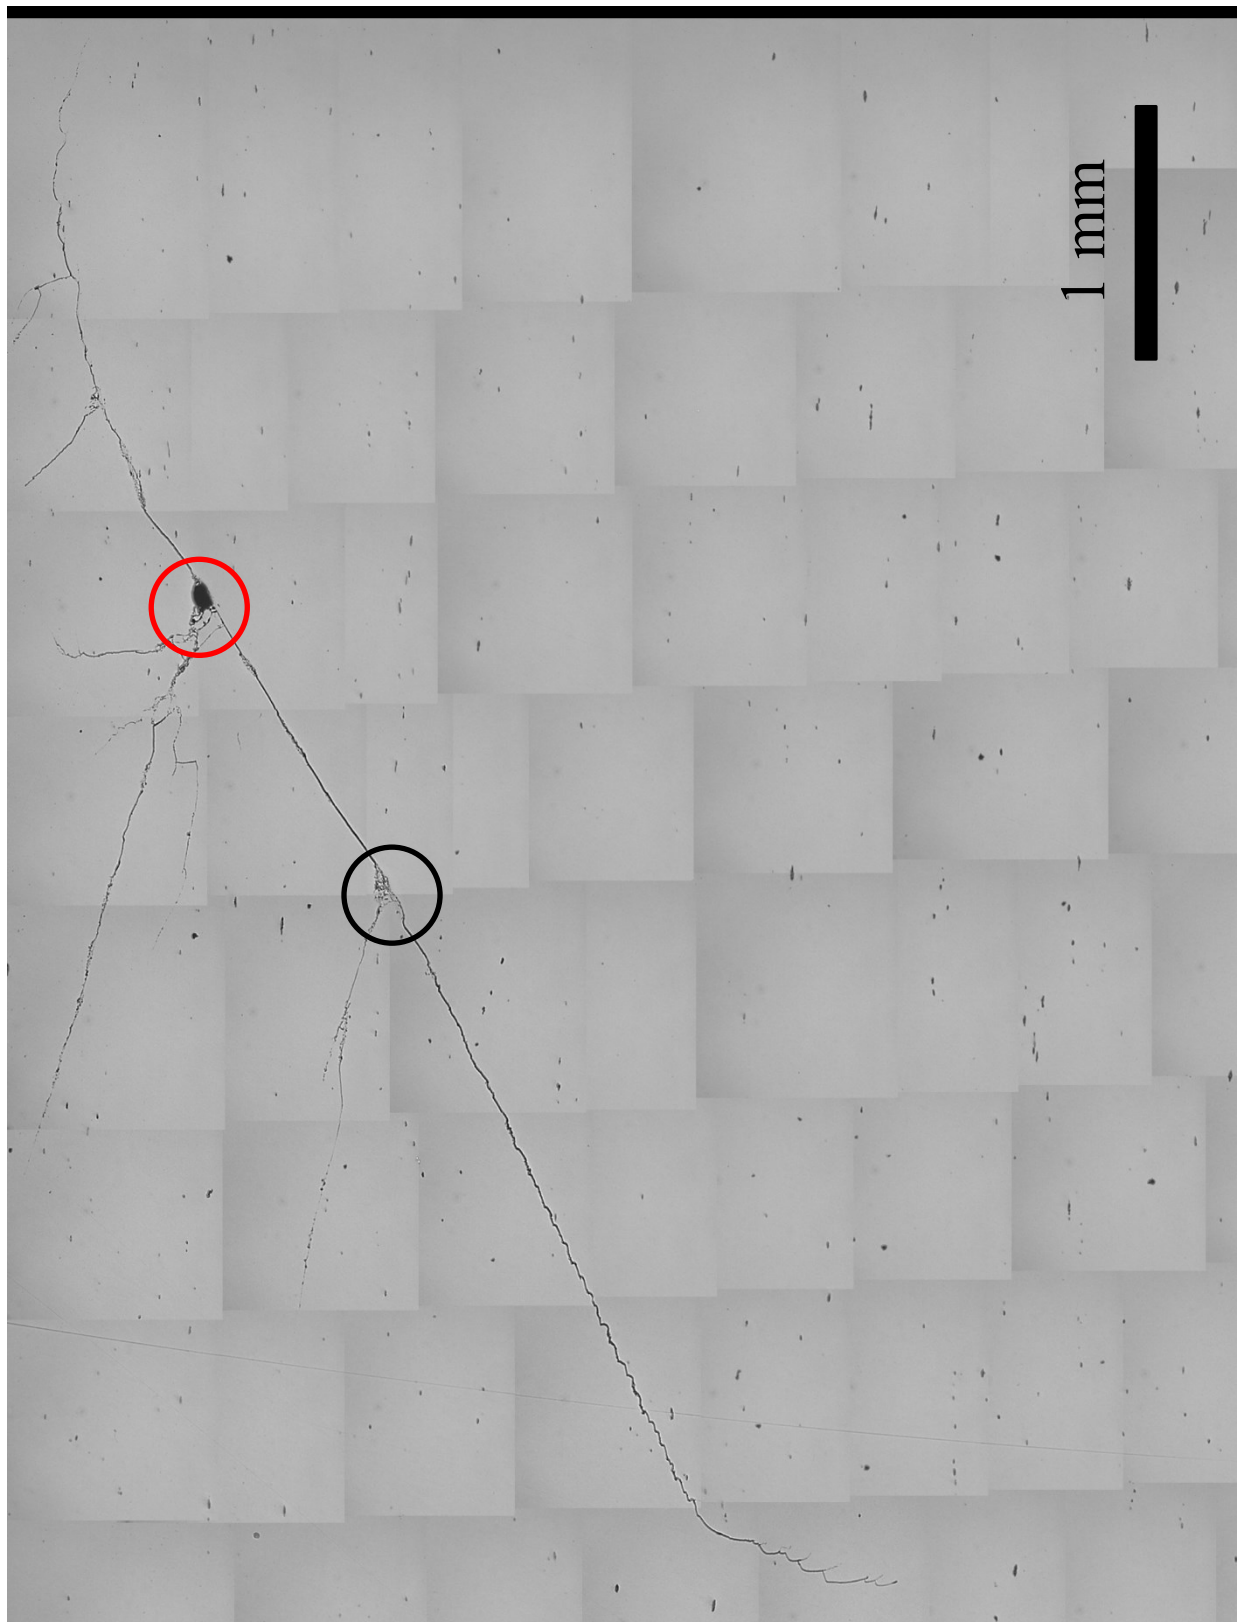
**Figure 34 Overview of crack on main bearing**

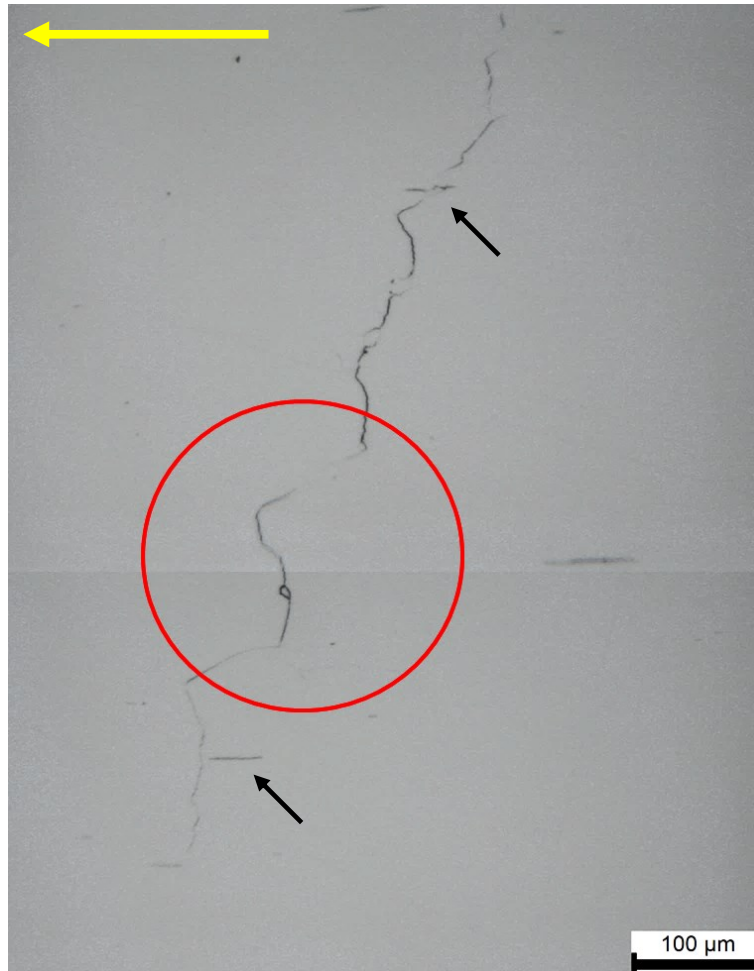
**Figure 35 Crack from radial bearing under test rig**

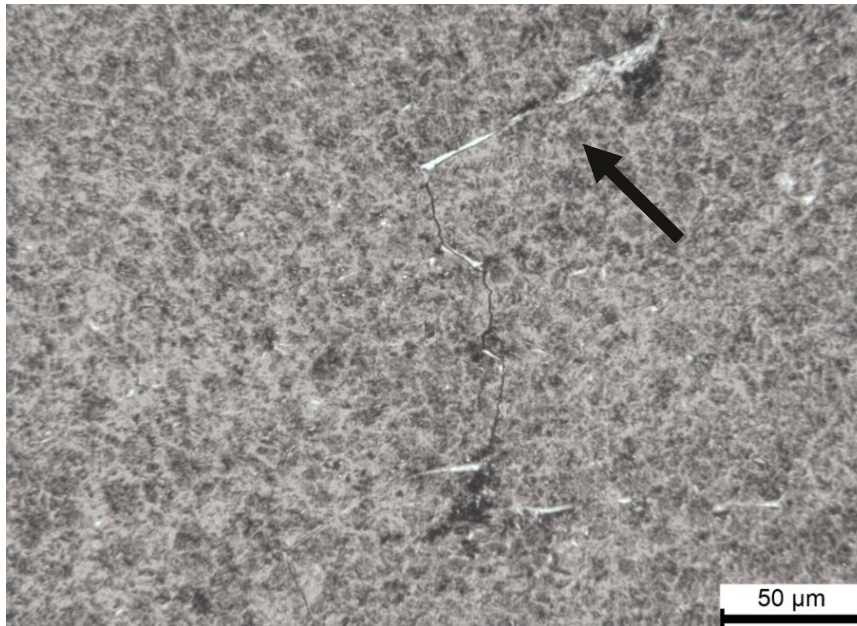
After being etched some WECs were observed especially in the region enclosed by the red circle in Figure 35 and shown in Figure 36.

**Figure 36 White etching cracks in radial bearing indicated by arrow, close-up from Figure 35**

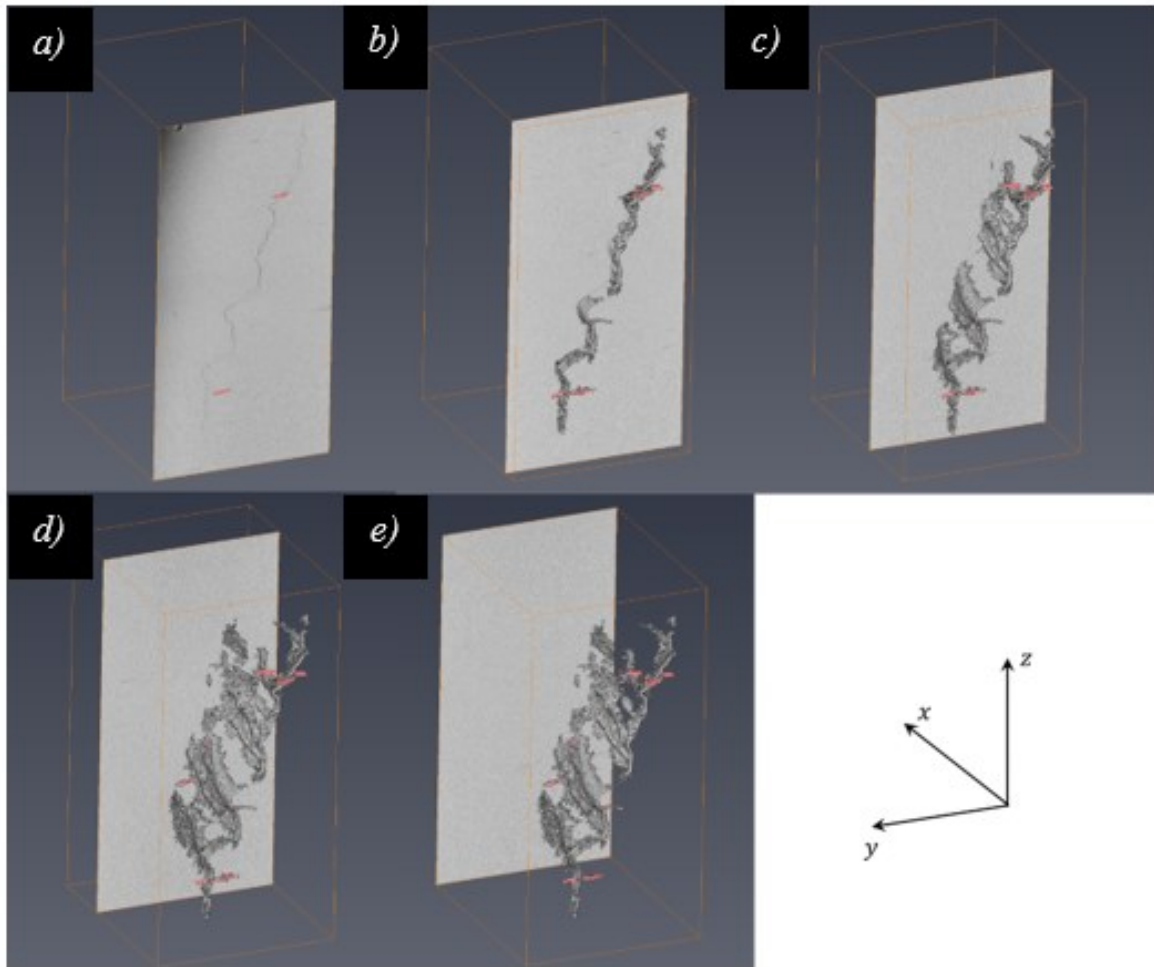
As the final step for this investigation a tomography scan was performed, and the results are shown in Figure 37 where the cracks and inclusions are colored in grey and pink respectively. The results captured the inclusions seen on the surface of Figure 35 and although the bottom inclusion seemed to be separated from the crack, the scan showed there was an interaction between them at a different depth.

**Figure 37** Tomography scan results from sample shown in Figure 35  
Physical dimensions of scan are  $x = 450\mu m$ ,  $y = 85\mu m$ ,  $z = 470\mu m$

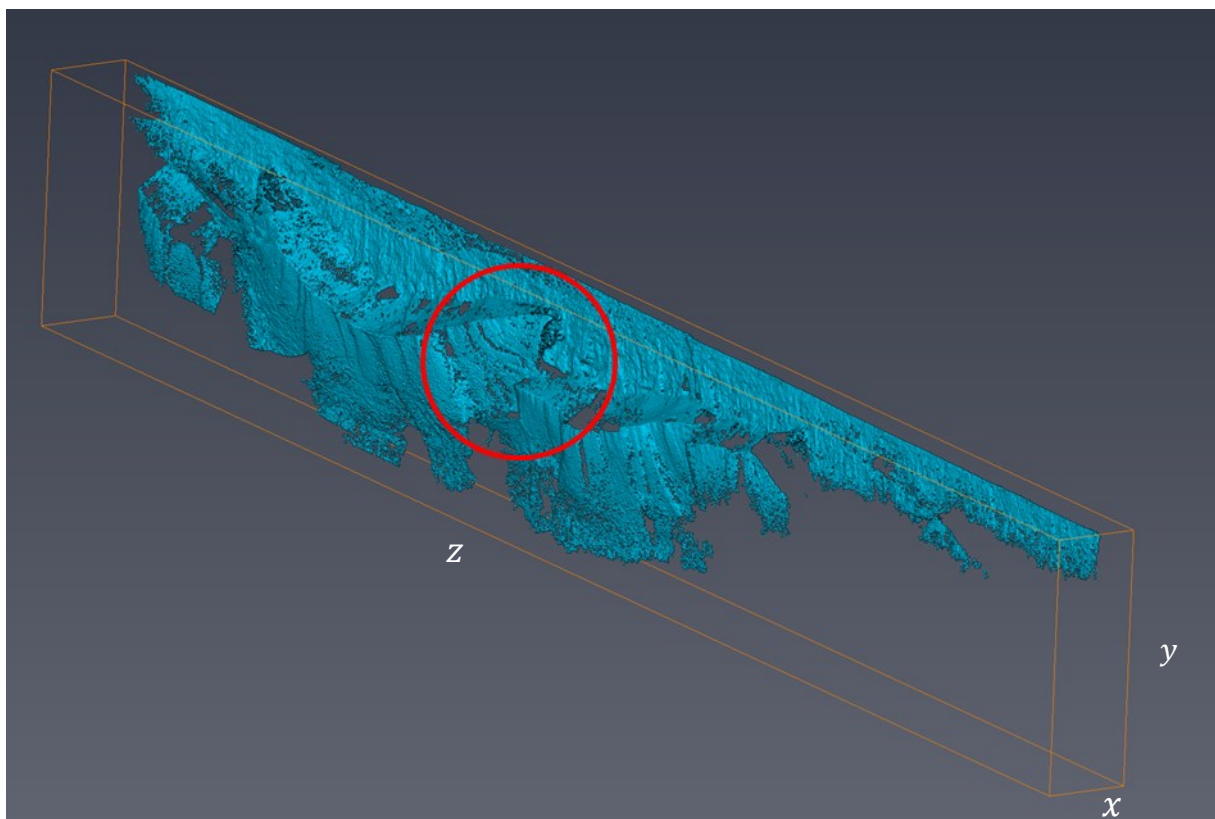
**Figure 38 Tomography scan of wind turbine tapered bearing**  
**Physical dimensions of scan are  $x = 1.51\text{mm}$ ,  $y = 4.50\text{mm}$ ,  $z = 32.87\text{mm}$**

Of interest is the region enclosed by the red circle in Figure 38, where two cracks interact, the cross-sectional results obtained from the tomography scan are presented in Figure 39, the arrows indicate particles or voids interacting with the crack.

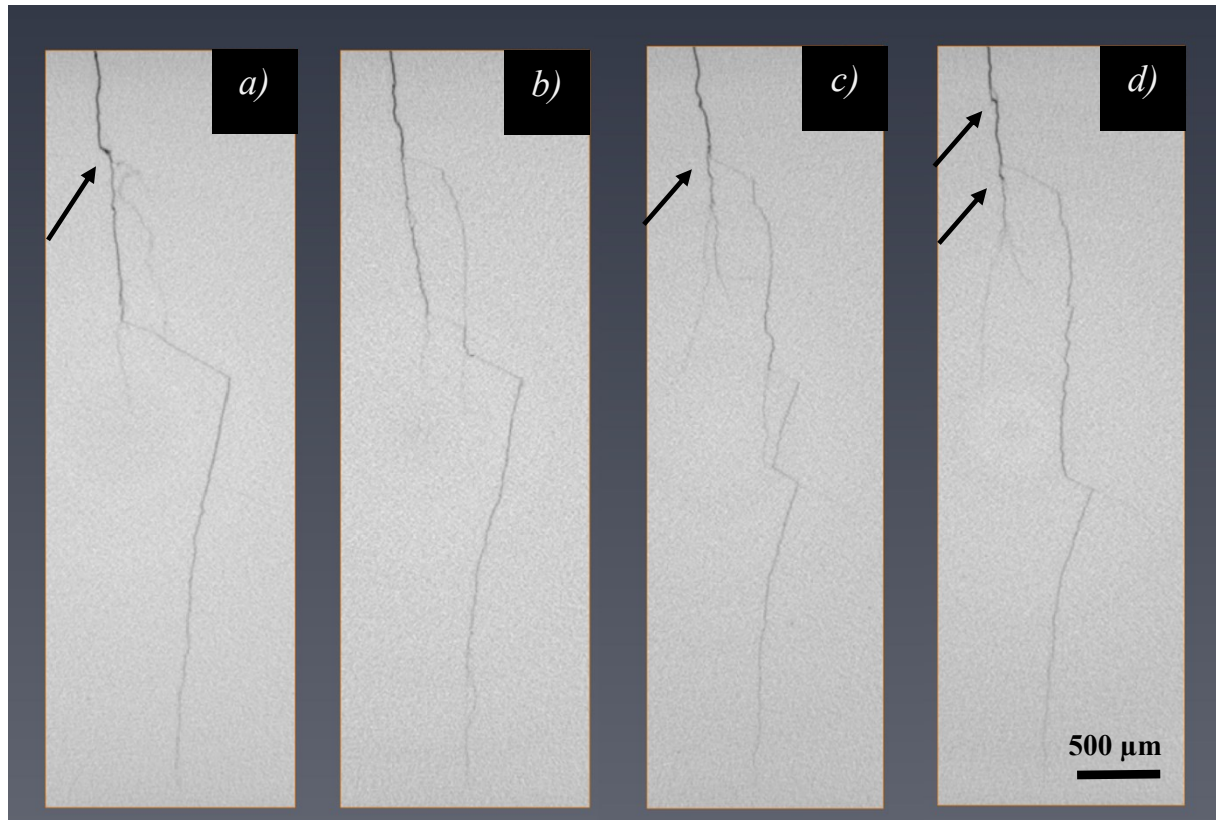
**Figure 39 Results of tomography scan showing the interaction between cracks, images were obtained from encircled area of Figure 38**

It can be observed that a small crack is formed in Figure 39 *a*), a particle is observed and pointed by the arrow. The crack seems to grow erratically but starts to grow perpendicularly to the main crack as shown in Figure 39 *b*) creating a step-like shape. The crack continues to grow downwards and the step like shape is lost as seen in Figure 39 *c*). Finally, it merges as a single crack and will continue to have this shape along the specimen as shown in Figure 39 *d*). A close-up of the crack in 3D is shown in Figure 40, the cross-sectional images from Figure 39 were obtained from this volume and the step-like shape is highlighted in red. Following the edges of the cracks it can be observed they have a slight curvature and these features are highlighted in yellow in Figure 40.

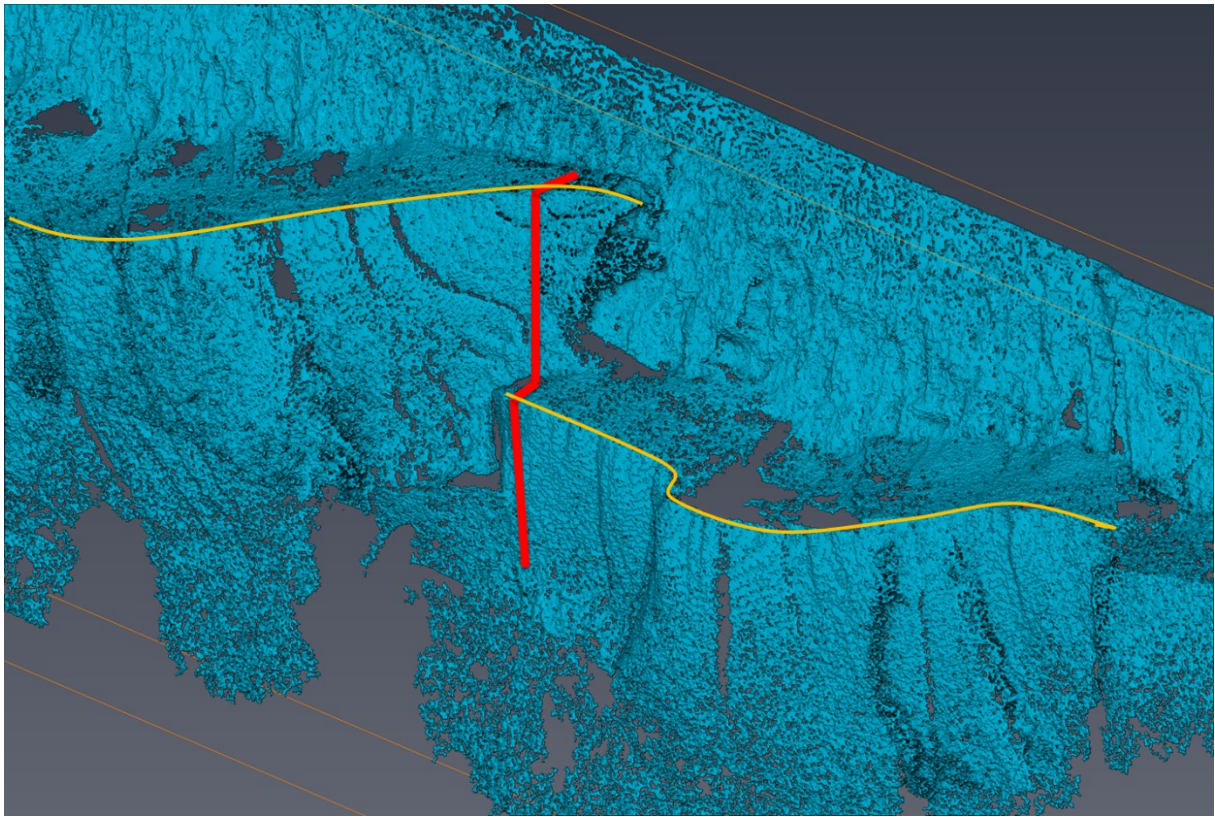
**Figure 40** Interaction between cracks, a close-up of enclosed region showed in Figure 38.  
Red line is the contour of cross-section shown in Figure 39 *b*)
