### A case study of St. Christopher in Maria Church, Nisse

# Application of shearography and the percussion method for the structural inspection of wall paintings: a case study of St. Christopher in the Mariakerk, Nisse

Valentina Gatto\*<sup>a</sup>, Andrei G. Anisimov<sup>b</sup>, Wouter Lettinga<sup>b</sup>, Nan Tao<sup>b</sup>, Merel Lantman<sup>a</sup>,  
Roger M. Groves<sup>b</sup>

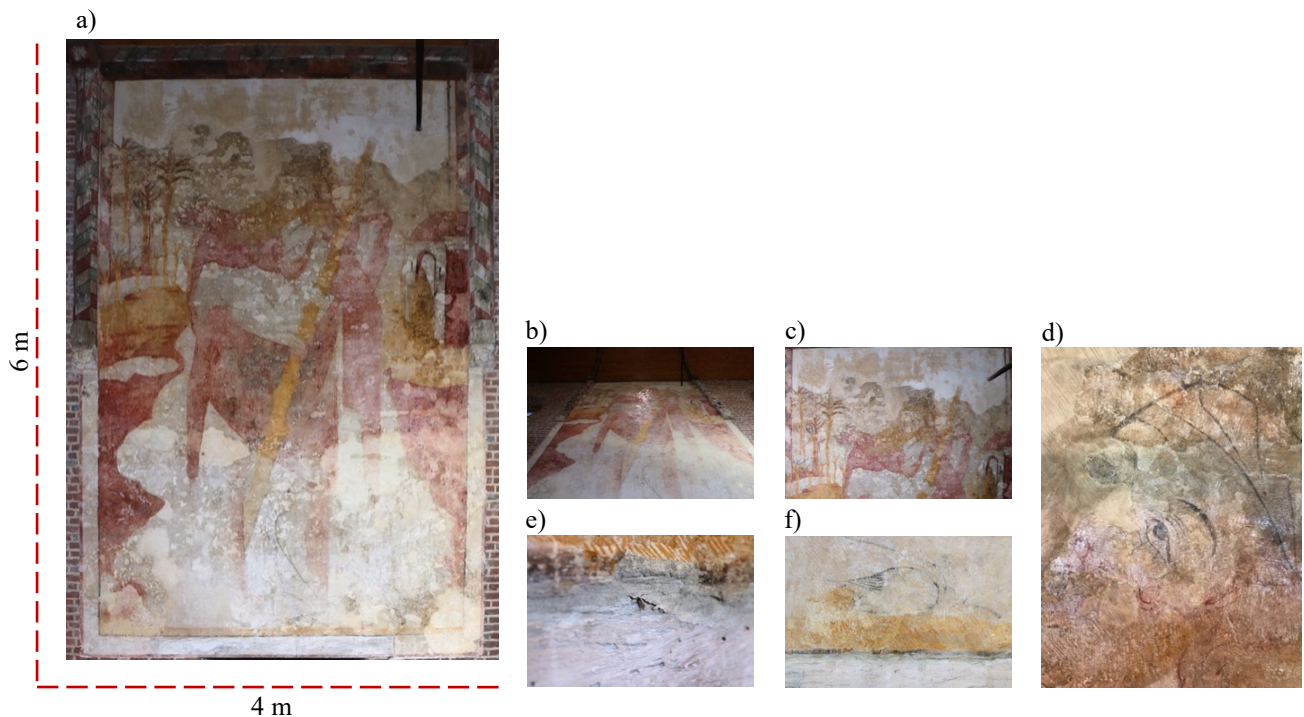
Figure 1. Wall painting depicting St. Christopher (a\*), with close-up details and degradation phenomena: (b) widespread surface gloss, (c) large areas of loss and retouching, (d) extensive retouching and visible surface gloss, (e\*) visible delamination, (f\*) fading of painted system and extensive retouching. \*Photo credit: Jorien Duivenvoorden

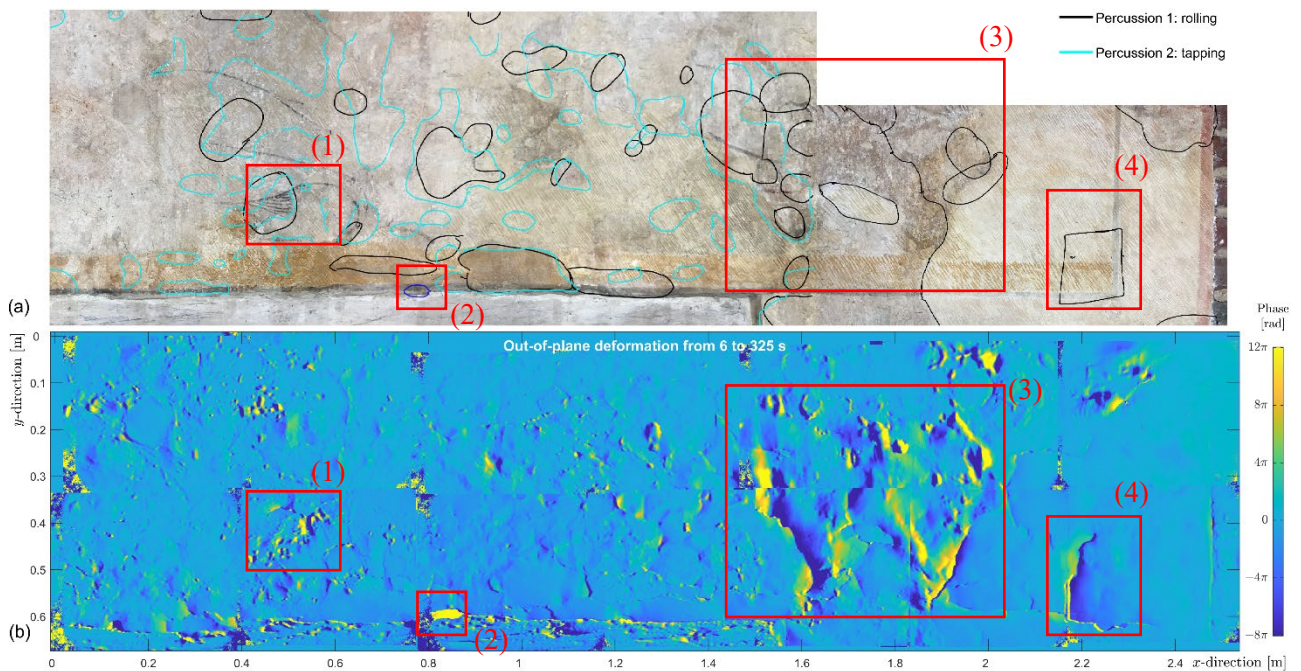
The percussion tests were executed in a collective approach, in order to reduce biases and subjective inclinations (Figure 2). After the tapping or the rolling of an area had occurred, the generated acoustic reactions were discussed and subsequently mapped (Figure 4 (a)). It can be easily observed that the implementation of the two percussion methods, despite involving the same mechanism of interpretation and collection of data, gave somewhat different results (Figure 4 (a)). It can be stated that the percussion method involving the tapping of a nail resulted in identifying more areas with delaminations than the percussion methods involving the rolling of the acoustically isolated plastic ball. In overall, some similarities in the results obtained were observed, especially in areas surrounding the wooden lintel, part of the door underlying the wall painting of St. Christopher (left and right side on the lower part of the wall painting in Figure 4 (a)).

Figure 4. Comparison of the inspection results obtained with (a) two percussion methods (shown as contour plots) and (b) the total phase difference obtained with shearography corresponding to the out-of-plane surface strain component. Four areas of particular interests have been identified in red, to facilitate argumentation.

The resultant phase map reveals multiple structural defects that relax after the thermal excitation to a stable state causing mechanical out-of-plane surface strain. The colour code in Figure 4 (b) is directly proportional to the strain magnitude.

Four main areas of interested have been identified and plotted in red in Figure 4 (b). As it can be observed by comparing area 1 in Figure 4 (b) and the correspondent area in Figure 4 (a), the presence of large areas of structural delamination was only identified by the percussion methods; shearography only detected a slight surface displacement, indicative of the presence of some structural defects. Area 2 has been mapped during all testing executed; it must be noted that the area in question was showing visible surface delamination and, therefore, could be easily identified with the naked eye (Figure 2 (e)). Similarly, strong correspondence in the detection of large areas of structural defects can be observed in area 3 in Figure 4 (b); the latter depicts a strong strain displacement which was also perceived as a vulnerable area during both percussion tests. Ultimately, it was deemed of interest to examine area 4 in Figure 4 (b). The latter is indicating an area where delamination might be occurring, which was only detected during the percussion testing that involved the rolling of an acoustically isolated plastic ball.

In conclusion, a partial correspondence between results obtained with the percussion methods and shearography was established. It can be argued that, areas perceived as vulnerable and indicative of the presence of delamination (such as area 1 in Figure 4 (a)) could not be detected by shearography because of two reasons:

1. The acoustic response documented during percussion testing was generated by the presence of materials of different composition and density.
2. The delamination might be relatively deep and might not affect the surface strain, therefore it would not be detected by shearography.
