Explosion Hazards of Aluminum Finishing Operations

Jérôme Taveau ^{a,b}, Simone Hochgreb ^c, Saul Lemkowitz ^d, Dirk Roekaerts ^{b,e}

Abstract

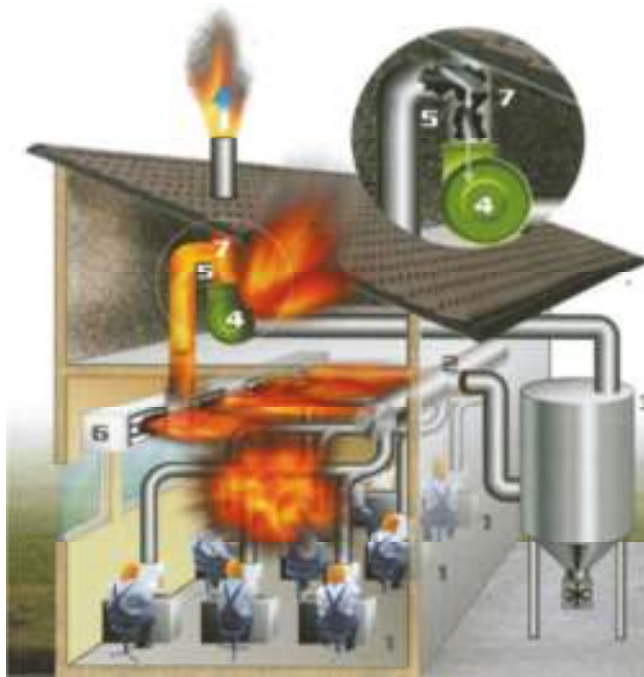
A very similar case to the Manitowoc explosion that happened many years after is discussed in a booklet published by the International Social Security Association (ISSA, 2005). The explosion took place in a facility where finishing work of cast aluminum parts was ongoing (Figure 3). The working stations were all equipped with a central dust collection connected to an extraction fan and a water-filled dust separator placed outside the building. Ignition was initiated by the shock of an air flap falling into the fan, causing an initial explosion in the ducting. The explosion propagated within the recirculating air ducting, which blew and ignited dust into the grinding room, and killed all eight workers. The grinding building was completely destroyed. The recommendations in the ISSA booklet highlighted the importance of avoiding a recirculating air system, unless the ducting is equipped with an explosion isolation system that can prevent the flame from propagating back to the building in case of an explosion.

Figure 3: Aluminum dust explosion in a grinding room (ISSA, 2005)

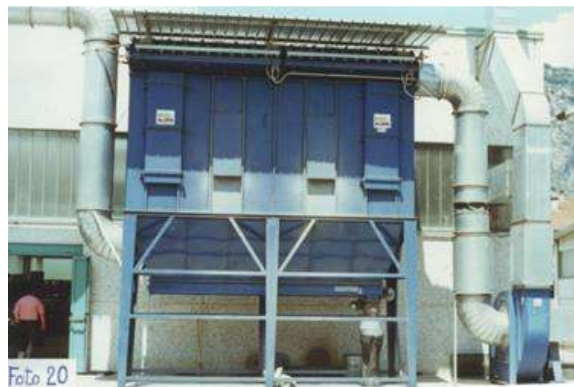
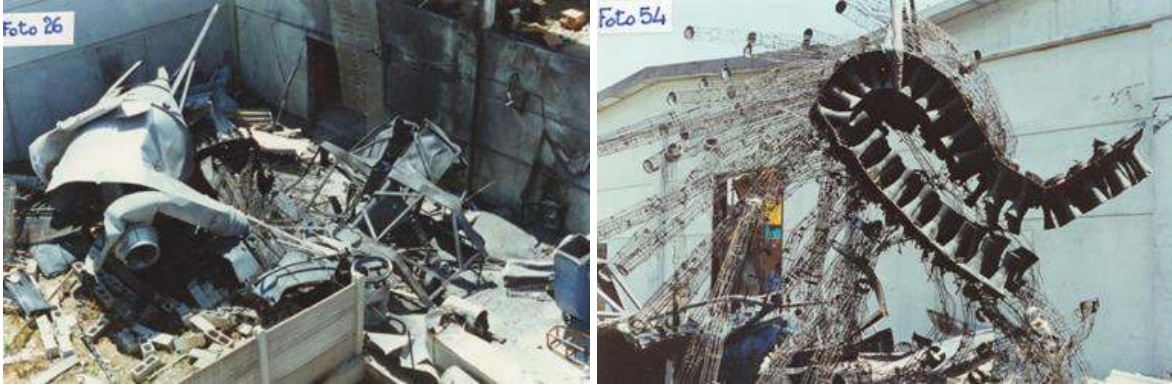
- A second accident (2000) took place in a small factory in the North-West of Italy (Marmo et al., 2015) where polishing and other surface finishing operations were routinely conducted on aluminum coffee pots using sixteen grinding machines. The dust was captured through sixteen drawholes and sent to a cyclone followed by a bag filter. The filter was equipped with four overpressure relief panels hinged to their upper parts, which were weighed down with four metallic 1.2 kg plates. The explosion destroyed the equipment and threw ejected equipment beyond 60 m. Three workers were slightly injured. The first deflagration happened inside one of the grinding machines and was caused by the breakage of one belt. Sparks and burning particles were aspirated by the abatement plant, causing the aluminum dust to ignite in the lower part of the cyclone, giving rise to the first major explosion. The cyclone collapsed and the pipes connected to the machines broke, releasing aluminum dust in the work areas. The flame front propagated to the bag filter, causing a second more violent explosion. Figures 4 shows the bag filter before and after the event.

Figure 4a. Bagfilter before the aluminum dust explosion (Marmo et al., 2015)

Figures 4b and 4c. Bagfilter before after the aluminum dust explosion (Marmo et al., 2015)

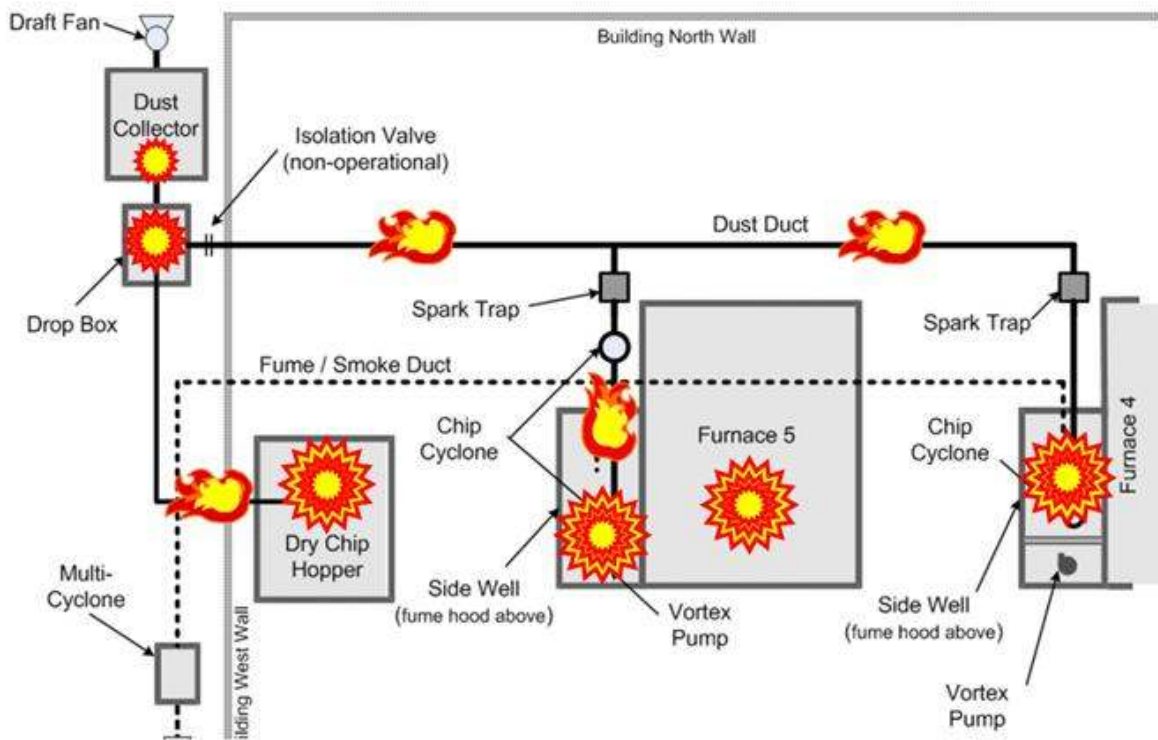
On October 29th, 2003, a deflagration started in the dust collector of a cast aluminum automotive wheels manufacturing plant located in Huntington, Indiana, and propagated to a drop box, interconnected pipes and finally to the plant (Figure 5). The deflagration caused major damage to the dust collector: the vent panels and three maintenance doors were blown open, the top section of the housing was dislodged and the cleanout section was distorted. According to the Chemical Safety Board (2005) which investigated the accident, this damage shows that the venting was not sufficient to prevent structural damage to the dust collector caused by the overpressure generated in this accident. The drop box, on the other hand, failed and fractured into several large pieces (Figures 6).

Figure 5: Assumed sequence of events (from top left): ignition in the dust collector, larger explosion in the drop box and propagation to other process areas (adapted from the Chemical Safety Board, 2005)

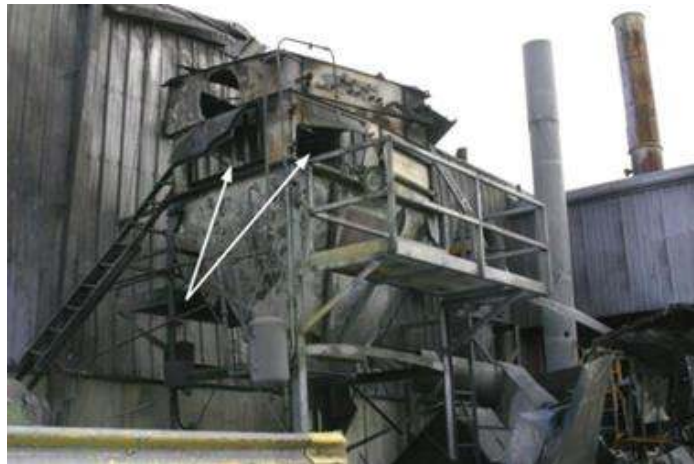
Figure 6a. Damage to the dust collector (Chemical Safety Board, 2005)

Some dust was sampled from the top of an electrical enclosure, yielding a deflagration index $K_{St} = 131 \text{ bar.m/s}$, which is a moderate value for aluminum. It was not possible to determine the source of ignition, but investigators found some signs of poor maintenance of the dust collection system. An isolation gate valve was installed in the 20-inch line outside the building, close to the drop box (Figure 5). However the valve actuator had been disconnected because of operational problems and employees were not aware that this valve was intended to isolate the pipe in case of a dust deflagration.

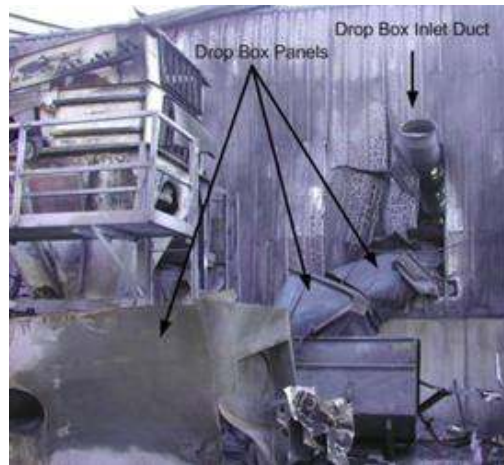
Figure 6b. Damage to the drop box (Chemical Safety Board, 2005)

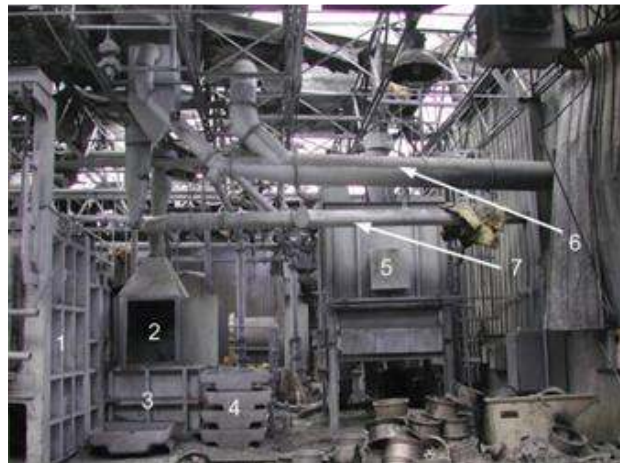
Figure 6c. Damage to the interior of the facility (Chemical Safety Board, 2005)

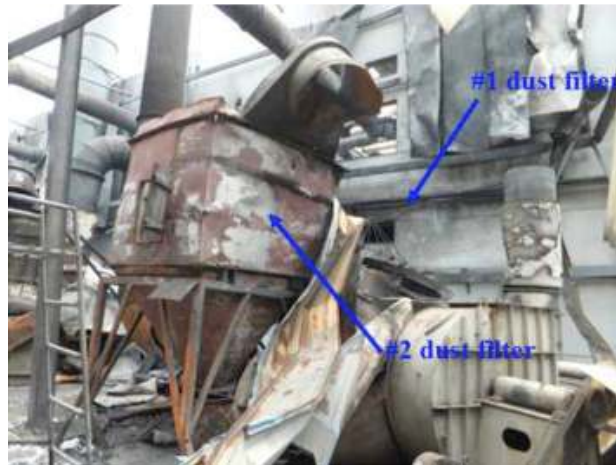
Figure 7b: Damage to the dust collectors (Li et al., 2016)

The investigation concluded that the primary deflagration started in a dust collector located outside, which then propagated into the main building via the dust extraction system. Ignition was determined to be the self-heating of aluminum dust in a collecting barrel below one of the dust collectors. Some dust samples were collected across the facility. The results of tests using the collected powders are given in Table 2. The authors underline that the presence of explosion isolation systems in the ducting would have limited the consequences of the deflagration substantially. They also point out the difficulties of isolating deflagrations involving highly reactive dusts, especially when dust collectors and work rooms are separated by short distances.

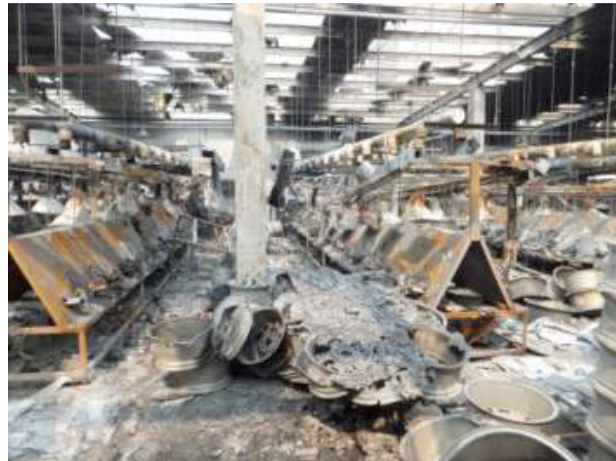
Figure 7c: Damage to the production lines and work stations (Li et al., 2016)

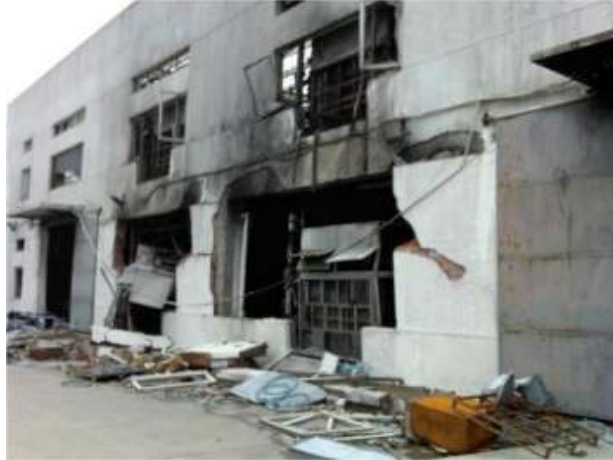
Figure 7d: Damage to the eastern wall of the main building (Li et al., 2016)

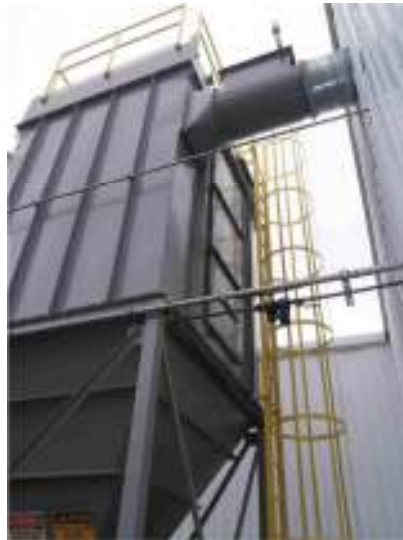
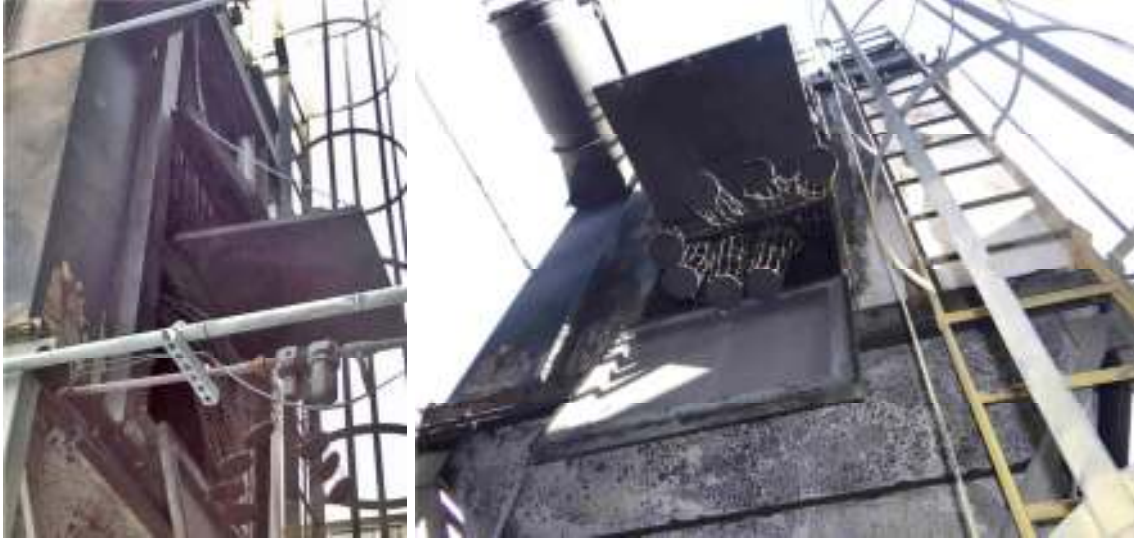
A recent incident, referred in a public input to NFPA 68 2013 edition (Luzik, 2015), further questions the scalability of aluminum dust explosibility parameters. The dust involved in this incident was an aluminum alloy with a tested $K_{St} = 186$ bar.m/s. While the installed vent area (20.4 ft²) exceeded the required vent area per NFPA 68 (17.9 ft²), the dust collector experienced significant structural deformation during the deflagration (Figures 11), suggesting that the internal pressure was higher than calculated.

Figure 11a: Dust collector before the deflagration (Luzik, 2015)

Figures 11b and 11c: Dust collector after the deflagration: filters blown through the vents (Luzik, 2015)

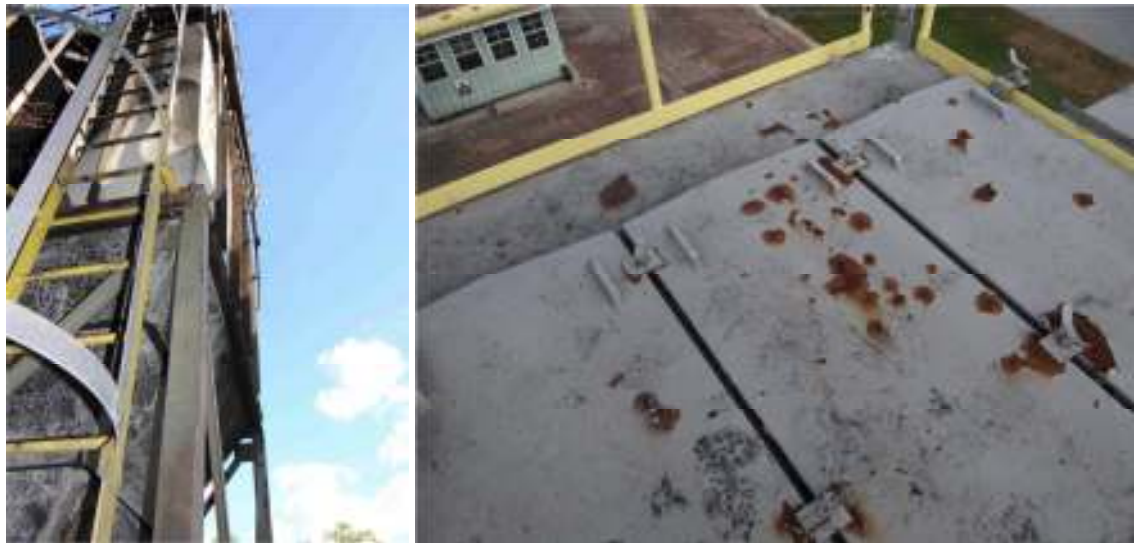
Figure 11d and 11e: Dust collector after the deflagration: deformation of the reinforced wall and access doors (Luzik, 2015)
