# Application of shearography with thermal loading for structural inspection of Rembrandt's *Night Watch*

## ABSTRACT

*The Night Watch* is a large oil on canvas painting with overall dimensions of 3.795×4.535 m (Figure 1). The original canvas support consists of three horizontal strips of canvas with two seams. Two inspected areas, including the Captain's breeches (0.5×1 m) and the drum (0.2×0.5 m), are marked in green and red rectangles. To minimize the exposure of the paint layers to the light and heat from the shearography heating source, these two areas were inspected from the reverse of the painting.

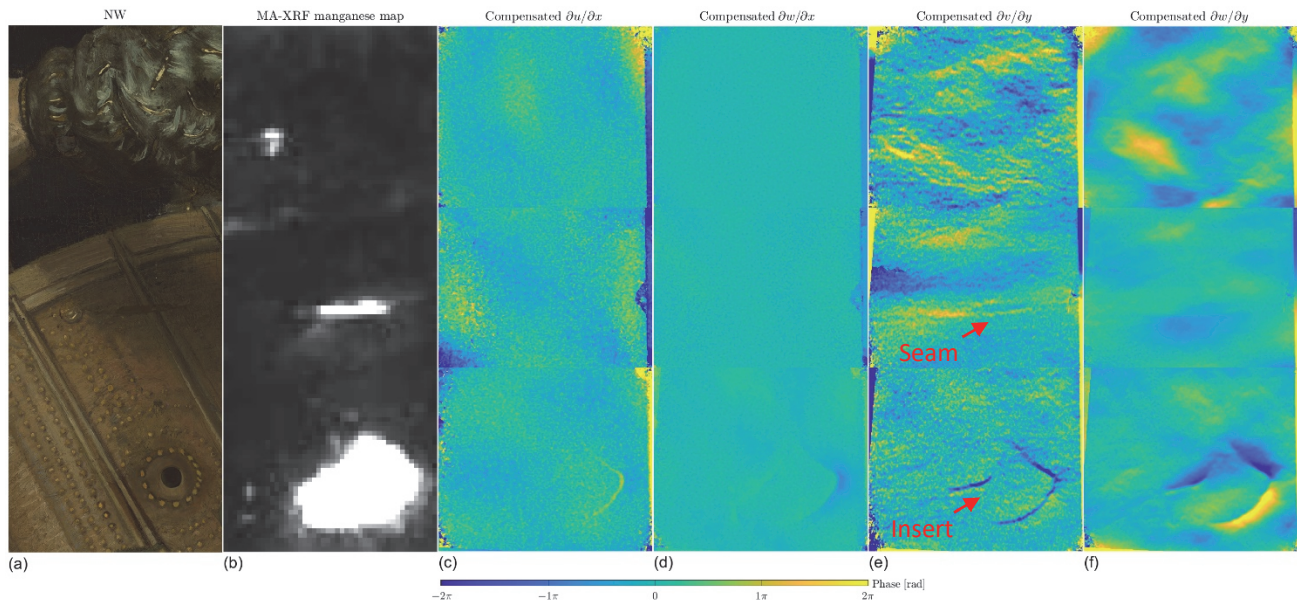
The inspected area of the drum with the canvas insert and the canvas seam in the original support is shown in Figure 3 (a). The seam and the canvas insert are detectable in the in-plane  $\partial v/\partial y$  and the out-of-plane  $\partial w/\partial y$  phase maps with the shear in the  $y$ -direction (Figure 3 (e, f)).

Figure 3. 3D shearography inspection results of the drum area with the canvas seam and insert (198×484 mm). (a) white light image with corrected intensity levels, (b) manganese (Mn-K) map, macro X-ray fluorescence scanning spectroscopy (MA-XRF) associated with the pigment umber used during the restoration, (c) the in-plane phase  $\partial u/\partial x$  and (d) the out-of-plane phase  $\partial w/\partial x$  with the shear in the x-direction (horizontal), (e) the in-plane phase  $\partial v/\partial y$  and (f) the out-of-plane phase  $\partial w/\partial y$  with the shear in the y-direction (vertical).

The inspection results of both investigated areas (Figures 3 and 4) show that known structural features can be reliably identified and mapped (viz. the seam and the insert in the drum, Figure 3). The overall pattern of the repaired slashes in the breeches area can be traced in the out-of-plane phase map with the shear in the  $x$ -direction ( $\partial w / \partial x$ , Figure 4 (d)). However, both the in-plane (Figure 4 (c, e)) and out-of-plane phase maps (Figure 4 (d, f)) do not have clear and significant local variations as compared to the area around the drum insert (Figure 3 (e, f)). The localised strain around the drum insert can be explained by the lower quality of the patched canvas compared to the repaired slashes in the breeches of Banninck Cocq.

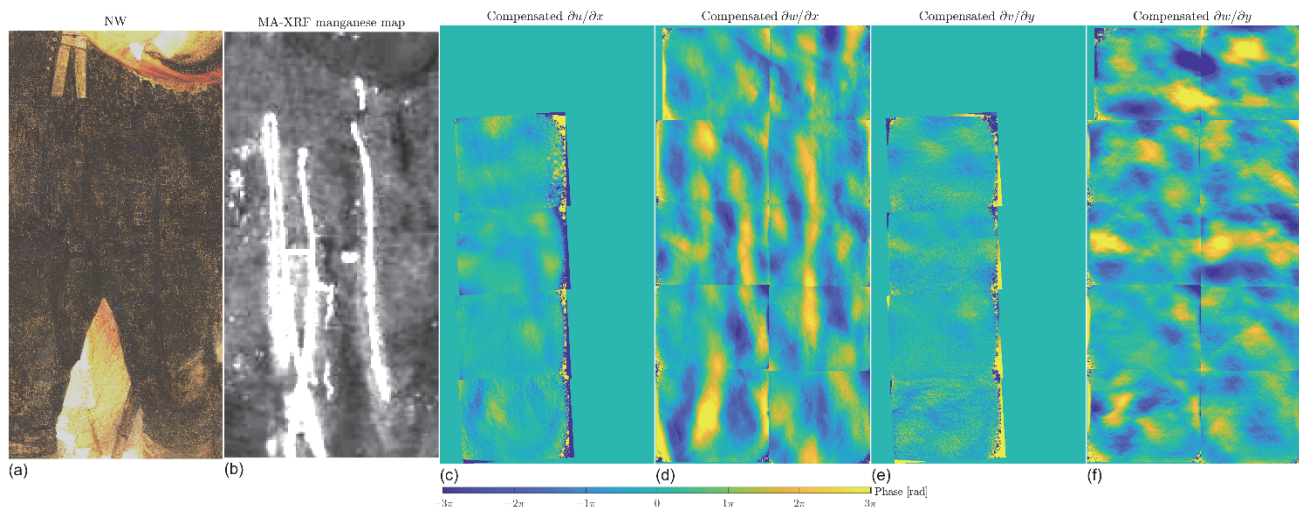
The area investigated in the breeches of Captain Banninck Cocq (445×909 mm) was significantly larger than the drum area (198×484 mm), therefore inspection of the full area with 3D shearography was found not to be efficient from the time and effort point of view. The entire breeches area was inspected with the out-of-plane configuration of the instrument (Figure 4 (d, f)) to identify possible delaminations between the original canvas and the lining canvas given the slashes incurred in 1975 in this area were the largest. A smaller area, which was considered the most critical was inspected with 3D shearography (Figure 4 (c, e)).

Figure 4. 3D shearography inspection results of the Captain Banninck Cocq's breeches area (445×909 mm). (a) white light image with corrected intensity levels, (b) manganese (Mn-K) map, macro X-ray fluorescence scanning spectroscopy (MA-XRF) associated with the pigment umber used for repairing the slashes during the 1975-76 restoration, (c) the in-plane phase  $\partial u/\partial x$  and (d) the out-of-plane phase  $\partial w/\partial x$  with the shear in the x-direction (horizontal), (e) the in-plane phase  $\partial v/\partial y$  and (f) the out-of-plane phase  $\partial w/\partial y$  with the shear in the y-direction (vertical).

Overall, 3D shearography provided valuable inspection results for assurances regarding the structural integrity of the 1975 repairs and the wax-resin lining in *The Night Watch*, reducing the risks and providing the confidence to proceed with the planned retensioning of the canvas.
