Microbiologically Influenced Corrosion of a Pipeline in a Petrochemical Plant

Abstract: This paper investigates a severe microbiologically influenced failure in the elbows of a buried amine pipeline in a petrochemical plant. Pipelines can experience different corrosion mechanisms, including microbiologically influenced corrosion (MIC). MIC, a form of biodeterioration initiated by microorganisms, can have a devastating impact on the reliability and lifetime of buried installations. This paper provides a systematic investigation of a severe MIC-related failure in a buried amine pipeline and includes a detailed microstructural analysis, corrosion products/biofilm analyses, and monitoring of the presence of causative microorganisms. Conclusions were drawn based on experimental data, obtained from visual observations, optical/electron microscopy, and Energy-dispersive X-ray spectroscopy (EDS)/X-Ray Diffraction (XRD) analyses. Additionally, monitoring the presence of causative microorganisms, especially sulfate-reducing bacteria which play the main role in corrosion, was performed. The results confirmed that the failure, in this case, is attributable to sulfate-reducing bacteria (SRB),

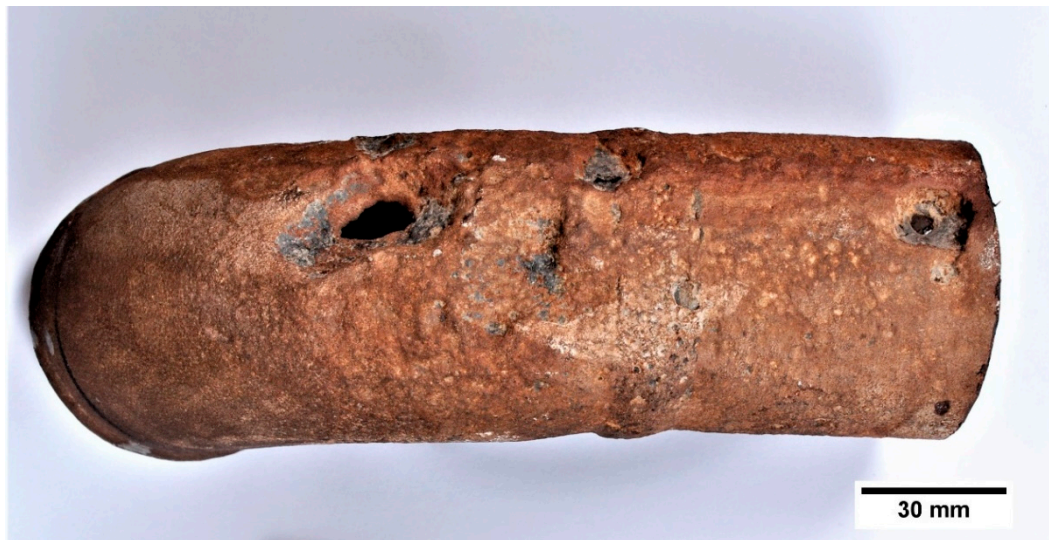
Figure 2 shows a typical failed elbow, taken out of the service. Both the inner and outer surfaces were covered with red/yellow–brown and, in some spots, black rust layers. The elbows were heavily damaged at the outer surface. Large pits and perforations were seen on the surface. Pits on the exterior of the failed elbows were at different stages, with some at the early stages, while a few have turned into big holes during service. While the outside part of the elbows had undergone severe localized corrosion, the inside part hardly showed any pitting, see Figure 3, indicating that the pitting had started from the outer surface. There were hardly any signs of surface irregularities (e.g., erosion or surface deformation) other than severe surface pitting.

Figure 2. An example of the failed elbows.

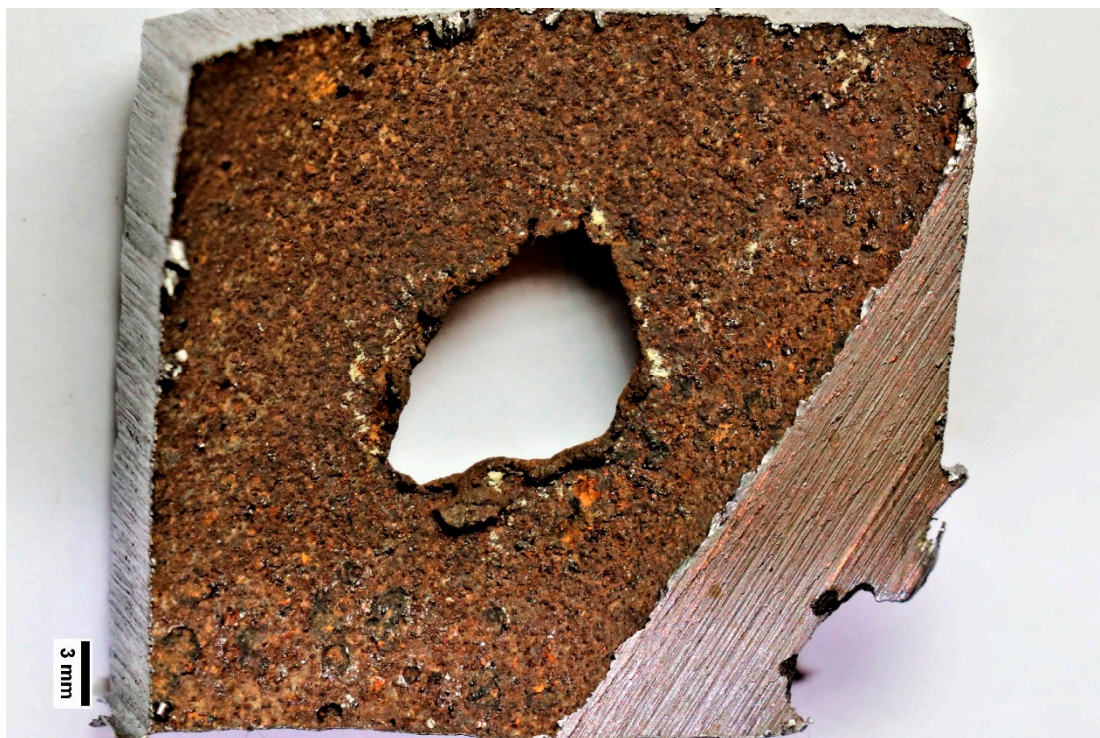
Figure 3. An inner surface of the failed elbows.

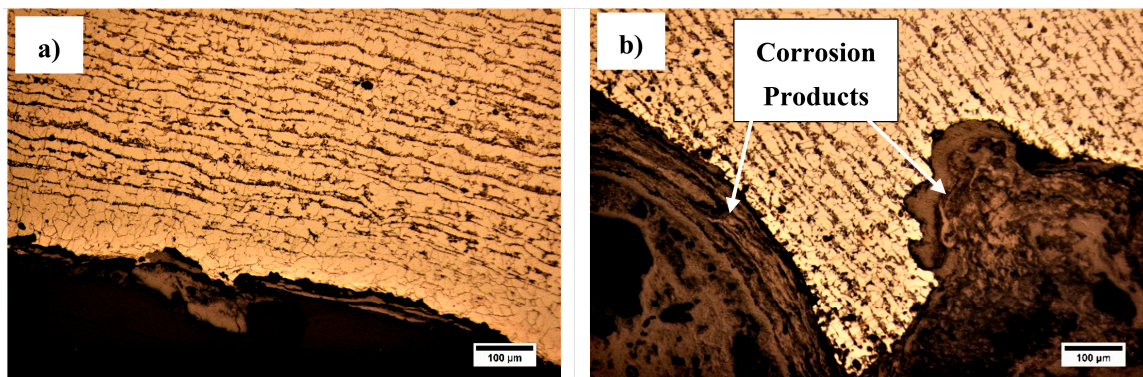
Figure 4a shows the microstructure of the failed elbow at the inner surface. The observed elongated ferritic–pearlitic microstructure is an indication that the alloy was in the as-rolled state. As mentioned before, there was no indication of pitting at the inner surface. Figure 4b shows the microstructure of a cross-section at the outer surface. Severe perforation and deep pits were observed at the outer surface. Furthermore, pits were covered with corrosion products, while in some cases, corrosion products had a layered structure.

Figure 4. The optical microscopy (OM) microstructures of the (a) inner surface and (b) the outer surface.

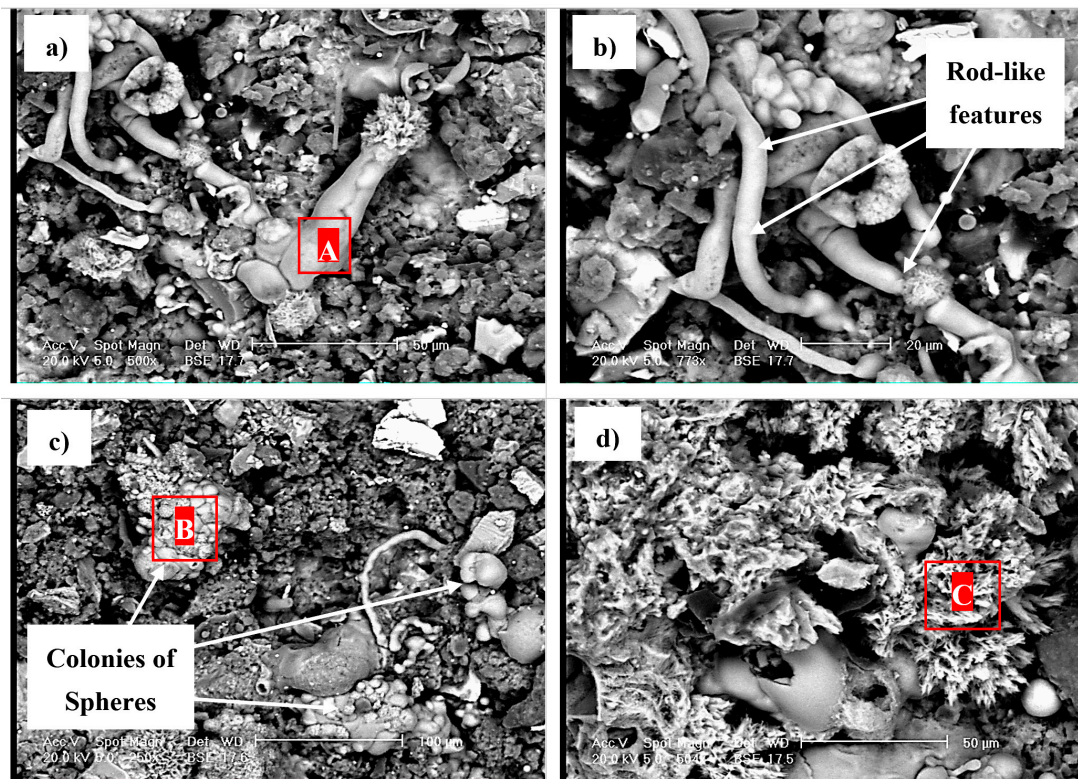
Figure 5 shows the typical features found inside pits at the outer surface. This figure clearly shows that the surface was covered with a biofilm. Biofilms, consisting of complex communities/colonies of microorganisms and EPS, can dissolve oxygen and create gradients of pH, resulting in localized forms of corrosion, such as crevice corrosion and pitting [10]. Three noticeable features were seen in the biofilm:

- (i) Rod-shaped products, with approximate length of 50 μm ;
- (ii) Colonies of spheres, with their size ranging from 10 to 100 μm ;
- (iii) Flower-like surface features, all shown in Figure 5.

Rod-like features were, statistically, more frequently seen than the other two morphologies. The distributions of all the mentioned morphologies were rather homogeneous, i.e., all features were seen in each and every pit.

Figure 5. Scanning Electron Microscope (SEM) photomicrographs showing biofilms (or surface deposit) and features inside biofilms, i.e., (a) and (b) rod-like features, (c) colonies of spheres, and (d) flower-like features.

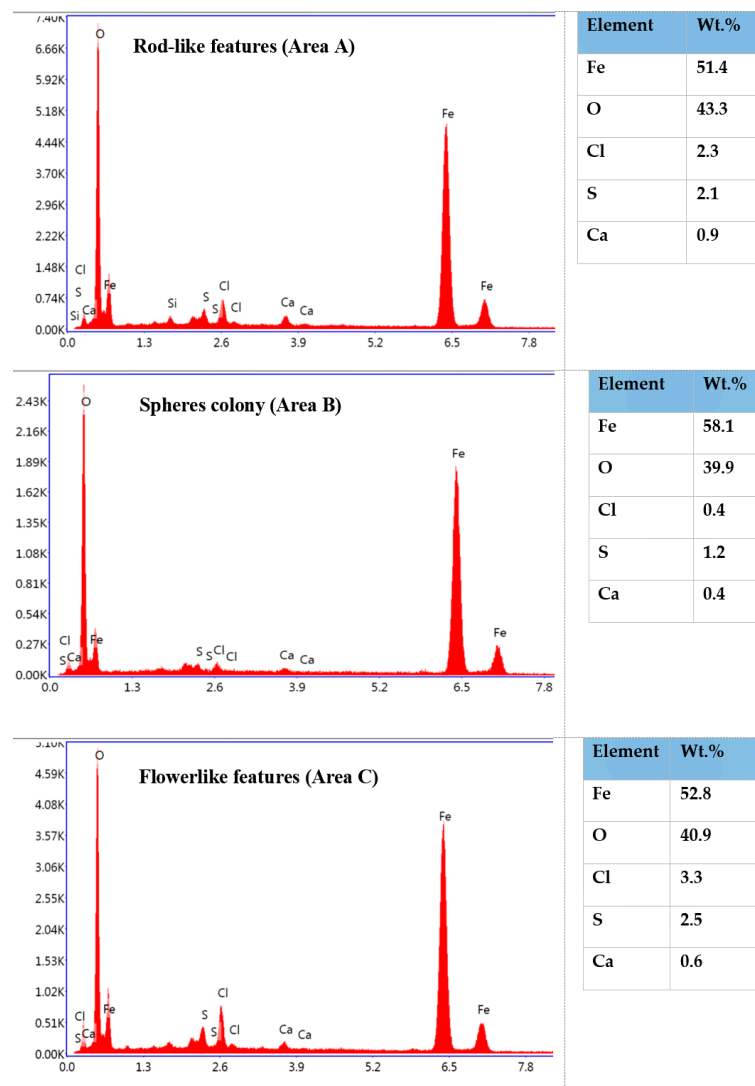
Figure 6 shows the results of EDS analyses of rod-like, spherical, and flowerlike corrosion products. In terms of the chemistry, there was no meaningful difference between these features, inferring that the difference between these features is only morphological. The presence of sulfur in all the EDS spectra is an indication that the observed features are SRB, which is an anaerobic bacterium. SRB is known to be the primary factor of MIC. Organic compounds attracted to the surface of steel make it an ideal environment for the colonization of microorganisms [2]. Amongst different microorganisms, SRB is known to have excellent adaptability to extreme conditions. Biochemical energy for the growth of SRB is obtained by reducing sulfate (SO_4^{-2}) to sulfide (S^{-2}) in the presence of natural organic compounds. At the same time, with the absorption of atomic hydrogen (H) on the surface of iron, it will gradually disappear [16]. Overall, the major detrimental metabolic activities of SRB are mostly related to its ability to:

Figure 6. Energy dispersive X-ray spectroscopy (EDS) analyses of areas shown in Figure 5, related to rod-like, spherical, and flower-like features (x -axis: Energy (KeV), y -axis: a.u.).

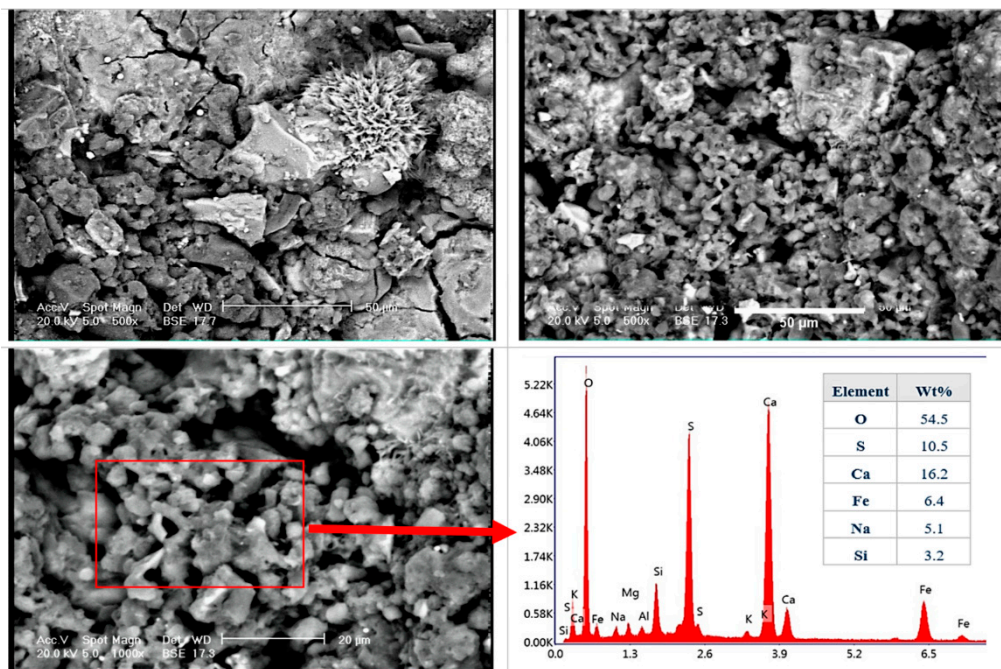
Figure 7 represents a closer look at the biofilm in the outer surface in which microorganisms are distributed. Biofilm is a self-produced firmly-attached EPS surface layer. In fact, the stability of microorganisms is dependent on the biofilm, given that the biofilm provides structural support for microorganisms and, to a great extent, protects them from environmental, physical, and chemical stresses. Biofilms could host a variety of different microorganisms including fungi, bacteria, eukaryotes, and archaea, with each having a different metabolic ability [2]. The SRB, in particular, has a vigorous metabolism, producing a certain amount of EPS (in fact, often there are also other microorganisms present that are mainly responsible for EPS production), which rapidly adhere to the surface of the metal and build a biofilm [14,18]. The biofilm, in this case, has a porous nature, making the ion/nutrition exchange much easier. EPS are composed of charged polymers and can significantly contribute to the accumulation of different chemical species inside EPS. In the case where organic acids are produced by microbial species, mineral dissolution rates are expected to increase [19,20]. The results of EDS analysis show that elements oxygen, sulfur, calcium, chloride, and iron were present in the biofilm. Figure 8 shows typical XRD patterns of corrosion products, taken from the surface of the pipe. The results confirmed the formation of a significant amount of oxide-hydroxide (FeOOH), iron oxide, and iron sulfide. The latter is a typical corrosion product when SRB is the controlling microorganism.

Figure 7. Examples of SEM images of biofilms together with EDS analysis.

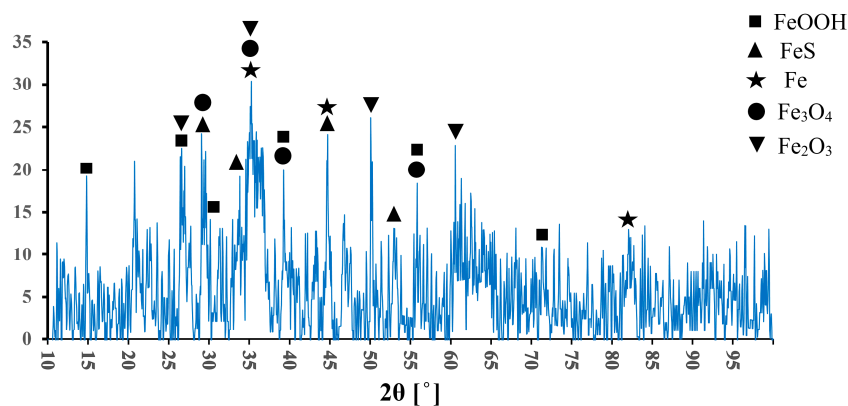
Figure 8. An X-ray diffraction analysis of the surface of the pipe.

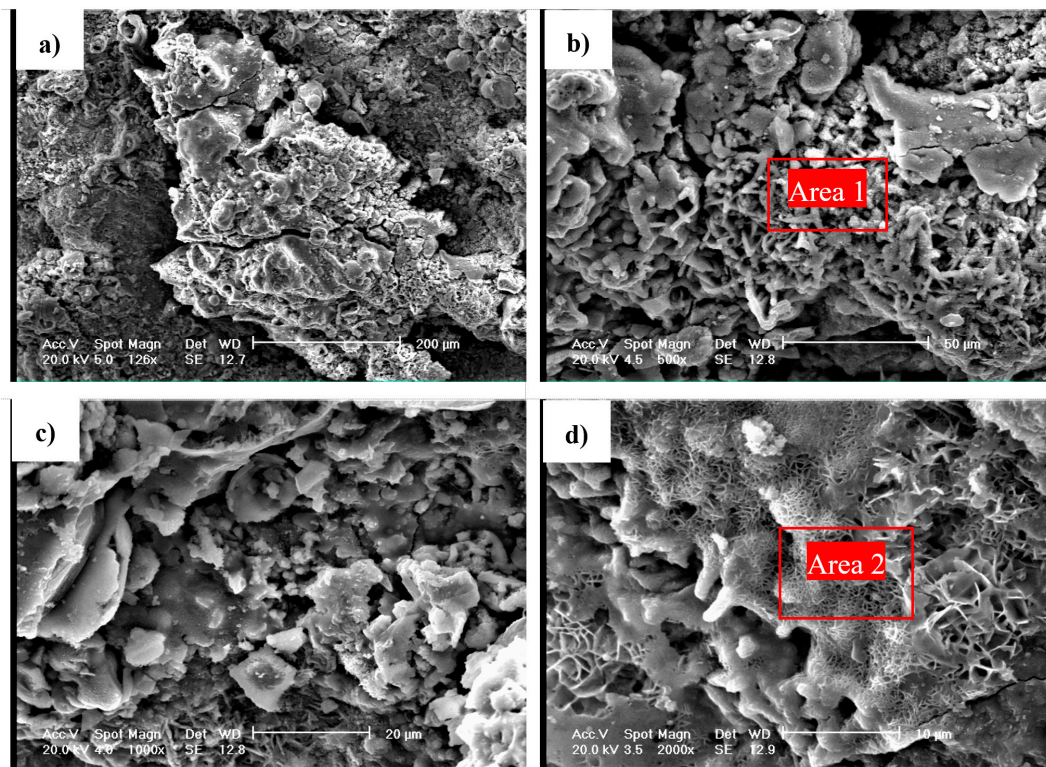
Figure 9 shows SEM images of corrosion products at the inner surface. As mentioned earlier, there was hardly any sign of localized corrosion. The inner surface in some areas was covered with a porous scale-like layer intermingled with some globular α -FeOOH particles, see Figure 9a,b. Other observed morphologies of corrosion products were plate-like micaceous crystalline features, see Figure 9c, and honeycomb-like structures, see Figure 9d, with both being typical morphologies of γ -FeOOH. Therefore, overall, the inner surface was covered with different iron oxide-hydroxides and possibly other oxide products. Figure 10 shows the EDS analysis of the areas shown in Figure 9. There was no sign of sulfur and chloride, unlike what was seen at the outer surface. It appears that the failure has started from the outer pipe surface, and corrosion products at the inner surface were caused by the liquid inside the pipeline.

Figure 9. Different morphologies of the corrosion products at the inner surface: (a) and (b) scale-like layer intermingled with some globular α -FeOOH particles, (c) plate-like micaceous crystalline features, and (d) honeycomb-like structures.

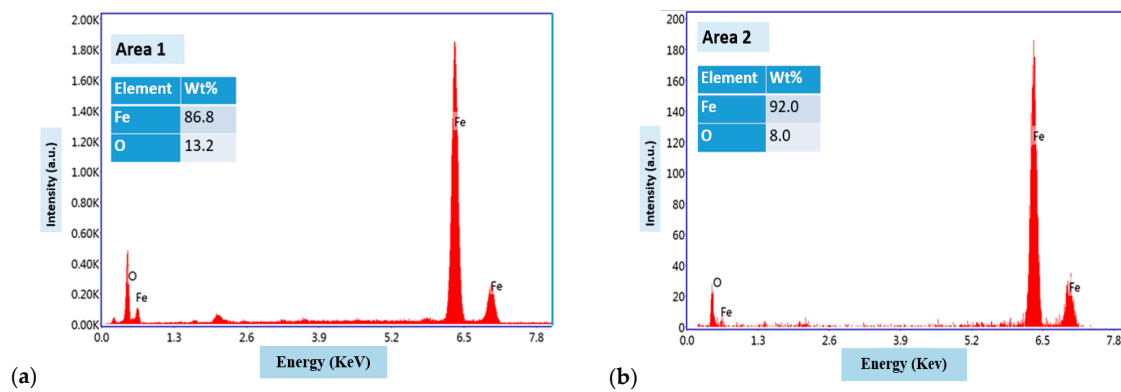
Figure 10. EDS analyses of (a) area 1 and (b) area 2, shown in Figure 9.

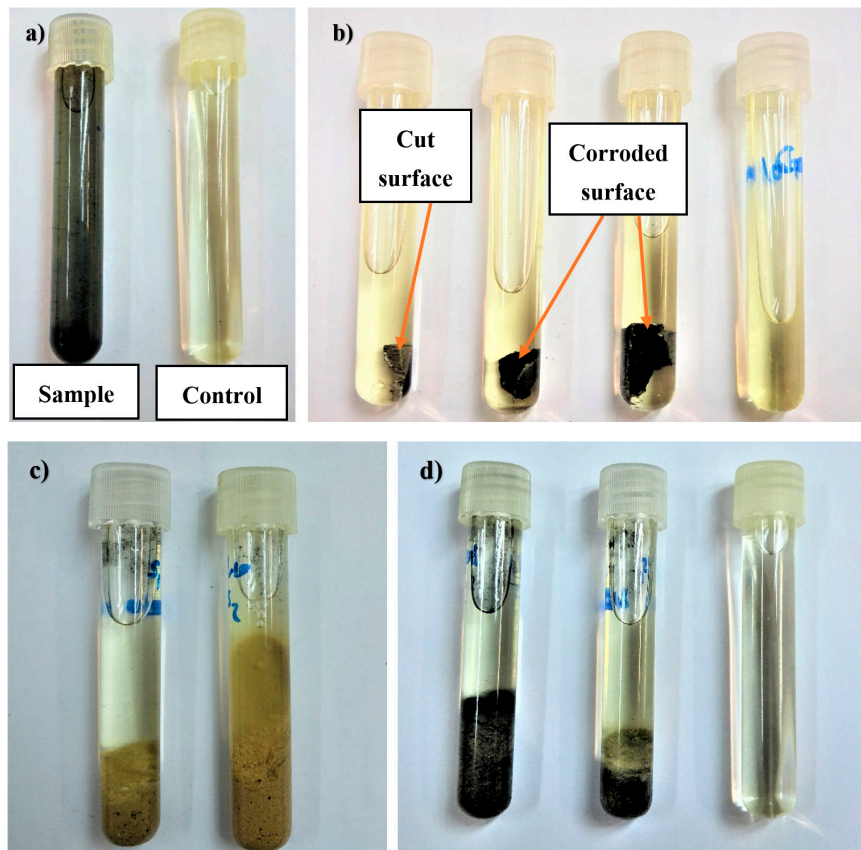
Surface scratches from the corroded elbows and samples of soil from the corrosion area were inoculated in SRB-specific media and incubated in anaerobic conditions for 20 days. As shown in Figure 11, the black precipitation is created due to SRB growth and H_2S and FeS production in the media. It is noticeable that the SRB-induced black precipitation was only created on the corroded surface of the failed elbow, and there was no sign of black precipitation on the cut surface, see Figure 11b. The formation of SRB cells was confirmed by SEM images, see Figure 12, and EDS spectra, see Figure 13. SRB is resistant to environmental stresses such as pH and temperature variations, chloride concentration, and high values of pressure. They form biofilms and create massive corrosion products by deteriorative mechanisms [21,22].

Figure 11. SRB growth monitoring in specific media after 20 days. Control: The specific medium without inoculation. (a) Surface scratch from corrosion tube, (b) the corrosion tube cuts (c) the soil samples of corrosion area after five days, and (d) after 20 days.

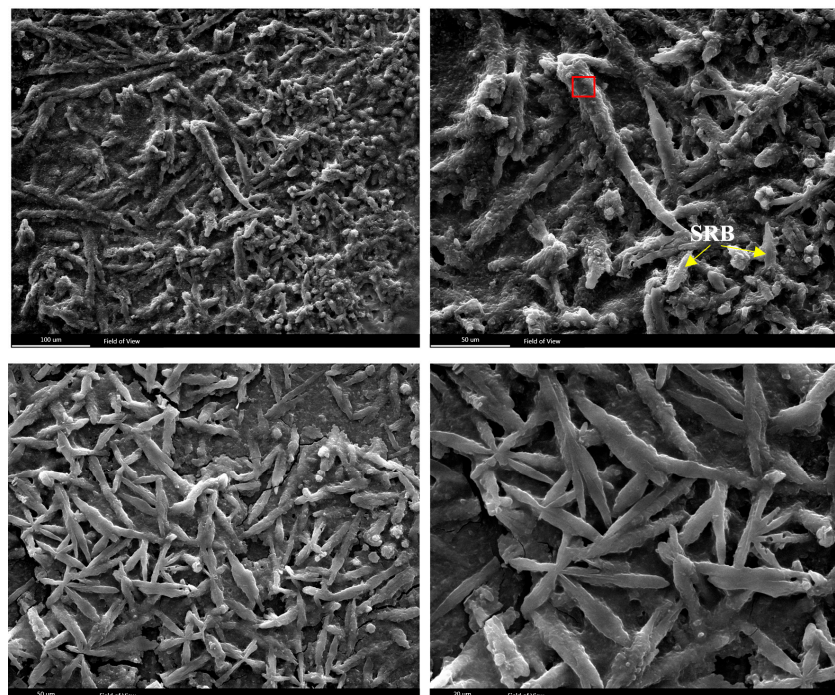
Figure 12. SEM images of SRB growth in specific media inoculated by the surface scratches of the corroded sample (all pictures are from similar features with different magnifications).

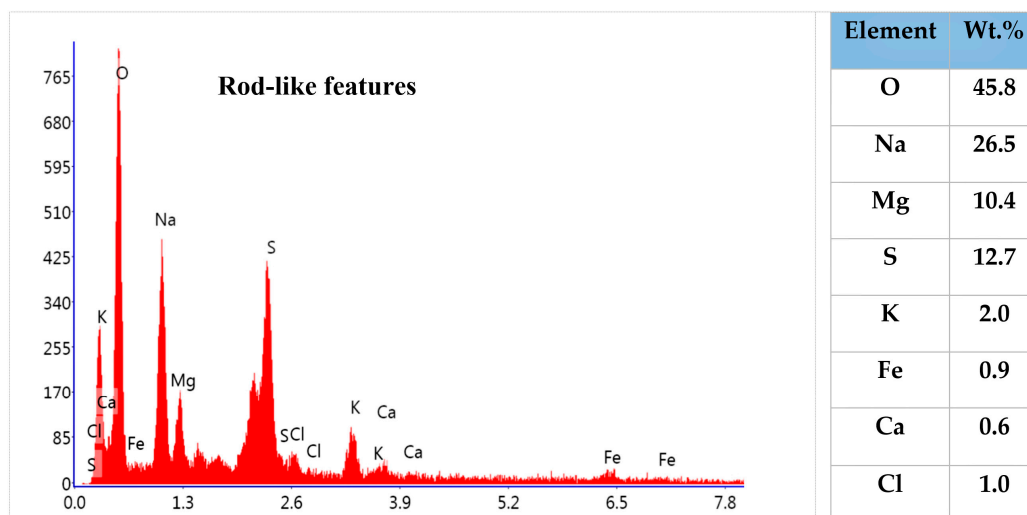
Figure 13. An EDS analysis of area shown in Figure 12 (*x*-axis: Energy (KeV), *y*-axis: a.u.).

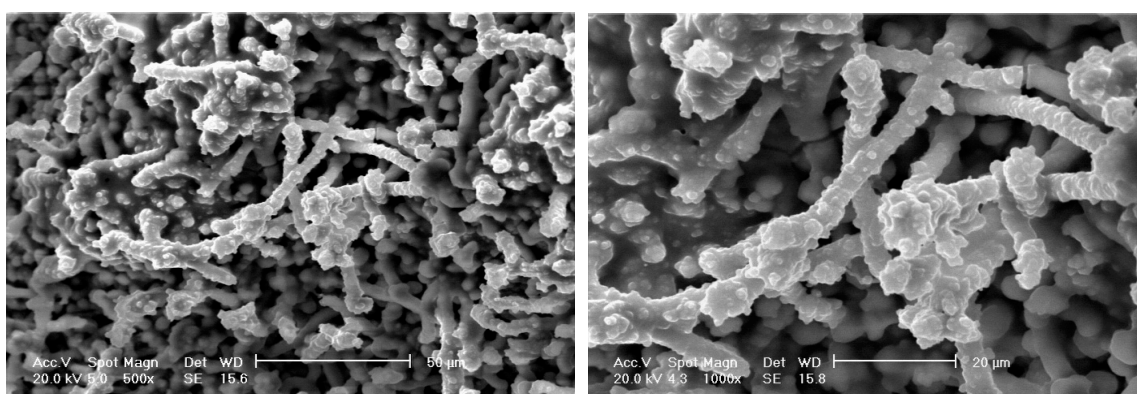
The corroded tube was also cultivated in the media. The results revealed that due to reactivation and reproduction of SRB, the amount of corrosion products increased. The corrosive effects of SRB are shown in Figure 14. The redox potentials of as-received soil before inoculation in an SRB-specific medium and that after inoculation were 19 and -315 mV, respectively. The decrease in the redox potential can be attributed to the enhanced activity of SRB, which is in accordance with the presented results of Figures 11–13 [23,24].

Figure 14. Corrosion products development after reactivation of SRB due to inoculation of the corroded tube cuts in the SRB-specific media (Images are from similar features with different magnifications).
