Safety and Health Concerns for the Users of a Playground, Built with Reused Rotor Blades from a Dismantled Wind Turbine

2020

Sustainability

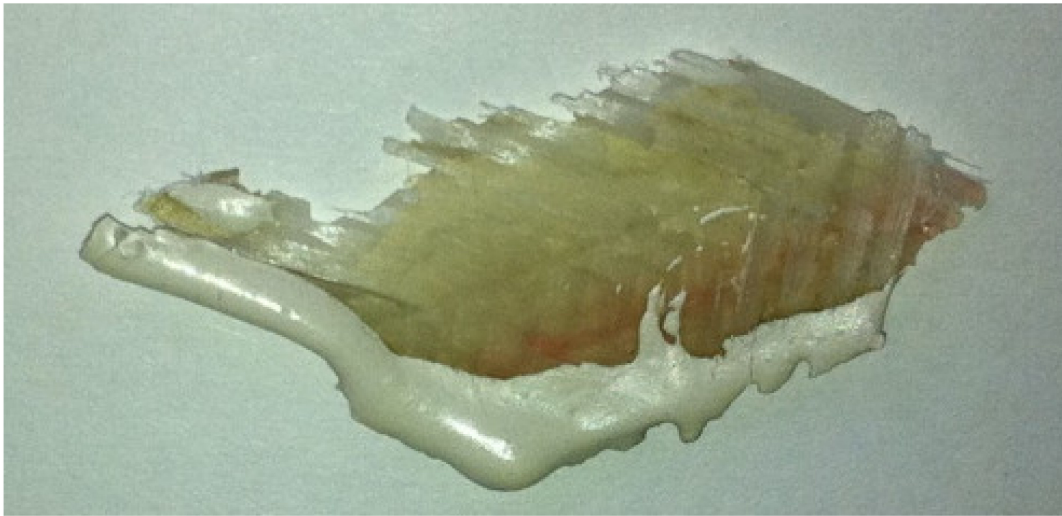
Figure 5. Piece of sharp finish of glass fibre, epoxy and white paint coating, a sample from the location illustrated in Figure 4 (Photo by Piero Medici, 2011).

The second location, where the glass fibres and the epoxy resin were exposed, was inside one of the hollow blades (Figures 4 and 6). These glass fibres belonged to the finishes by Maropol. It was established that this part was quite sharp and that it should have been smoothed out. A small piece was removed as a sample for investigation. It was sharp at the touch, and the glass fibres, the epoxy resin, and the white paint coating (Figure 5) were apparent.

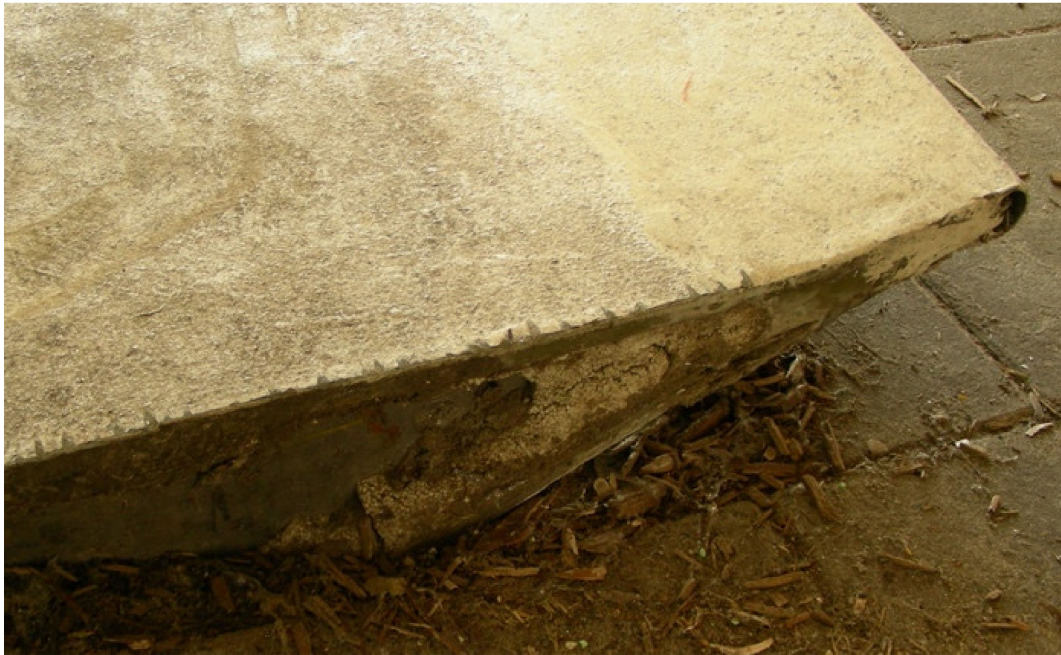
At the time of the site visits, which was three years after Wikado's opening, some parts of the blades were already brittle (Figures 4–12) and some parts of the glass fibres were exposed, sharp, and with the potential to cut the skin when being touched on site. Both glass fibres of the rotor blades by NGup and glass fibres used by Maropol were used for the finishes. During the visits to Wikado, it was observed that the glass fibres had the potential to come into contact with the users, especially on two locations of the blades. The first location faced the entrance of the playground in the street called Tochtstraat, and it had a height of a typical step (Figures 7 and 8). The glass fibres were exposed, most likely because users often stepped on the edge of the blade. These glass fibres probably belonged to both the finishes by Maropol and the blades manufactured by NGup. In the same location (Figure 7), some polystyrene had also detached from the edge.

Figure 7. Edge of the rotor blade already brittle with polystyrene coming out, as a consequence of the users walking on it (Photo by Piero Medici, 2011).

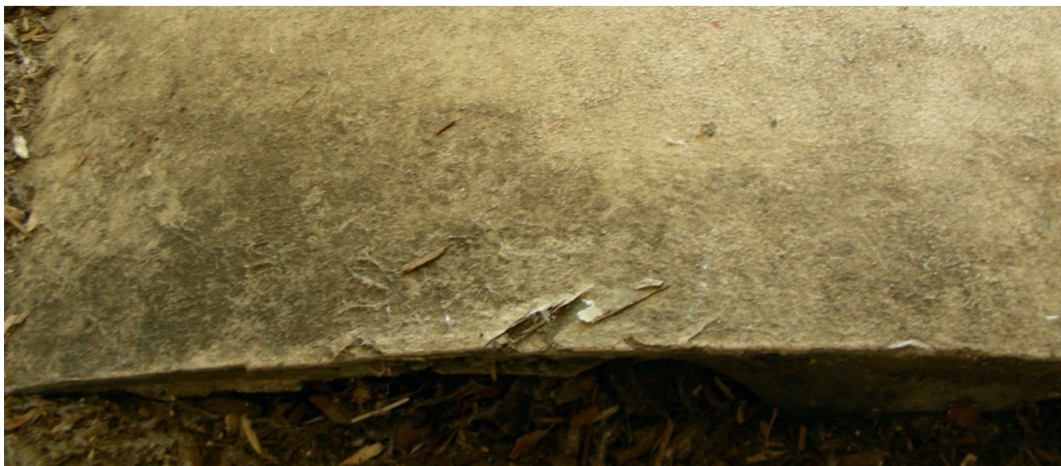
Figure 8. Edge of the blade already brittle, with glass fibres and parts of the coating exposed to the users (Photo by Piero Medici, 2011).

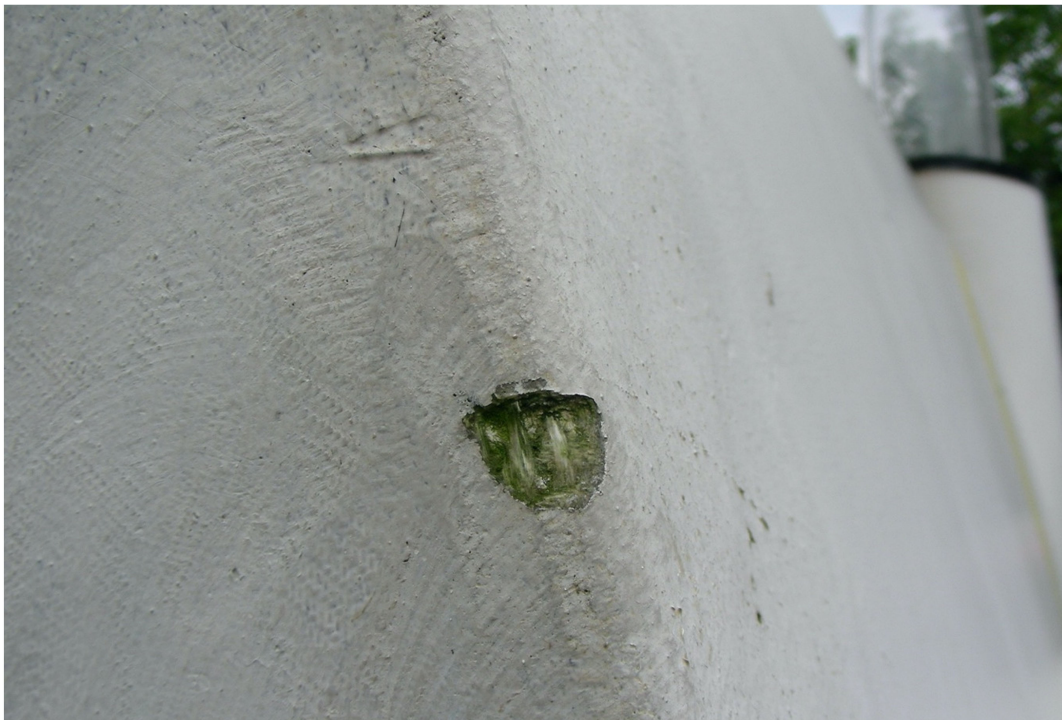
Figure 9. Damaged finish by Maropol, with glass fibres exposed, as a consequence of use damage (Photo by Piero Medici, 2011).

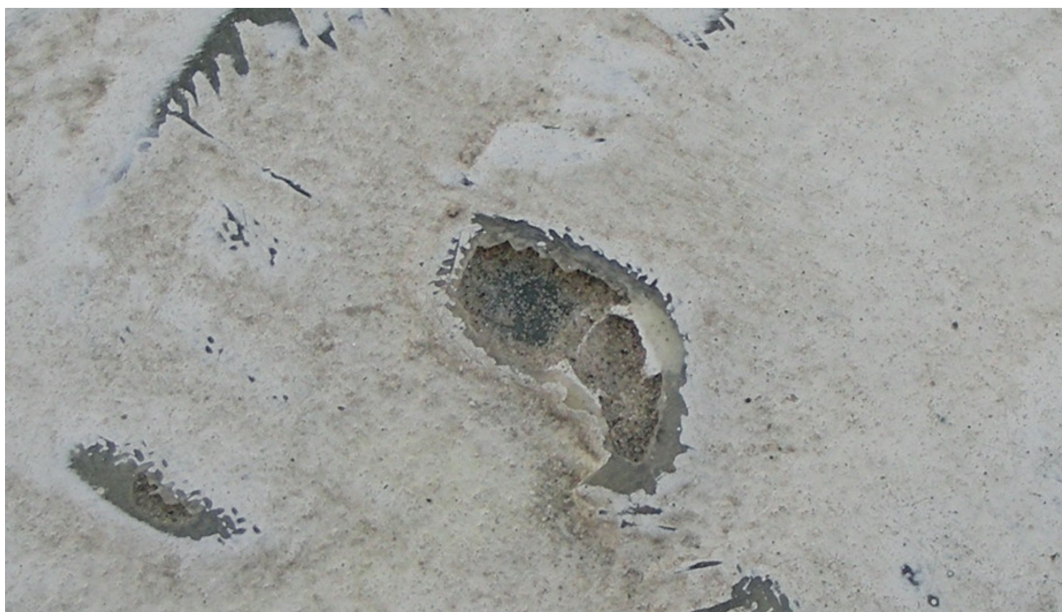
Figure 10. Damaged and sharp surface of a blade, as a consequence of the users walking and playing on it (Photo by Piero Medici, 2011).

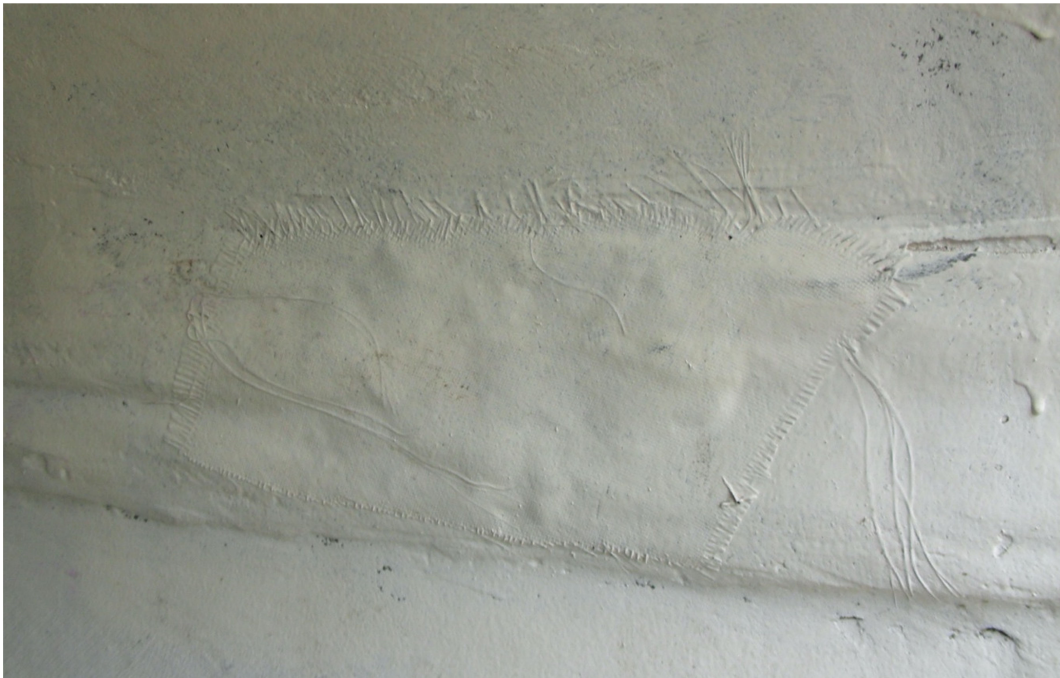
Figure 11. Detail of a finish and coating by Maropol (Photo by Piero Medici, 2011).

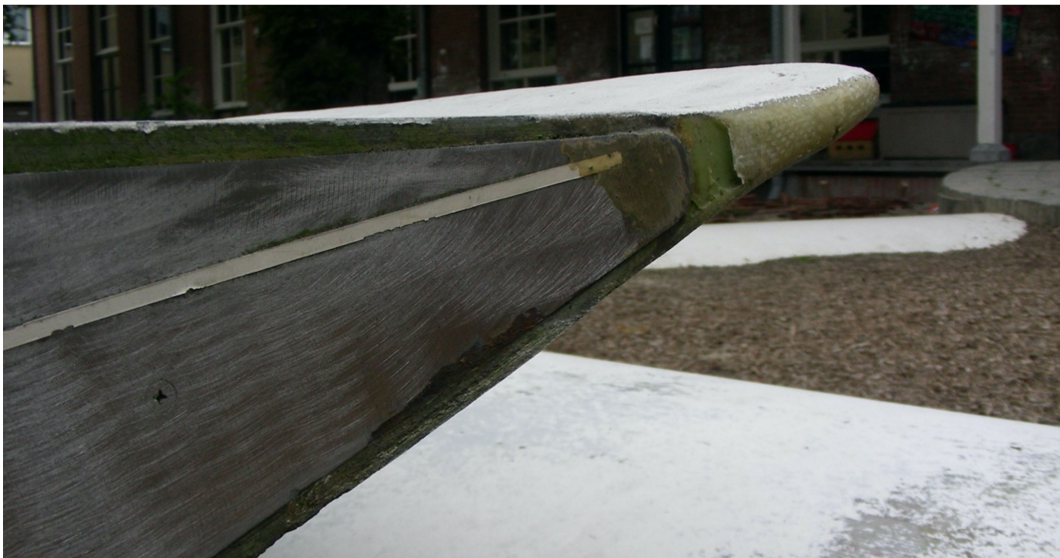
Figure 12. Brittle edge of a blade, sharp on the top-right part of the picture, where the epoxy resin and the glass fibres are damaged (Photo by Piero Medici, 2011).

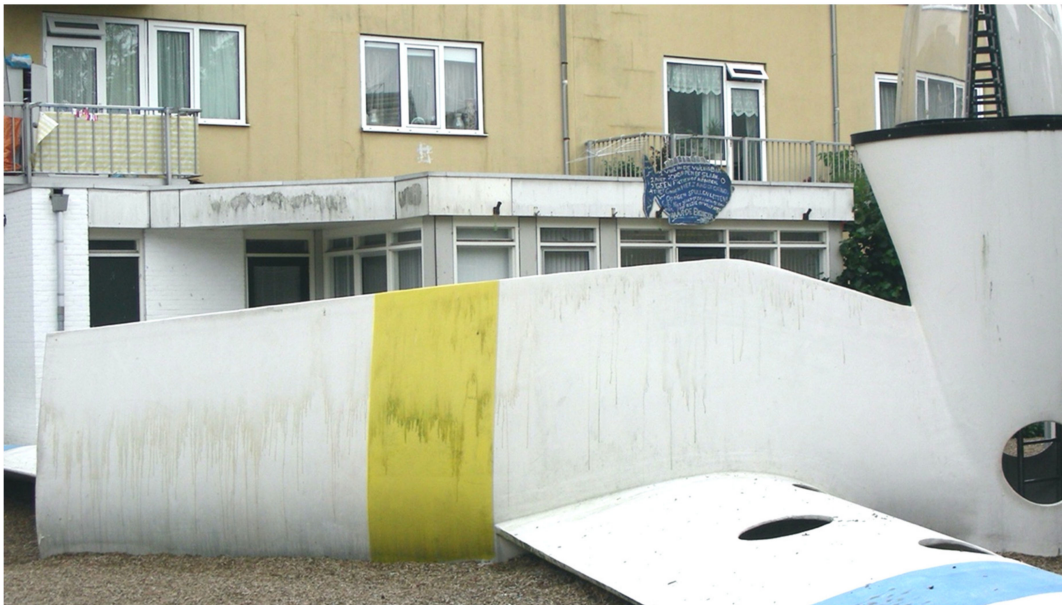
Figure 14. Leaching on the surface facing north-west of the blade standing on the long side (Photo by Piero Medici, 2011).

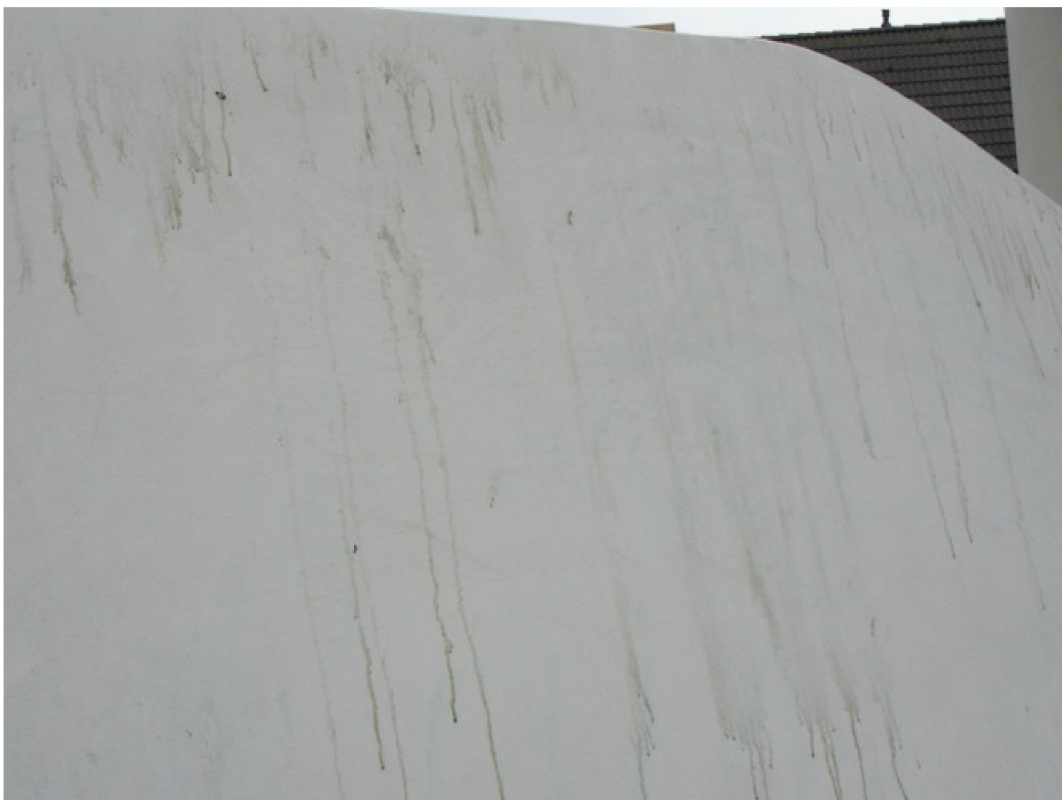
Figure 15. Drops leaching along the north-west surface of the blade standing on the long side (Photo by Piero Medici, 2011).

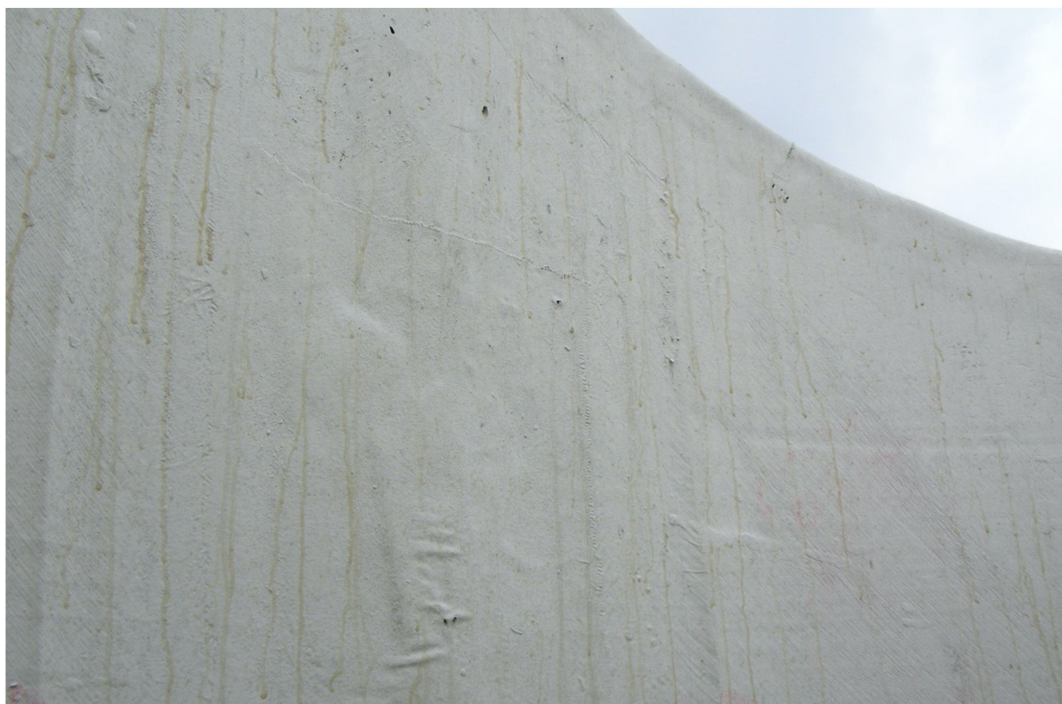
Figure 17. Leaching from the top of a tower (Photo by Piero Medici, 2011).

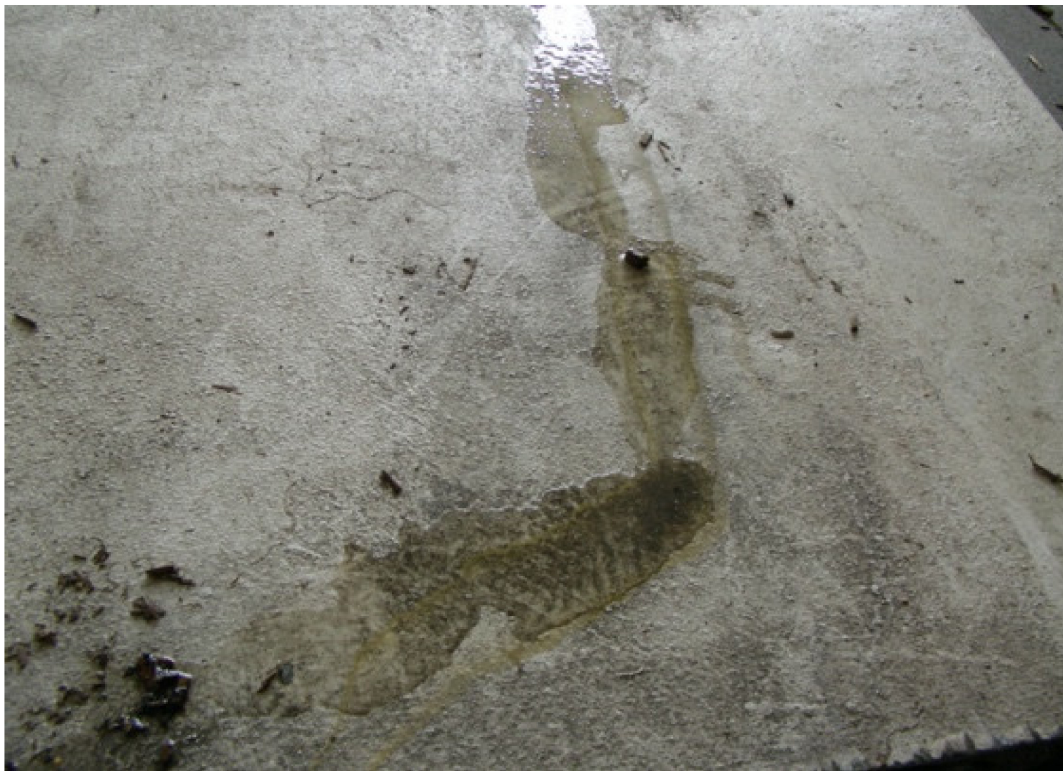
Figure 20. Blade lying horizontally working as a rain gutter, a yellow leach is visible (Photo by Piero Medici, 2011).

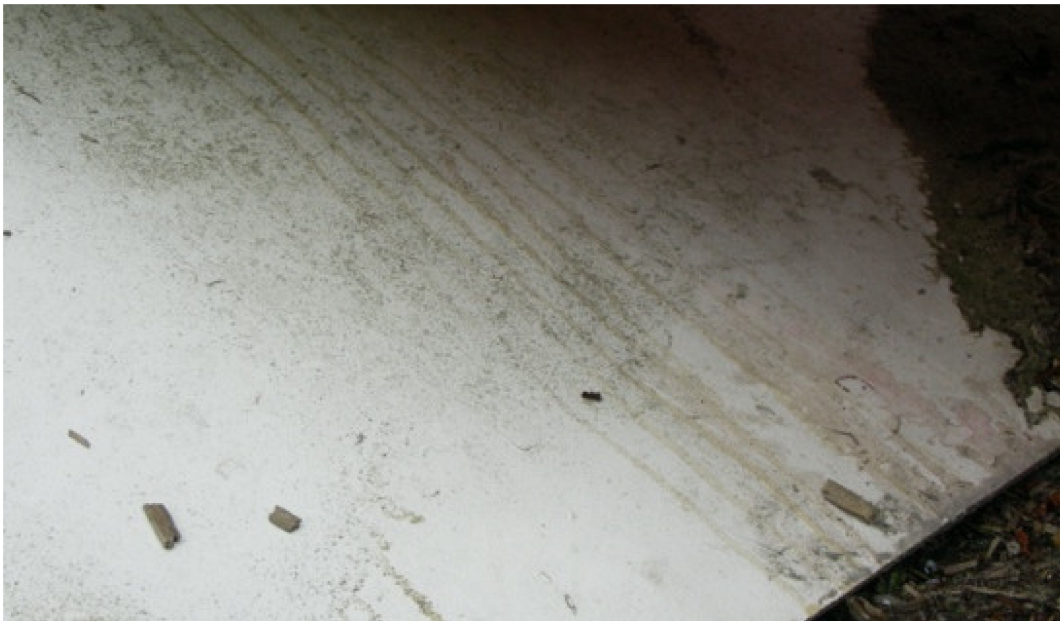
Figure 22. Close-up of the drops, on a blade lying horizontally (Photo by Piero Medici, 2011).

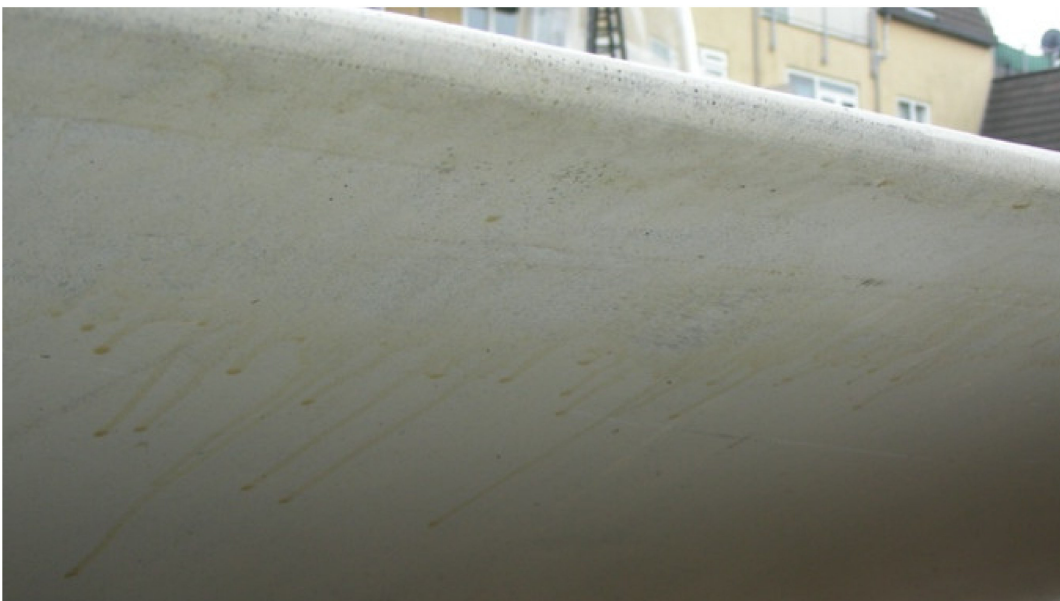
Figure 23. Leaching below a blade lying horizontally (Photo by Piero Medici, 2011).

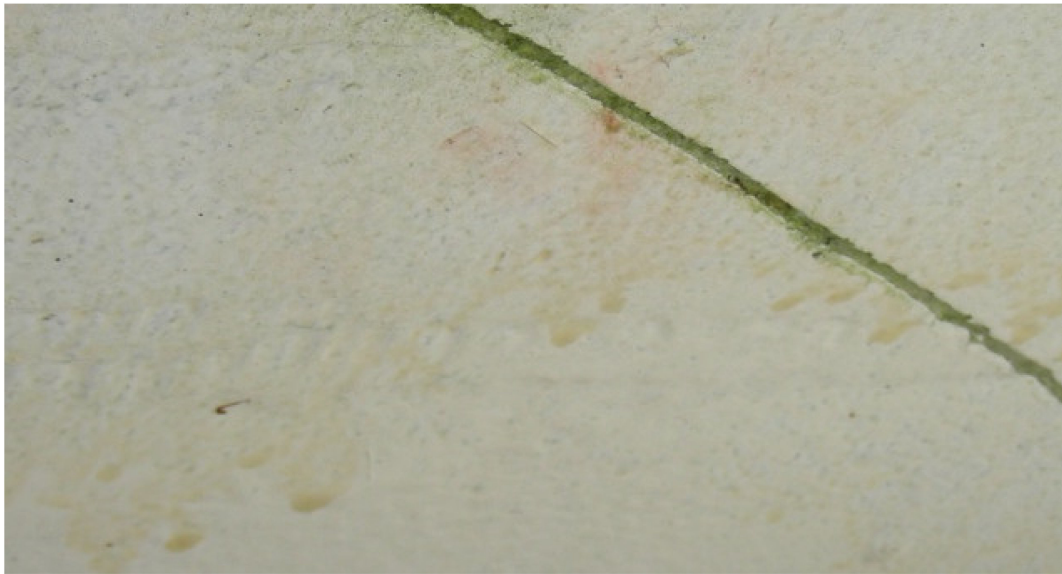
Figure 24. Close-up of the drops next to a surface opening (Photo by Piero Medici, 2011).

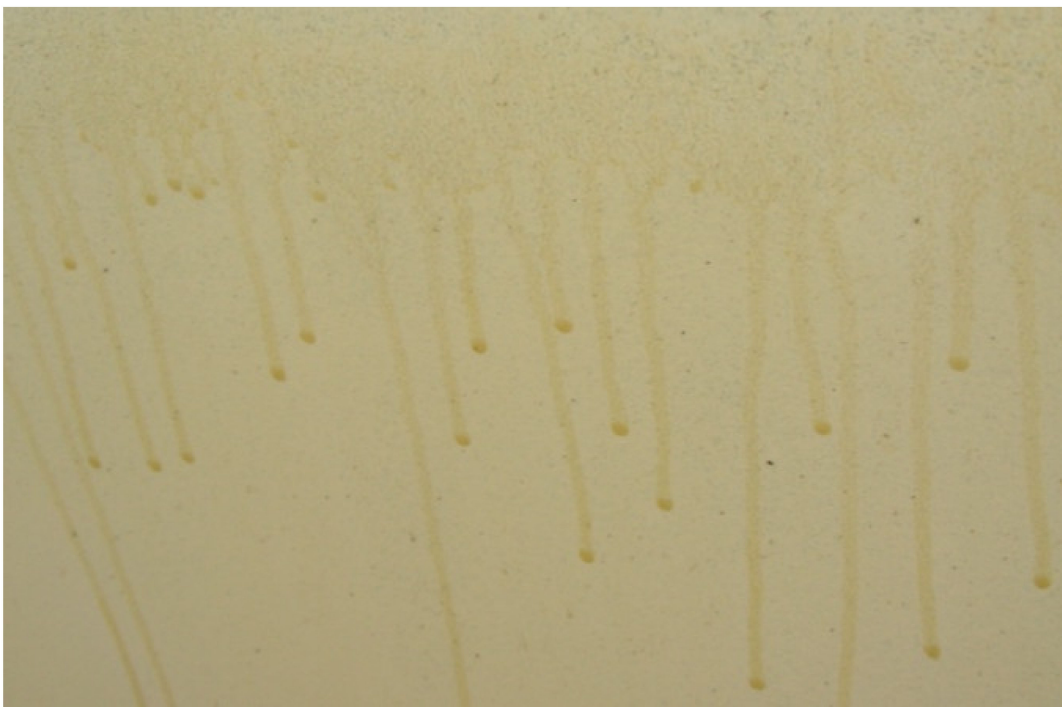
Figure 25. Drops leaching down, close-up (Photo by Piero Medici, 2011).

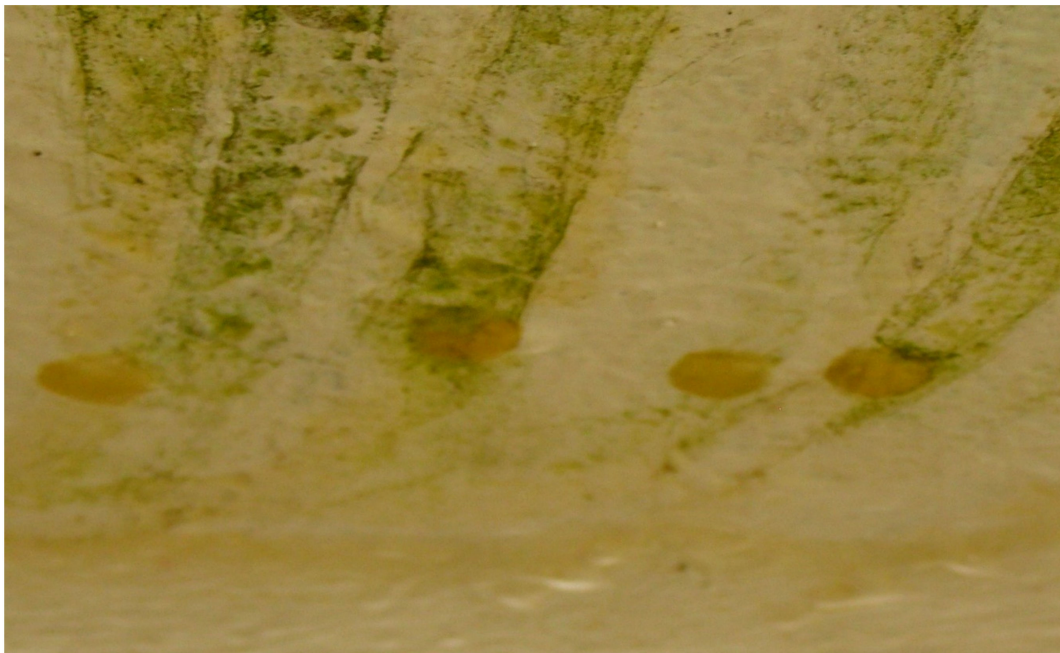
Figure 26. Drops leaching below the blade, close-up (Photo by Piero Medici, 2011).

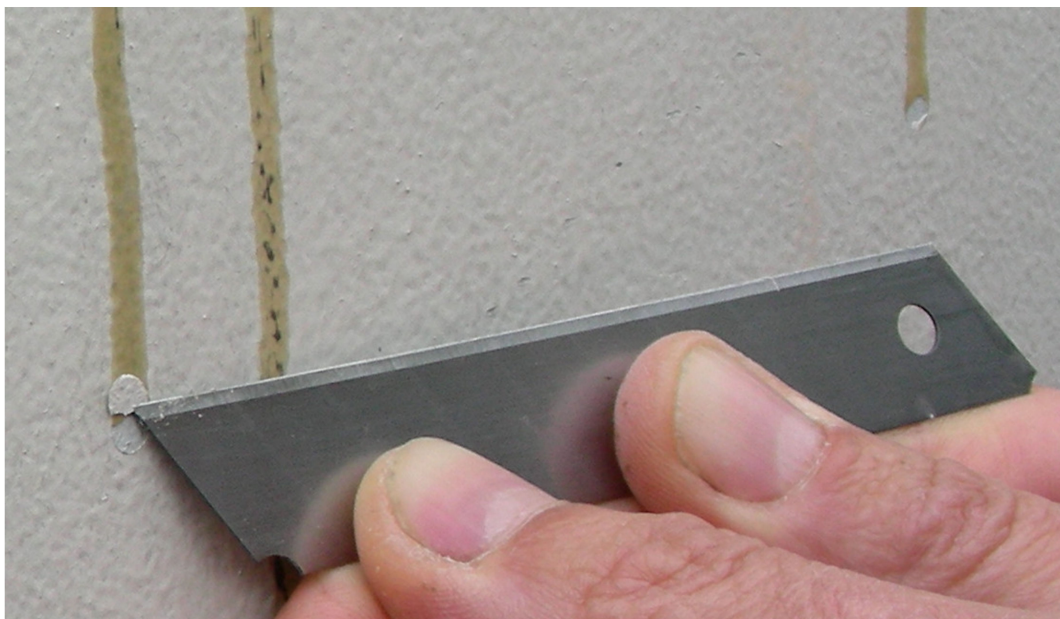
Figure 27. Test with the cutter on the surface of the blade standing on the short side; some paint is attached to the detached drop (Photo by Piero Medici, 2011).
