Fieldwork Report

Multidisciplinary Project

Hanoi, Vietnam

October 2013

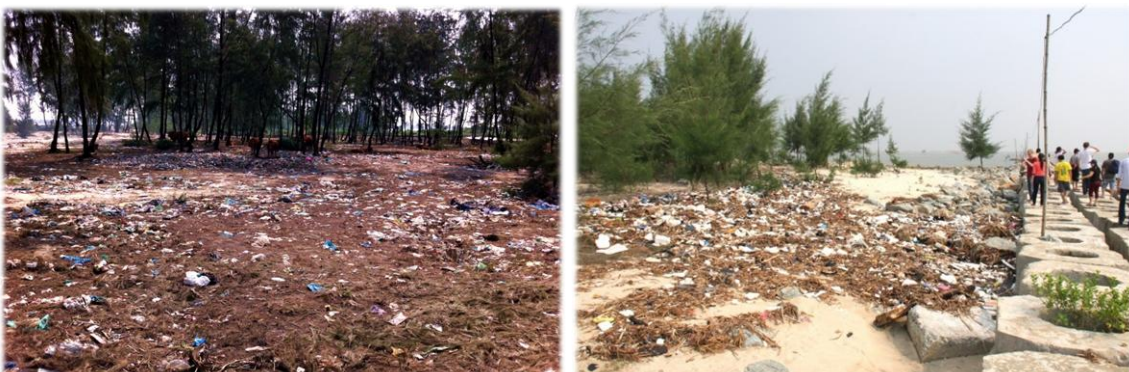
Figure 5: Waste and litter in the lagoon area.

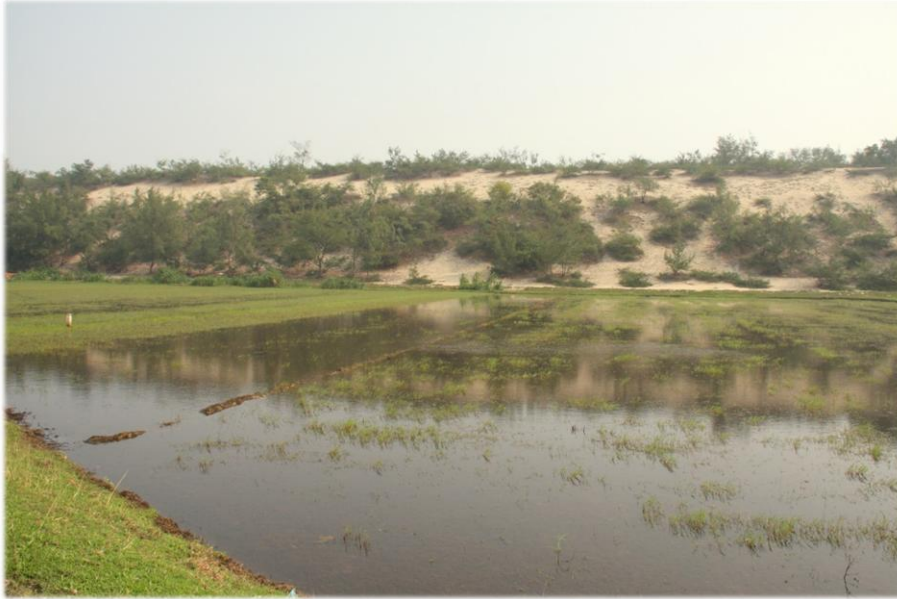
The sand dunes that form the sand barrier between the South Chinese sea and the lagoon are quite high (order 10-15 meters) but look quite unnatural. A normal dune system is wide with small dunes developing in bigger dunes, but in this situation only a single row of large dunes is present with all the land in front cultivated by rice paddies, see Figure 7. An inevitable result is erosion, since sand blown away is not replaced by new sand. The erosion is enhanced by 'vandalizing' the dunes by using sand and trees growing on the dunes for construction works; and by walking on the dunes.

Figure 7: Row of sand dunes, with cultivated land visible at the front. Due to a lack of sand the dunes are eroding.

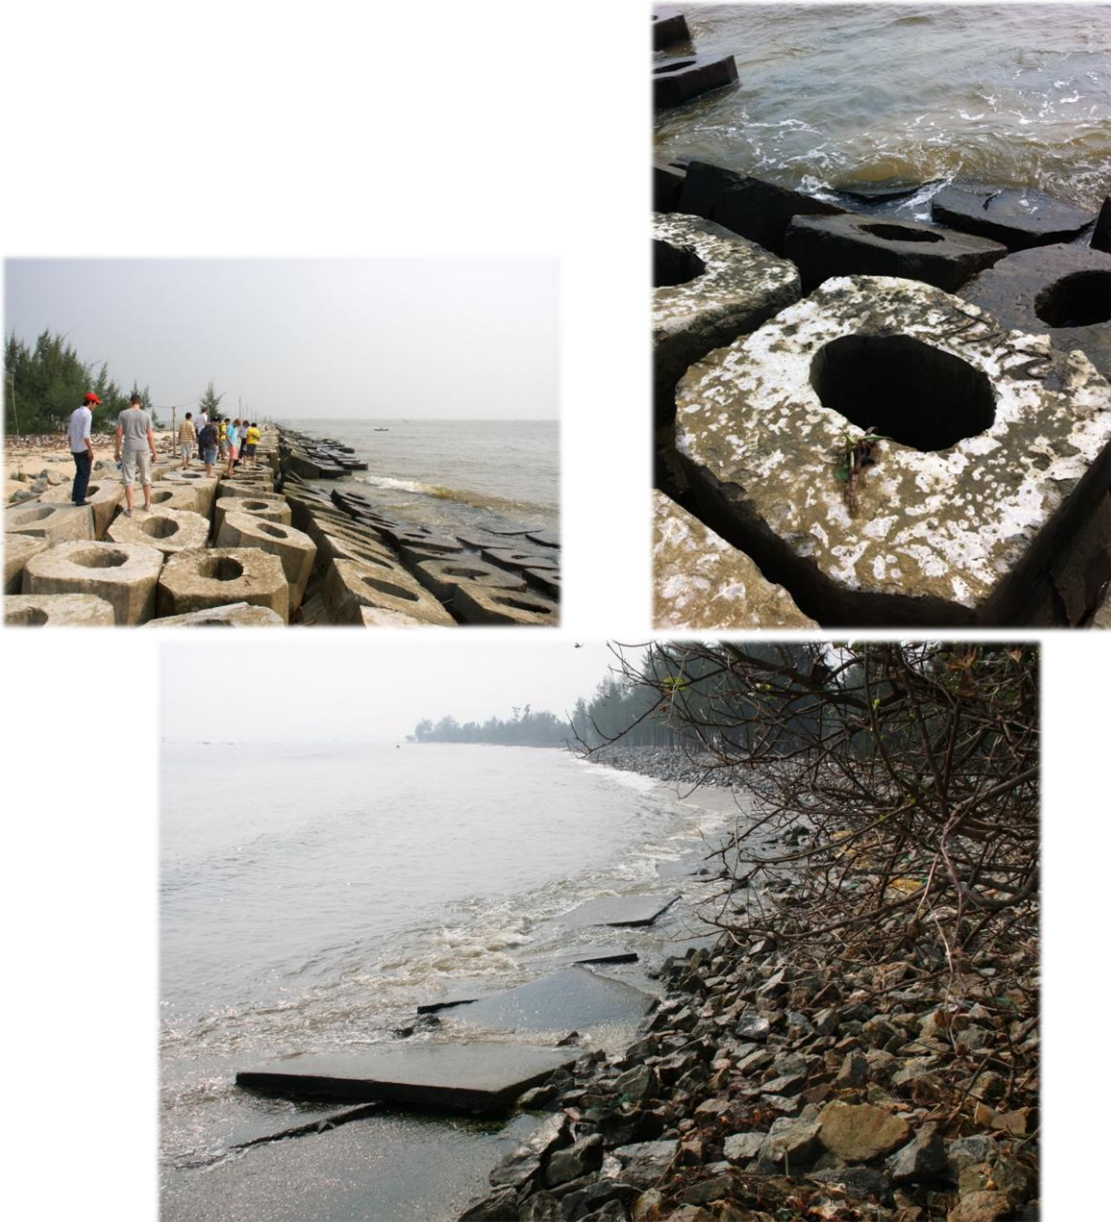
This jetty (about 550 meters long) consists of large armour units (modified Haros of about 5-10 ton) which are placed on a sandy bottom, often without (a proper) foundation. When a foundation is present it is unequal in height and not serrated. These facts combined result in severe erosion between the armour units and consequently cause sagging of individual units (Figure 8). While the jetty is about 550 meters long, it sags more and more towards deeper water, so its effective length is less. The jetty as a whole does not function as a jetty anymore, and can be characterized by a bunch of loose concrete blocks.

Near the jetty some revetments were built, based on revetments used in rivers: concrete slabs. Sand underneath the slabs is eroded, where after the slabs break down under their own weight. This results in malfunctioning revetments.

Figure 8: Modified Haros' placed without foundation (upper photos). The west jetty as a whole looks like a bunch of randomly placed armour units. Near the west jetty broken revetments can be observed (lower picture).

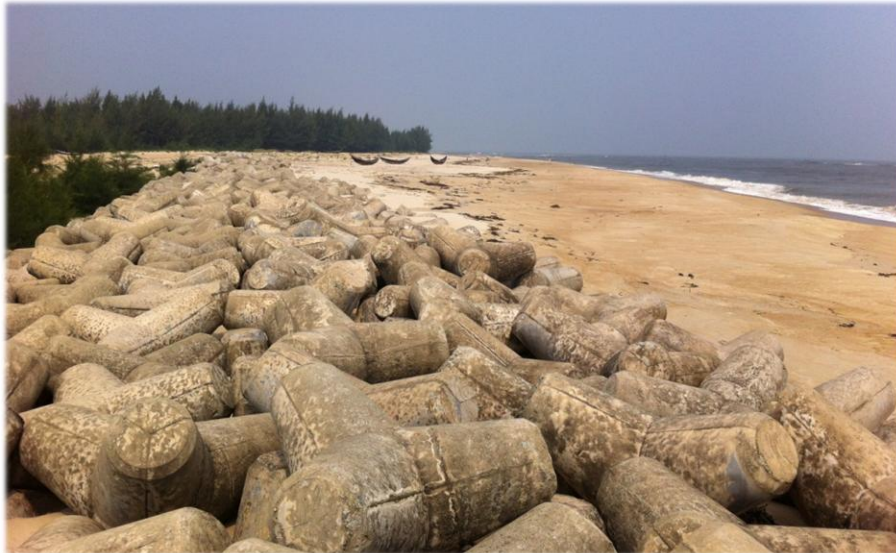
Figure 9: Tetrapod breakwater, with Tetrapods of 1.5-2.0 metres high placed quite regularly.

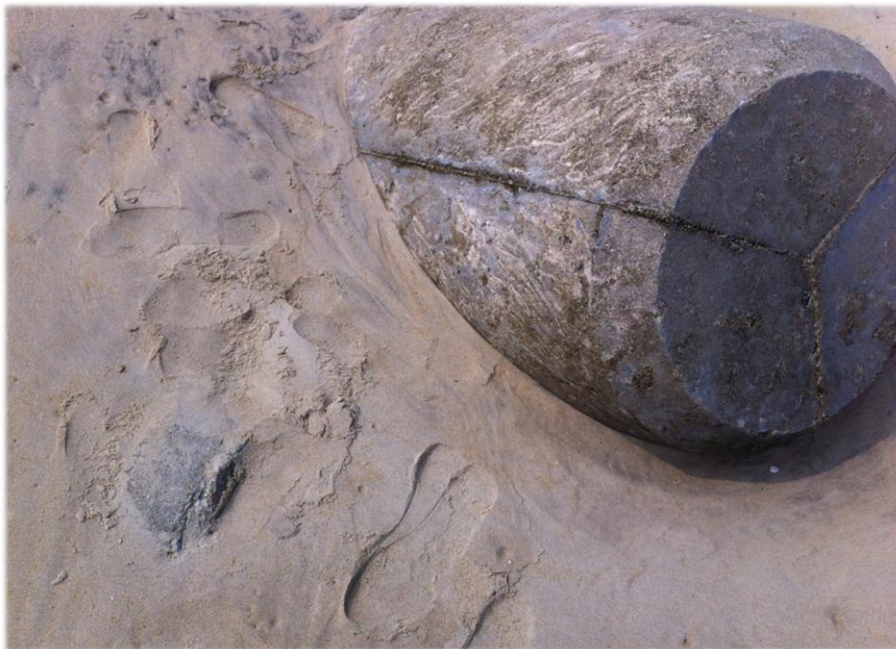
Figure 10: Tetrapods of about 1.5-2.0 meters high, completely covered by sand.

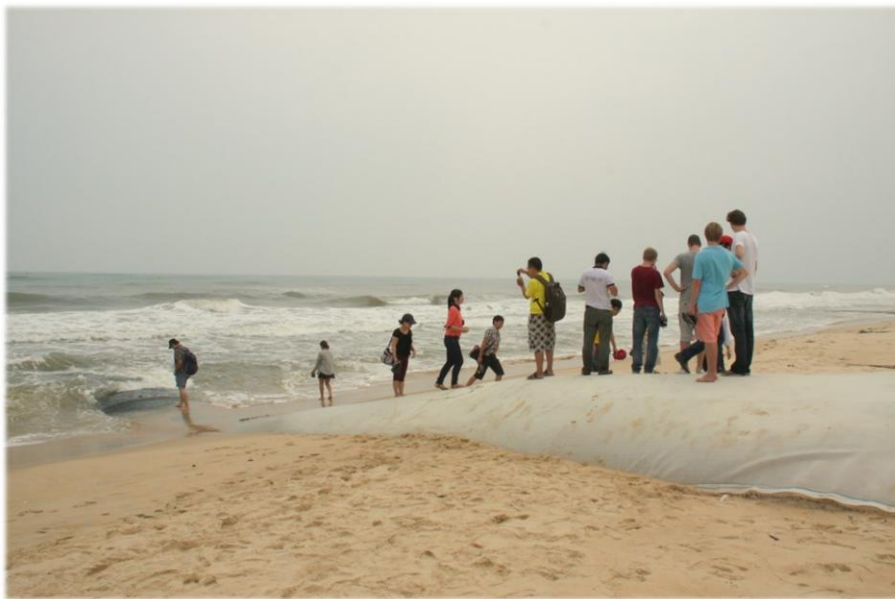
The coast between the Thuan An and Thuan Hien inlets is eroding quite severely, and therefore several measures have been taken in the past: a groin has been constructed and several geotubes have been placed to capture the sand. At this moment the groin is destroyed completely, and most of the geotubes have disappeared (Figure 13). The geotubes break down due to several reasons, of which the most important are an underestimated wave impact (and thus deformation, Figure 12) and vandalism by cutting the geotextile.

Figure 12: A deformed geotube, especially where the waves impact.

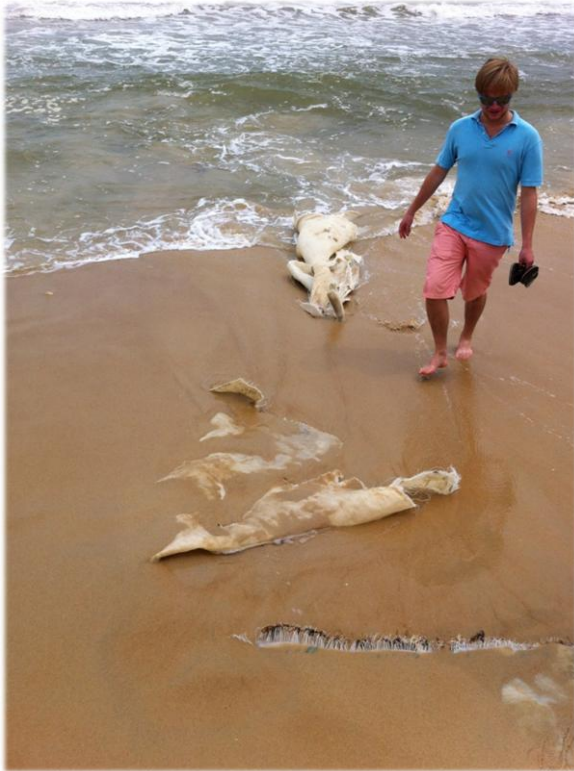
Figure 13: Leftovers of a geotube.

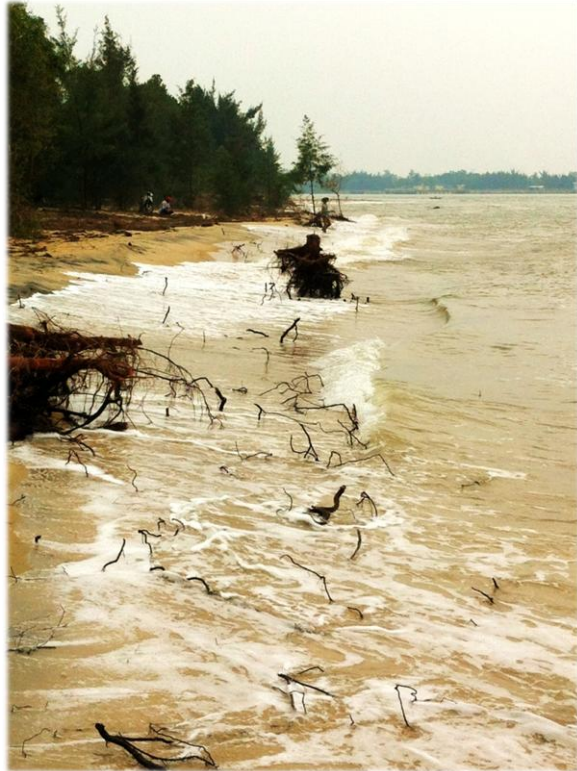
This inlet is smaller than the Thuan An inlet, and has a large sand spit growing from the north. This spit is growing with such a rate that it causes erosion on the other side of the inlet. This erosion is enhanced by degrading of the local forest due to storms and deforestation (Figure 14).

Figure 14: Eroded beach near the Tu Hien inlet, with roots of trees laying bare. In the back some people are cutting trees.

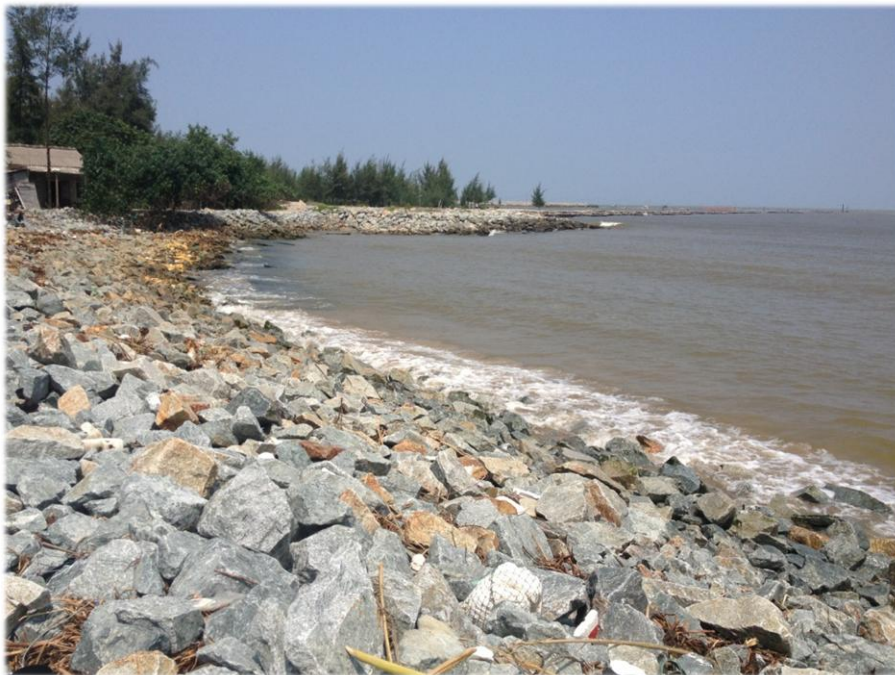
The revetments on the east side of the sand barrier have been constructed to protect the shrimp farms behind it. However, at the moment these farms have been abandoned. On the remaining land people are burning their waste and cutting branches from trees for personal use. In the past the revetments were constructed with concrete slabs. This eventually failed, because of fact that sand eroded under the slabs. Now, only loose stones are used, which works adequately. The revetment is presented in Figure 30. At the most southeast part of the sand barrier a spit is growing.

Figure 30: Working revetment on the east side of the west-barrier.

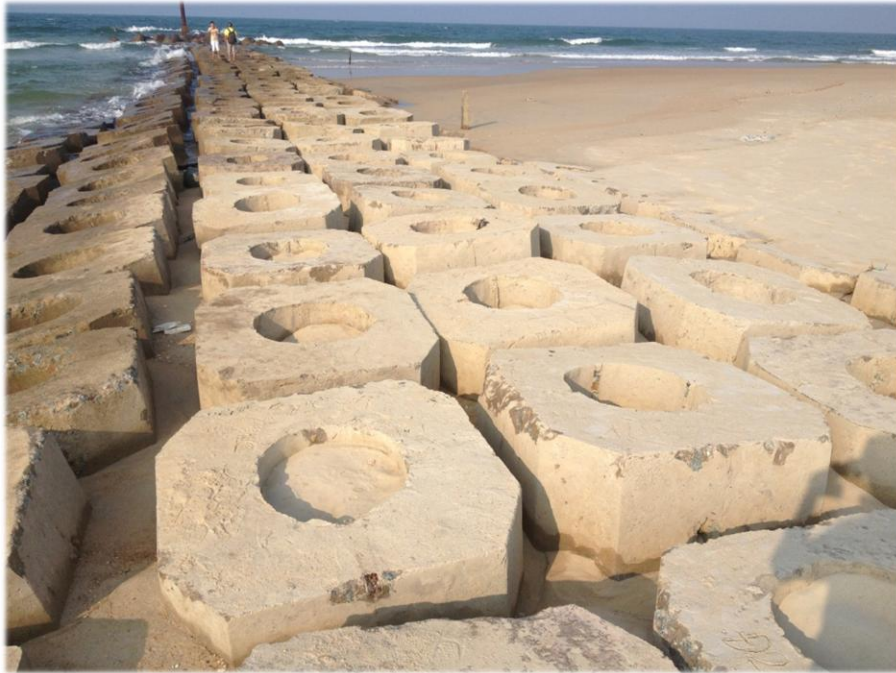
At the tip of the sand barrier a jetty is constructed, which consists of two parts. The first part, most directed landwards, is constructed with modified Haros. The second part, at the seaward side, is constructed with Tetrapods. This construction has been carried out only one year ago, but already by-passing of the groin occurs. The groin is completely filled-up with sediment (Figure 34). Besides this sedimentation process also the structural integrity of the jetty is failing. The modified Haros are not placed on a filter which results in shifting of the blocks. The Tetrapods simply lie everywhere except at the tip where they should be. This is probably because of a lack of foundation.

Figure 34: Sedimentated jetty on the most northwest part of the east-side of the barrier.

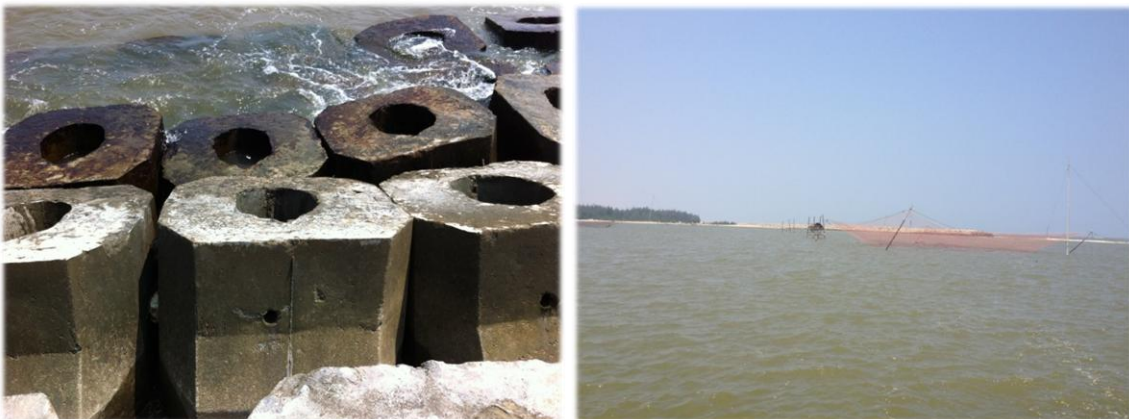
Figure 38: Failing modified Haros (left) and the basin with fishing activity (right).

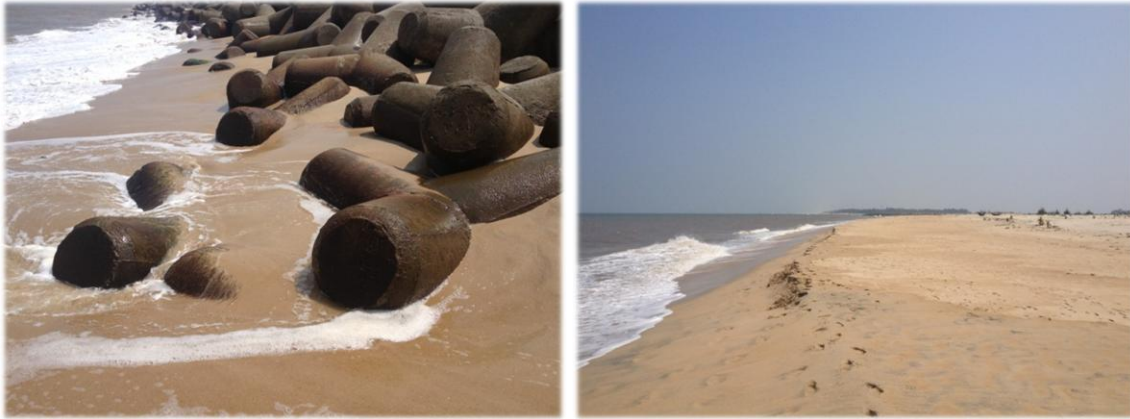
Figure 39: Sedimentated Tetrapods (left) and accretion (right).
