# **Post-flood field investigation in the Lower Chao Phraya River Basin 23 - 27 January 2012**

## **Findings of the Thai - Dutch Reconnaissance Team**

Organized by ENW: the Dutch Expertise Network for Flood Protection

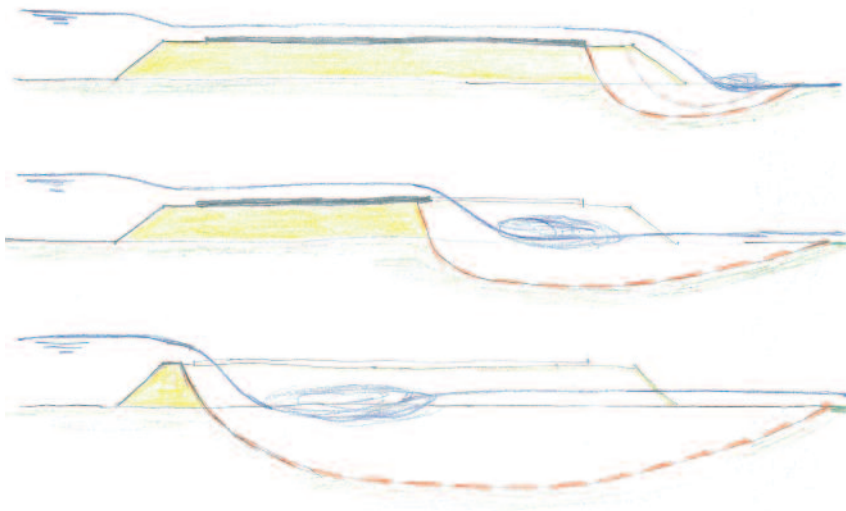
Overflow of dykes was reported in large parts of the Lower Chao Phraya river Basin. The reported water depths on top of the dyke ranged from 0.3m to 1m. Most failure cases were due to overflow of water, consequent erosion of the dyke at the inner slope and formation of a breach (Figure 3.1). One of the largest breaches that was visited is described more in detail in Textbox 1.

*Figure 3.1*  
*Erosion of dykes due to overflow*

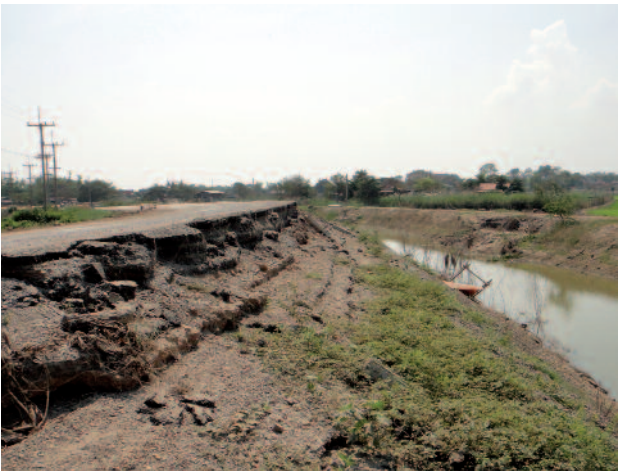
At several locations the erosion and breaching process was not fully developed. Here severe erosion of the earthen dyke and asphalt road on top of the dyke was observed at the inner slope, see Figure 3.2.

*Figure 3.2*  
*Erosion on the inner slope of the dyke and the asphalt road of a dyke near the Klong Ta Nueng floodgate*

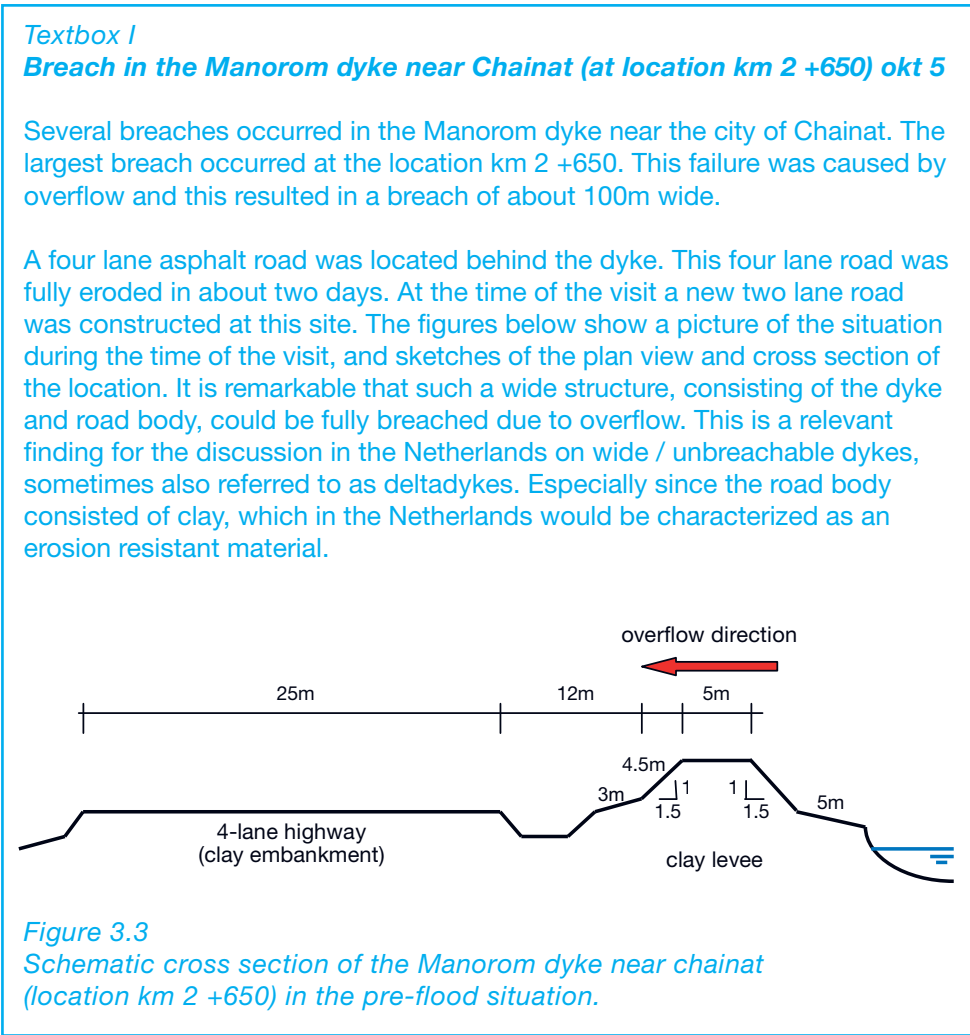
*Figure 3.3*  
*Schematic cross section of the Manorom dyke near chainat (location km 2 +650) in the pre-flood situation.*

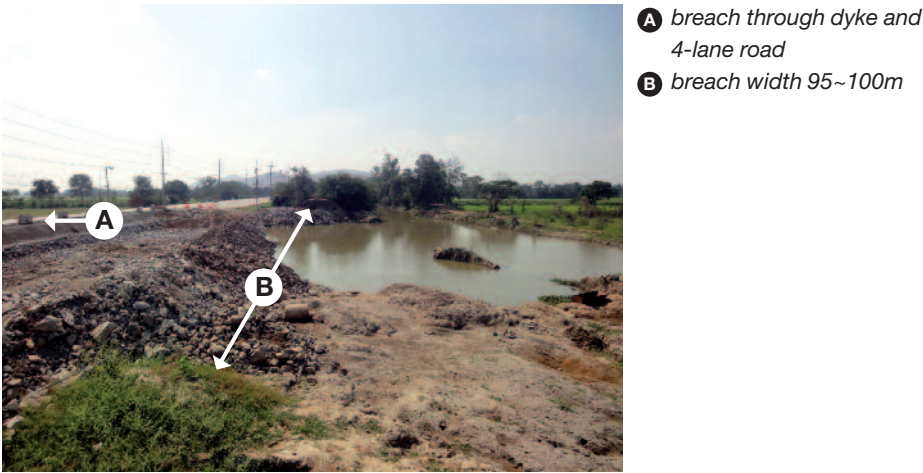
Figure 3.4  
Breach in the Manorom dyke near Chainat (location km 2 +650)

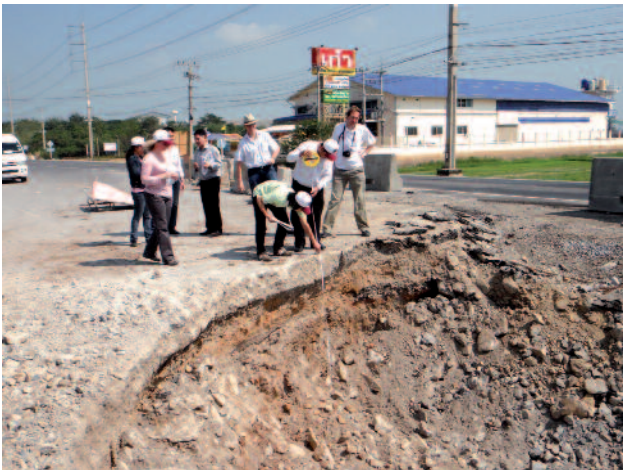
Figure 3.5  
Measuring the breach in the Manorom dyke near Chainat (location km 2 +650)

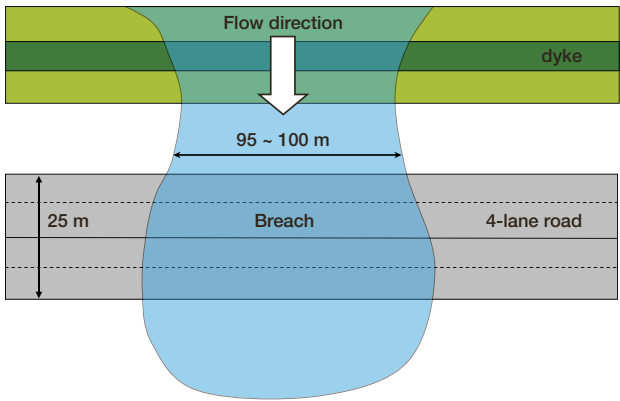
Figure 3.6  
Schematic plan view of the breach in the Manorom dyke near Chainat (location km 2 +650)

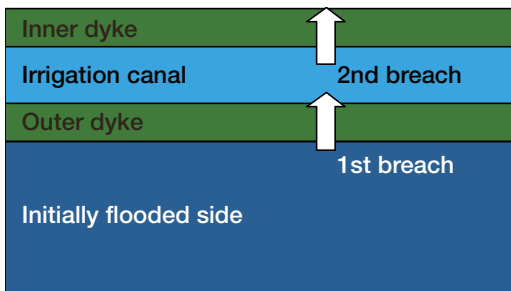
In many situations two parallel dykes were breached. They formed the boundaries of the irrigation canal (see Figure 2.5). Overflow, and consequent erosion and breaching of the outer dykes led to an increased hydraulic impact on the second dyke. In many cases it was observed that both canal dykes breaches at the same location.

*Figure 3.7*  
*Schematic plan view of double breaches in the dykes of the irrigation canal*

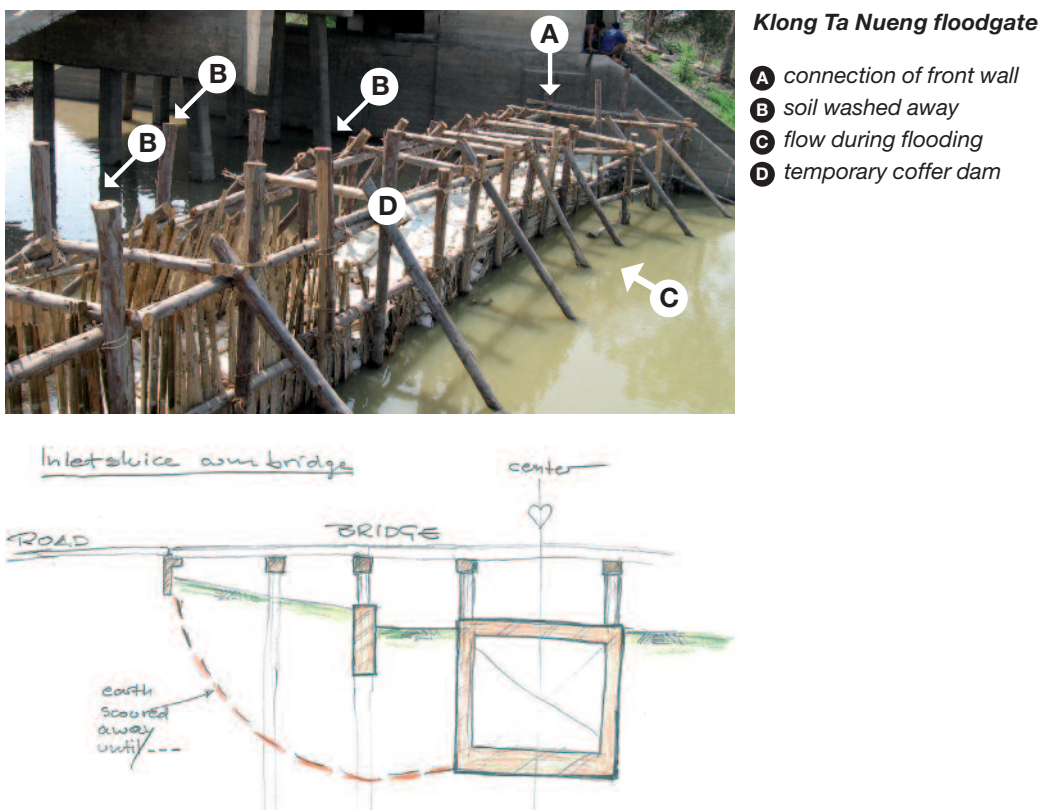
- The structures were mainly designed for irrigation and not so much for flood control. During the 2011 events the structures experienced higher loads and sometimes loads from a different direction than during normal irrigation conditions. During the floods sandbags were placed on top of the structure to prevent or reduce overflow.
- All the structures that were visited failed at the connection of the structure and the earthen dyke. This indicated how vulnerable these connections are <sup>2</sup>.

- Because the structures are mainly designed for irrigation purposes with small water heads, provisions to prevent seepage / piping during floods seem to be limited, especially on the connection with the adjoining dykes or dam. Thereby scouring and breaching could occur besides the structures. This is illustrated in Figure 3.8 (Klong Ta Nueng floodgate) and Figure 3.9 (Pra Ngam floodgate), which show a photo of the situation and a sketch of the failure.

**Figure 3.8**  
**Failure of the Klong Ta Nueng floodgate**

- It was indicated by employees from RID that seepage screens / front walls will be placed in permanently repairing the floodgates. The use of rock fill and gabions introduces a new problem. It is very difficult, if not impossible, to drive sheet piles through the rock fill or to excavate trenches to construct seepage walls next to the structure. A point of attention is the size of the screen. The screens should be wide and deep enough to prevent seepage and erosion of materials under and besides the structure. A last point of attention is the connection of the front wall / seepage wall to the structure. At the field visits no reinforcing steel rods were seen sticking out of the structure. Therefore it is expected that there was no connection between the structure and the original front wall that could transfer loads.

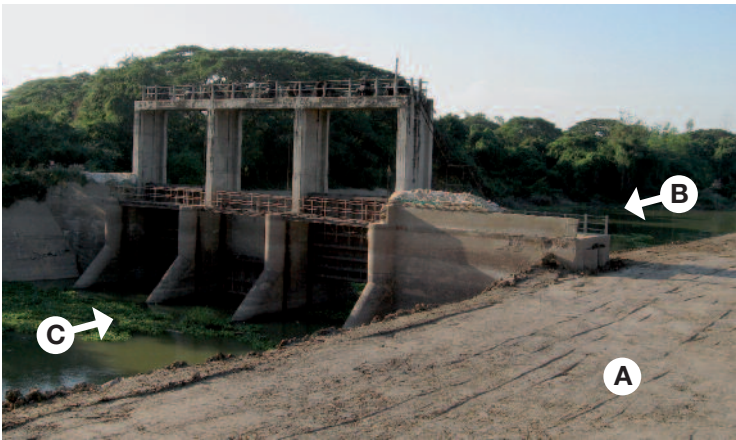
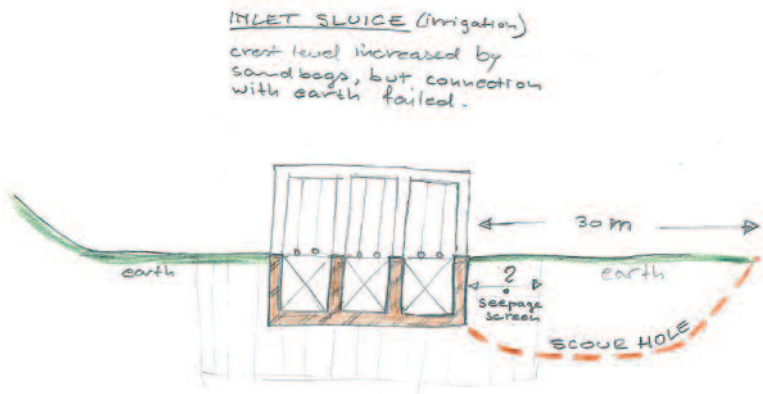
**Pra Ngam floodgate**

- A** sand fill at the original breach
- B** regular flow
- C** flow during flooding

**Figure 3.9**  
**Failure of the Pra Ngam floodgate**

- A separate rock-fill closure dam was constructed behind the Pra Ngam floodgate to close the canal. For the initial closing of the gaps gabions and loose rock fill were used. In the last stages of the closure single gabions were washed away due to high flow velocities. In that case up to 8 gabions were tied together. Later the rock fill is covered with compacted clay and revetments. These are temporary measures.

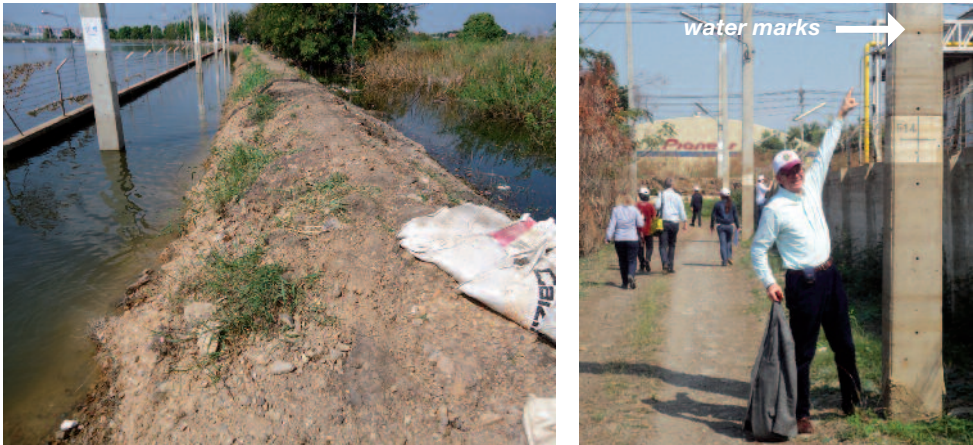
The flood levels were higher than the flood defences and led to overtopping and consequent breaching of the dykes. In total seven breaches occurred, most of those due to severe overtopping. Flood depths up to 3 meters occurred within the estate (Figure 3.10).

*Figure 3.10*

*Left: Dyke section at Rojana Industrial Estate during the 2011 floods (Oct. 8th, 2011);*

*Right: Water marks indicating the flood levels within the estate*

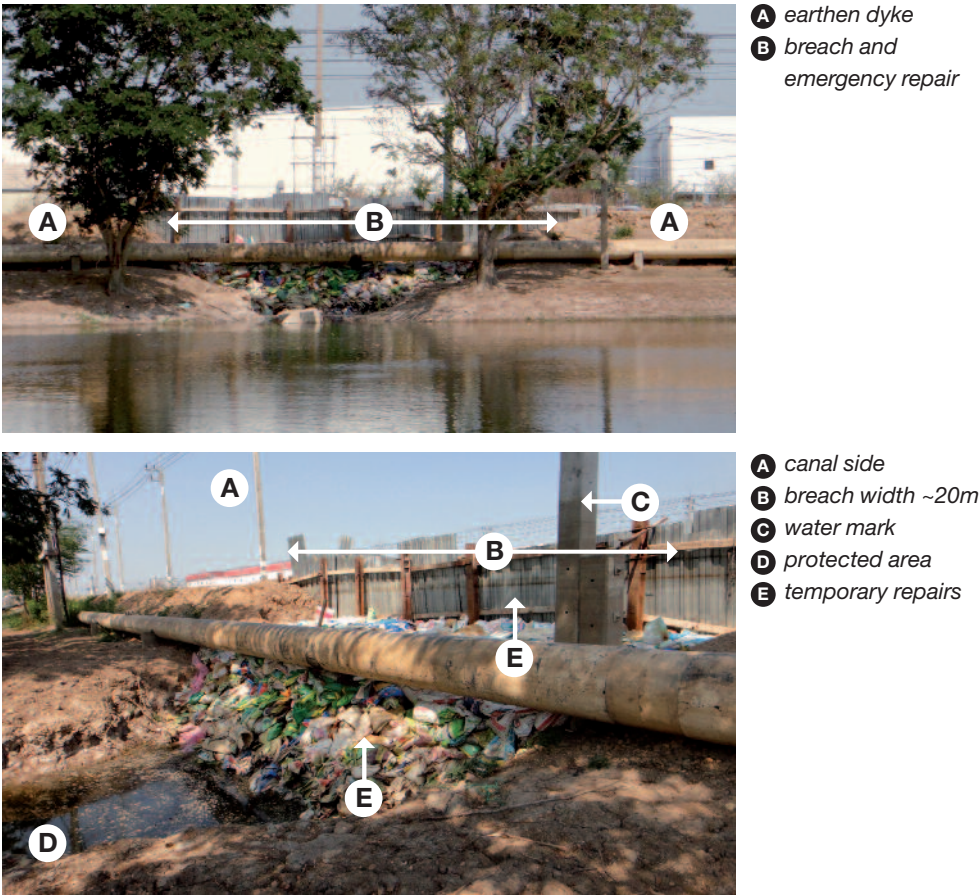
Two breaches were visited. The first breach was caused by overtopping and it had a width of about 20m. The canal levee had been raised as flood fighting measure by 0.5m with a backhoe. Still, the final flood levels exceeded the crest level by far (0.8 ~ 1.0m). The pipe along the slope and the columns on the protected area side may be speculated to have contributed to the erosion failure. The failure had occurred after no more than 6 hours after the levee started being overtopped.

*Figure 3.11*  
*First breach visited in Rojana Industrial estate*

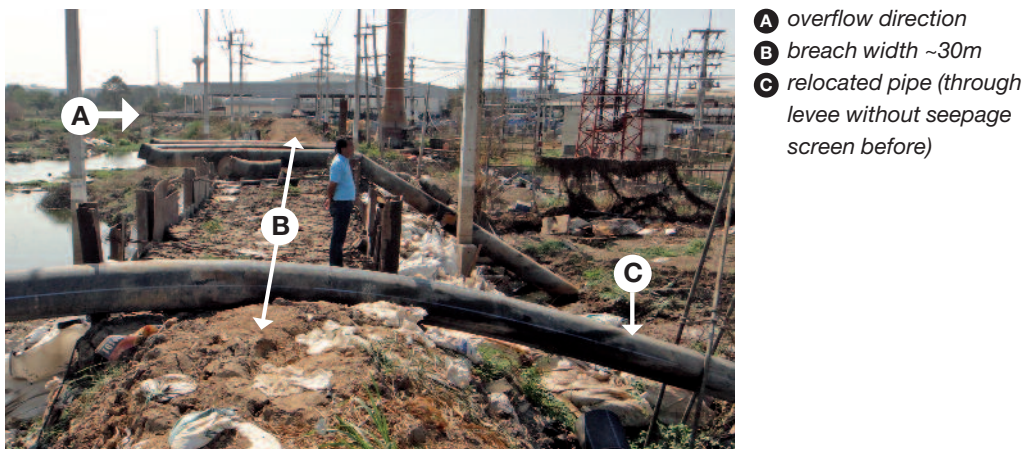
The second breach that was visited occurred at a pipe in the dyke, which was not protected by seepage screens. At this location the failure started with seepage along a pipe through the levee (no seepage screen) and failure progression accelerated when it was also overtopped. According to eye witnesses it took about 2 hours to form the 30 wide breach. The levee was rather new and built after floods in 1999.

*Figure 3.12  
Breach at Rojana Industrial Estate (location 2) from canal side*

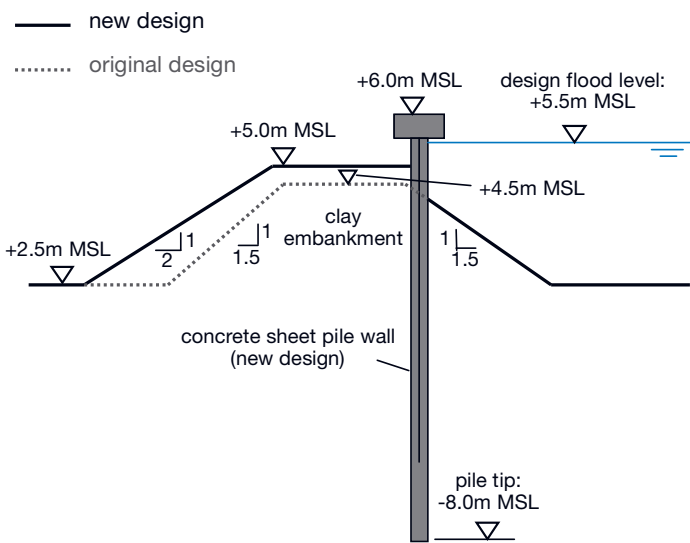
Figure 3.13  
Original and new design of the dykes around Rojana estate

At the time of the visit the industrial estate already had plans to reinforce levees around the area before the next flood season. The figures below show the original as well as the new designs. In the new design, the earthen dyke is strengthened and heightened by 1.5m by means of floodwall. About 10m long sheetpiles are used to prevent instability and seepage.

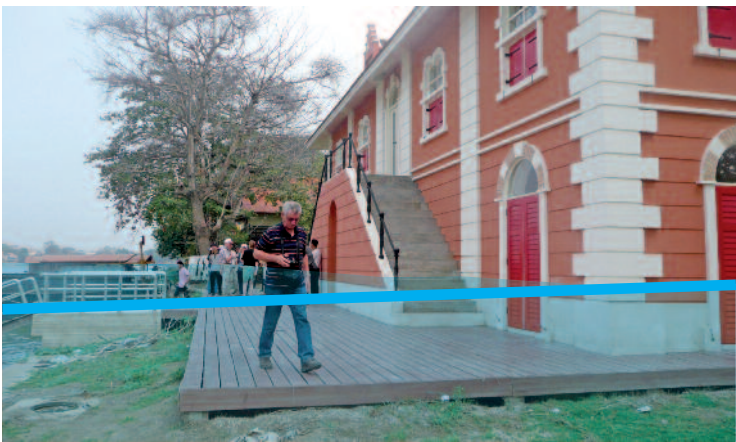
Baan Hollanda (Holland House) is a reconstructed historical Dutch settlement that is located on the banks of the Ayutthaya river. It was flooded by about 1m of water during the events in 2011 (Figure 3.14). It took a team of about 20 people a week to clean-up this site. The representative from the embassy made a request to the Dutch experts to develop solutions to prevent flooding of Baan Hollanda in the future.

Figure 3.14  
View on Baan Hollanda from the riverside, and indication of the flood level during the 2011 floods

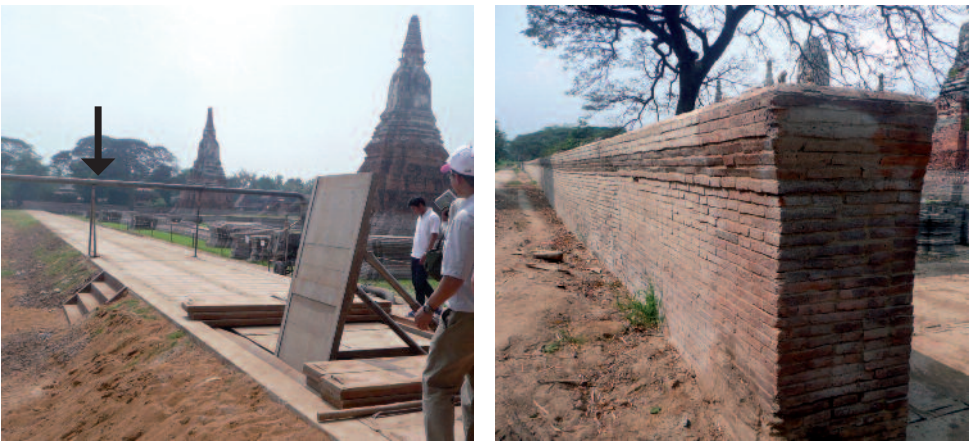
The Wai Chai Wattanaram temple is also located at the river banks. It is protected by movable flapgates on the river site and masonry walls on the other sites of the area. Flooding occurred at the southern corner at the connection of the movable gates and the wall, illustrating the vulnerability of such connections. The exact cause of flooding (overflow due to local waterlevel rise and/or breaching of walls) could not be determined on-site. The flooding has had a severe impact and most of the site is still closed for the public. Both cultural sites could be used as very visible ‘beacons’ to monitor flood risk resilience during future floods.

*Figure 3.15*  
*Movable floodgates at The Wai Chai Wattanaram temple (left) and location of connection at southern end of the terrain where flooding occurred (right)*

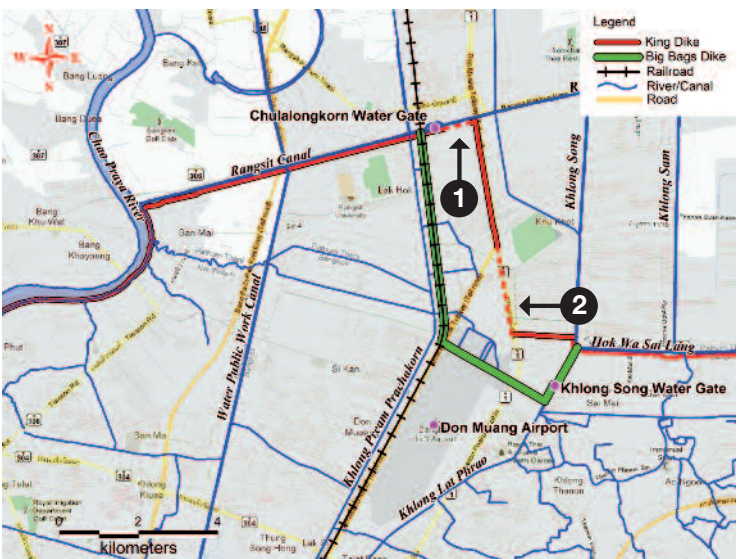
The team has made a short visit to parts of the King’s dyke around Bangkok. At most of the locations the dyke is integrated in the road system and has a limited elevation ranging from +1.0 to 2.9m (MSL). At some locations the dyke is not present. The team visited one of these sections. The flooding that occurred due to missing sections of the dyke resulted in flooding of parts of Bangkok, including the Don Muang airport.

*Figure 3.16*  
*Openings (1 and 2) in the King’s dyke on the Northern side of Bangkok and the temporary dyke of big bags*
