## A case study of apparently spontaneous fracture

Veer, Fred; Bristogianni, T; Baardolf, Gerardus

Glass Structures and Engineering

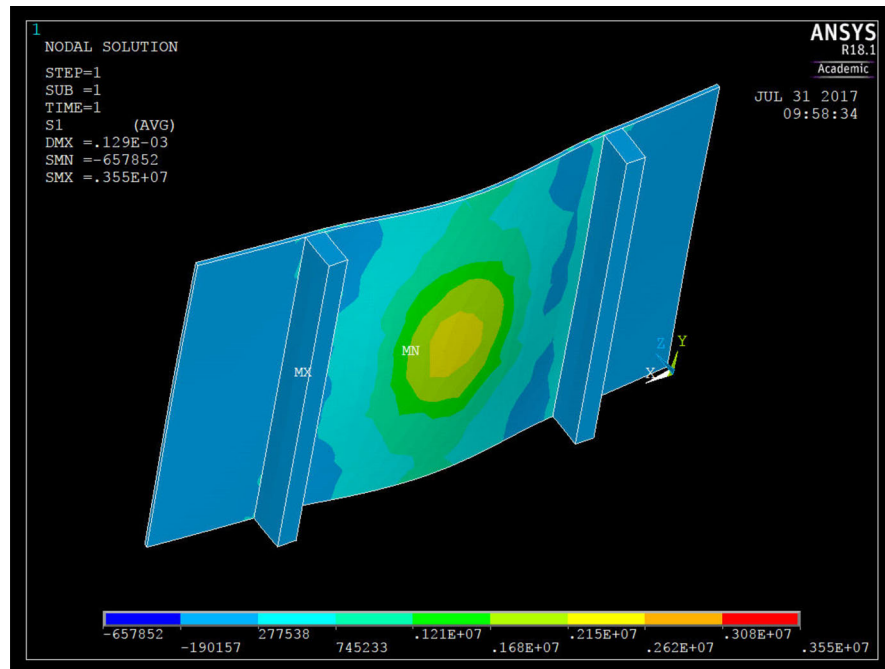
**Fig. 6** Stress distribution according to ANSYS model

and illustrated in Fig. 7. All failures originated in the area with the highest applied stress shown in Fig. 6. The bands of large and small shards visible in Fig. 7 corresponded to the bands of lower and higher compressive surface pre-stress measured with the SCALP 5 device.

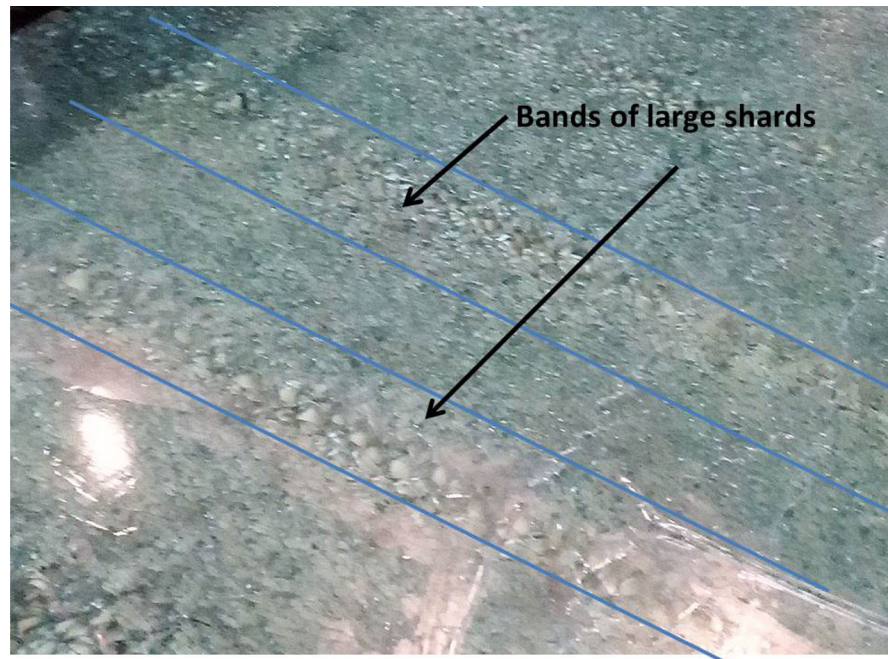
The loading rate was 250 N/min. Table 3 gives the calculated failure stresses. After failure, all specimens showed the same pattern of bands of small and large shards as observed in the spontaneously failed windows

**Fig. 7** Specimen after failure, drawn bands are approximately 40 mm wide

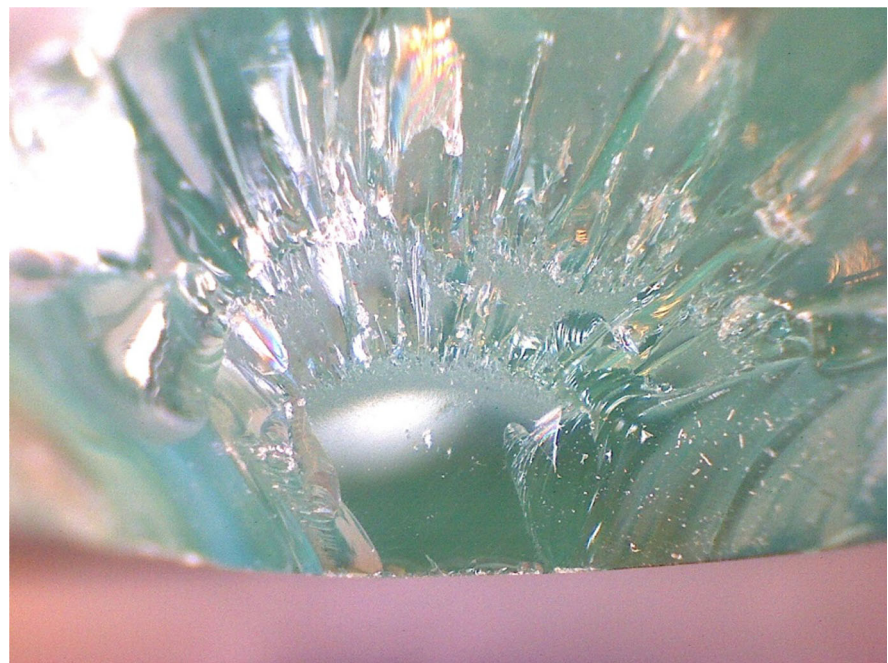
**Fig. 8** Fractography of butterfly piece, typical mist, mirror, hackle zones

The second set of butterfly pieces showed a clear fractographic pattern under a microscope. This is shown in Fig. 8. The source of failure is clearly at the surface of the specimen and not in the interior, where a NiS failure would originate. The failure pattern is simi-

lar to that for an overload as given by Ono (2004), showing the typical mist, mirror and hackle pattern. This pattern alone makes it clear that no inclusion caused the original “spontaneous” failure.

Fractographic analysis shows that the failures were the result of overloading the glass.
