Risk Management of a Complex Remediation of the Former Feijenoord Gasworks Site in Rotterdam

M. DE VRIES, K. HULSBOS, J. BLAAUW

Department of City Development, Rotterdam, the Netherlands

Abstract. This paper will show how the project's geotechnical risk profile was put into design and contract, the experience of the risk monitoring and risk measures, followed by a short evaluation.

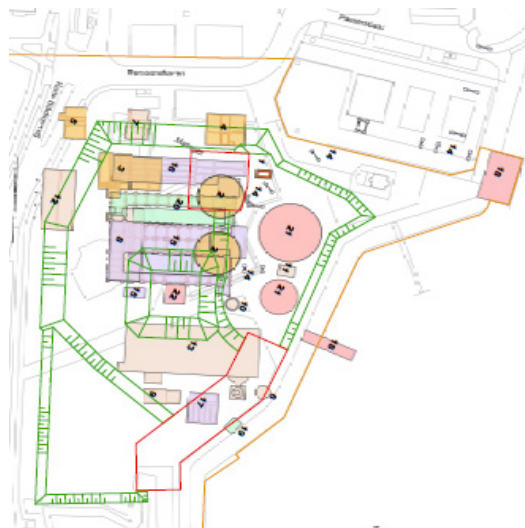
Figure 4. Projection of lay-out of former buildings

Based on the archive study and the soil survey the possible obstacles such as foundation remains and former underground oil reservoirs are mapped (see Figure 4). It was uncertain which part of the building foundations were demolished in 1969. Only a part of the wooden foundation piles have been removed. This underground information is both of use for understanding the pollution situation, exploring the excavation possibilities and locating possible underground obstacles.

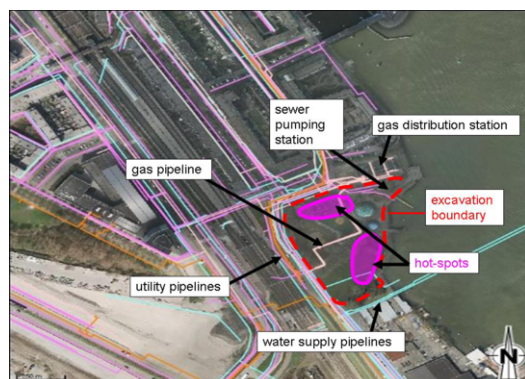
Figure 5. Excavation area with contamination hot-spots

Figure 5 shows the excavation site with two contamination hotspots. The two gasholder domes (in use by a sports club) and the water tower (not in use) are in the middle of the excavation area, as well as the high pressure gas pipeline, a data cable and a double main water supply pipeline all in operation. Around the site there's a bundle of utility pipelines.

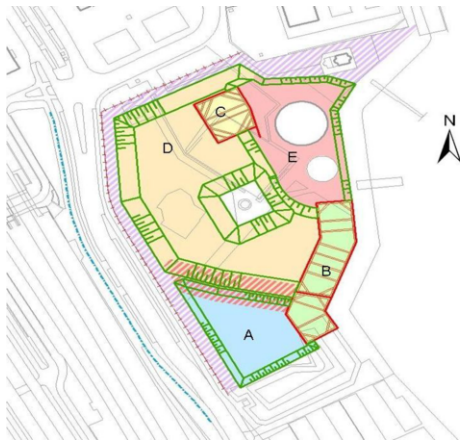
Figure 6. Excavation plan

The excavation area is divided in five sections (see Figure 6). Section A is a shallow sloped excavation. B and C are deep excavation pits (8 m) with sheet pile walls at the hotspots. Section D was a deep sloped excavation (up to 6 m). For section E less pollution information was available and a shallow excavation was required to ensure the stability of the gasholder foundations.

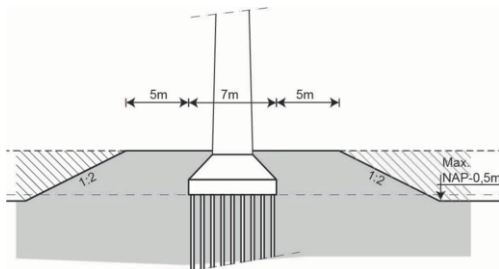
Figure 7. Excavation around water tower

The exact degree and extent of the contamination could indeed only be determined during excavation, so the majority of the contaminated soil was removed by sloped excavation which provided flexible excavation boundaries. Around the water tower the excavation was symmetrical to prevent uneven lateral earth pressures and unacceptable deformation.

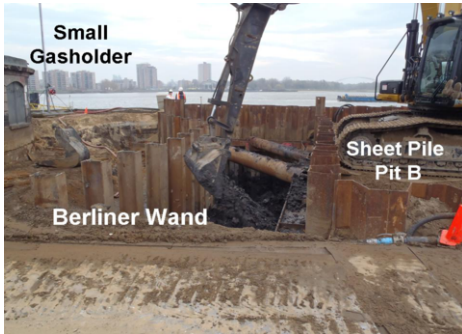
Figure 8. Deep excavation in section E

An additional deep excavation was carried out in section E in order to remove contaminated soil at the hotspot between the small gasholder and the sheet pile wall of pit B. A Berliner Wand was used as a retaining wall, which made excavation possible to a depth of 5,5m.

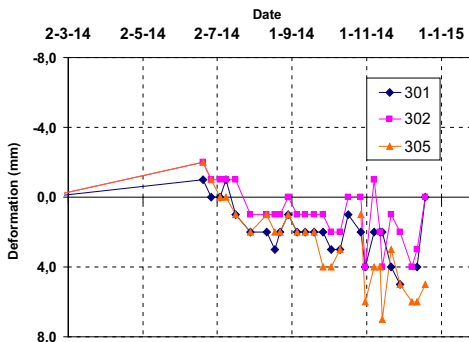
Chart 1. Settlements small gasholder

The installation and removal of the Berliner Wand resulted in minor settlements of the small gasholder (see chart 1), but these were still below the intervention limit of 10mm.

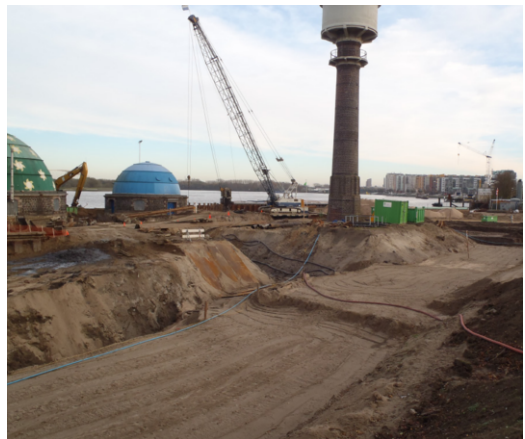
Figure 9. Excavations around water tower

The deformations of the water tower stayed below the intervention value of 7mm.

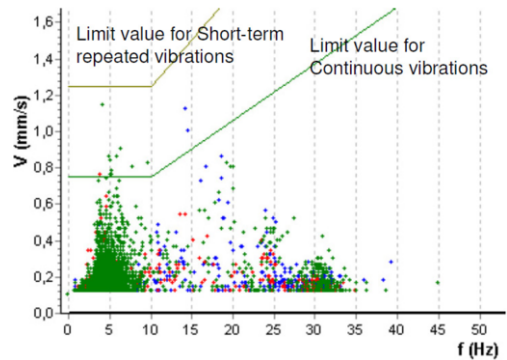
Chart 2. Monitored vibrations (Hanselman 2014)

Sheet piles were installed with high frequency vibratory hammers. A few limit exceeding values were reported. Chart 2 shows overruns occur at low-frequency activities ranging 0-10 Hz, typical for every day traffic and heavy vehicles.
