Small Hard Body Impact on Annealed, Heat Strengthened and Fully Tempered Laminated Glass

International Journal of Structural Glass and Advanced Materials Research

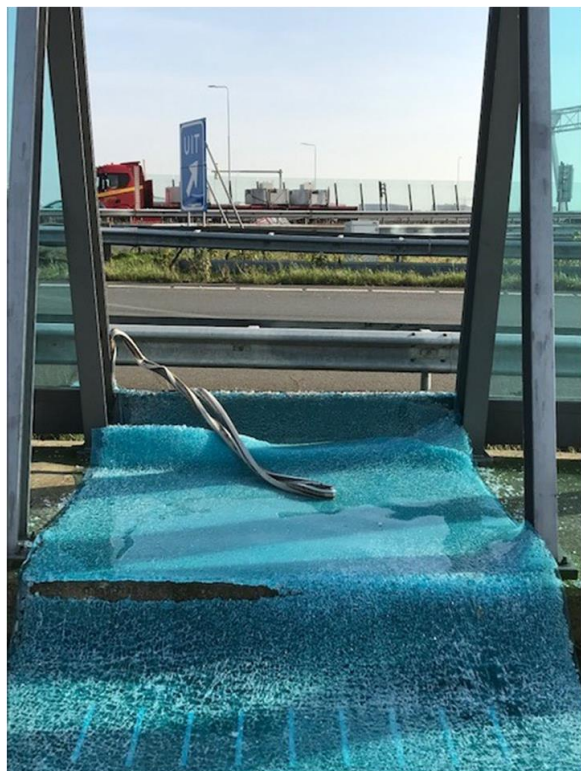
Fig. 1: Failed tempered laminated glass sound screen panel

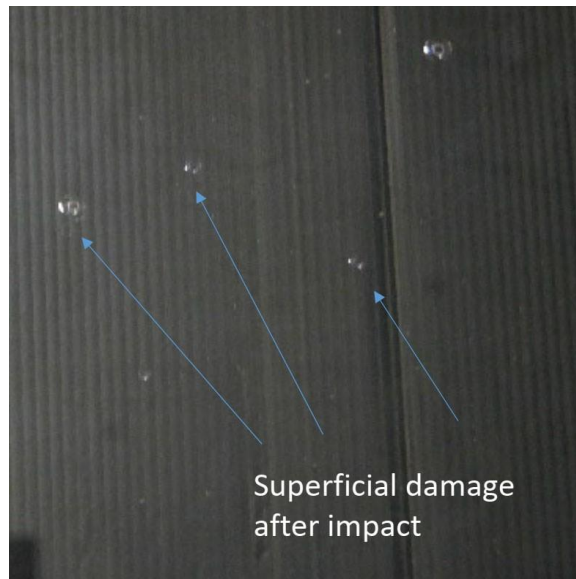
In fully tempered glass with sub-critical impactors slight chipping of the surface, as shown in Fig. 8 is observed. This is not noticeable in annealed and heat-strengthened glass. Larger impactors of 20 mm diameter or more cause total failure of the top layer. An example is shown in Fig. 9. Additional impact of a 25 mm diameter spherical impactors caused failure of the bottom plate also in some cases, leading to total structural failure of the fully tempered panel, as shown in Fig. 10.

Fig. 8: Superficial damage to fully tempered glass by non-critical impacts

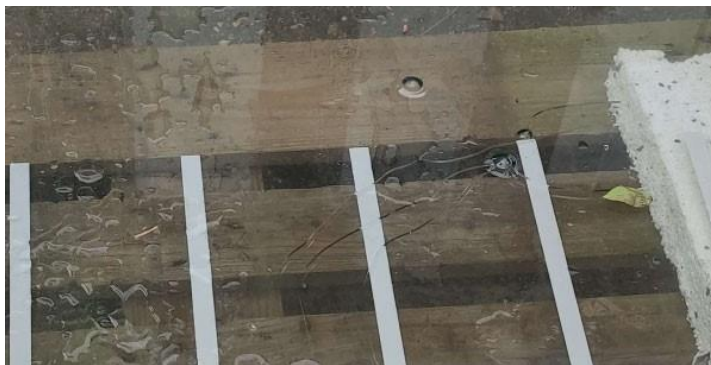
Fig. 11: Results of tests on location 1

Tests were done at 6 different locations of the panel, varying in support and aiming at the middle or edge of the panel. The results are described for each location in Table 4 and Fig. 11, 12 and 13 show the impact damage.
