HOPTILLE, FROM STIGMA TO CHARISMA

TECHNICAL ANALYSIS - COLLECTIVE

*Image enhancing transformation of
post-modern architecture while retaining its identity*

*S2C.3: Technical Analysis - collective
AR3AH105 - New Heritage
Graduation studio Adapting to 20th Century Heritage
Master Architecture, Urbanism and Building Sciences*

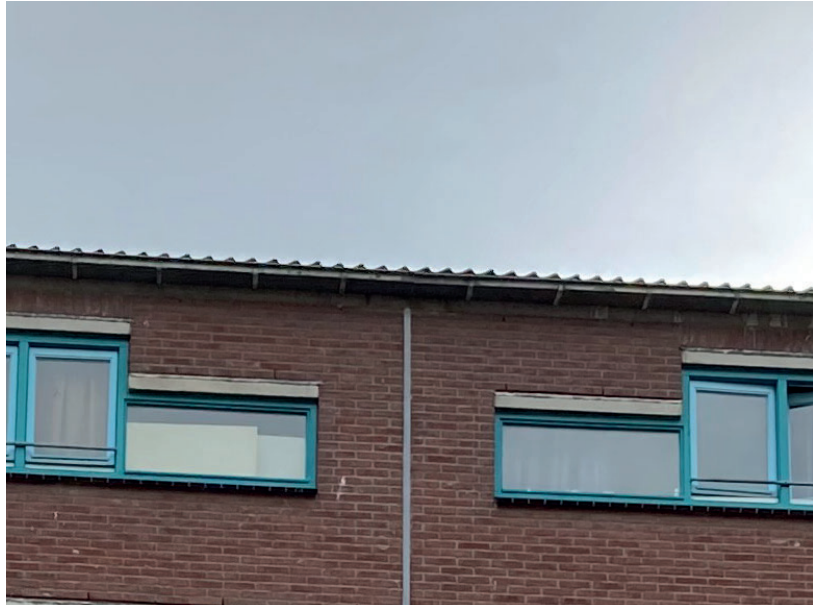
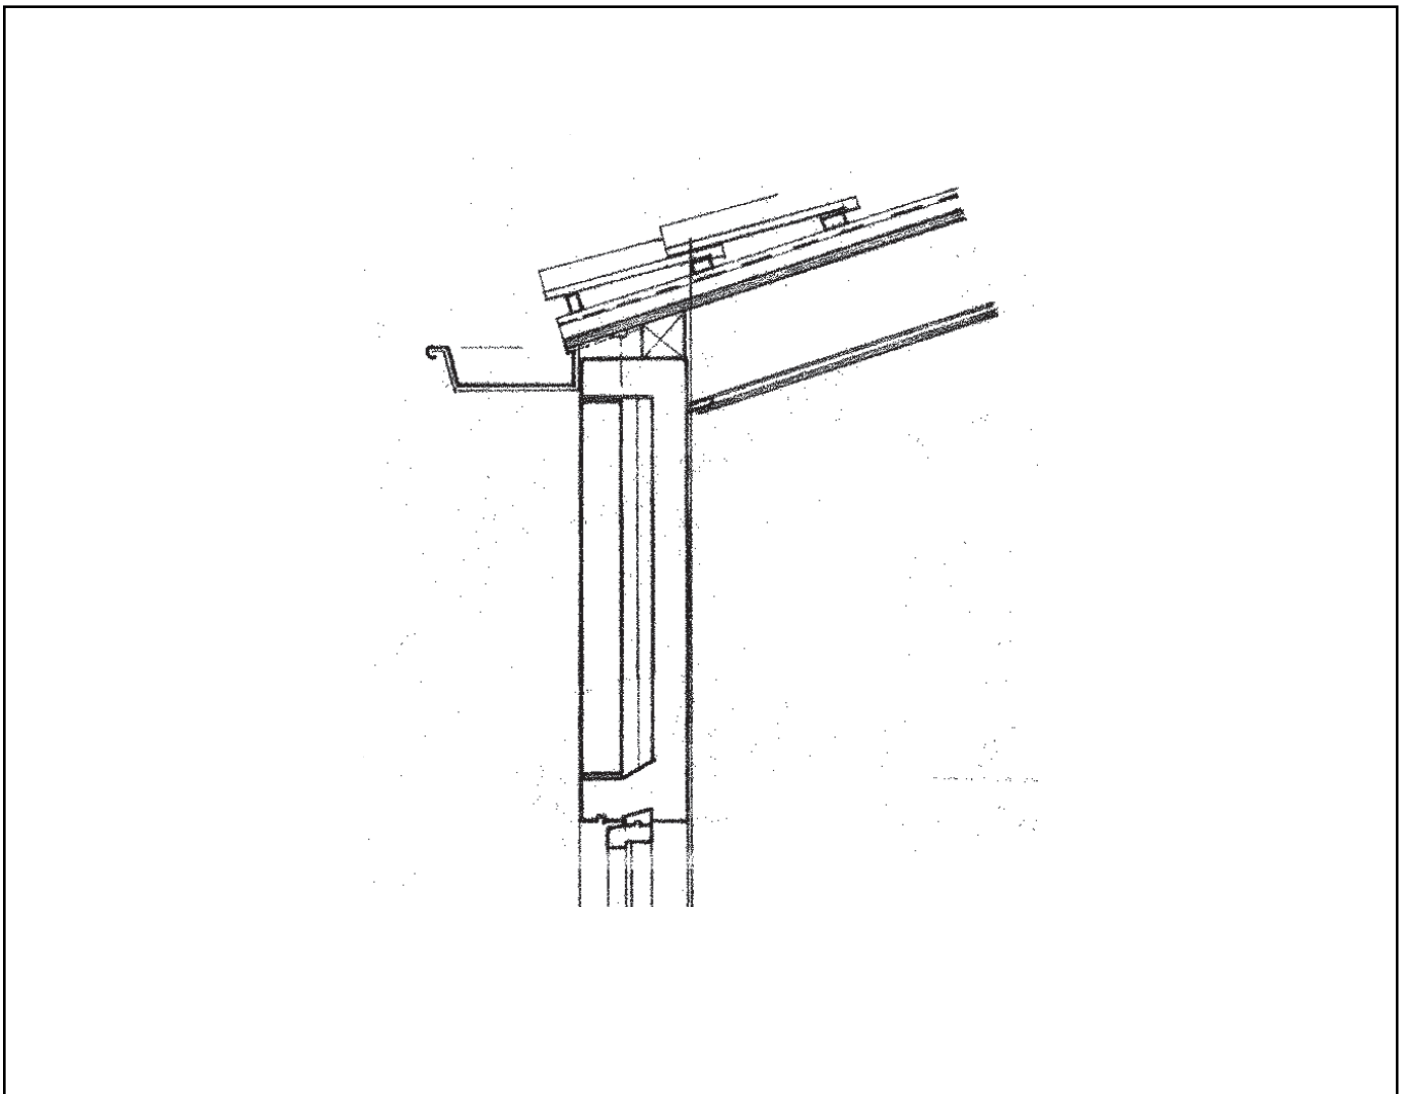
DETAIL 1

Pitched roof

Steel structure, no insulation
cold bridge

In general, the roof is steel structure with concrete roof tile. The steel structures seat in the prefabricated concrete wall in the main structure and prefab concrete in the facade. The 240mm I-beam profile has a span of 4,350mm. The rafters are made out of wood meanwhile the battens are steel hollows to support the concrete roof tile. From the original drawing of this detail, it did not indicate the presence of any roof insulation. So this raised concerns of heat loss and a cold bridge from the roof.

The facade in the fifth floor shares the same principle with other parts of the Hoptille' s facades. It has brick work as outer layer and cavity of 65mm followed by prefabricated concrete panel 100mm in which also becomes a cold bridge because of exposure to the outside just above the windows.

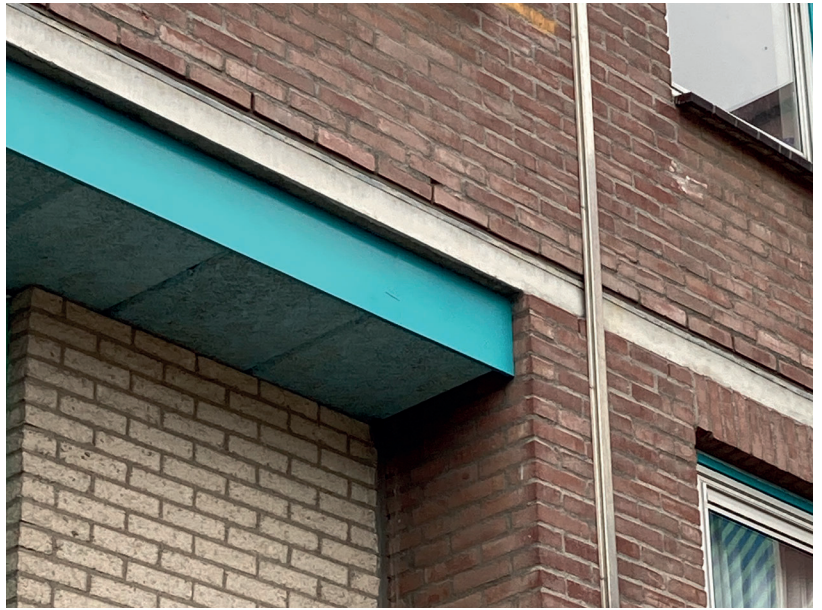
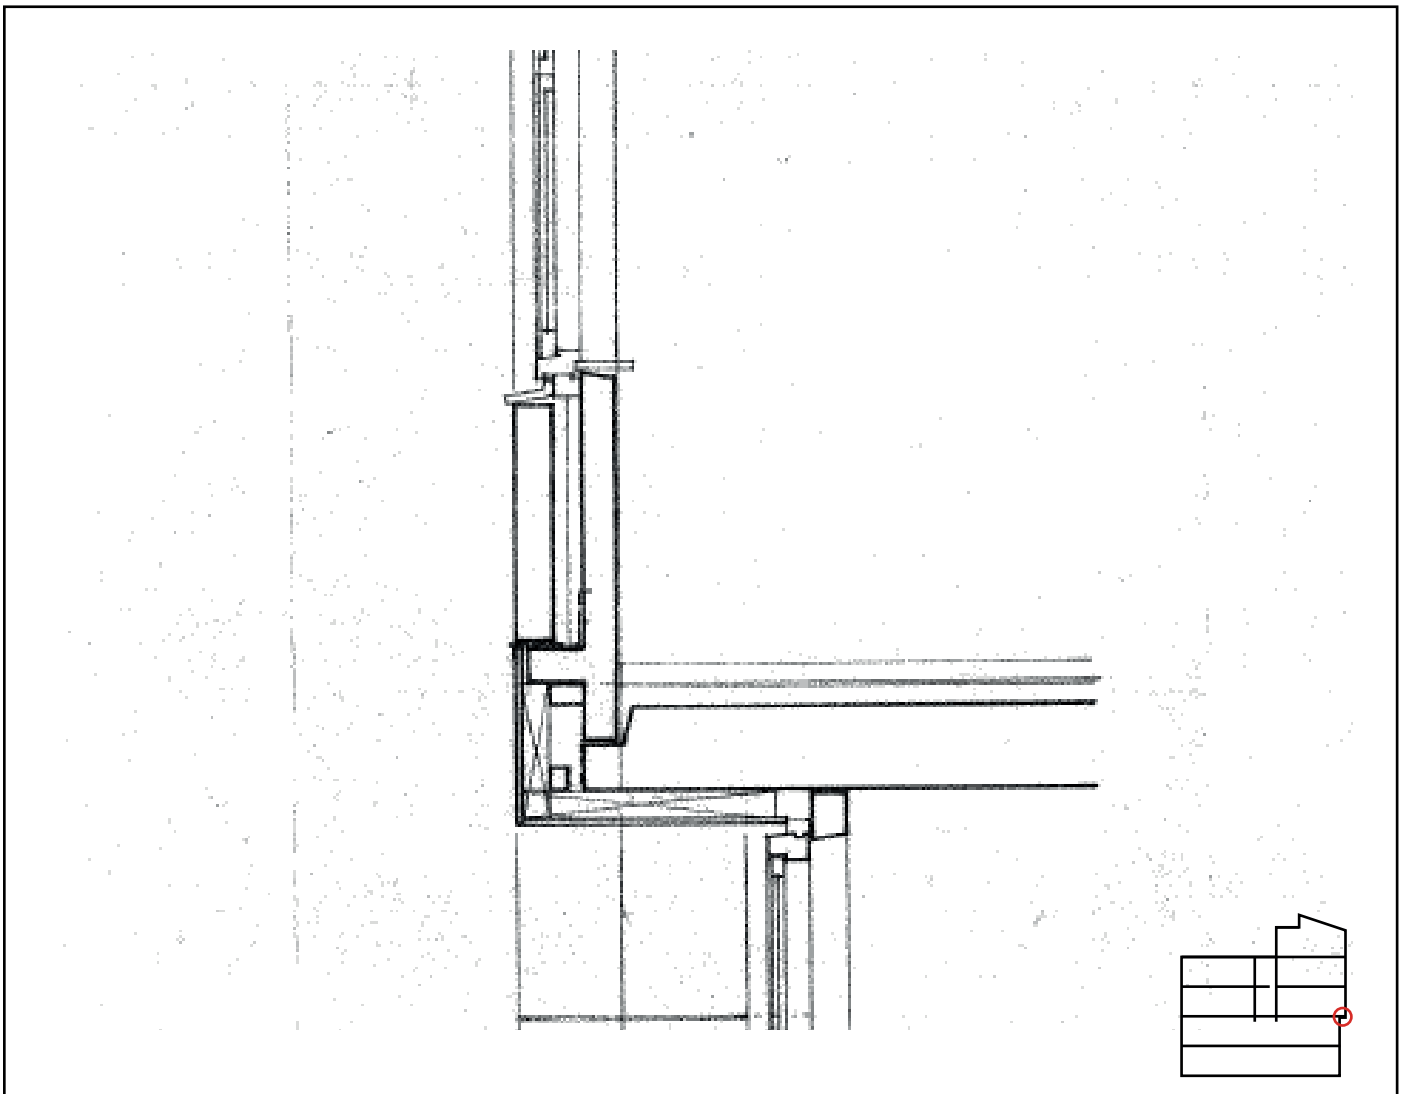
DETAIL 2

Recessed facade

Self supporting facade,
cold bridge

Considering the recessed façade, the detail differs from the original. The self-supporting facade was conceived in the original design by a wooden plate of approximately 500 mm high, but the plate is according to recent photos half as high. Secondly, this wooden plate would also be used on the bottom of the recessed façade. Ultimately, a fire-resistant and insulating wood wool cement board was chosen. Finally, the visible concrete facade construction takes on a different shape than originally conceived. The load-bearing facade element is located completely at the bottom instead of the 150 mm higher, aligned with the higher wooden plate. This has no consequences for the technical performance; both variants are a cold bridge.

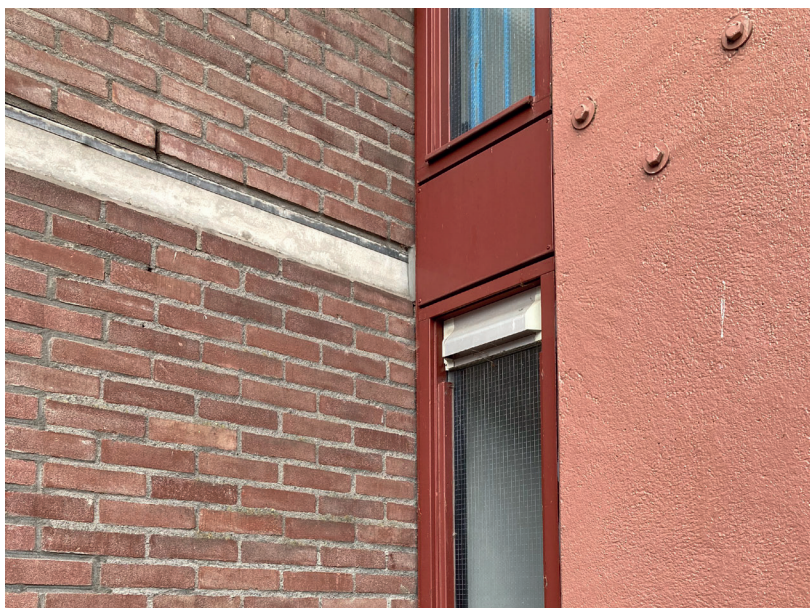
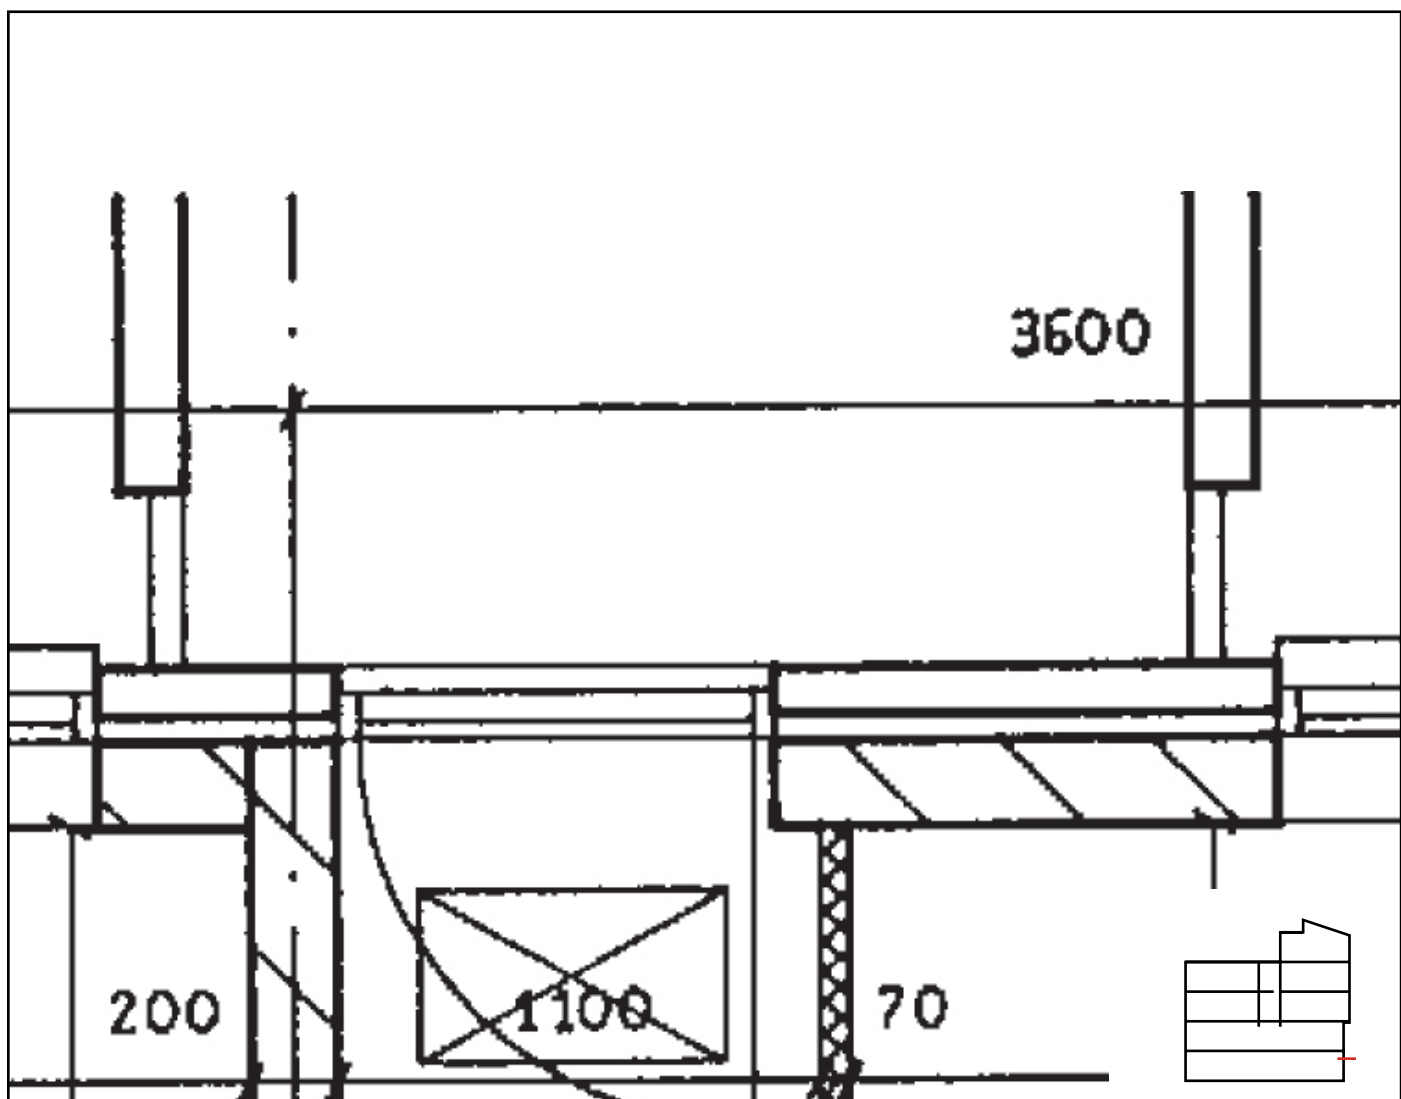
DETAIL 3

Horizontal connection

Connection between the facade and staircase, renovation

Given the floor plan drawing, not much has changed the original. The details show that not much has been done to insulate the house properly. The load-bearing wall is not insulated, which creates thermal bridges

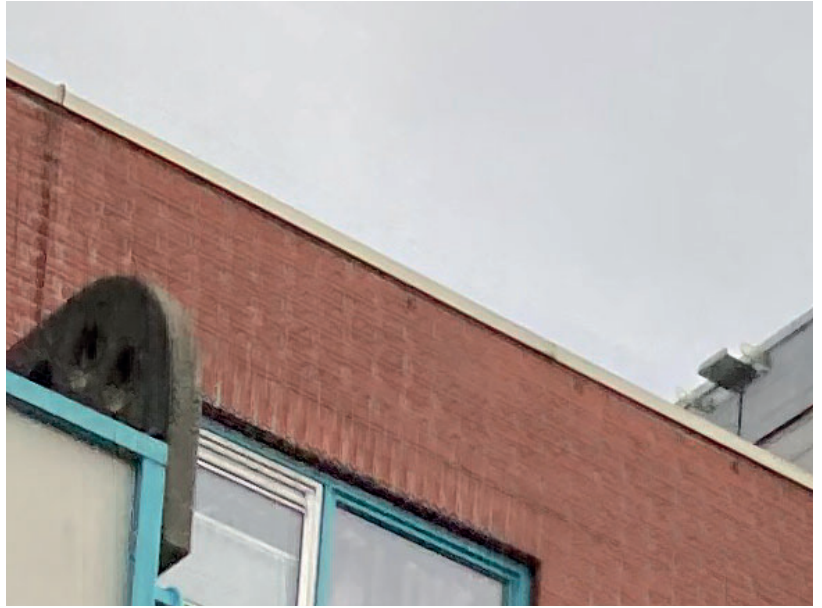
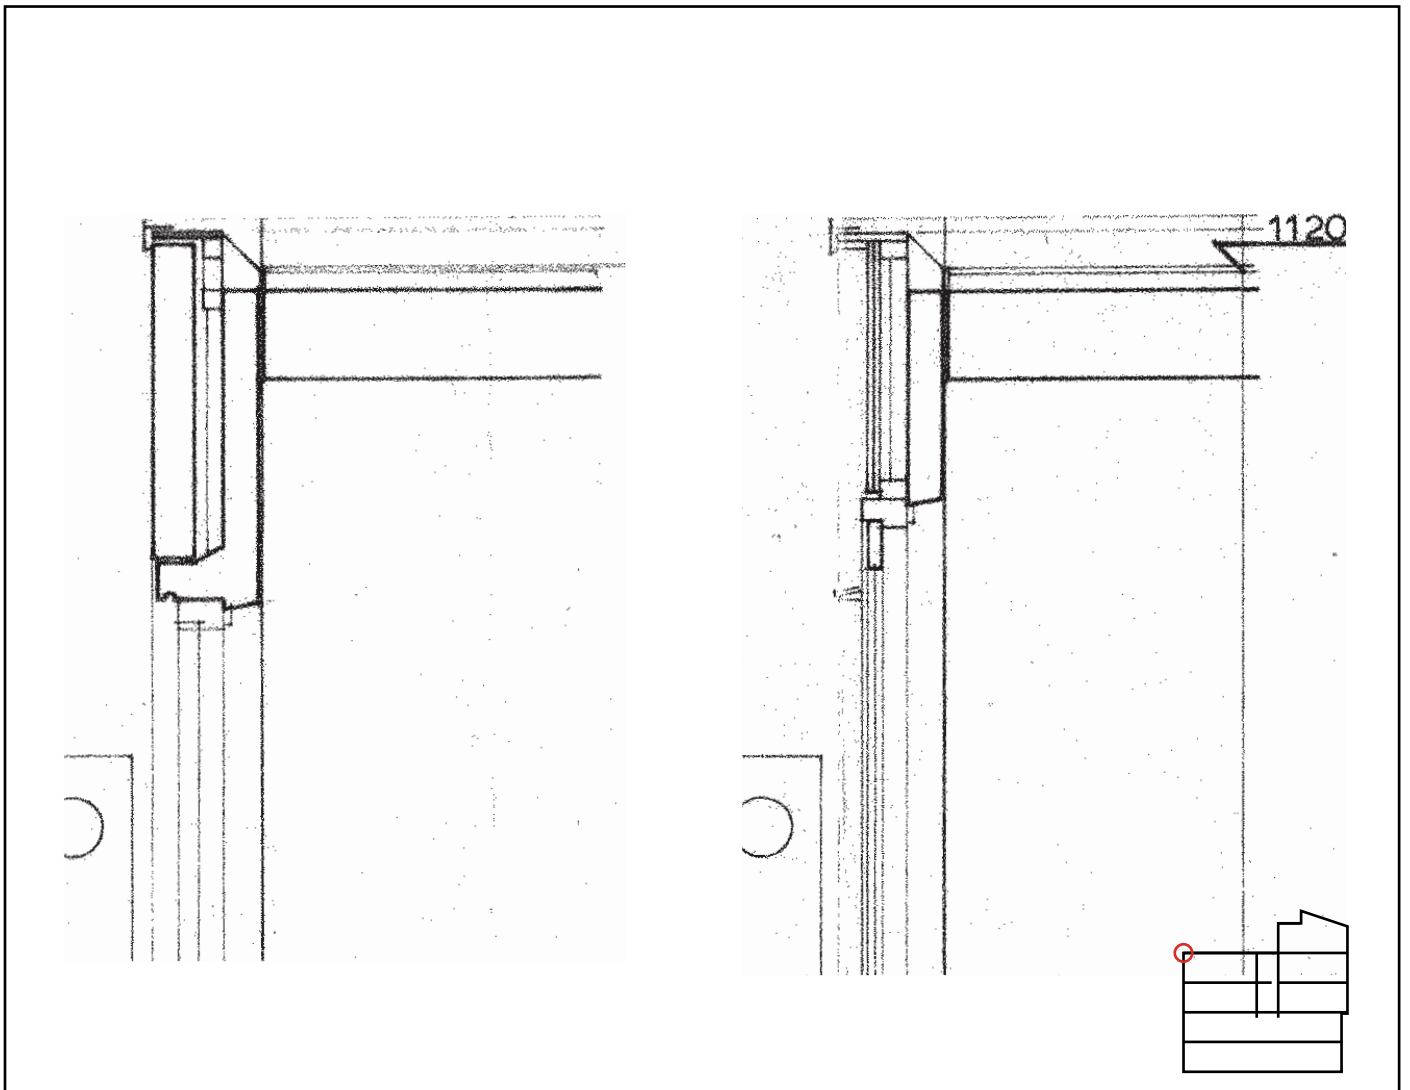
DETAIL 4

Flat roof

Significant change drawing and construction

This detail shows the connection of the roof to the facade on the south-west side of the building. Originally this detail had 2 variations, one with brickwork and one with panels as the facade exterior finish. This last variant however, is not present in the mid-rise building of Hoptille. While comparing the brickwork detail with the pictures of the facade it turned out that there was one major difference in the two. The detail shows that the final facade should show a concrete strip right above the windows on this floor, when looking at the picture it becomes clear that this has been changed in the process. The updated detail shows how we suspect that the current facade is built.

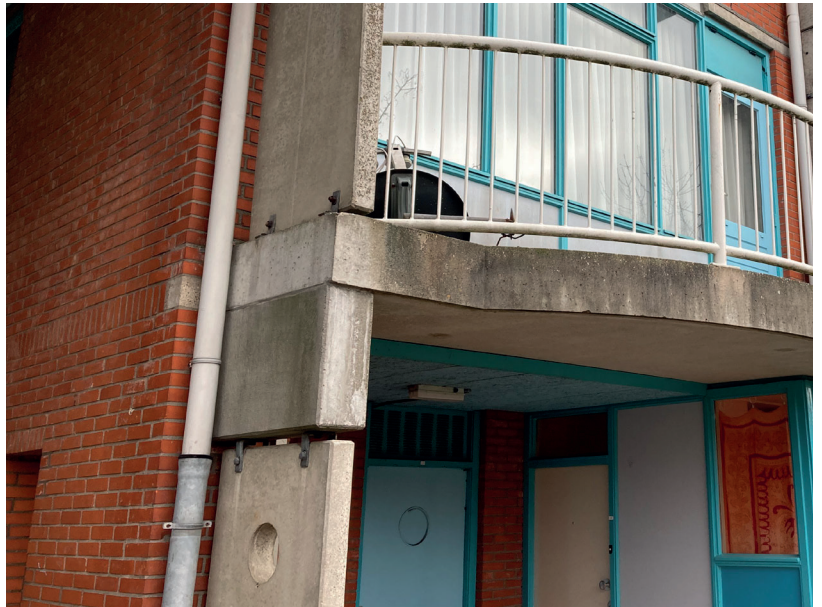
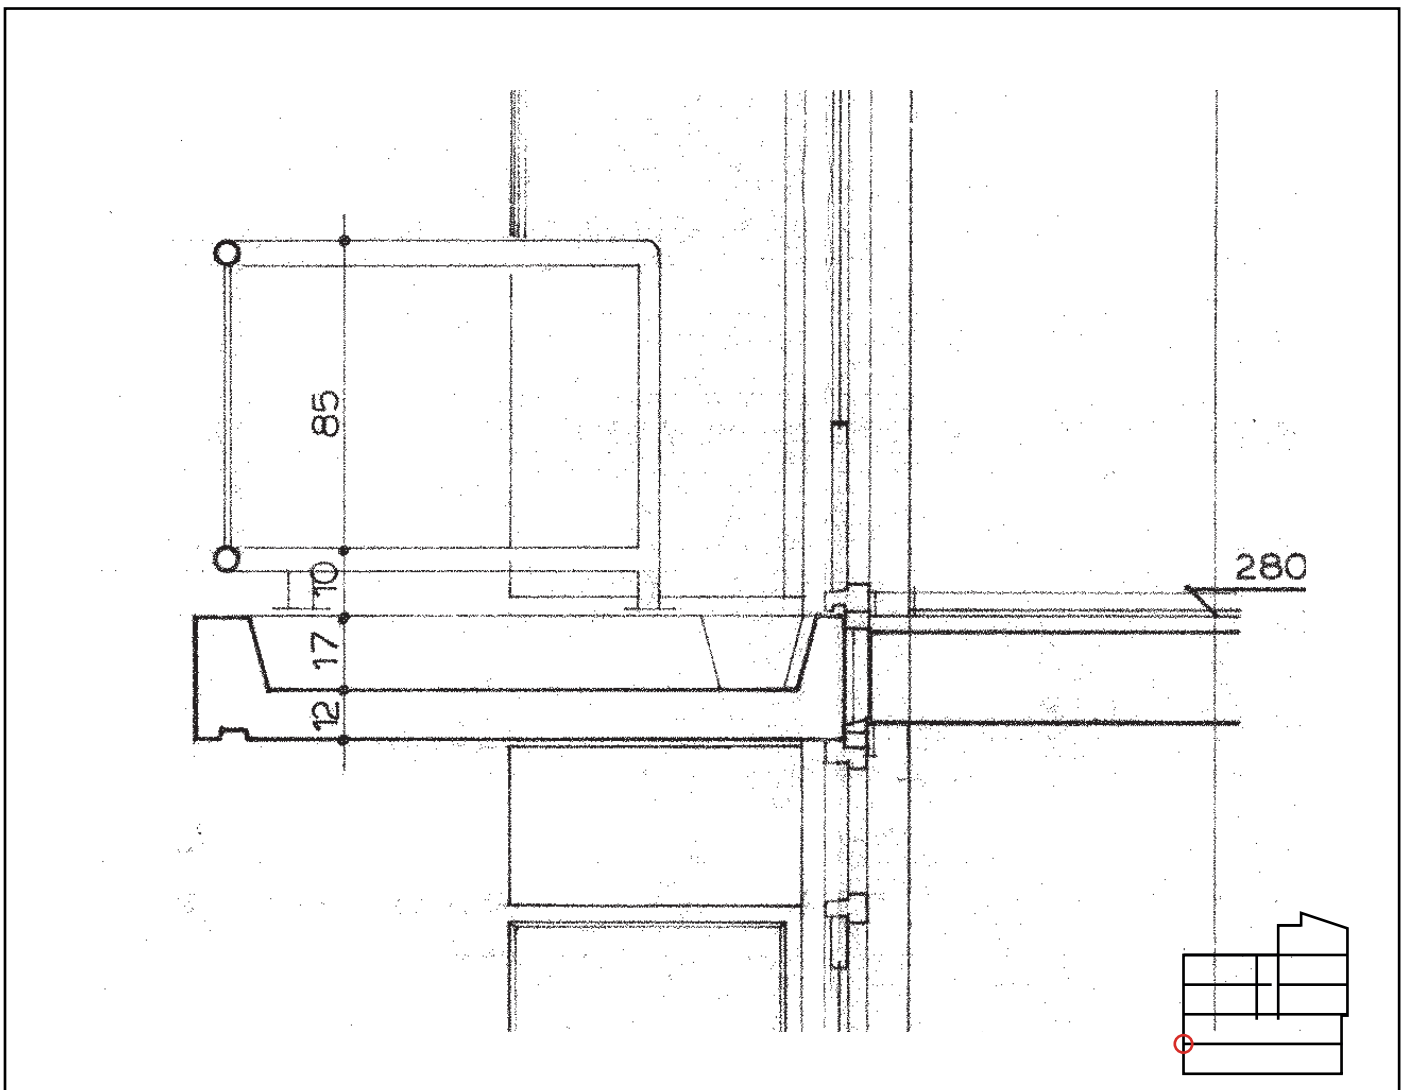
DETAIL 5

Balcony/floor, 1st floor

Prefab balcony on consoles,
meeting the concrete floor and
facade window frame.

The facade is made of wood window frames spanning from floor to floor. And the balcony is made of prefab elements, resting on the consoles sticking outside the facade. These consoles are connected to the bearing walls and thus puncture the thermal line of the facade.

The balconies themselves must have some way of draining rainwater near the facade side, since there is no visible path to drain that surface on the front side. The drain pipes in some cases even go through the interior of the building.

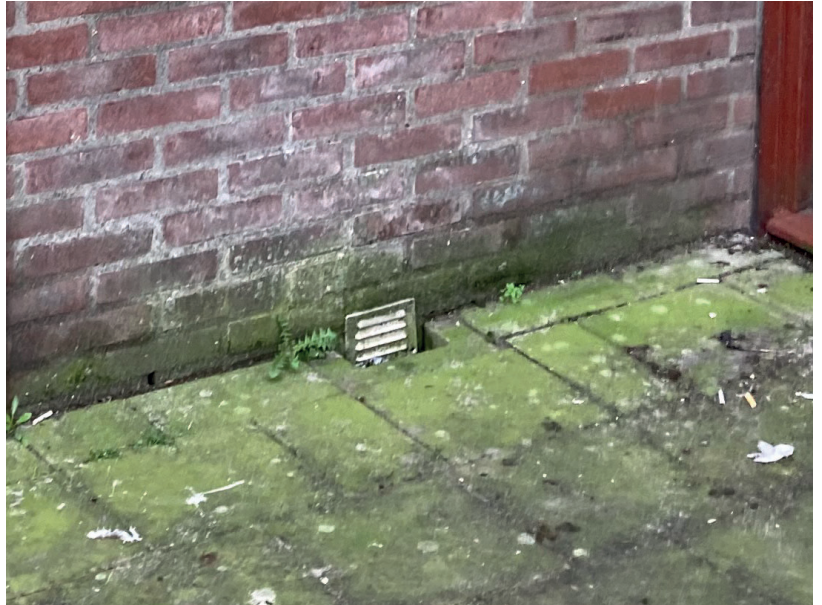
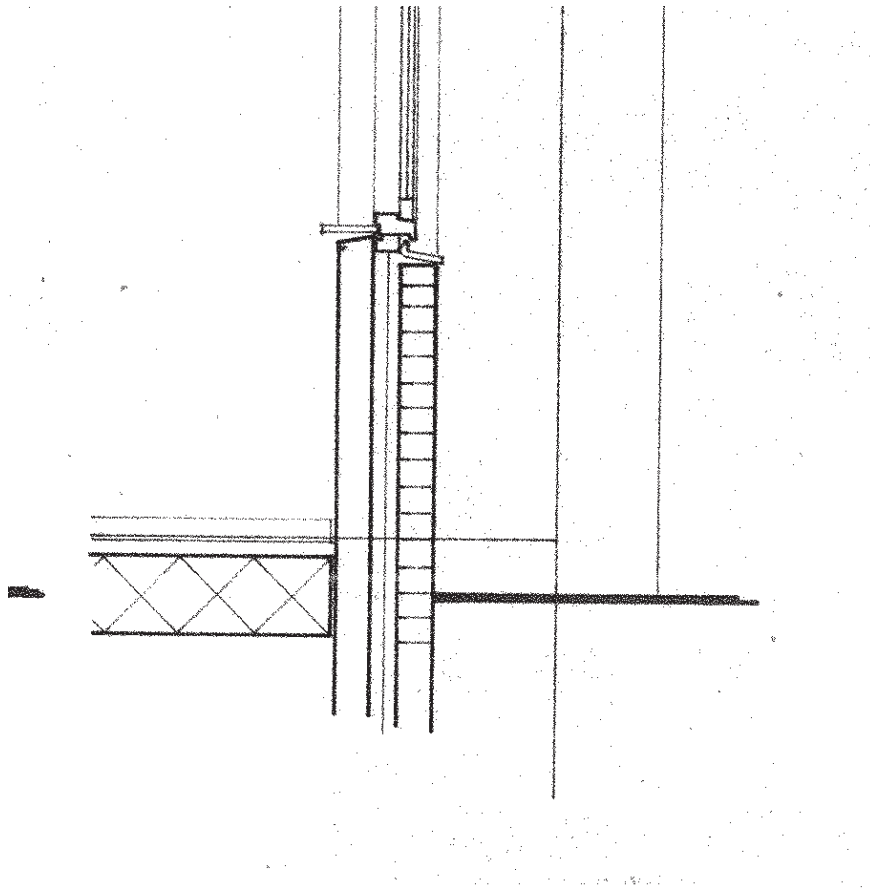
DETAIL 6

Ground floor

Connection between foundation, beam and block floor and precast concrete facade

The original drawing does not show the detail as it has been constructed. Some features are not shown on the drawing, such as the ventilation shaft, as shown in the photograph, which is used to ventilate the crawl space beneath the building.

show the actual connection between the facade and the ground floor, as the drawing is quite abstract. A standard drawing supplied by the contractor creates a better understanding of the connection, even though the facade in this drawing does not match the facade of the building.
