# The fire safety of car parks

# Focussing on structural damage

# K. Terlouw

Delft, October 2019

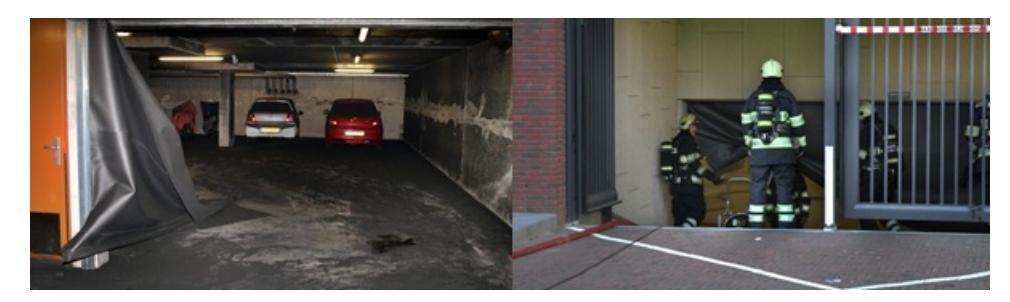
Figure 2.20: Fire curtains applied in Kanaleneiland in Utrecht. The fire department needed to demolishes the fire curtains to localise the fire [76].

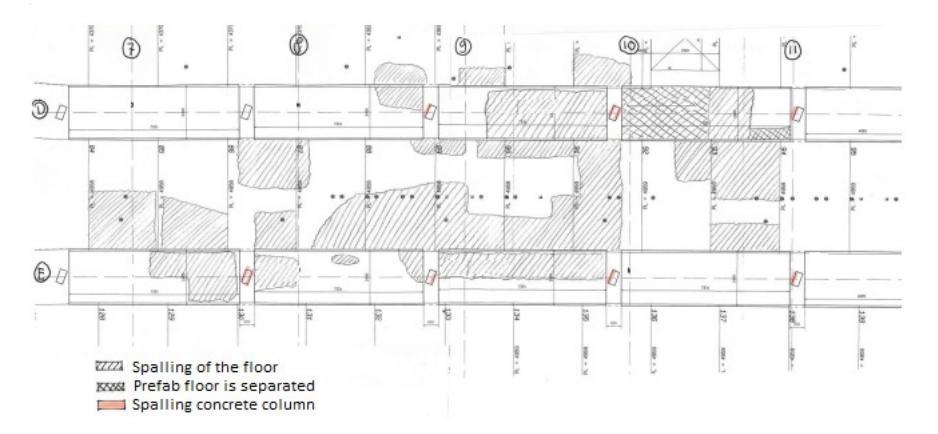
Figure 3.3: Enlargement of the area with structural damage of the Appelaar car park (red box, figure 3.2). The spalling damage is highlighted.

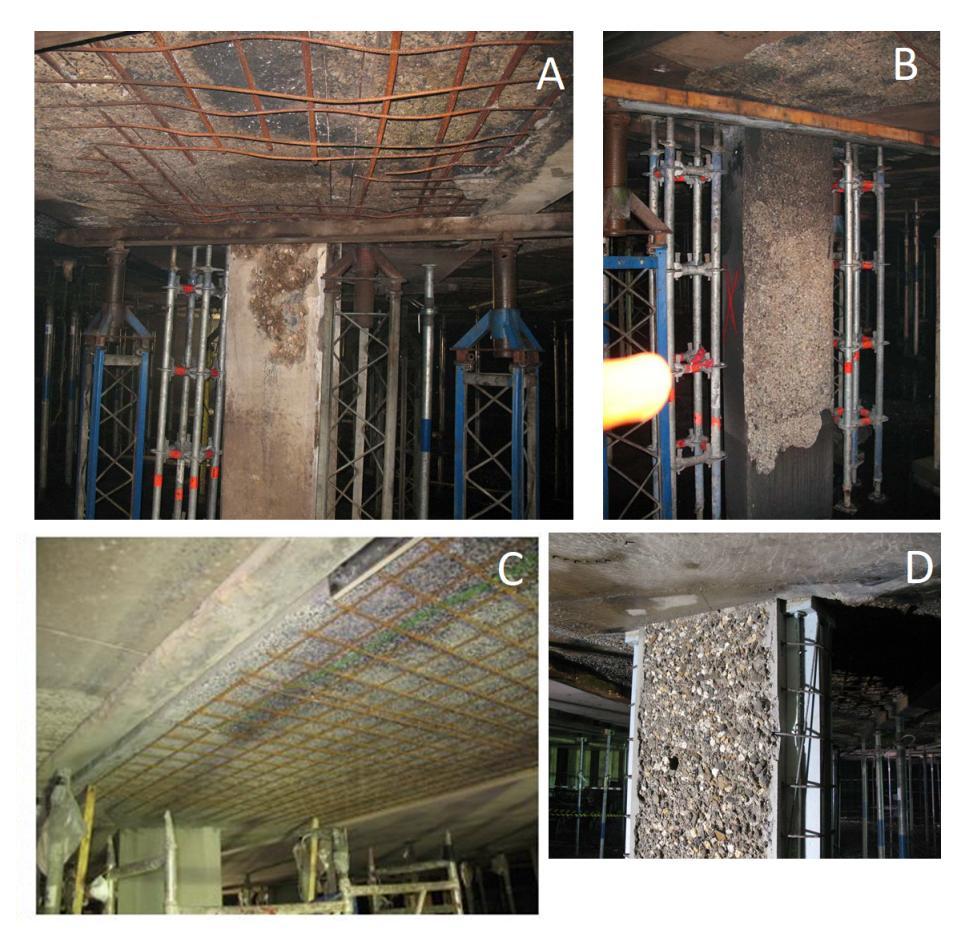
Figure 3.4: An overview of the damages and repairs in the Appelaar car park. Figure A shows spalling damage of the beam, the reinforcement is exposed. Figure B shows spalling damage of the concrete column, reinforcement is not visible. Figure C shows how the beam is repaired, an extra steel mesh applied. Figure D shows how the column is repaired, two extra steel columns are placed on both sides.

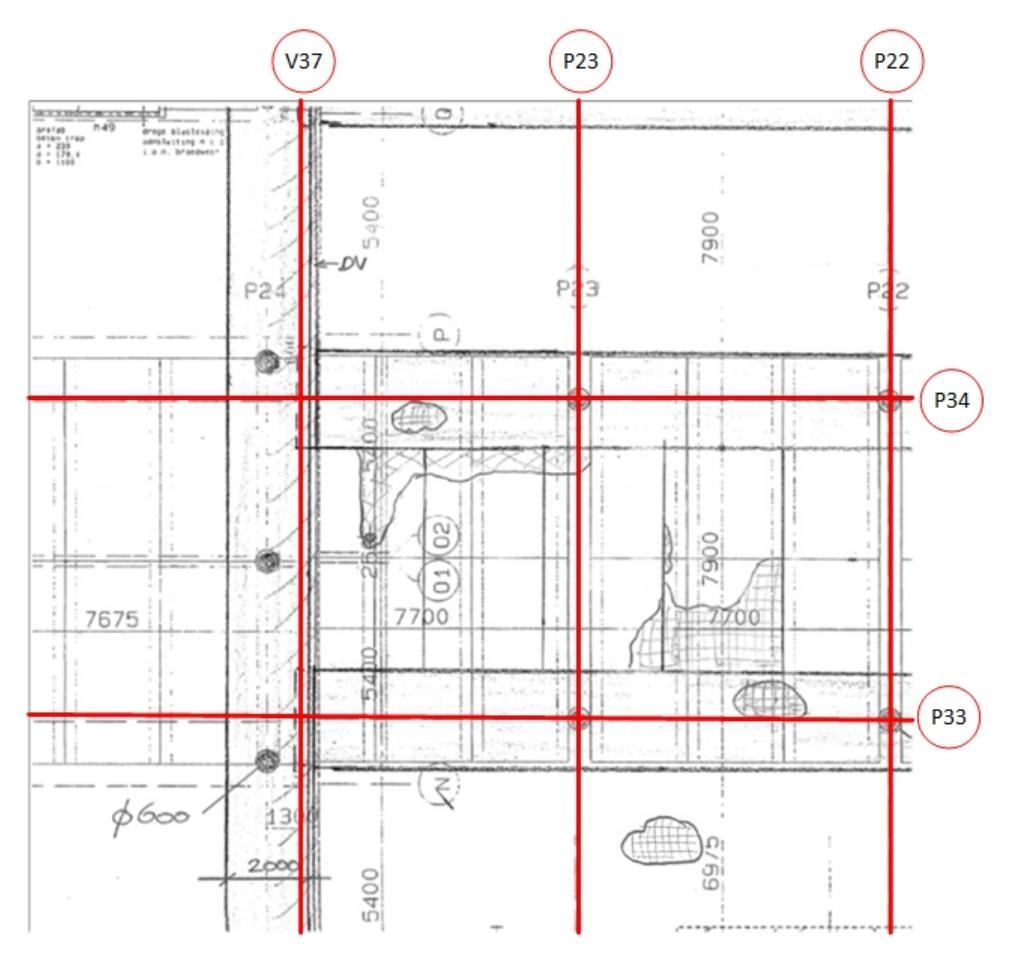
Figure 3.8: Overview of the structural damaged, the highlighted areas are spalling damaged. Between P22-P23 and P34-P33, the reinforcement of the floor was hanging from the ceiling.

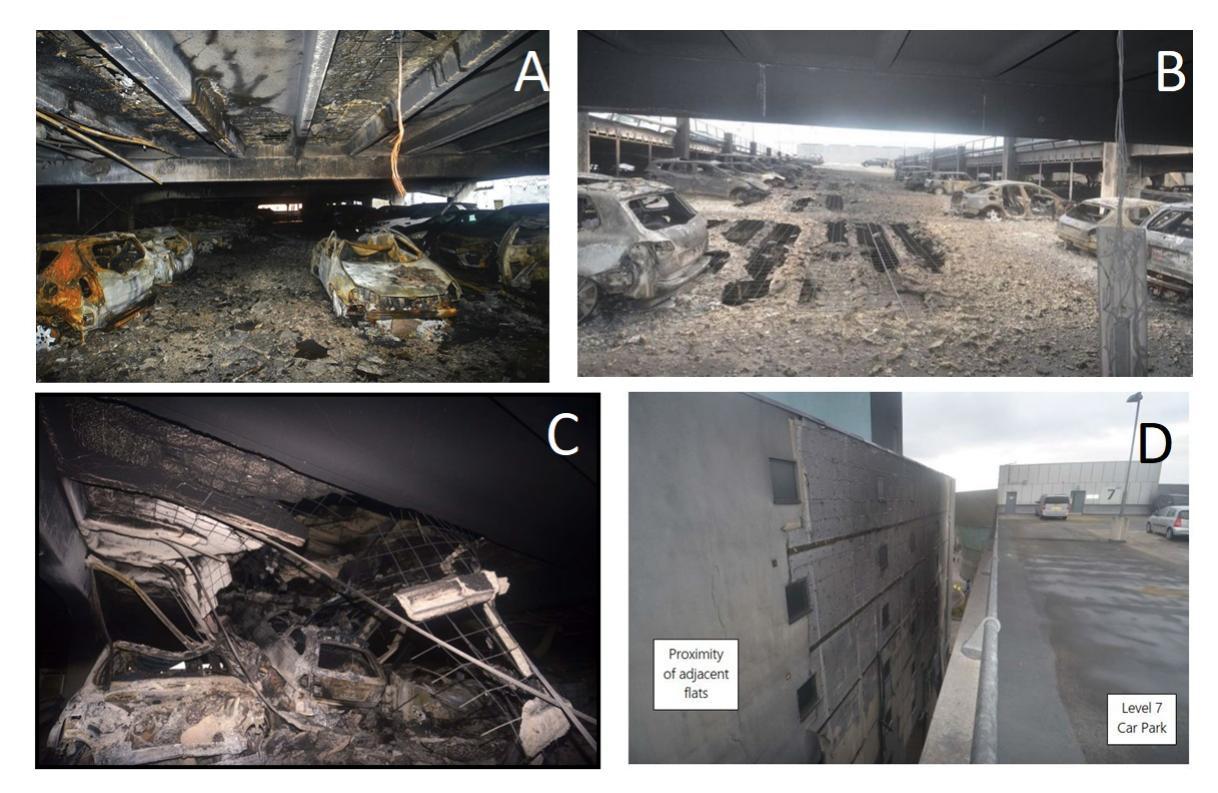
Figure 3.13: The damage in the car park self and on the surrounding buildings. Figure A, B and C show spalling damage in the car park. Figure D shows damage to the adjacent building due to the fire in the car park.

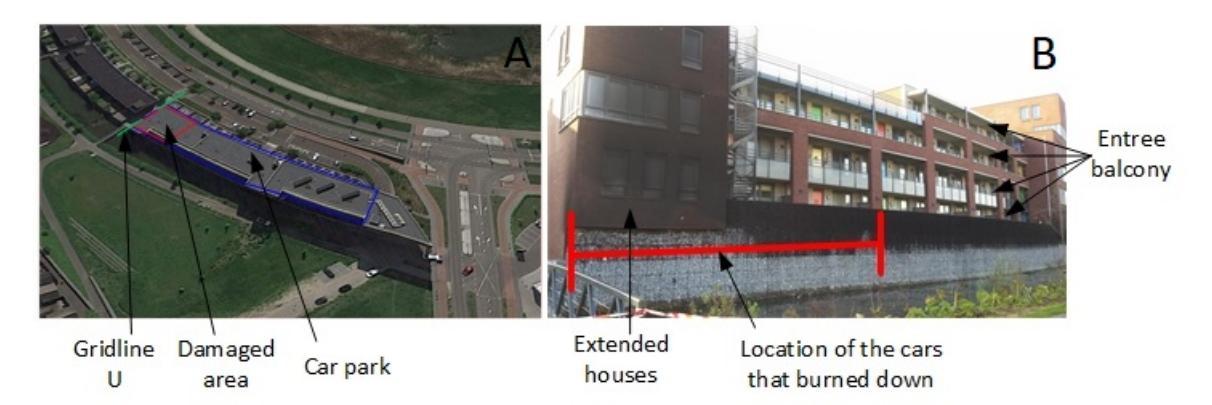
Figure 3.14: Figure A is an overview of the building and the surroundings. The damaged area is indicated with the red box and the complete car park is indicated with a blue box [28]. Gridline U is used as a reference line for other figures. Figure B is the Goudbaard car park from the side. The steel gabions with the stone can be seen on this figure, smoke damage can be seen on these gabions [44].

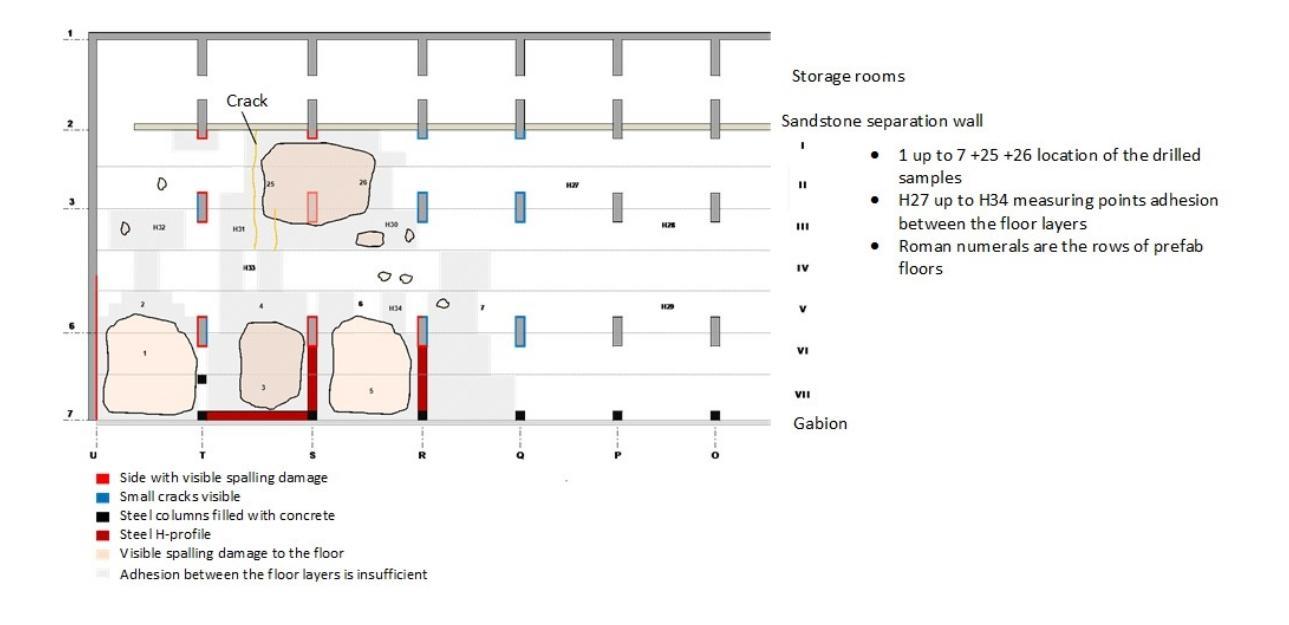
Figure 3.16: Overview of the damage in the Goudbaard car park [33].

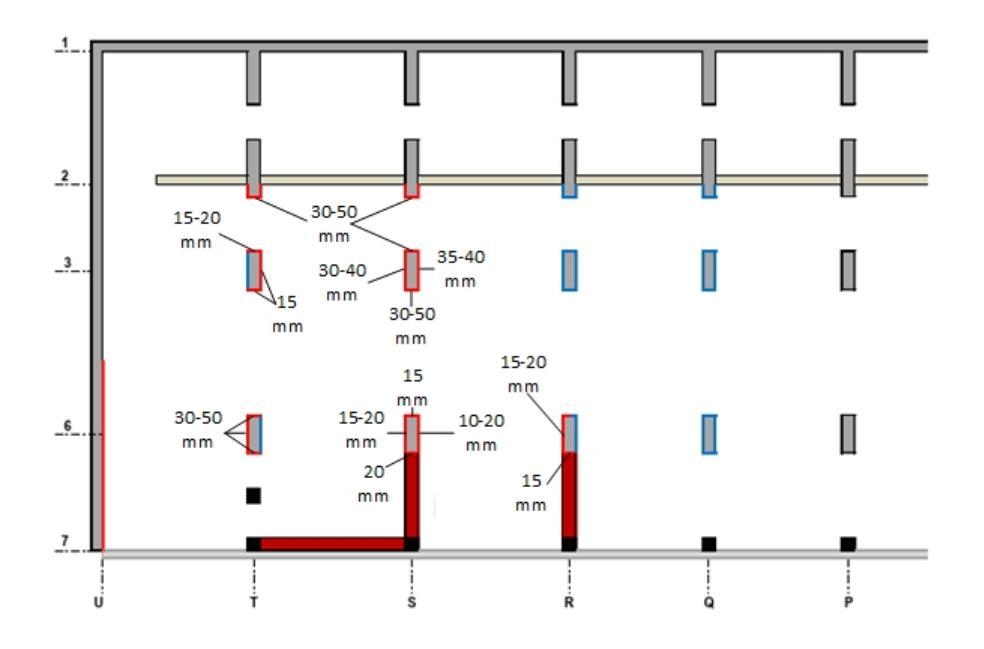
Figure 3.17: Overview on the spalling depth on the columns in the Goudbaard car park [32].

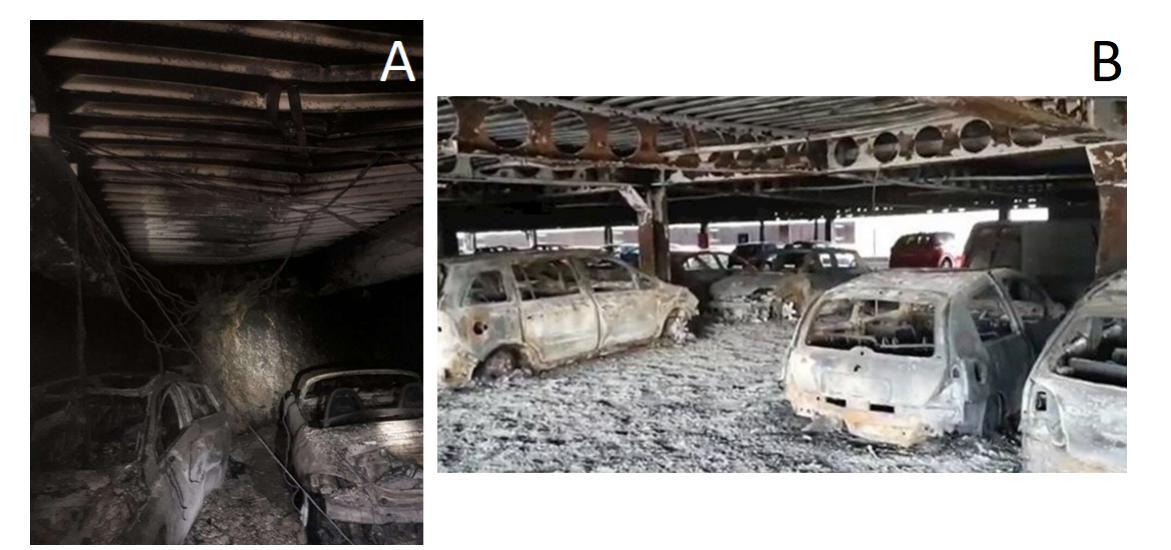
Figure 4.5: The damage of composite floors as result of a car park fire. Figure A is the damage of the fire in Bordeaux [27]. Figure B is the damage of the fire in Cork [20].
