Effect of Kinetic Energy due to Hail Impact on Damage Evolution in Gelcoated Glass Fibre Reinforced Polymer Composite

AE5711: Thesis Aerospace Structures and Materials Saran John Vaseekaran

Thesis committee:Dr. ir. C.D.RansTDr R.M.GrovesTDr ir J.J.E TeuwenTProject Duration:March 2022, - January , 2023Faculty:Faculty of Aerospace Engineering, Delft

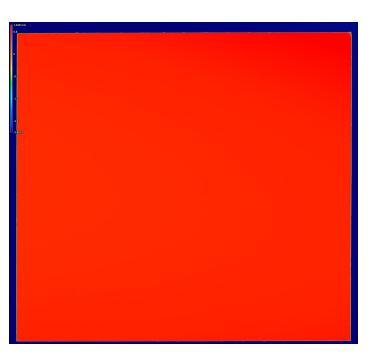
Figure 4.8: Height profile of A7 post 10 impacts

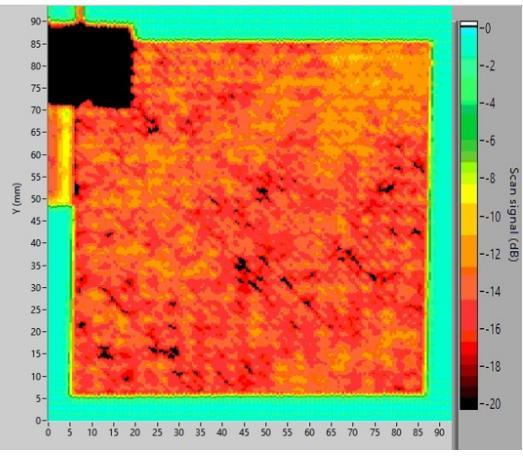
Figure 4.12: C-scan images of sample B10 impacted with 18 mm SHI at 100 m/s (10 impacts)

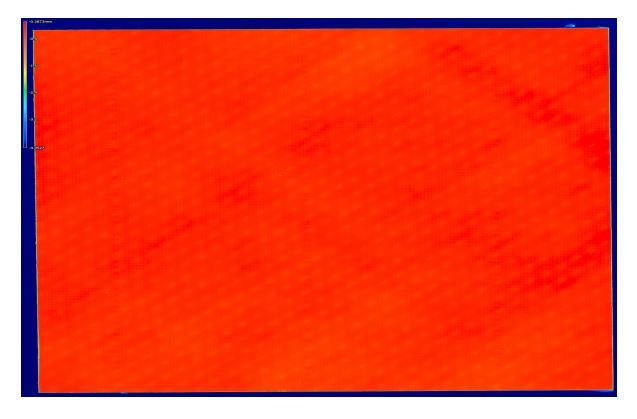
Figure 4.13: Height profile of A10 sample impacted with 20mm SHI at 90 m/s(after 10 impacts)

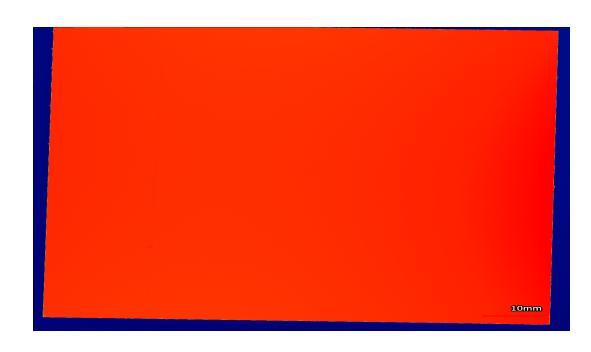
Figure 4.15: Height profile of A5 sample impacted with 15mm SHI at 160 m/s (after 10 impacts)

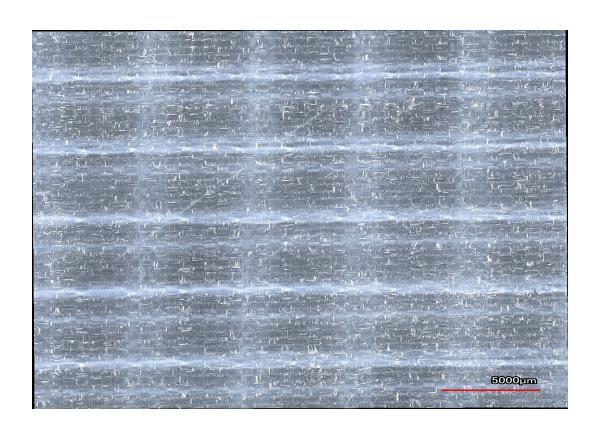
Figure 4.16: Matrix crack a observed from back of the sample under Keyence VK-1000x Laser Microscope for sample after 10 impacts with an 18mm SHI at 140 m/s

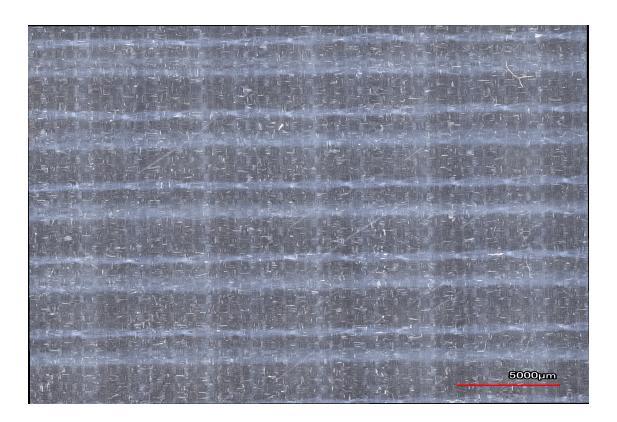
Figure 4.17: Matrix crack observed from the back of the sample under Keyence VK-1000x Laser Microscope impacted at 90 m/s with 20mm SHI(after 10 impacts)

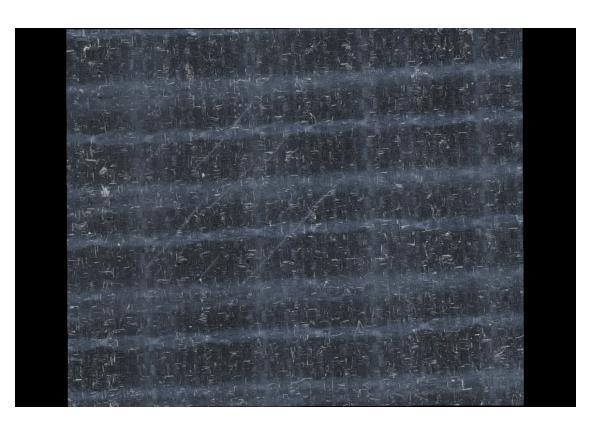
Figure 4.18: Matrix crack observed from the back of the sample under Keyence VK-1000x Laser Microscope impacted at 160 m/s with 15mm (after 10 impacts)

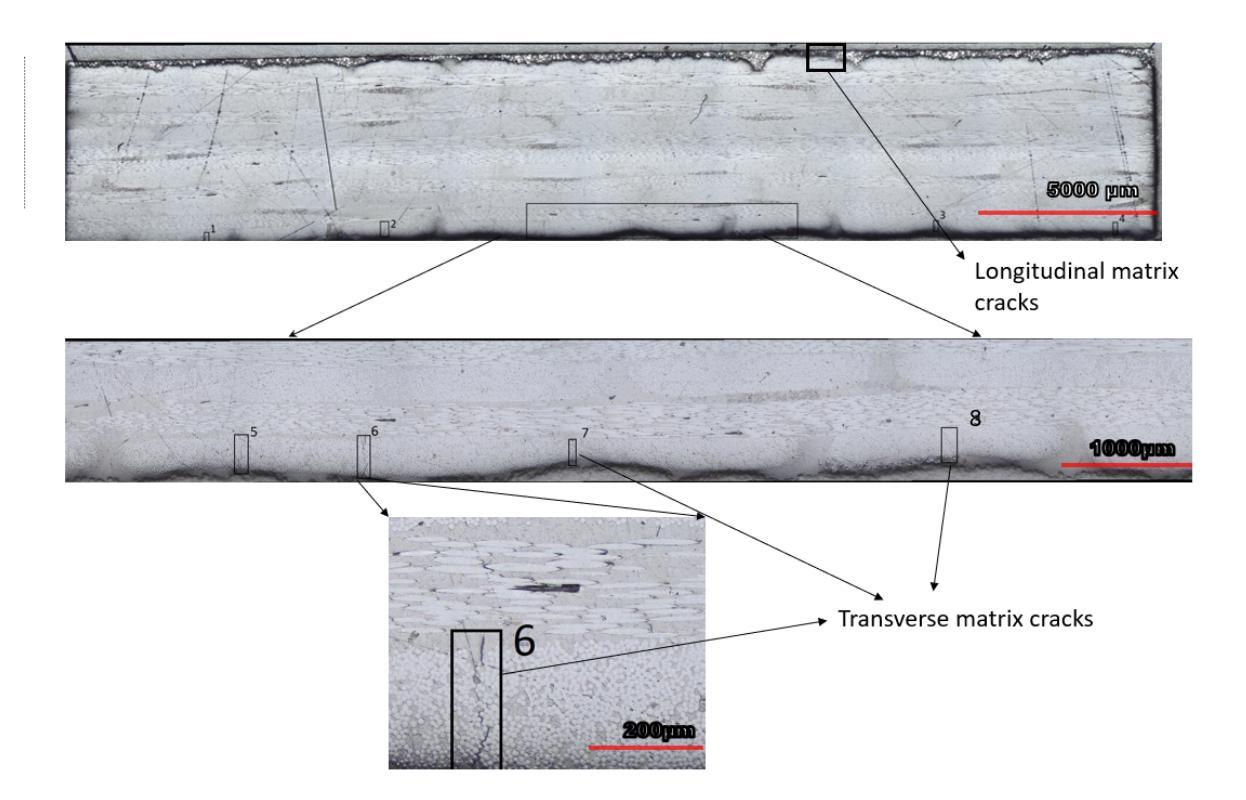
Figure 4.21: A step by step high resolution image of the matrix crack observed in sample B6 impacted with 15mm SHI at 160m/s

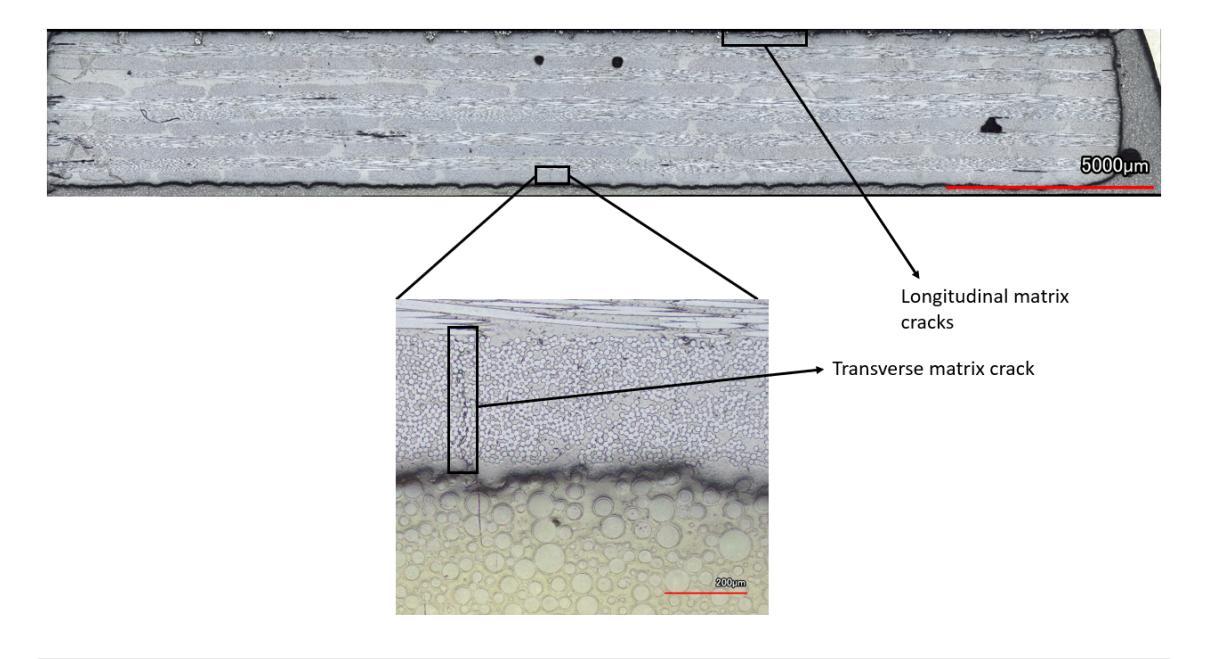
Figure D.1: Cross-sectional view of sample B4 subjected to 10 impacts 15 mm hailstone at 150m/s

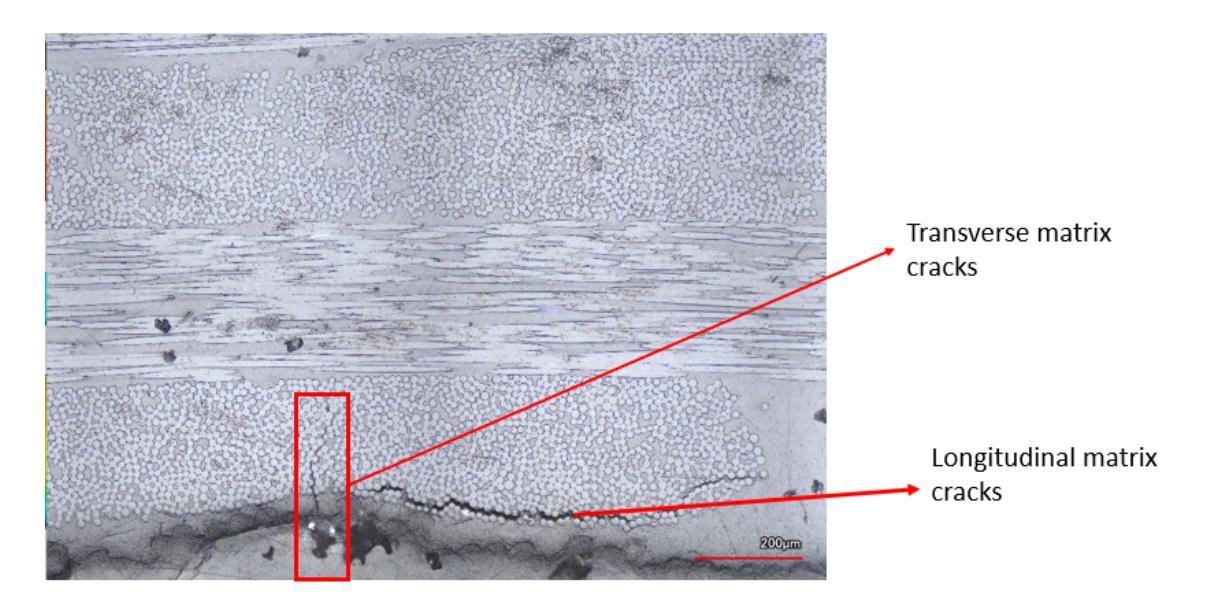
Figure D.3: Cross sectional view of sample B5 subjected to 10 impacts with impact 18 mm hailstone at 110m/s

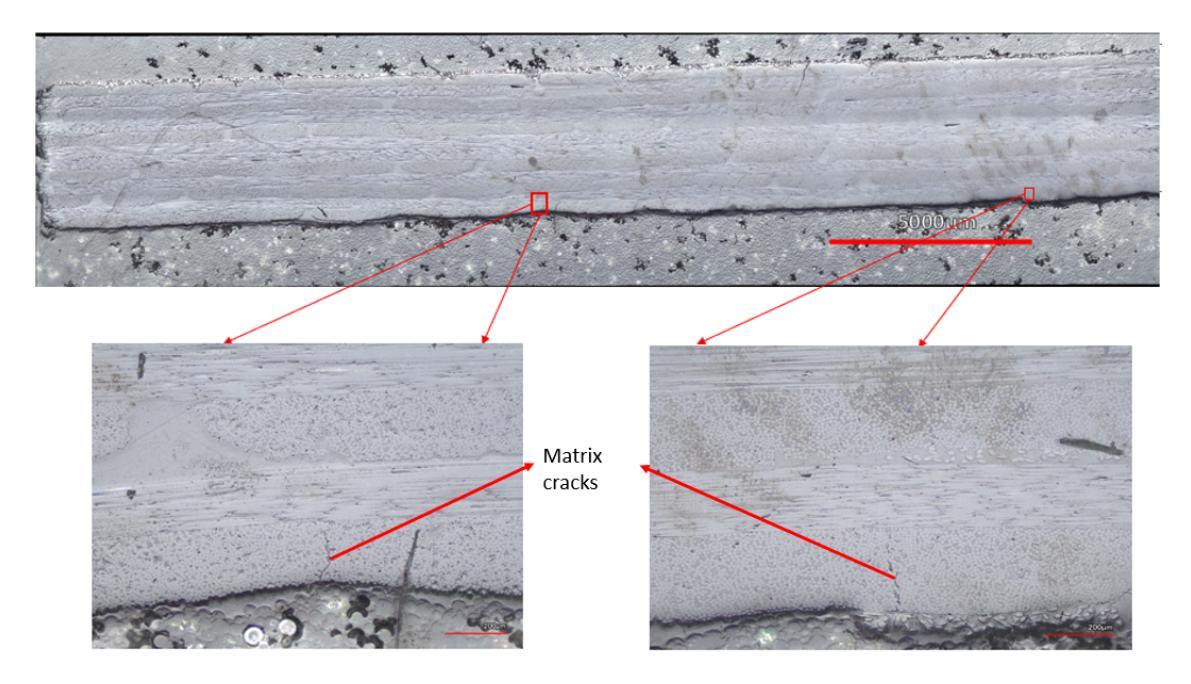
Figure D.5: Cross sectional view of sample A10 view subjected to 10 impacts with 20 mm hailstone at 90m/s
