MAISON DE LA MISERICORDE
RESEARCH BOOKLET

Floor Visser
4345053
Master track Architecture
Studio: Heritage and Architecture
Graduation tutors: prof. ir. Wessel de Jonge, ir. Lidy Meijers,
ir. Frank W.A. Koopman, ir. Bert van Bommel
Delft University of Technology
19-05-2017

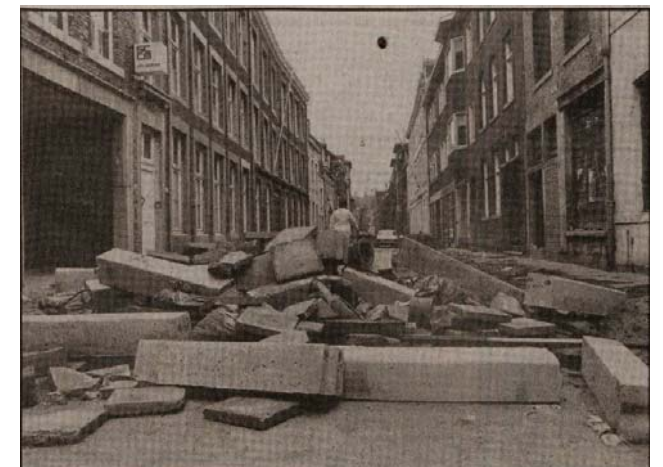
Figure 52. Damage after the squatters had a farewell party

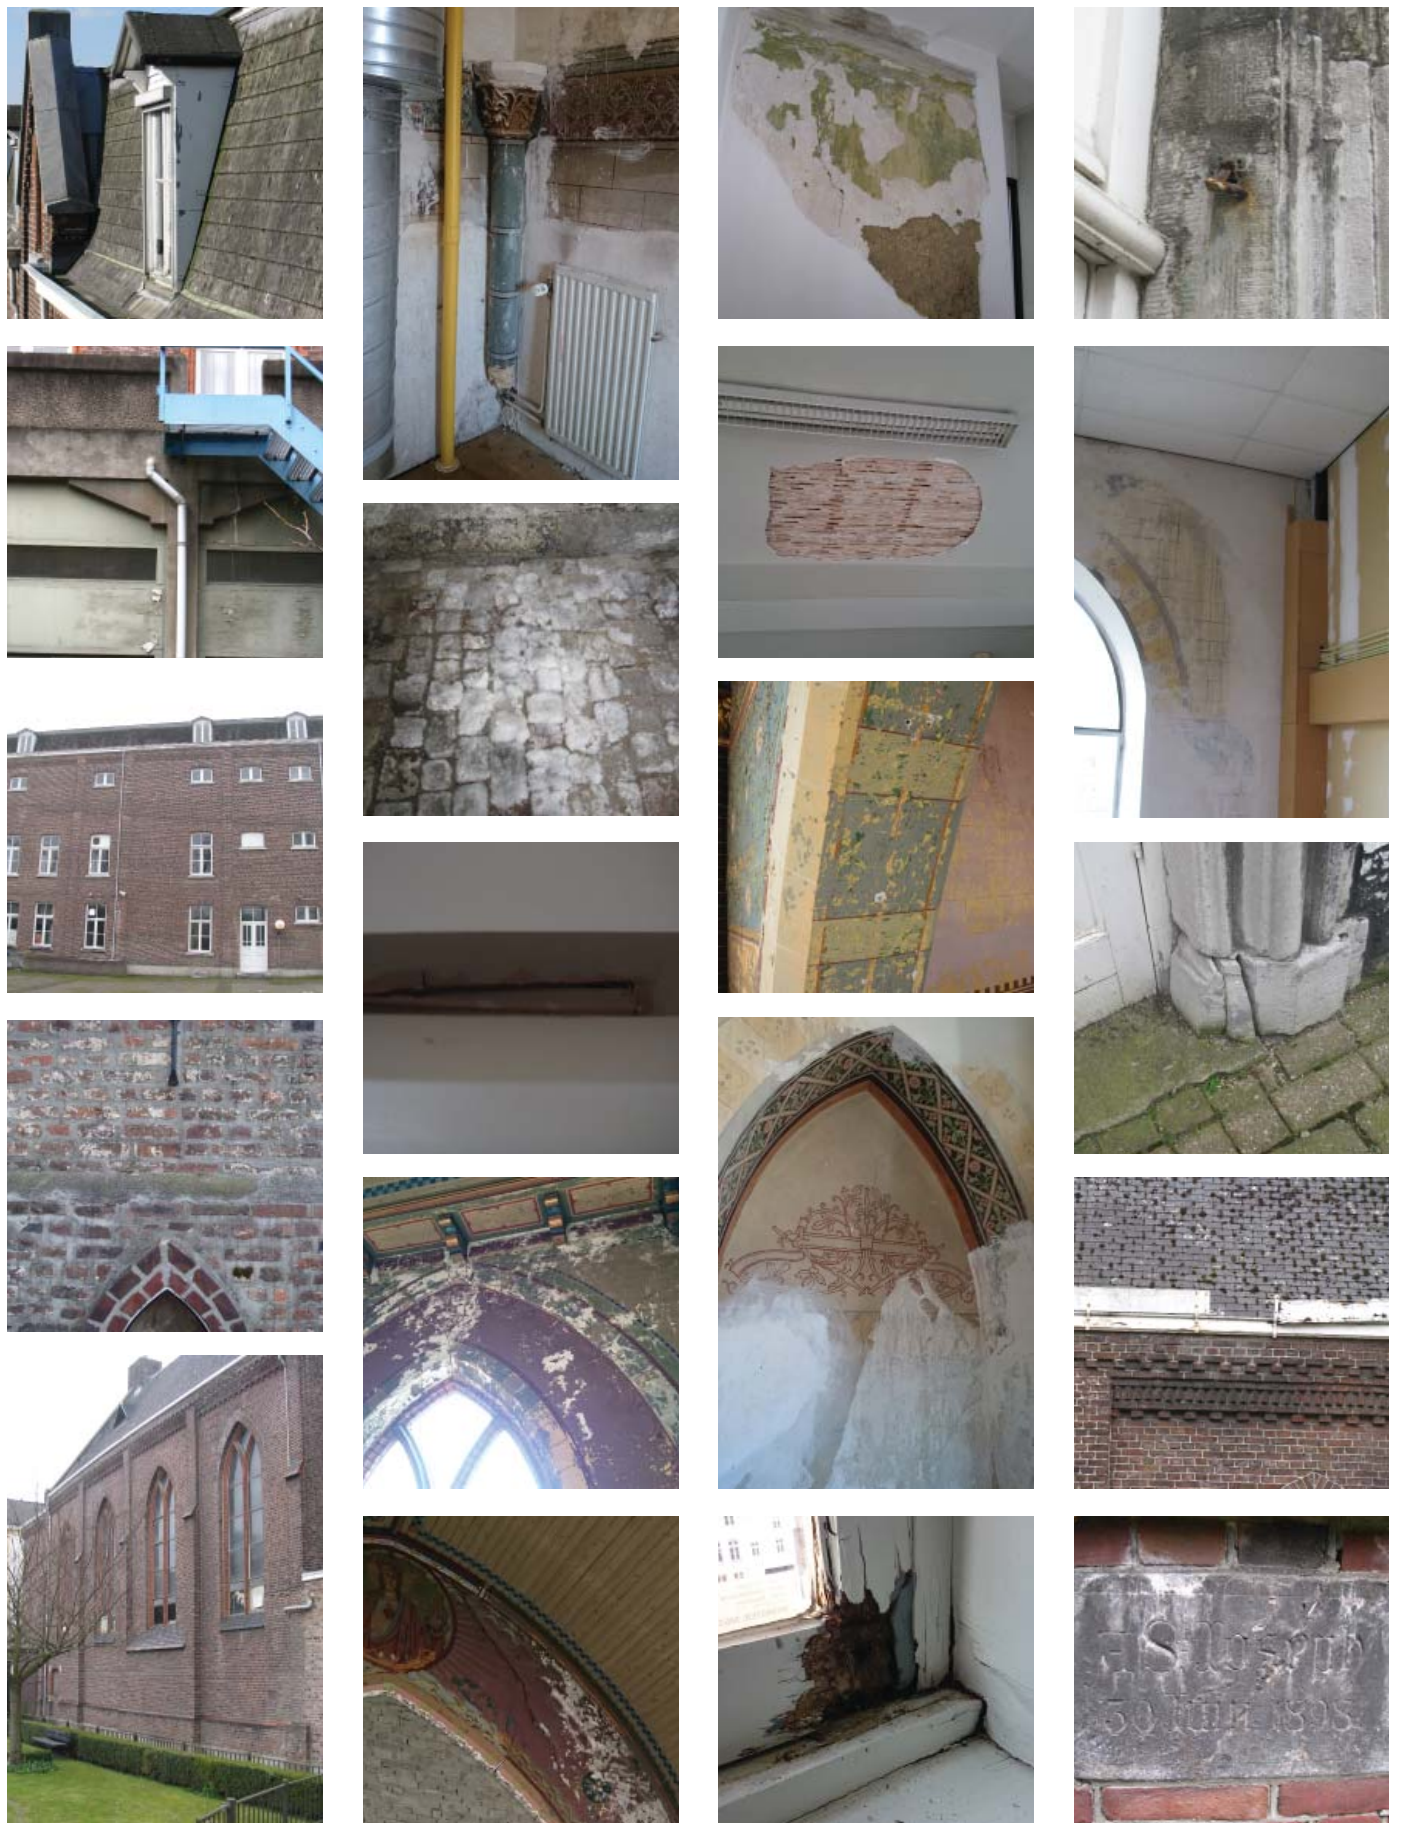
1. Cracks

It is quite common for older buildings to possess a (larger) amount of small cracks in the load bearing walls. Therefore it is not surprising that the building complex has an innumerable amount of these.

However, there are some extensive cracks present in the Laymen's chapel. The south facing wall and the wall that divides the nave and the choir in particular are in bad shape, this will be explained further on.

The efflorescence of salt can be found in more places than one but is most abundant in the cellars of the Capucijnenstraat wing, the salt efflorescence lies thickly on these floors.

4. Dry rot (wood)

Along the whole complex some of the wooden window frames are subjected to dry rot. The gutter of the Laymen's chapel is also in a bad shape due to wood rot, as can be seen from the inside as well as outside the building.

5. Corrosion (and expansion because of it)

A lot of the natural stone window frames have had shutters in the past. The steel connections in the natural stone have begun to rust through their contact with rainwater.

6. Damage done by renovation(s)

A big part of all the damages that can be found along Maison de la Miséricorde has been done by human hands. Some of the greater damages are for example: The paintings in the Laymen's chapel as well as the Sisters' chapel have been painted over. The vaults of the Sisters' chapel has been removed in the recent past to make place for steel beams and columns. Unfortunately there are many more examples.

Figure 170. Several degradation processes can be found in Maison de la Miséricorde

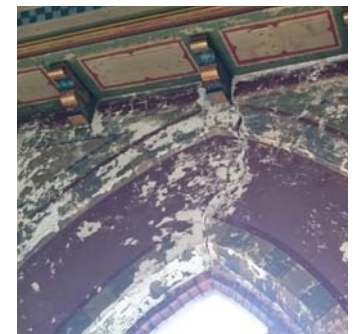
Missing this vital connection, the walls of the chapel began to expand/bulge outward. This is shown in figure 172. The expansion/bulging of the walls caused major fractures in the load-bearing walls and in the wall between the nave and the choir.

Figure 173. Crack in load-bearing wall

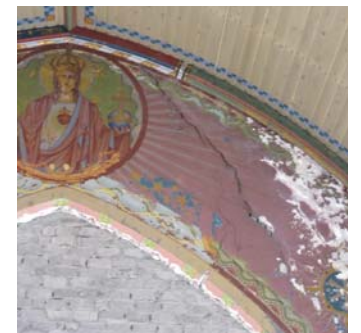
Figure 174. Crack in wall between nave and choir

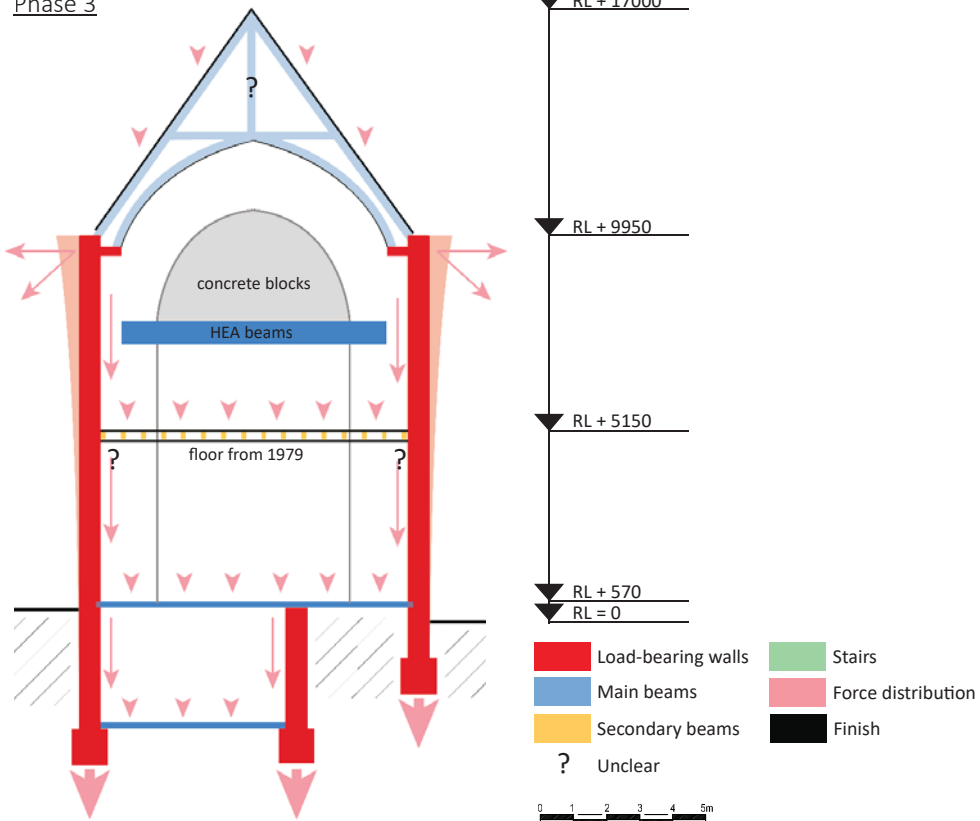
Phase 3

Figure 175. First repair attempt

Around the period of the redevelopment of the convent in 1979 the biggest damages in the chapel were strutted, visualized in figure 175. Two steel HEA beams were added under the arc in the wall between the nave and the choir. Later the filled the space between the beams and the masonry with concrete blocks, ensuring the wall wouldn't collapse.

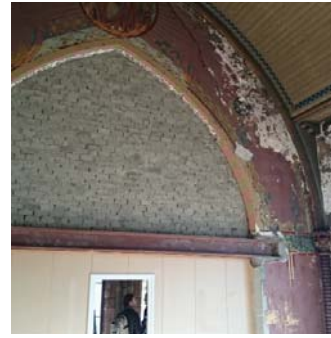
Figure 176. Damage control

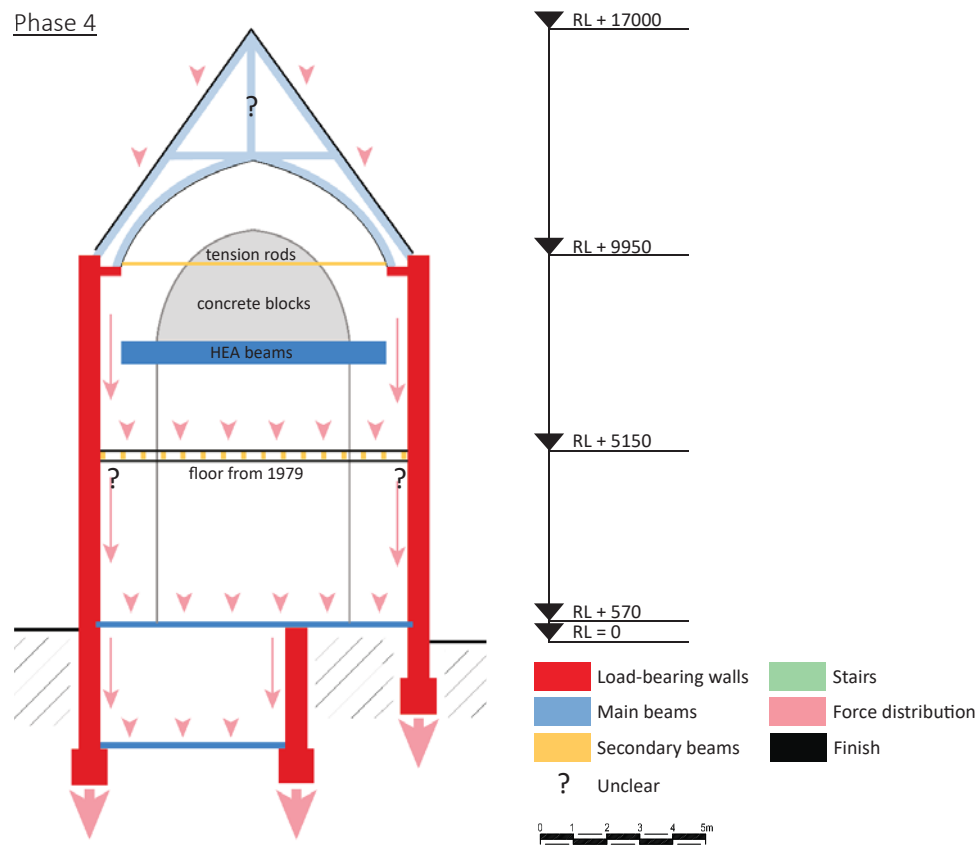
Phase 4

Figure 177. Present situation

The latest addition to the structure of the chapel are tension rods. These tension rods make the horizontal connection between the two load-bearing walls. In theory this would re-establish the balance of the force distribution of the walls. In practice, it is unknown whether the tension rods have actually done this.

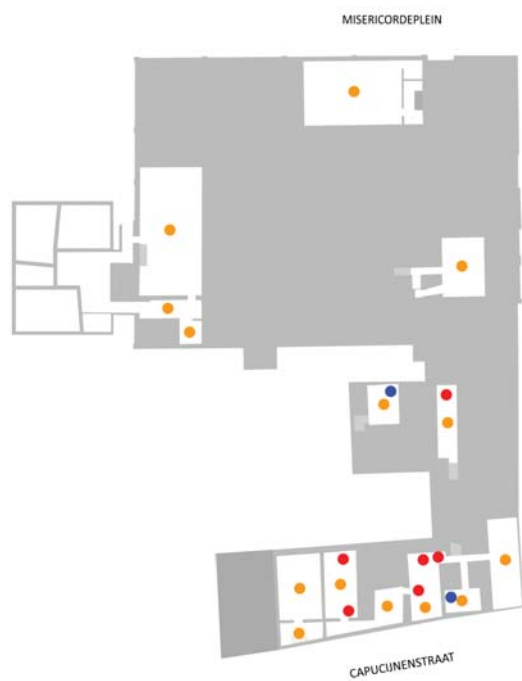
Figure 185. Cellars; Technical deficiencies

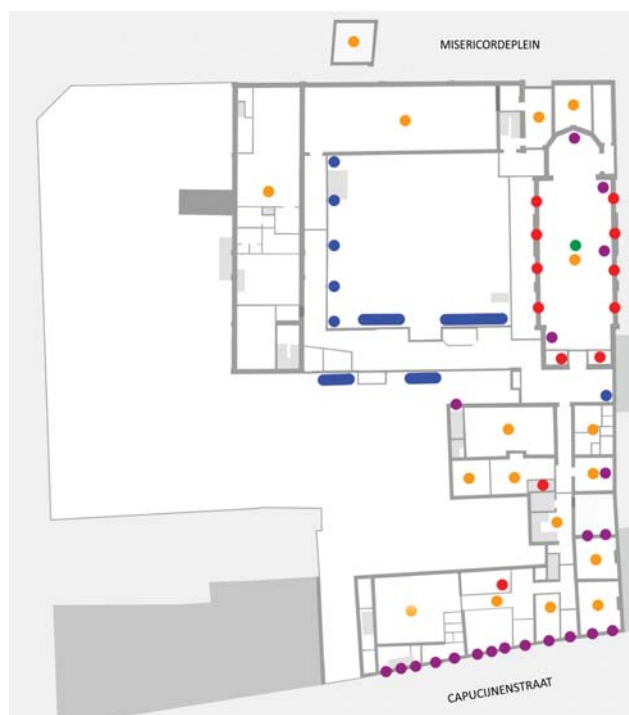
Figure 186. Ground floor; Technical deficiencies

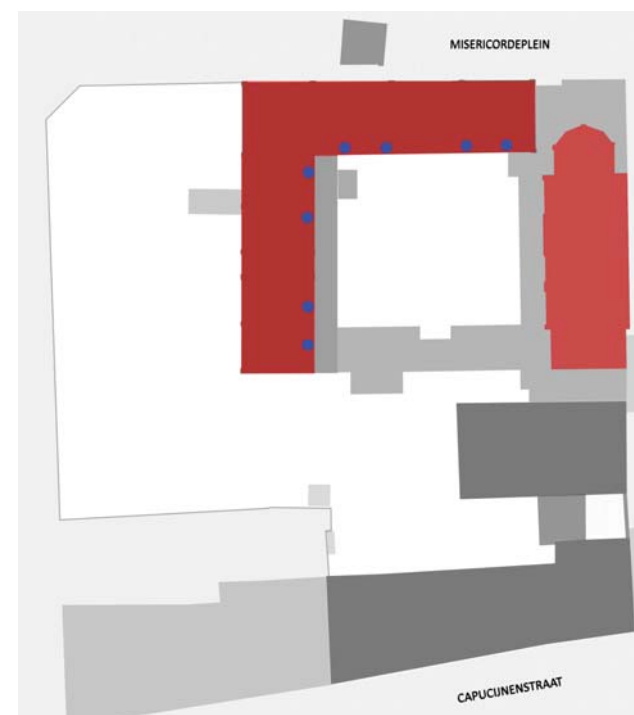
Figure 187. Roof; Technical deficiencies

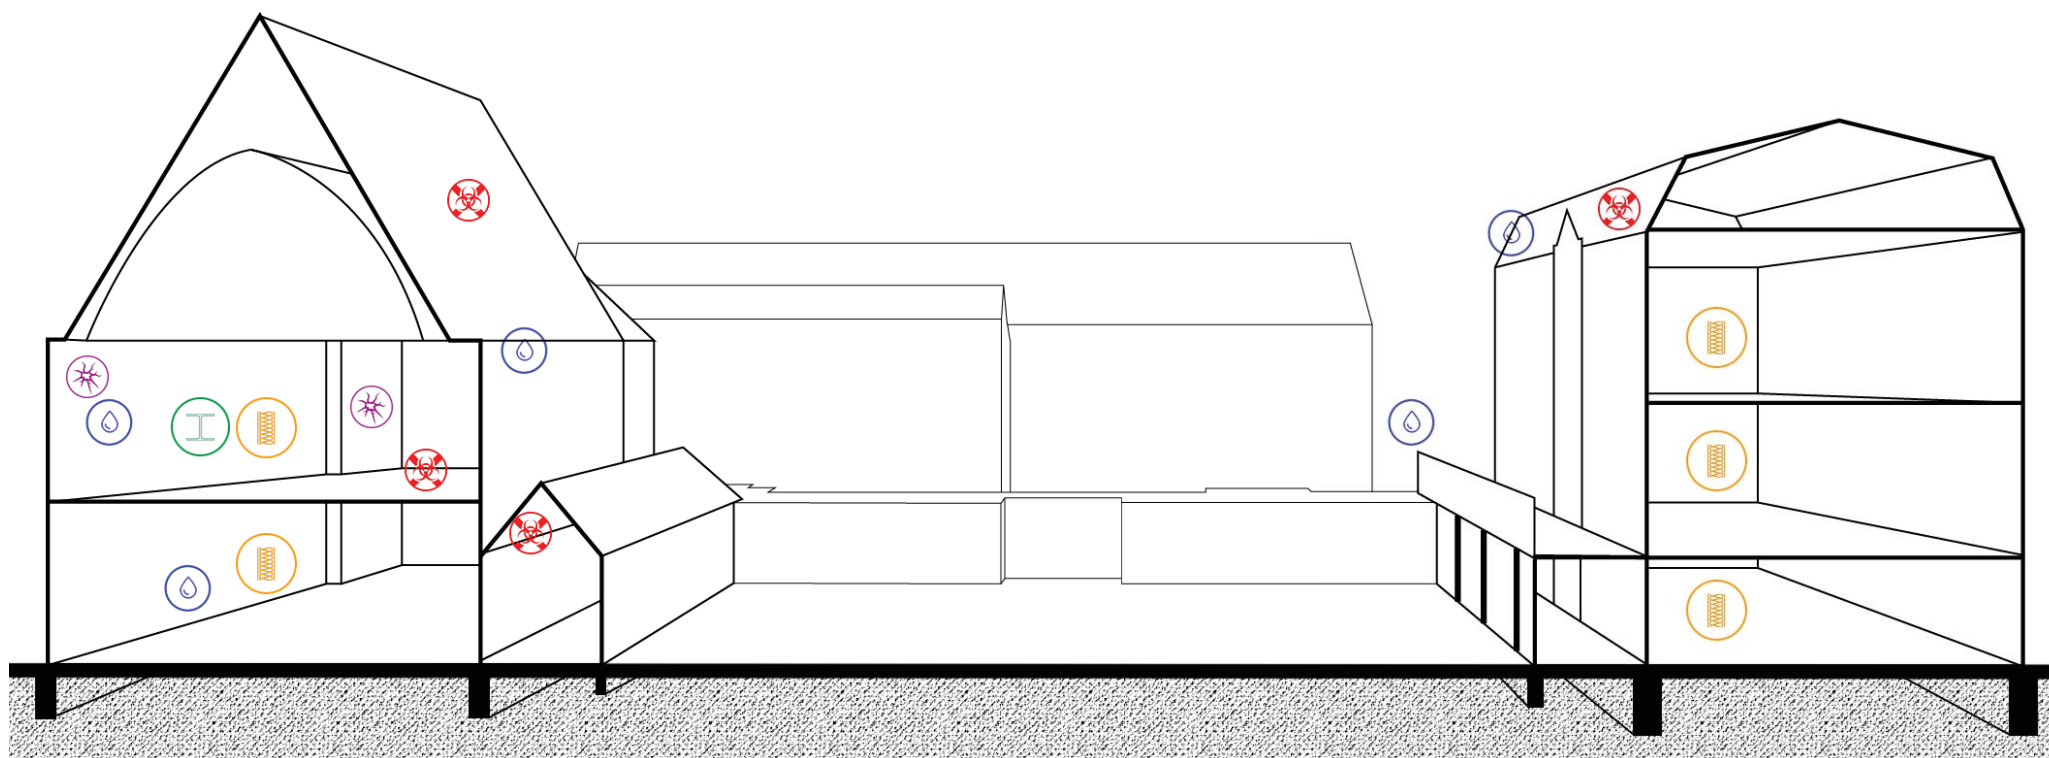
Figure 188. Section through Laymen's chapel and extension of laundry and ironing wing; Technical deficiencies
