## Assessing the structural integrity of the wax-resin lining of The Night Watch using 3D shearography

Tao, Nan; van Duijn, Esther; Vos, Lisette; Steeman, Ilse; Groves, Roger M.; Keune, Katrien; Noble, Petria; Anisimov, Andrei G.

Publication date 2025 Document Version Final published version Published in Journal of Cultural Heritage

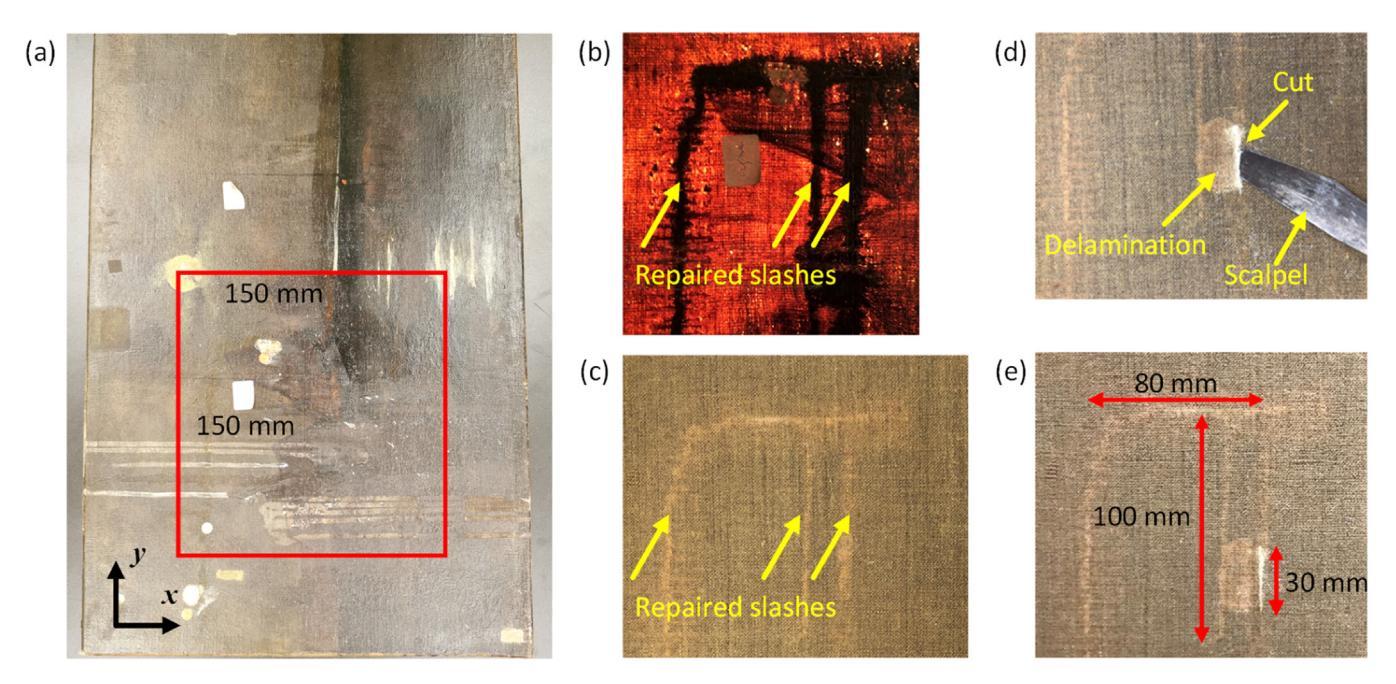
A transmitted light photo (Fig. 1(b)), taken by illuminating the back of the painting, highlights three parallel vertical slashes in the original canvas and one adjoining horizontal cut. The cuts in the canvas support of the test painting were joined together using thread 'bridges' dipped in a strong, rigid adhesive (epoxy resin) placed at small, regular intervals per cm. After drying and before

**Fig. 1.** The anonymous twentieth-century painting used for testing. (a) The test painting with the highlighted region of interest. (b) Transmitted light photo showing the repaired slashes using horizontal thread 'bridges'. (c) The reverse of the test painting before the intervention, (d) the intervention by a scalpel and (e) the cut and delamination. (b-d) horizontally flipped to match the photo in (a) directly.

relining, the threads would have been mechanically thinned with a scalpel. This painting was chosen as the tears in the canvas of the test painting have been repaired by using the same 'bridging' technique that was used to repair the slashes in *The Night Watch*. Like *The Night Watch*, the test painting was wax-resin relined with the second canvas. The repaired slashes are also partially visible through the lining canvas when observed from the reverse of the painting (Figs. 1(b,c)).

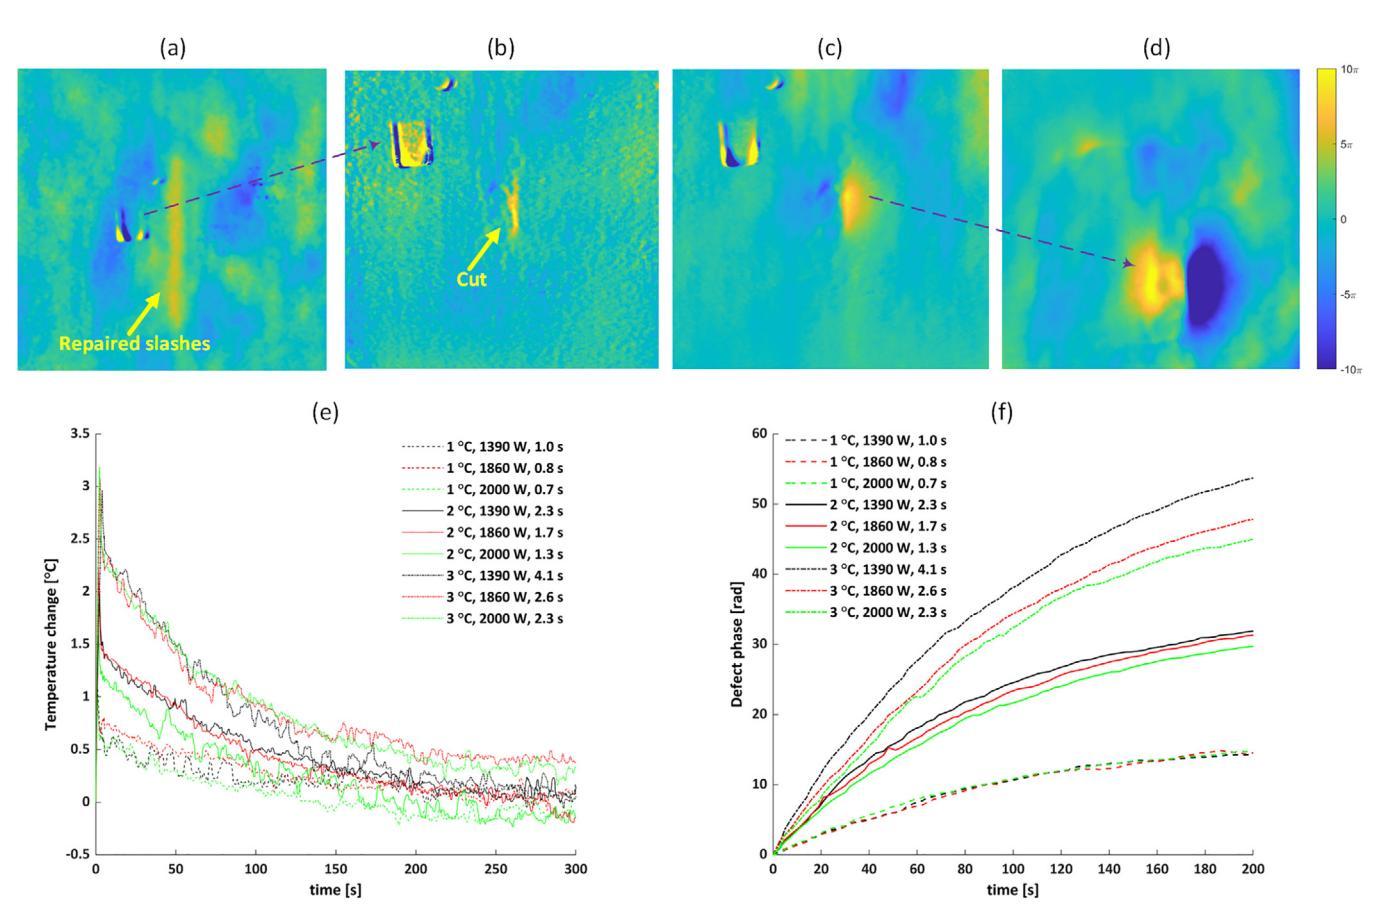
**Fig. 6.** Inspection phase maps, delamination-induced phase and the effective temperature increase. (a) Out-of-plane phase map before the cut (corresponding to  $\partial w/\partial x$ , inspected from the front, compensated). (b) In-plane phase map after the cut ( $\partial u/\partial x$ , front). (c) Out-of-plane phase map after the cut ( $\partial w/\partial x$ , front, compensated). (d) Out-of-plane phase map after the cut ( $\partial w/\partial x$ , reverse, compensated). (e) The surface temperature during thermal loading with varying power and the following cooling. (f) The dependence of the out-of-plane phase caused by the delamination from (c) on the heating power and heating time with controlled surface temperature increase.

The test painting was preliminarily inspected from the front with only the out-of-plane configuration of the instrument (with only camera 4, Figs. 3,4). The repaired slashes in the canvas were detected in the compensated phase map (Fig. 6(a); the detected phase at the slash area was around 16–21 rad, with the overall canvas deformation around 240 rad). According to the shearography principle, vertical defects and features are more visible when the shear is applied in the horizontal direction, which is highlighted in Fig. 6(a) with the vertical repaired slashes.

Second, after the cut and delamination (Figs. 1(d,e)) were created in the lining canvas, the test painting was inspected with 3D shearography from the front (Figs. 6(b,c)). From the expectations and the results, the cut affects the in-plane strain field (corresponding to  $\partial u/\partial x$ ), while the delamination affects the out-ofplane strain (corresponding to  $\partial w/\partial x$ ). The intensity of the cut and delamination is around 36 and 30 rad, respectively, while the repaired slash (Fig. 6(a)) causes 16–21 rad. Therefore, the cut and the delamination cause higher strain concentrations and are easier to detect than the repaired slashes.

Third, the test painting with the cut and the delamination was inspected from the reverse side with the out-of-plane instrument configuration (Fig. 6(d)). The delamination causes comparable phase variations when inspected from the front and reverse sides (Figs. 6(c,d), respectively).

The presented phase levels of 16–21 rad for the repaired slashes and 30–36 rad for the cut and delamination correspond to several shearography fringes ( $2\pi$  or 6.28 rad each) and could be considered as detected defects in standard inspection practice. However, in this case, the overall canvas deformation is about 10 times higher (240 rad, about 40 fringes) than the signal from these areas of interest. When this significant overall deformation is compensated (Fig. 5), the compensated phase map reveals background phase variations of approx. ±16 radians in known reference regions (Fig. 6(a); blue areas left and right from the vertical repair). These background variations can be explained by the local thickness and density differences which do not follow the smooth compensation curve.

The correspondent shearography phases caused by the delamination from Fig. 1(d) during these loading scenarios are presented in Fig. 6(f). For the temperature increase of 3 °C, the out-of-plane phase induced by the delamination increases if the thermal power decreases. So, slower thermal loading with less power up to the same temperature causes a higher defect signal. However, this effect decreases with the decrease of temperature change and is not resolved with a temperature increase of 1 °C.

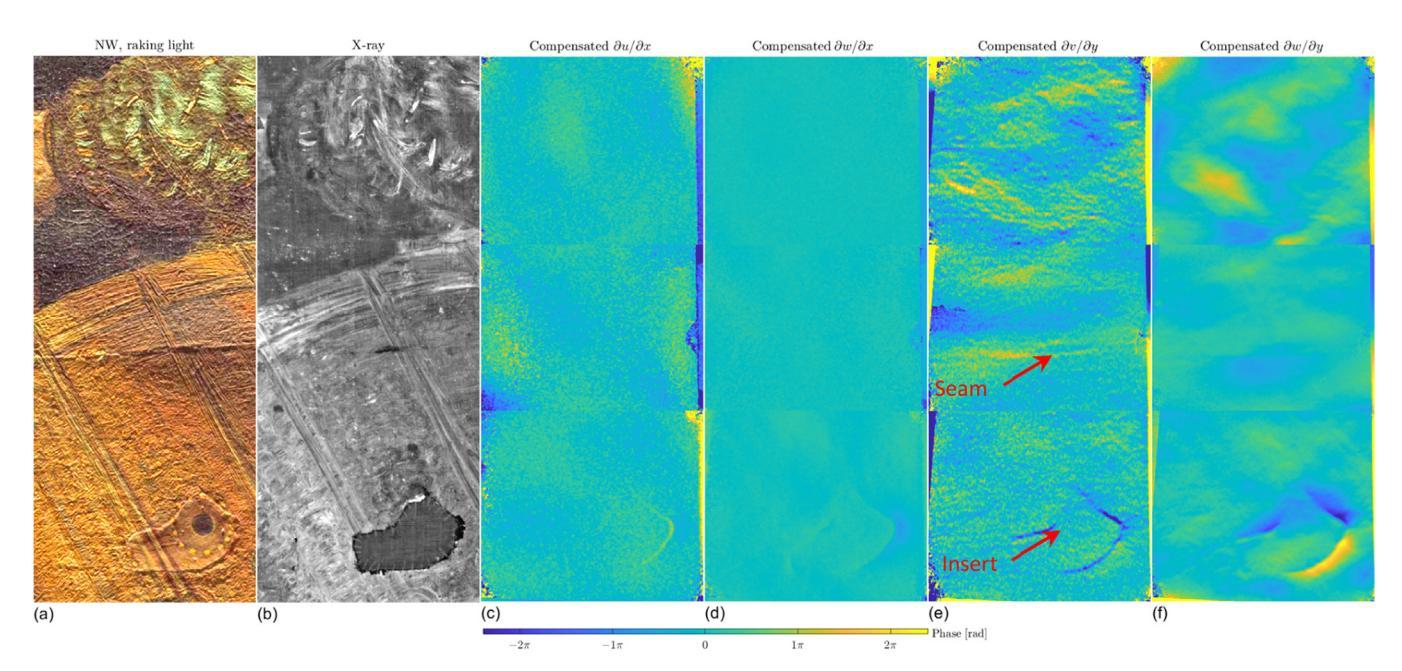
**Fig. 7.** 3D shearography inspection results of the drum area with the canvas seam and insert ( $198 \times 484$  mm). (a) Raking light image with corrected brightness and contrast, (b) X-ray radiography image of the same area with corrected brightness and contrast, (c) the in-plane  $\frac{\partial u}{\partial x}$  and (d) the compensated out-of-plane phase maps  $\frac{\partial w}{\partial x}$  with the shear in the x-direction (horizontal), (e) the in-plane  $\frac{\partial v}{\partial y}$  and (f) the compensated out-of-plane phase maps  $\frac{\partial w}{\partial y}$  with the shear in the y-direction (vertical).

The inspection results of both investigated areas (Figs. 7 and 9) show that known structural features can be identified and mapped (viz. the seam in the original canvas and the insert in the drum, Fig. 7). The overall pattern of the repaired slashes in the breeches area can be traced in the out-of-plane phase map with the shear

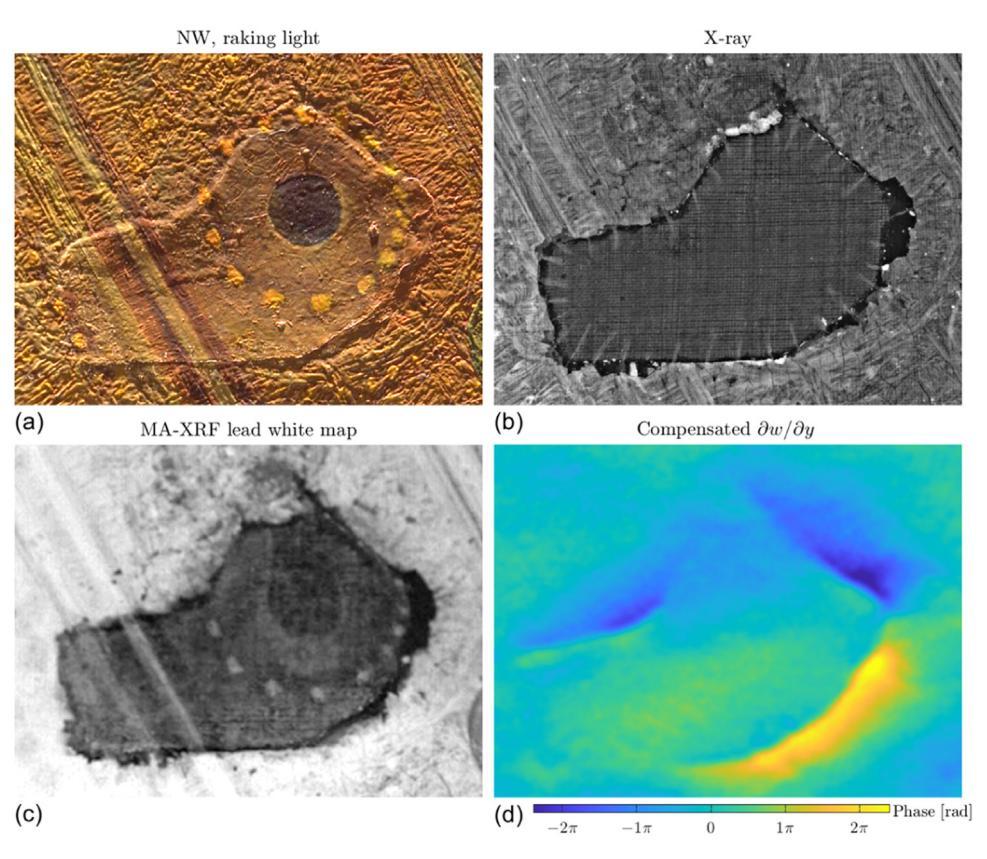
**Fig. 8.** Zoom into the inspection results of the drum insert. (a) Raking light image, (b) X-ray radiography image of the same area, (c) lead (Pb-L) map, macro X-ray fluorescence scanning spectroscopy (MA-XRF) associated with white lead. Brightness and contrast were corrected in (a-c). (d) The compensated out-of-plane phase map  $\frac{\partial w}{\partial y}$  with the shear in the y-direction (vertical).

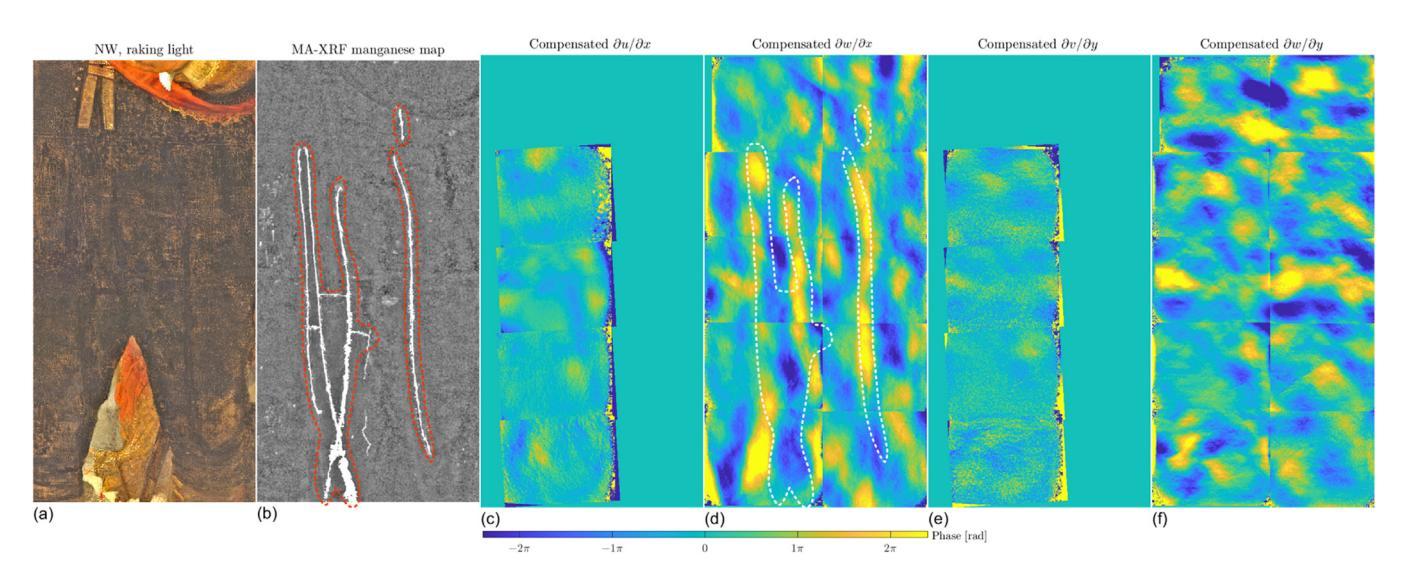
in the x-direction (red contour in Fig. 9(b) and white in  $\partial w/\partial x$ , Fig. 9(d)). The white dotted line in Fig. 9(d) is copied from the red contour in Fig. 9(b) for demonstration purposes. However, both the in-plane (Figs. 9(c, e)) and out-of-plane phase maps (Figs. 9(d, f)) do not have clear and significant local and sharp variations as compared to the area around the drum insert (Figs. 7(e, f)). If there were delaminations, higher localised phase signals would be expected (2–3 times higher than the signal from the repairs) following the effect of a delamination in the test painting (Fig. 6). The background variations (e.g. Fig. 9(f)) are the residuals from the phase compensation and can be explained by the local thickness and density differences.

In general, it is possible to use only shearography results for defect detection and classification as in Figs. 6(b-d). However defect detection in Figs 9(c-f) is challenging. From the shearography inspection results, no critical structural problems associated with the repaired slashes, nor with adhesion of the lining canvas, could be detected.

- The results of the 3D shearography inspection from the reverse of the painting showed that the out-of-plane strain in the Captain's breeches does not show significant deviation that would indicate weakness in the adhesion between the repaired slashes and the lining canvas. The other repair, the canvas patch in the drum showed higher localised in- and out-of-plane strain variations. This can be explained by the less exacting repair of the hole in the canvas as compared to the repaired slashes in the breeches of Banninck Cocq.
- 2. Inspecting a large painting is more challenging than the small test painting. Vibrations and airflow are the main influencing parameters that affect in-situ shearography measurements. Ad-

**Fig. 9.** 3D shearography inspection results of the Captain Banninck Cocq's breeches area ( $445 \times 909 \text{ mm}$ ). (a) Raking light image with corrected brightness and contrast, (b) manganese (Mn-K) map, macro X-ray fluorescence scanning spectroscopy (MA-XRF) associated with the pigment umber used for repairing the slashes during the 1975–76 restoration with corrected brightness and contrast, (c) the in-plane  $\frac{\partial u}{\partial x}$  and (d) the compensated out-of-plane phase  $\frac{\partial w}{\partial x}$  with the shear in the x-direction (horizontal), (e) the in-plane  $\frac{\partial u}{\partial y}$  with the shear in the y-direction (vertical).

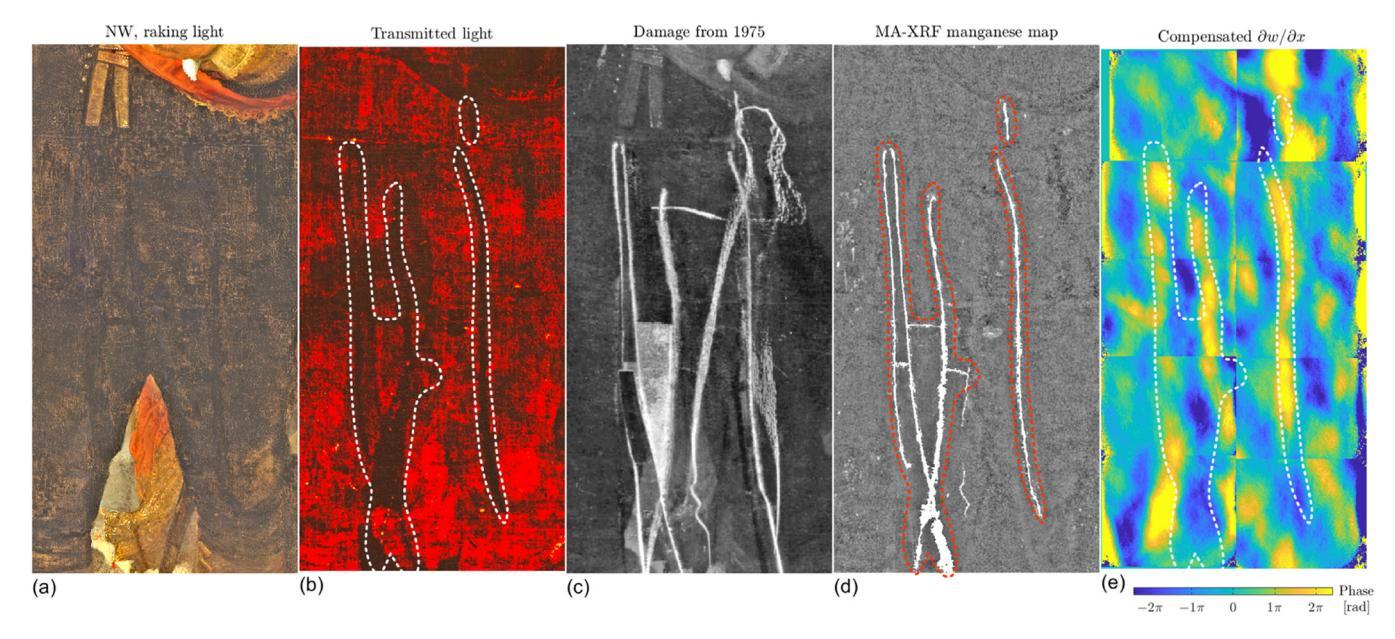
**Fig. 10.** Inspection results of the repaired slashes in Captain Banninck Cocq's breeches area ( $445 \times 909 \text{ mm}$ ). (a) Raking light and (b) transmitted light images, (c) photo of the damage from 1975 before the tear repair, (d) manganese (Mn-K) map, macro X-ray fluorescence scanning spectroscopy (MA-XRF) associated with the pigment umber used for repairing the slashes during the 1975–76 restoration. Brightness and contrast were corrected in (a-d). (e) The out-of-plane phase map  $\frac{\partial w}{\partial x}$  with the shear in the x-direction (horizontal, compensated).

The most informative shearography results, namely the out-ofplane component  $\partial w/\partial x$  (Fig. 9(d)), are presented as supplementary material in Fig. 10 together with the transmitted light image and photo of the damage from 1975 (Figs. 10(b,c)). The contours presented in Figs. 10(b,d,e) are the same as in Figs. 9(b,d).
