# Non-destructive material evaluation of a reinforced concrete viaduct: a practical methodology

Gert Wilgenburg

Master's Thesis

**Civil Engineering**

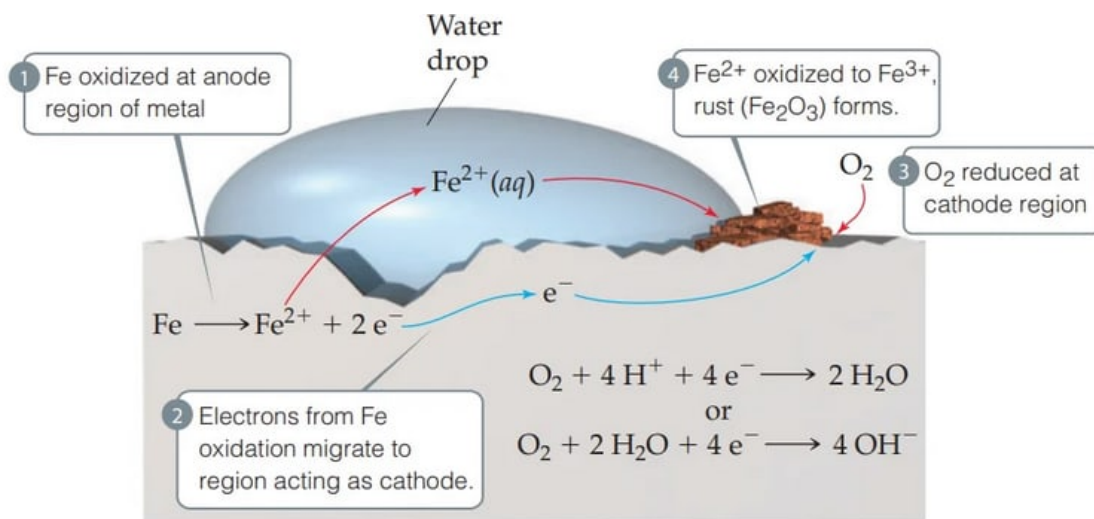
Figure 2.1: A schematic representation of the corrosion process of iron [4].

The corrosion process initiates when the reinforcement interacts with water and oxygen. While Figure 2.1 provides a general sketch of iron corrosion, it's important to note that the process is more complex and differs when reinforcement is embedded in concrete, as elaborated in Section 2.2.2. The primary anodic (oxidation) and cathodic (reduction) reactions are described in Equations 2.1 and 2.2, respectively.

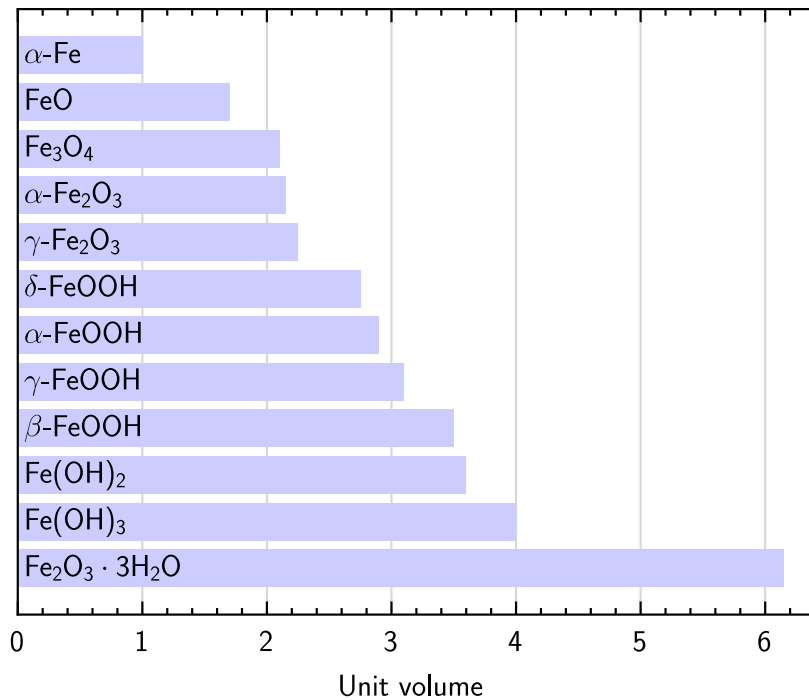
Figure 2.2: The relative volumes of iron corrosion products (adapted from [5]).

The corrosion process results in rust formation and the build-up of expansive pressure in the concrete. The expansive products formed at the steel-concrete interface, can occupy approximately 2 – 6 times the volume of the original steel, as illustrated in Figure 2.2. This can result in cracking of the concrete which further facilitates the ingress of aggressive agents, ultimately contributing to concrete spalling. Moreover, the ongoing corrosion causes a reduction in the thickness of the reinforcement and weakens the bond between the concrete and the reinforcement.

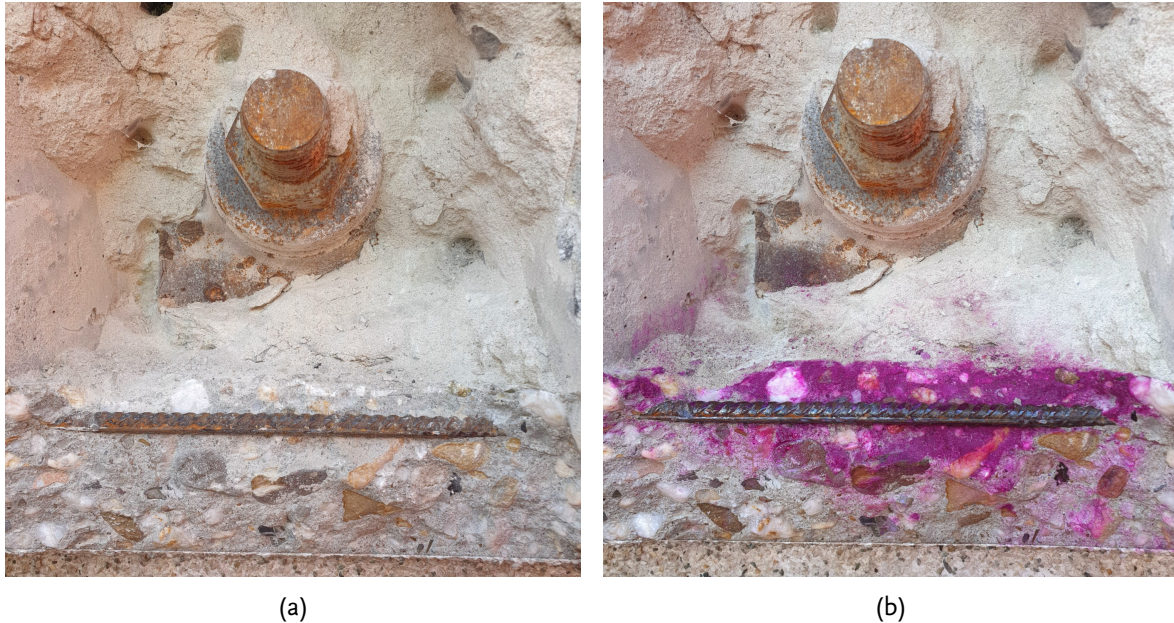
Figure 2.4: Before (a) and after (b) spraying with phenolphthalein.

The most common way to indicate the carbonation depth is by spraying a solution of phenolphthalein on a freshly broken face. A color change can be observed from fuchsia to colorless when the pH decreases below 8.5. Figure 2.4 provides an example of where the carbonation front has not reached the rebar.

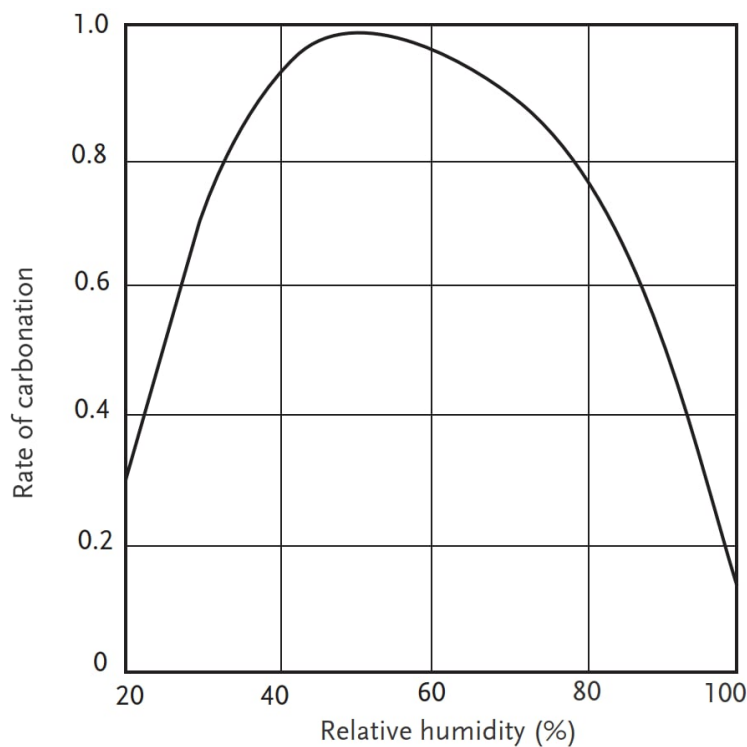
Figure 2.5: Rate of carbonation as a function of the relative humidity, under equilibrium conditions [11].

As discussed in section 2.3.1, the rate of carbonation is strongly dependent on the relative humidity. The transport of  $\text{CO}_2$  through water-filled pores is slow, therefore the diffusion of  $\text{CO}_2$  decreases with an increase in relative humidity. However, the carbonation reaction can only occur with the presence of water and so the carbonation rate becomes negligible in dry concrete. This principle is illustrated in Figure 2.5.

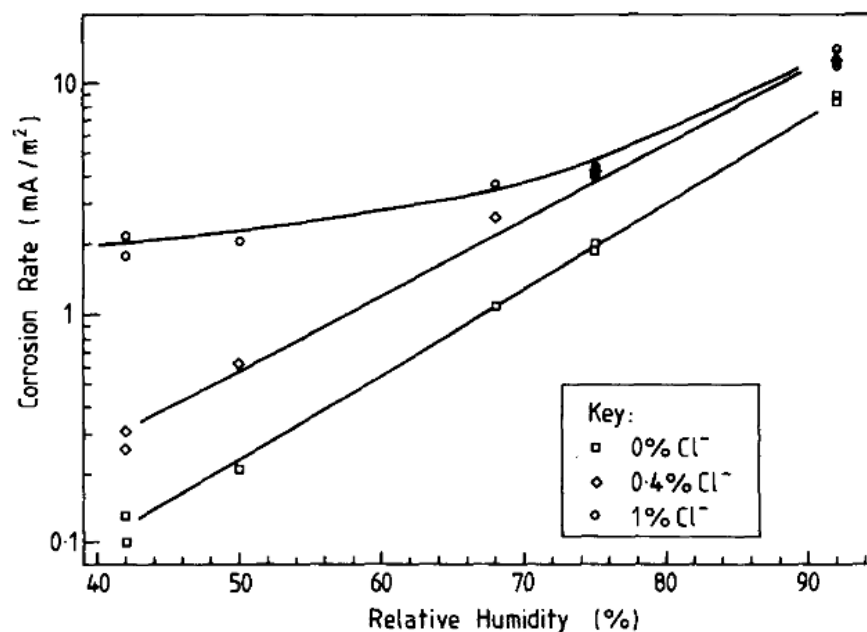
Figure 2.6: The relationship between relative humidity and corrosion rate obtained on polarisation resistance probes exposed to carbonated mortars containing 0, 0.4 and 1% chloride [15].

When carbonated concrete is contaminated with chlorides, the corrosion process can intensify. Chloride contamination increases the ionic conductivity of the pore solution and facilitates moisture retention, leading to a lower resistivity [15]. Figure 2.6 shows the corrosion rate in carbonated mortars with varying chloride contents. It can be observed that in case of the absence of chlorides, the corrosion rate becomes negligible only when the external relative humidity drops below 70%. This threshold decreases to less than 40% in the case of a 1% chloride content.

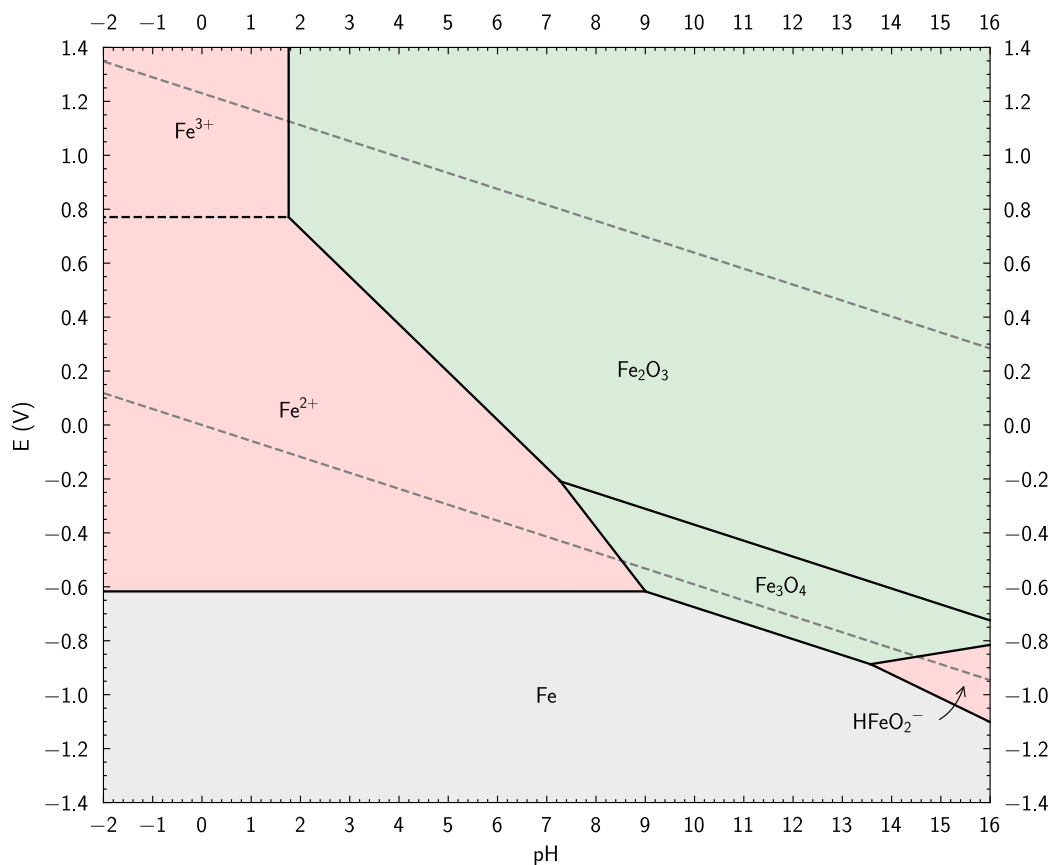
Figure 2.8: Pourbaix diagram for a Fe – H<sub>2</sub>O system ( $T = 25^\circ\text{C}$ ,  $P = 1$  atm and all ionic concentrations  $10^{-6}$  M).

The Nernst equation can be used to construct thermodynamic diagrams that represent the phases of an aqueous electrochemical system. These potential-pH diagrams were founded by Marcel Pourbaix in 1938 and are therefore called Pourbaix diagrams [16]. For the analysis of corrosion in reinforced concrete, the Pourbaix diagram of a Fe – H<sub>2</sub>O system, as depicted in Figure 2.8, holds particular significance. The construction of this diagram is detailed in Appendix A. It's important to emphasise that the presented diagram is a simplified representation of reality.

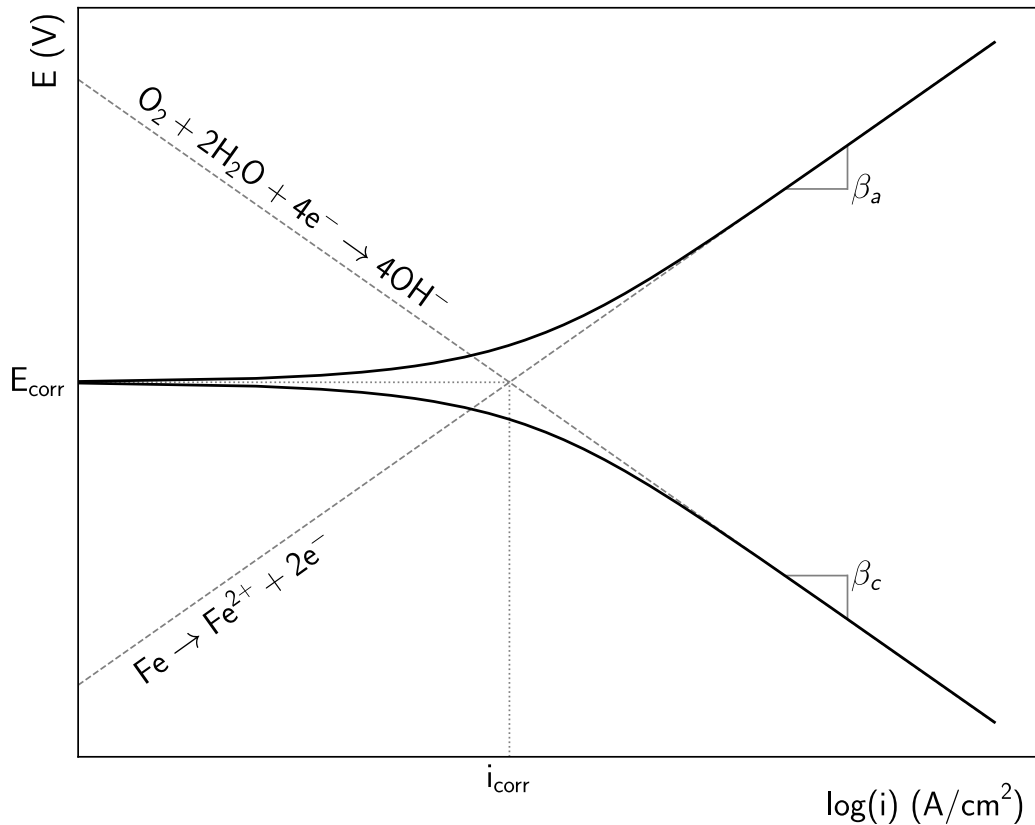
Figure 2.9: Schematic polarisation curve with Evans diagram.

The corrosion current density ( $i_{corr}$ ) can be determined by identifying the point of intersection between the anodic and cathodic Tafel slopes, as illustrated in Figure 2.9. The anodic and cathodic Tafel plots combined represent the so called *Evans diagram*. Note that in this figure, the lines are illustrated with similar slopes for clarity, but in reality, the slopes may differ due to variations in ionic concentrations and environmental factors.

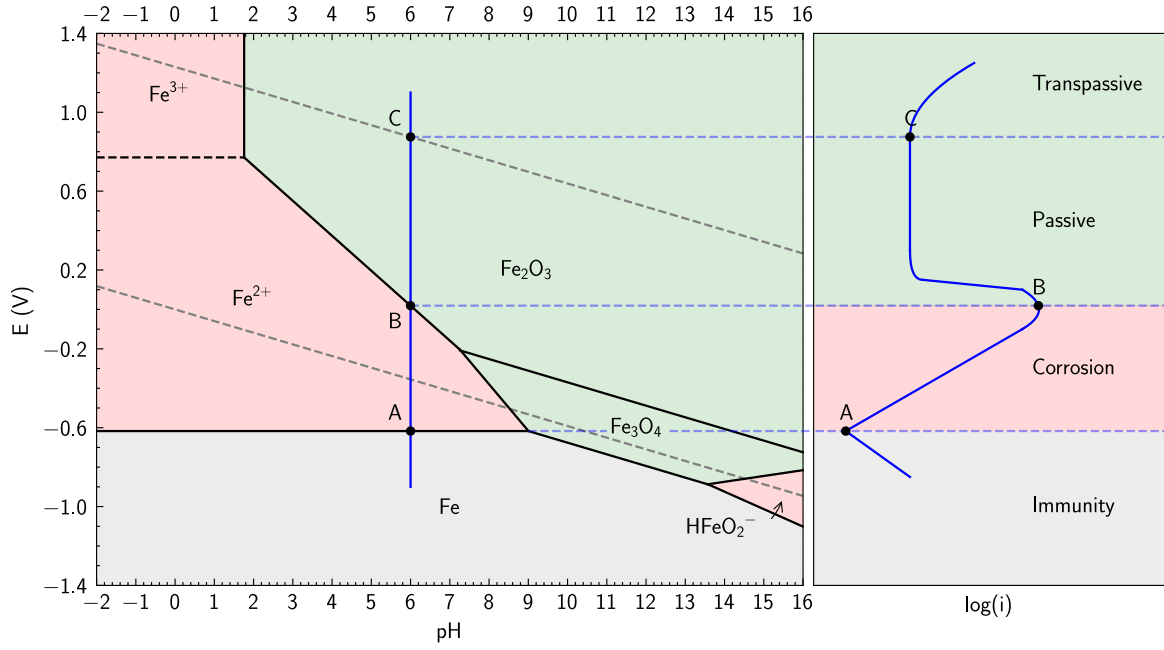
Figure 2.10: Anodic polarisation curve alongside the Pourbaix diagram at a pH of 6 (adapted from [6]).

An example of the anodic polarisation curve of steel at a pH of 6 is given in Figure 2.10. At potentials more negative than the equilibrium potential, steel remains immune to corrosion or dissolution. As the potential is progressively increased beyond this equilibrium potential, active corrosion initiates (A-B). At a critical point (B), the dissolution rate equals the rate of metal oxide formation. Beyond this point, the formation of a protective metal oxide layer predominates, resulting in a significant reduction of active corrosion, effectively rendering the steel passive (B-C). However, rapid dissolution starts if the metal's electrode potential becomes excessively positive, reaching the oxygen equilibrium line (C) from where oxygen will be generated. This marks the beginning of the transpassive region, where the metal's passive state breaks down, and rapid dissolution begins. The anodic polarisation curve varies with an increasing chloride content: passivity is lost at an increasingly lower potential. Consequently, the corrosion rate will increase [18].

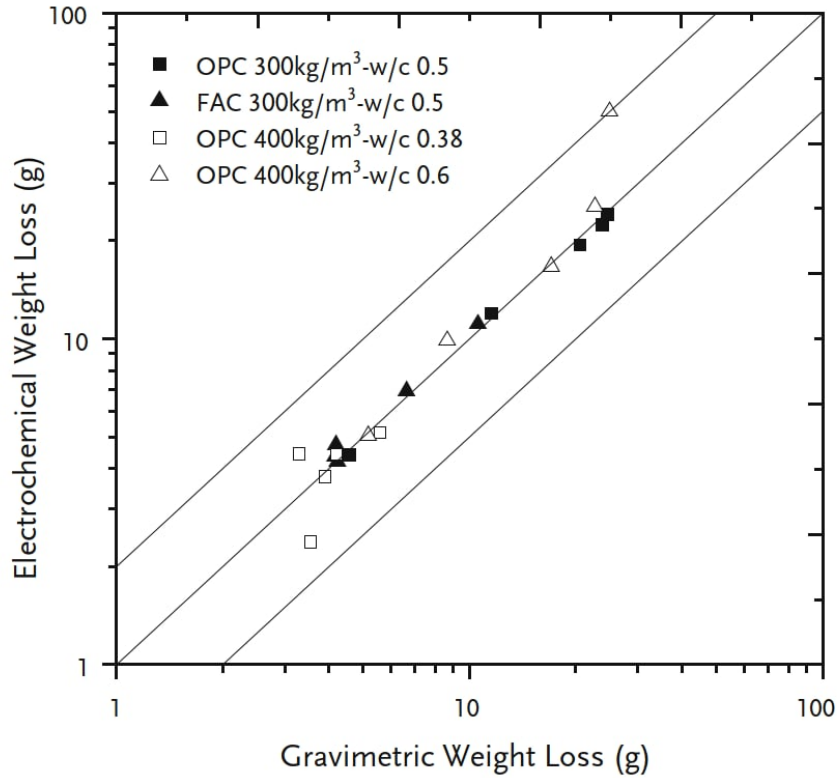
Figure 2.11: Gravimetric weight loss and electrochemical weight loss of concrete submerged in sea water for several years [21].

A relation between the electrochemical weight loss and gravimetric weight loss has been reported in [21]. It was found that the electrochemical weight loss determined by the modulated confinement method (Section 2.7.8) gives similar values to the gravimetric technique [22]. In cases of localised corrosion however, the corrosion current density may not be accurately represented by the measured average corrosion current density. As a result, the corrosion rate calculated based on this average may not accurately reflect the true corrosion rate, even after performing gravimetric tests.

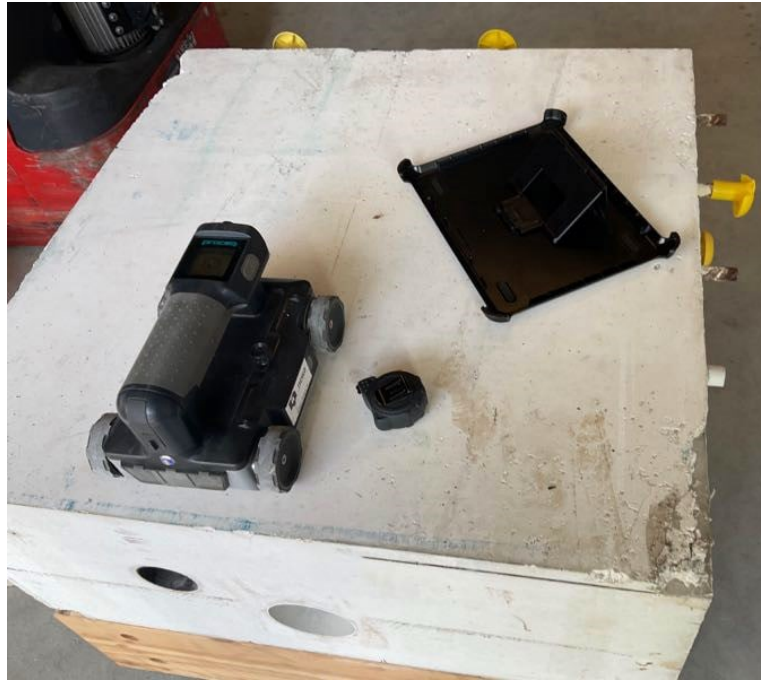
For the investigation of concrete structures, the method is particularly suitable for measuring the cover thickness and locating cracks, reinforcement, tendons or tendon ducts. A great advantage of the method is the significant depth it can reach, especially with low frequency transmitters, although the accuracy will decrease at higher depths. The method

Figure 2.13: Concrete testing block at Newa HQ and Screening Eagle's GP8000.

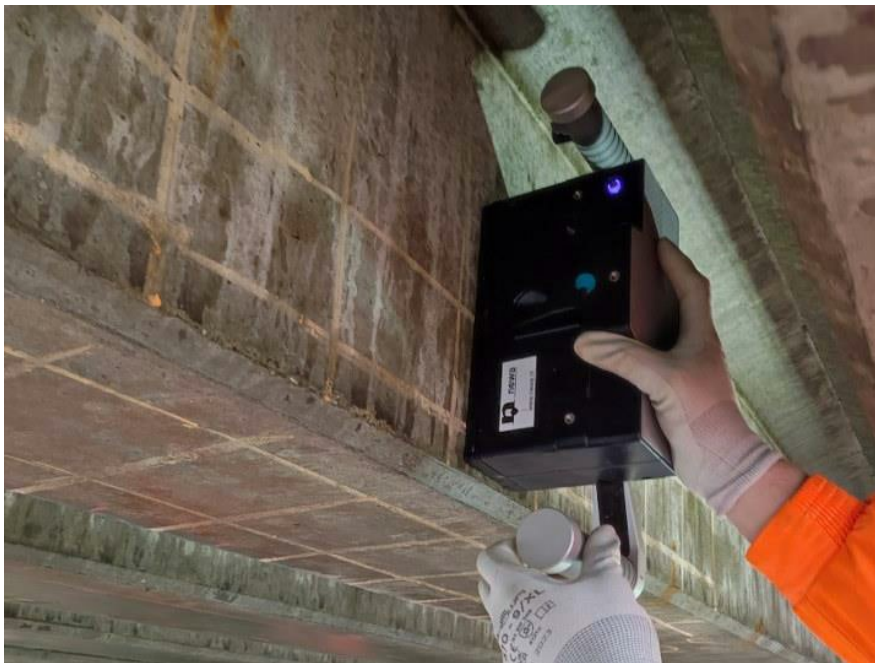
Figure 2.15: Proceq Pundit PD8050 UPE device used for inspecting tendon ducts after the localisation of the reinforcement with GPR.

In essence, GPR and UPE serve as complementary techniques, with GPR excelling in locating reinforcement and UPE being more adept at identifying defects. Properly combining these methods theoretically allows for the detection of grouting defects in tendon ducts. The initial step involves localising the reinforcement using GPR, followed by using UPE to search for grouting defects. UPE is particularly advantageous in this context as it can penetrate through thick layers of reinforcement. Fully grouted ducts result in partial reflection, whereas badly grouted ducts result in total reflection of the signal.

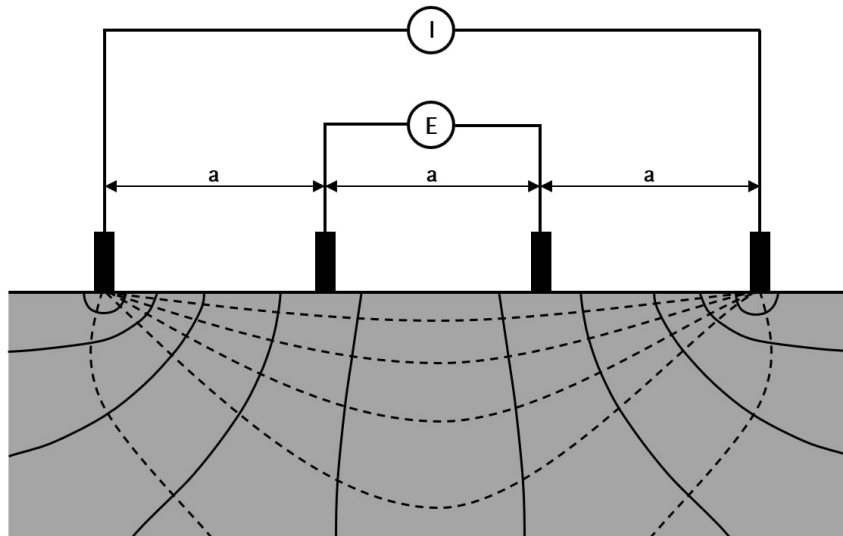
Figure 2.17: Wenner probe technique.

By identifying areas of low resistivity, the Wenner probe helps pinpoint the most permeable spots within the concrete, indicating where corrosion may occur more rapidly. However, it's important to note that it cannot determine whether the reinforcement steel is active or passive. Areas with low resistivity indicate a higher corrosion rate, especially in regions where depassivation has occurred. Also, the preparation of the concrete surface for measurement is crucial. Extensive pre-wetting is not recommended as it can alter the bulk resistivity of the material. Instead, using wet sponges without allowing water film formation on the surface is preferred. Wetting the sponge frequently may be necessary as concrete can absorb water over time. An average decrease of resistance of 6% for three measurements was observed when using wet sponges [52].

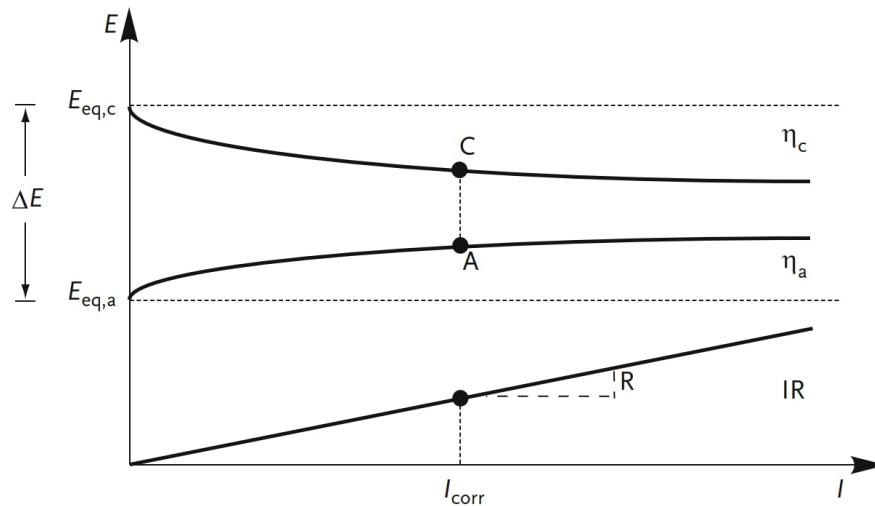
Figure 2.19: Effect of an ohmic drop in the electrolyte [57].

With macrocell or localised corrosion, a nuanced approach is necessary. In these cases, the measured potential does not represent the true corrosion potential due to the influence of an ohmic drop (IR-drop). Instead, it reflects a mixed value, dependent on the electrode's position and resistivity of concrete [57]. The most negative value always indicates the local anode.

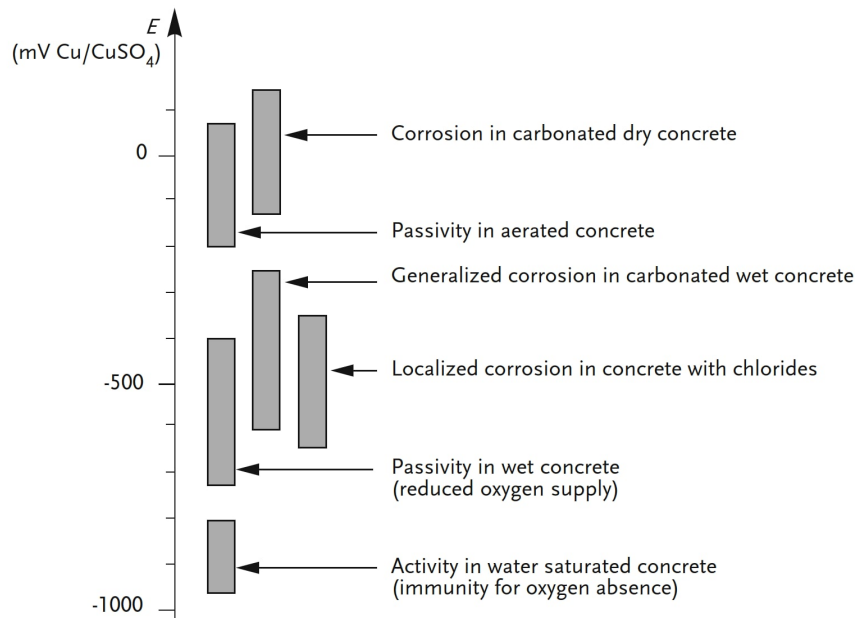
Figure 2.20: Typical potential ranges for reinforcement steel under different conditions [57].

It's important to note that these measurements are influenced by various factors such as moisture content, cover depth, resistivity, temperature, oxygen content and the presence of surface coatings. Concrete that has undergone carbonation tends to yield more positive potentials, and in the case of wet concrete, more negative potentials are obtained as illustrated in Figure 2.20. However, these changes in potential due to a changing moisture content do not necessarily affect potential gradients or the location of corroding spots in a structure [58].

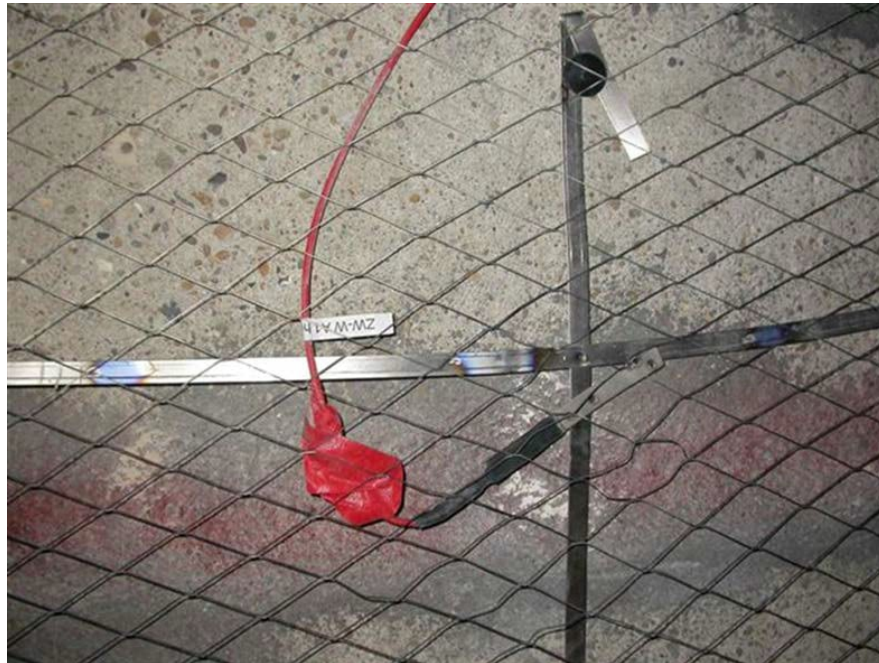
Activated titanium is typically titanium coated with noble metal oxides, known as Mixed Metal Oxides (MMO) [81]. It can be applied using either titanium mesh or titanium strips. The activated titanium meshes or strips are connected to primary anodes, which are typically strips or wires of plain titanium. An example of a connection between a titanium mesh with titanium strips as primary anodes is shown in Figure 2.24.

Figure 2.24: Connection between isolated copper cable, titanium mesh and plain titanium strip welded in-situ [81].

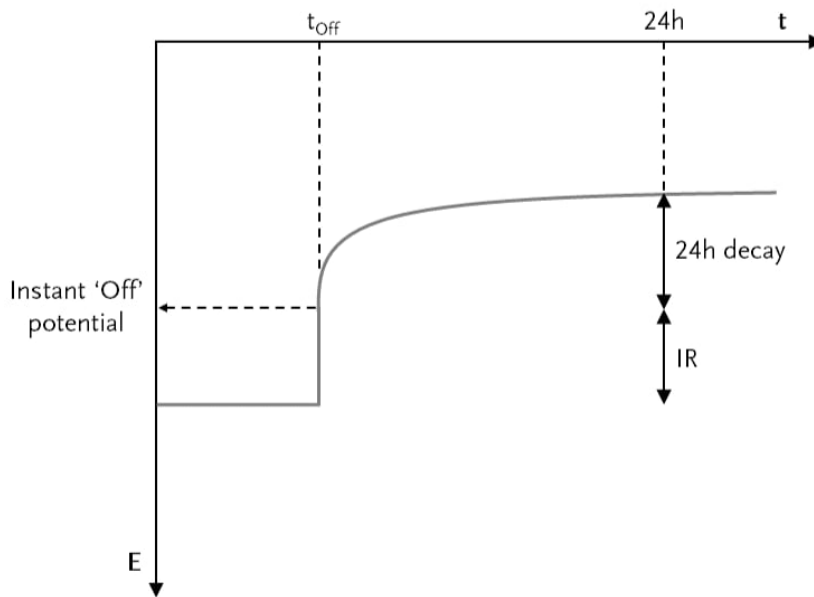
Figure 2.25: Idealised instantaneous off potential plot.

To monitor the cathodic protection system, various reference electrodes are often installed. There are two types: true reference electrodes and decay probes. True reference electrodes have a stable potential and can monitor the potential of the reinforcement and prestressing, but they are relatively expensive. Decay probes are suitable only for depolarisation measurements over a maximum of 24 hours, and they are relatively inexpensive. The depolarisation is measured from the instantaneous off potential, which refers to the immediate measurement of the electrode potential when the cathodic protection system is turned off as illustrated in Figure 2.25. All reference electrodes should be installed at corroding and non-corroding locations to provide the most representative data.

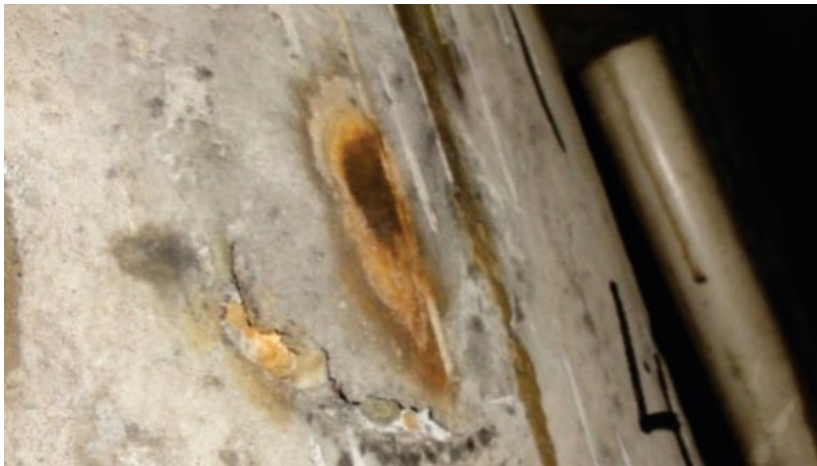
Figure 3.1: Example of a cone with corrosion damage (C4).

Damage levels for cones	
1	Cone has cracks.
2	Cone is loose or pushed out.
3	Cone is (partially) missing.
4	Cone with corrosion damage.
5	Cone with corrosion damage and a visible tendon.

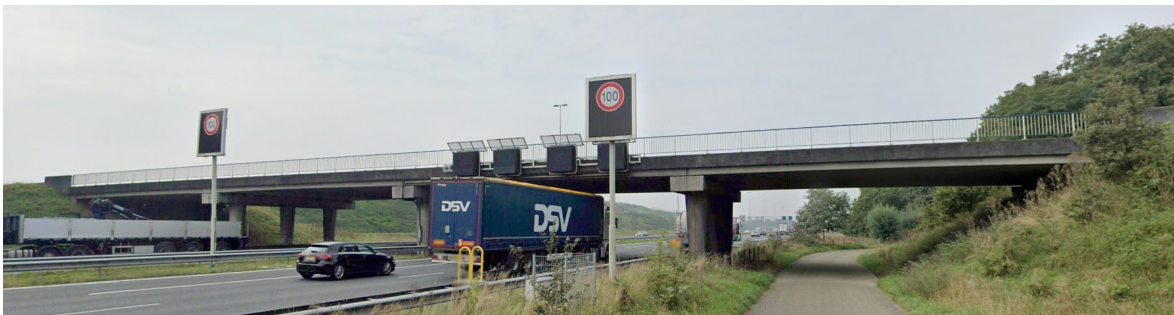
Figure 3.3: Sluinerweg viaduct as seen from the Blankenhuisweg.

The Sluinerweg viaduct was constructed in 1970 and consists of 4 spans with 5 supports (two abutments and three intermediate supports). Each span has a length of 18.95 m and contains 23 prefabricated T-beams. Additional characteristics are listed in Table 3.4. Noteworthy is the use of a KCG-layer, an abbreviation for the Dutch term *Kristal Cement Graniet* (Crystal Cement Granite). This coating was commonly applied to various structures across the Netherlands during the construction period of the Sluinerweg viaduct. It consists of a cement-based adhesive layer sprayed with granite granules. Its primary purpose is surface finishing, providing both functional and aesthetic benefits.

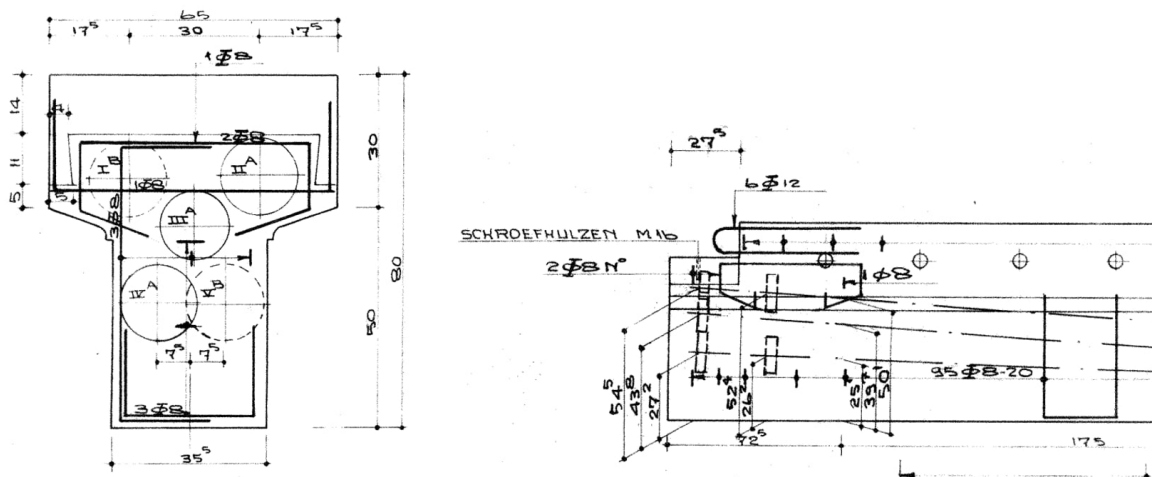
Figure 3.4: Technical drawing of the T-beams.

The beams are post-tensioned using five bar tendons placed inside steel-sheeted tendon ducts. Each prestressing tendon has one blind end anchorage and one regular anchorage at the opposite end of the beam. The blind end anchorage is completely embedded in the concrete, at some distance from the end of the beam. The other anchorage is secured and sealed after tensioning. The sealing compound, usually mortar, forms a cone to protect the anchorage from corrosion. According to the documentation and drawings, the anchor ducts were injected after tensioning the bars. The transverse prestressing is carried out using Dywidag bar tendons as well, spaced at 400 mm centers. The anchorages of the transverse prestressing bars are located behind the edge elements.

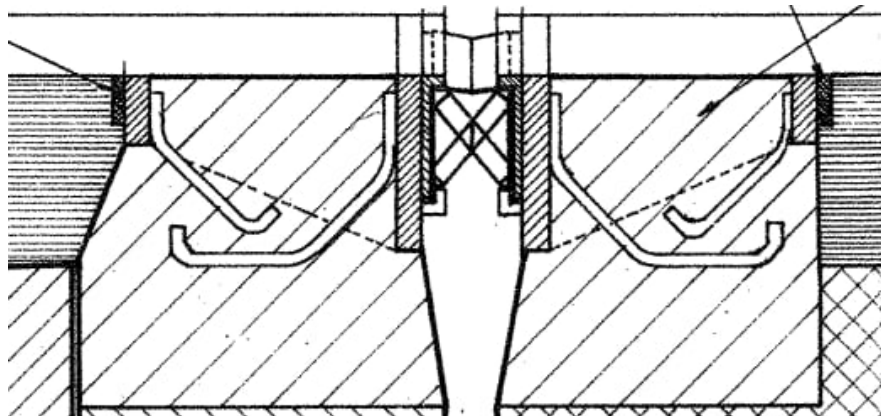
Figure 3.5: ACME type dilatation joint used for the Sluinerweg viaduct.

For the Sluinerweg viaduct, ACME joints were used, specifically ACME type 30D, which belongs to the family of nosing joints. This type of joint was frequently used in the 1960s and 1970s. The ACME joint profile is made of extruded EPDM rubber designed to withstand UV exposure, gasoline, oil, de-icing salts, and weather conditions. This type of joint consists furthermore of lane gratings anchored in the construction with clamped joint profiles.

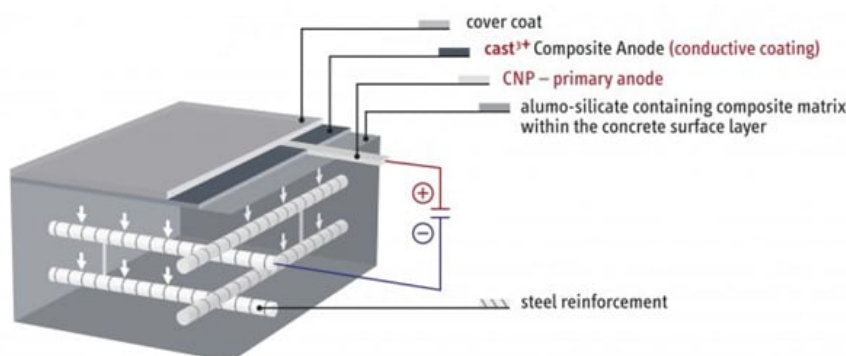
Figure 3.6: The cast<sup>3+</sup> composite anode system [85].

The applied cathodic protection system is a so called cast<sup>3+</sup> composite anode system which is shown in Figure 3.6. This system was chosen because of the long-time experience with the material in similar conditions, the durability of the conductive coating in relation to the requested lifetime of 20 years, good practical experience, and the advantages of a conductive coating with regard to the application in the restricted work space between the beam heads [1].

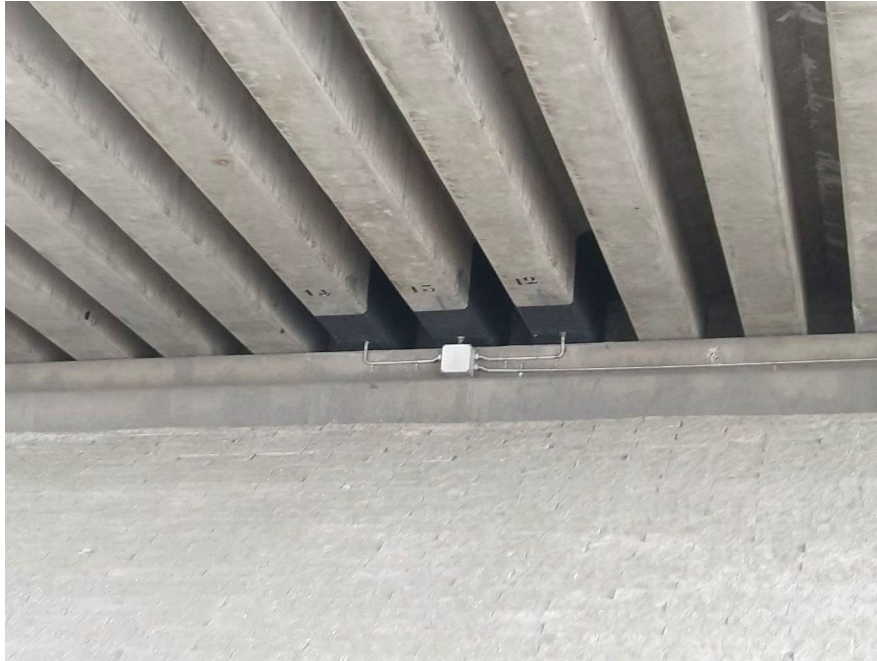
The system consists of a primary current-carrying anode made of CuNbPt wire, with the cast<sup>3+</sup> system serving as a secondary anode. Additionally, two types of reference electrodes were installed on the protected beam heads. A Ag/AgCl chloride true reference electrode was positioned near the prestressing to monitor the instantaneous off value

(approximately 25 years lifespan). Activated titanium electrodes, which are not stable over time due to factors like temperature, polarisation, or chloride content, were used to monitor the depolarisation value (approximately 75 years lifespan). A constant voltage of 5-6 volts was applied to the system.

Figure 3.7: The cast<sup>3+</sup> composite anode system applied to beams 12, 13 and 14 of STP01 on the Sluinerweg viaduct.

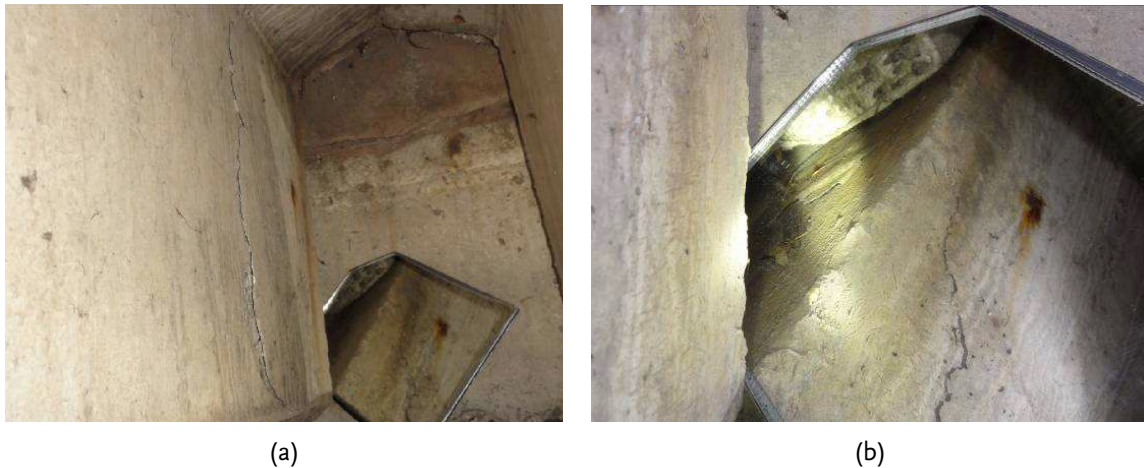
Figure 3.8: Damage to beam head (a) and cone (b) of beam 13 in 2011.

In 2011, a visual inspection of all beam heads was conducted using mirrors, and damages were classified according to the damage classes outlined in Tables 3.1 and 3.2. The most significant damage was observed on beam 13 at STP01 (Figure 3.9), classified as class 5 damage to the beam head and class 2 damage to the cone. These damages are shown in Figure 3.8. This beam head received cathodic protection in 2014. No leakages were observed during the inspection.

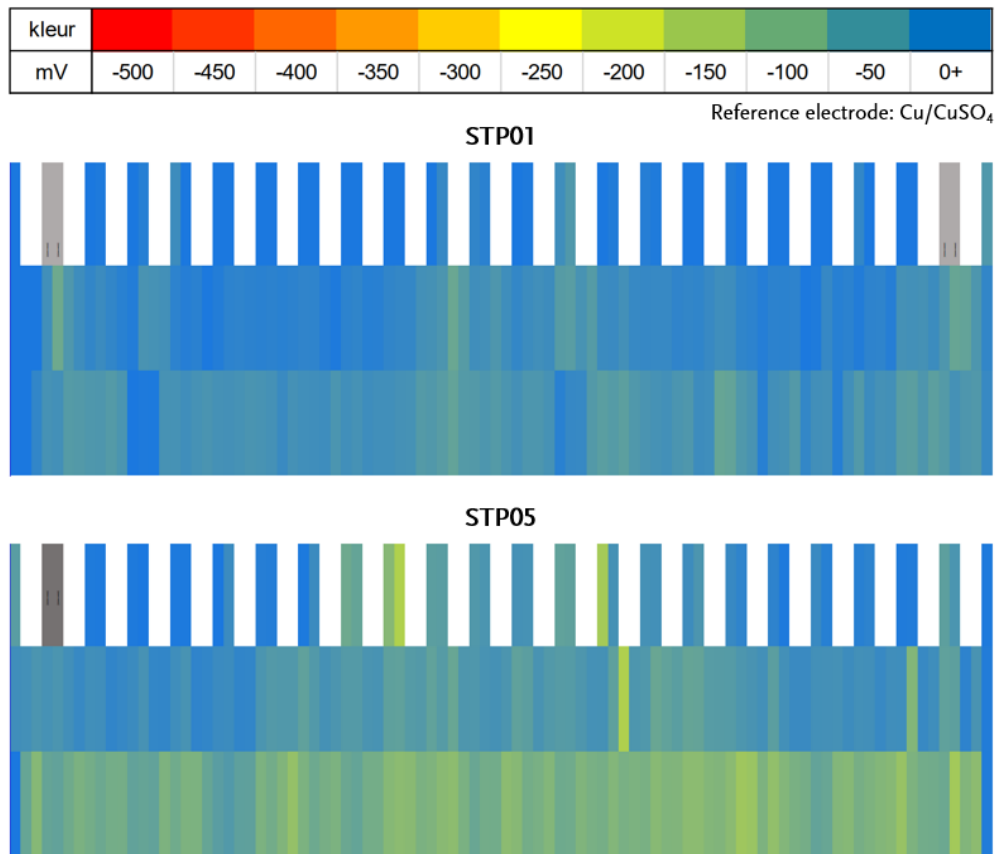
Figure 3.11: Potential maps for STP01 and STP05 [86].

Half-cell potential measurements were performed on STP01 and STP05 on the 4th of March 2020 using Cu/CuSO<sub>4</sub> reference electrodes. The results are presented in Figure 3.11. The top row represents the measurements taken on the horizontal face of the support beam in between the T-beams. Based on these figures, it can be concluded that the probability of corrosion is likely low, particularly for STP01, as none of the values fall below -200 mV. Additionally, no significant potential jumps are observed, except for some minor ones on STP05.

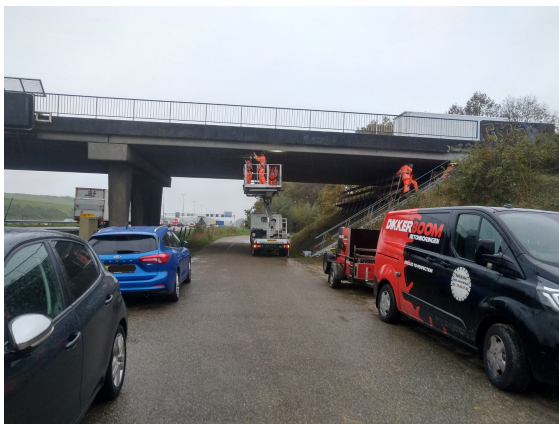
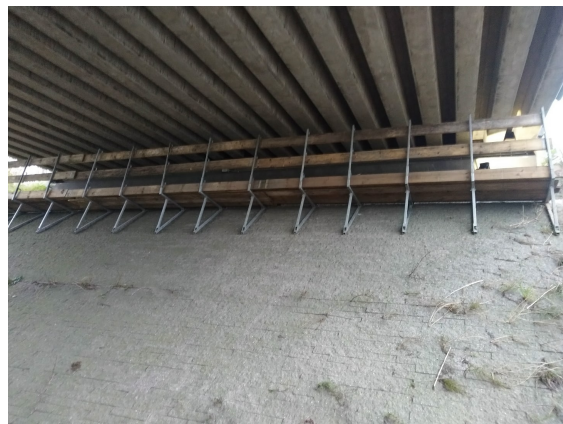
- **Aerial work platform.** For the inspection of the tendon ducts and initially for the inspection of STP02, an aerial work platform was required, as illustrated in Figure 4.1a. A certified operator handled this platform, and fall protection was worn as an additional safety measure.

- **Walkway platform.** A walkway platform was required for access to STP01 to ensure a safe work environment, as illustrated in Figure 4.1b. This platform made it possible to stand and pause after taking measurements, preventing the need to crawl each time and reducing the risk of falling. The platform could be accessed using a staircase.

Figure 4.1: Measurement site (a) and walkway platform (b).

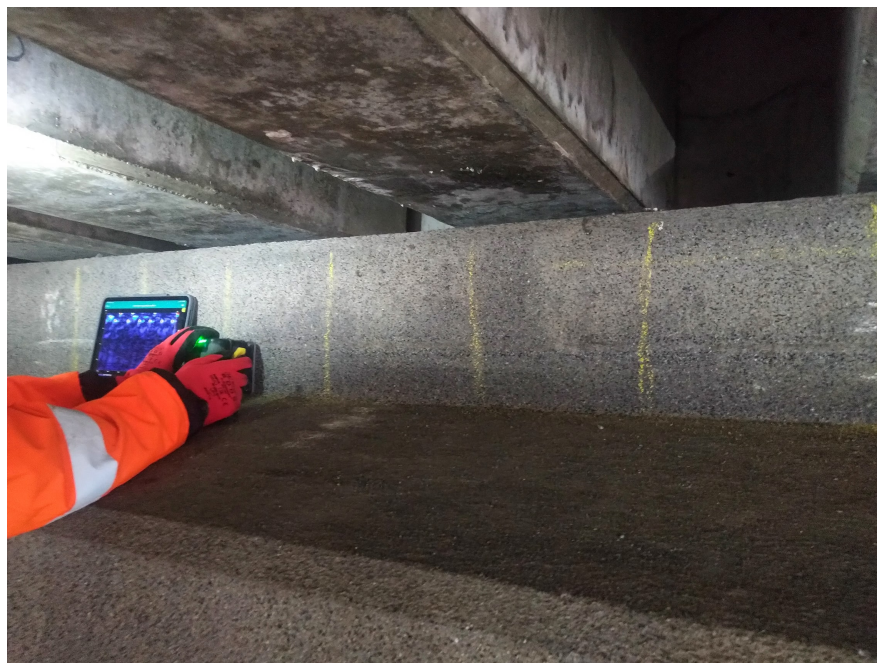
Figure 4.3: Using GPR to locate the reinforcement in the support beam.

First GPR measurements were performed using the Proceq GP8800 in two directions, allowing for the identification of both longitudinal and shear reinforcement in the beam. The rough KCG-layer posed no challenge for the GPR device. Yellow chalk was used to pinpoint the locations for compressive strength cores and to expose the reinforcement for potential and corrosion current density measurements (Figure 4.3). The initial dielectric constant was consistently set to 6 for all GPR measurements conducted on the support beam, as indicated in paragraph 2.7.2.

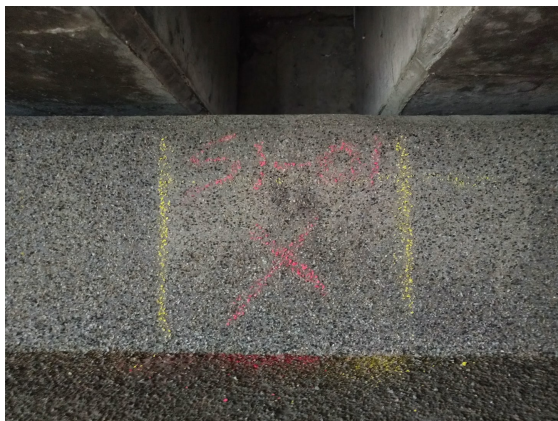
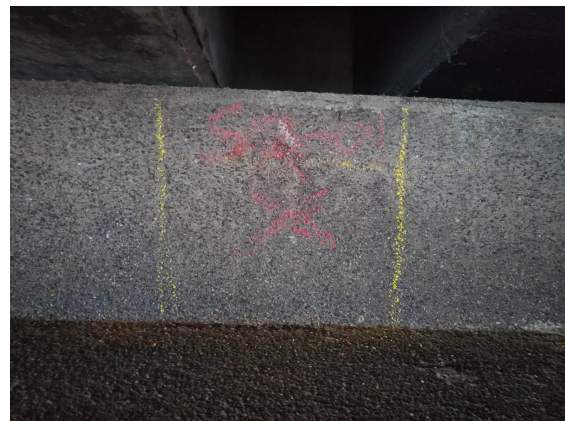
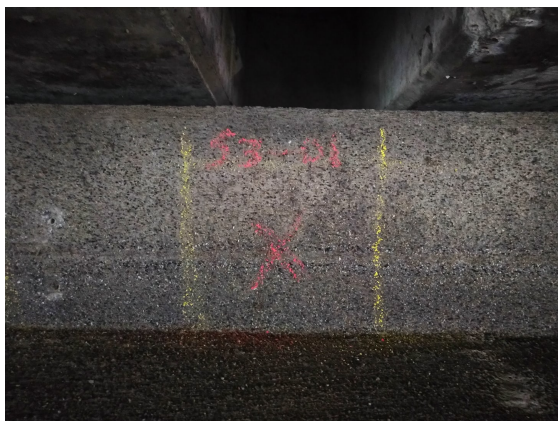
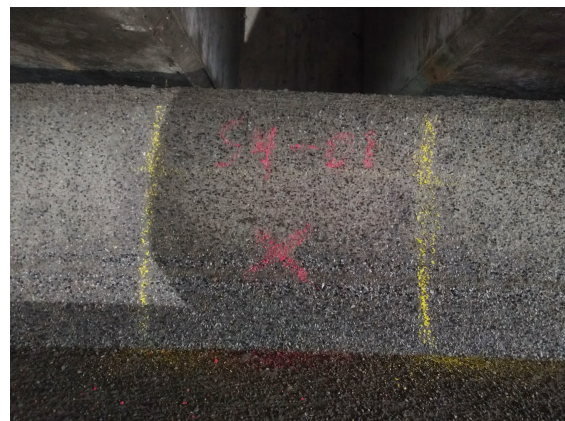
Four test locations were selected on the support beam for conducting rebound hammer and UPV measurements, followed by extracting cores from these designated locations, all conducted in accordance with EN 13791 [46]. Test location S1 is situated between beams 19 and 20, S2 between beams 14 and 15, S3 between beams 9 and 10, and S4 between beams 4 and 5, as illustrated in Figures 4.4 and 4.8. The UPV measurements were

Figure 4.5: Test locations S1 through S4 in-situ.

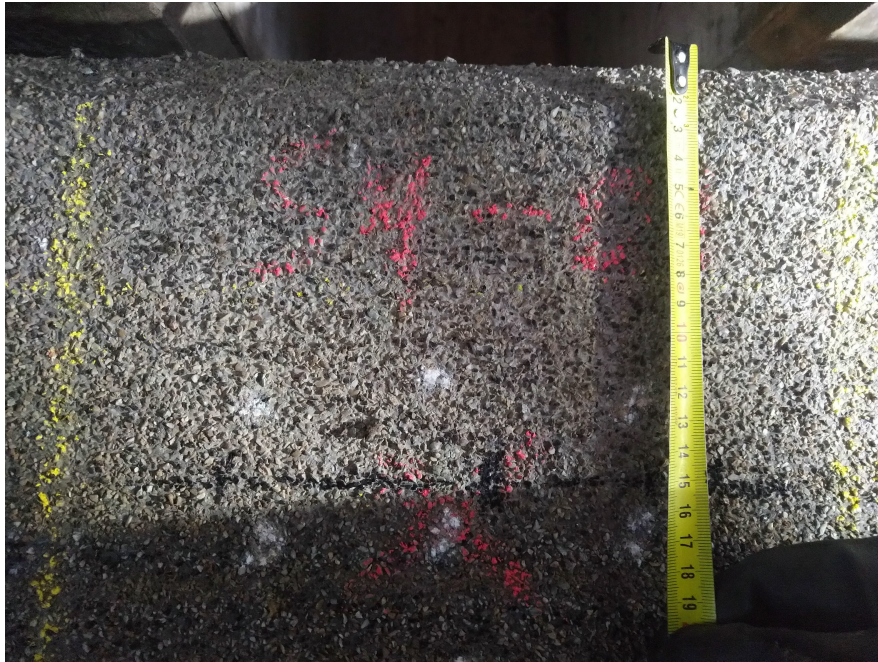
carried out in semi-direct transmission mode by transmitting the pulse from the top face to the vertical face of the support beam. This procedure was performed at three points along a horizontal centerline, ensuring a consistent distance of 15 cm between this centerline and the top of the support beam each time, as demonstrated in Figure 4.6. No significant issues were found with the rebound hammer and UPV measurements on the KCG-layer, except for the requirement of additional coupling gel for the UPV transducers.

Figure 4.6: Distance of 15 cm from the UPV centerline to the top of the support beam.

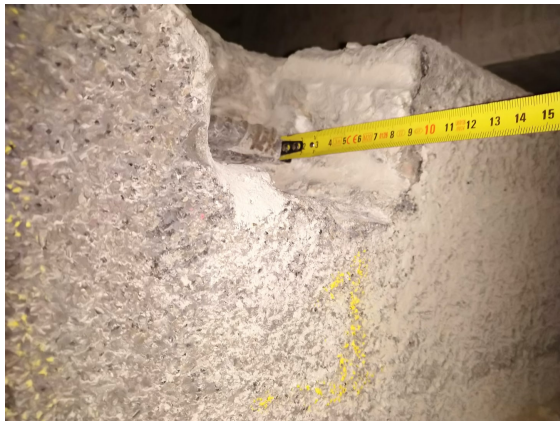
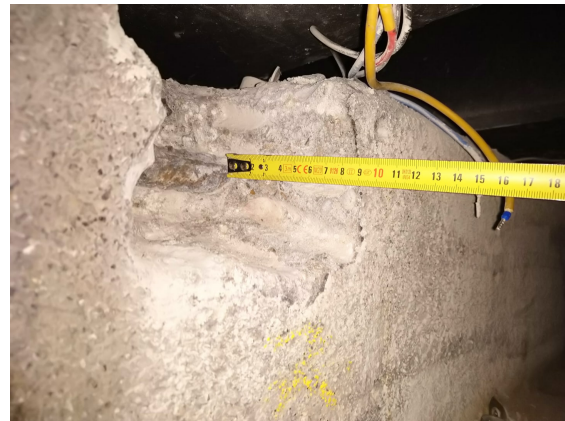
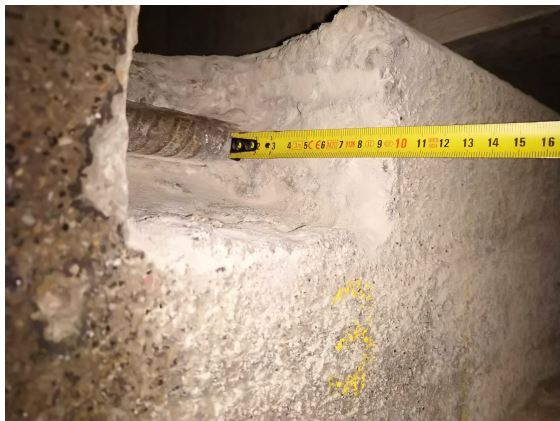
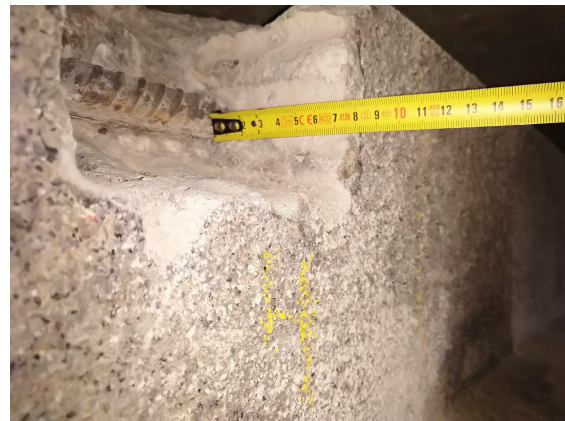
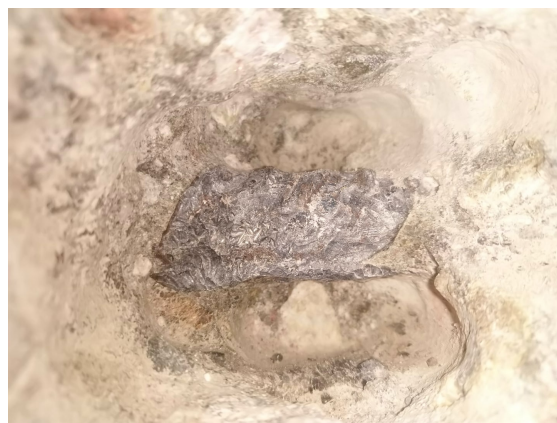
At four locations, the top rebar was exposed for conducting corrosion measurements. Due to the absence of drawings of the support beam, there was uncertainty regarding the location of the reinforcement. Upon inspection, it was found that the rebar had a diameter of 28 mm, with cover depths exceeding 80 mm as illustrated in Figure 4.7. This depth was significantly greater than initially anticipated based on previous inspections using a standard cover meter reliant on eddy currents. No notable corrosion was observed at the exposed locations.

Figure 4.7: Exposed top rebar in the support beam.
