# Non-destructive material evaluation of a reinforced concrete viaduct: a practical methodology

Gert Wilgenburg

Master's Thesis

**Civil Engineering**

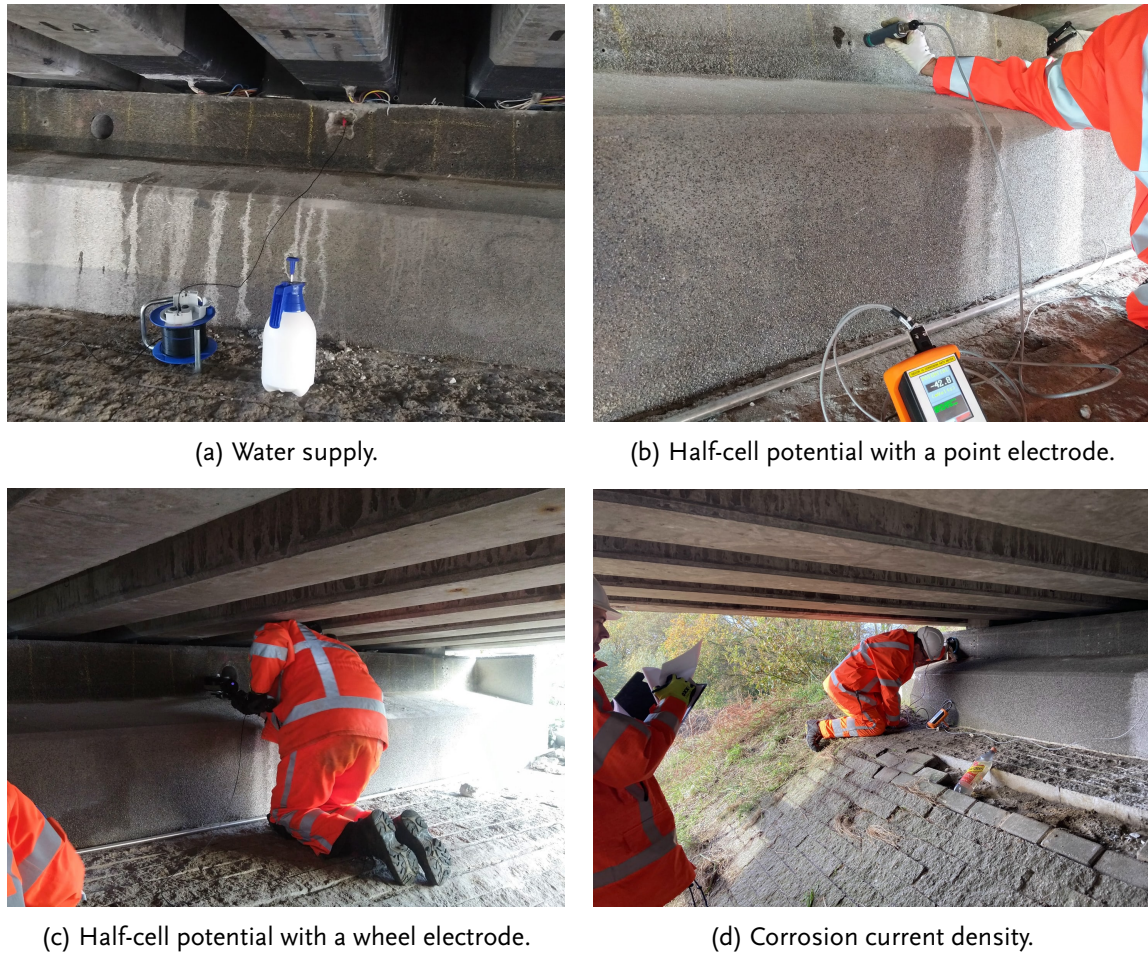
After verifying the continuity of the top rebar, corrosion measurements were conducted. Initially, measurements with the Profometer PM8500 were carried out. Subsequently, for measurements with the Gecor 10, the strategy discussed in Section 4.1.2 was implemented. A pulse duration of 100 seconds was applied for each CR measurement due to the expected passivity. Figure 4.8d shows the author attempting to record the measurements on a notepad in windy conditions

Figure 4.8: Corrosion measurements on the support beam.

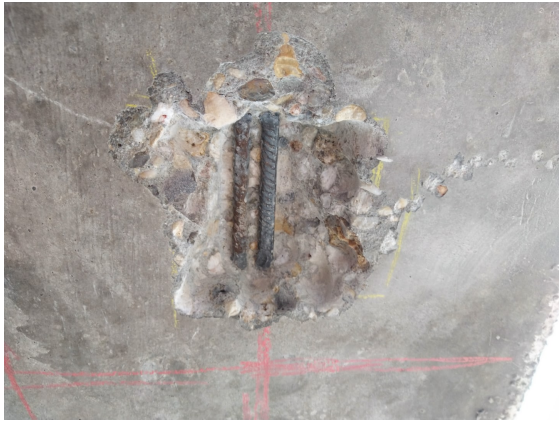
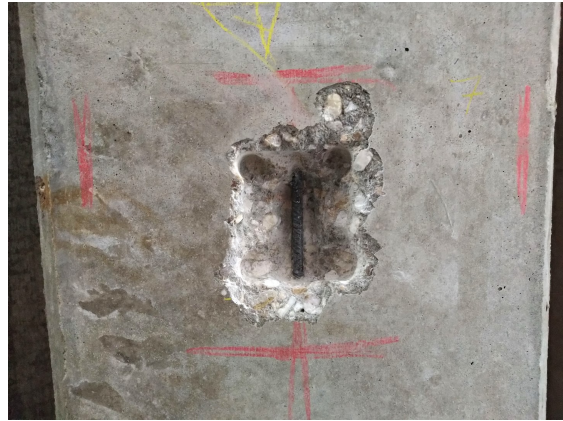
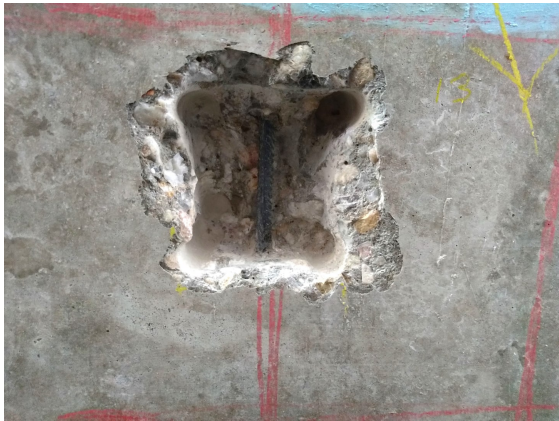
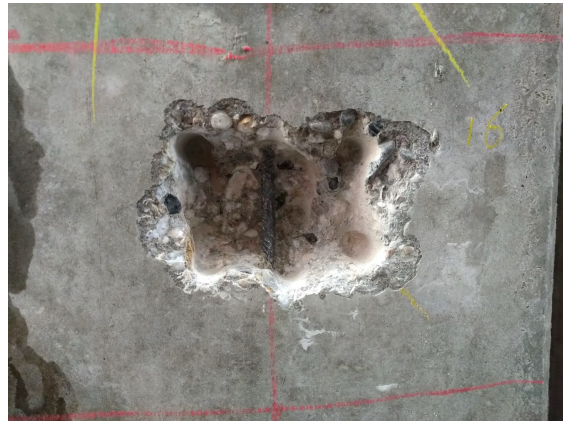
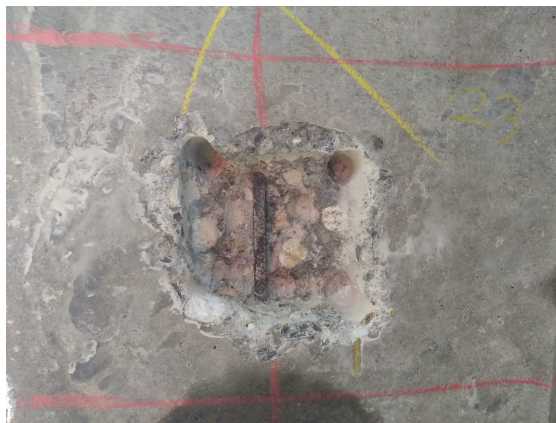
The reinforcement was exposed at the bottom of the T-beams at the level of the walkway platform, as shown in Figure 4.9. All identified rebars have a diameter of 8 mm and an average concrete cover of 35 mm.

Figure 4.9: Exposed bottom reinforcement in the T-beams.

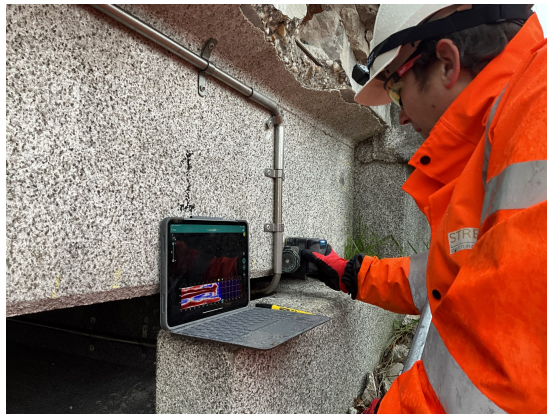
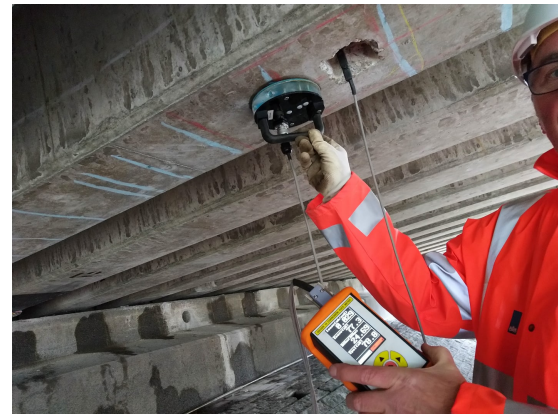
Figure 4.10: Using GPR on the outer face of beam 1 (a) and measuring the corrosion current density on beam 13 using the Gecor-10 (b).

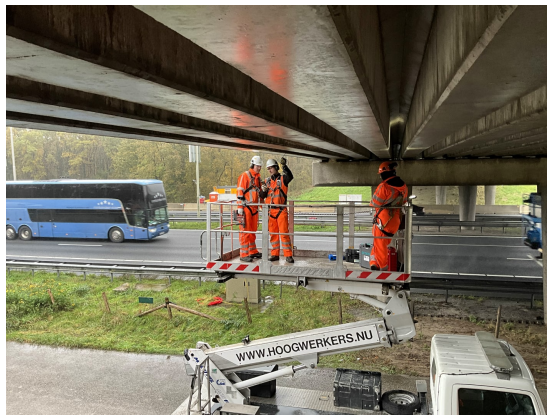
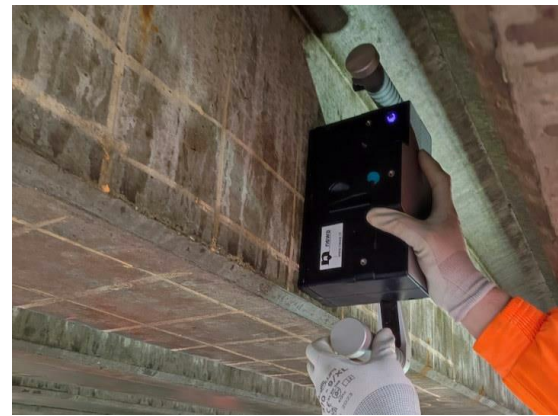
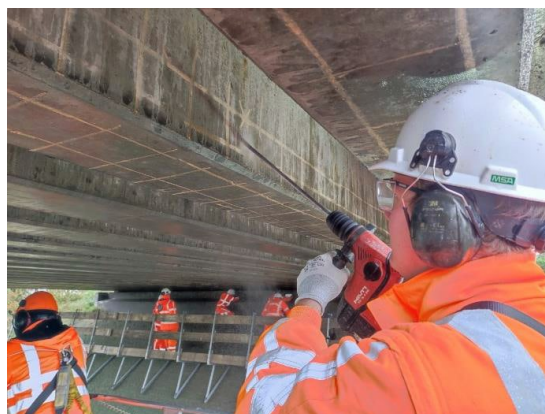
GPR was used to map the reinforcement within the beam heads, and in conjunction with UPE, an inspection of the tendon ducts was conducted to identify potential grouting defects, as shown in Figure 4.11. Following this, an assessment involving the rebound hammer and UPV with direct transmission was undertaken. Corrosion measurements were subsequently performed on the beam heads, using the previously exposed reinforcement. Prior to this, electrical continuity was established. Beam 13 has been previously equipped with cathodic protection as described in Section 3.3.5.

Figure 4.11: Performing endoscopy on a tendon duct at midspan on beam 2 (a), UPE testing (b) and drilling a 12 mm borehole (c).

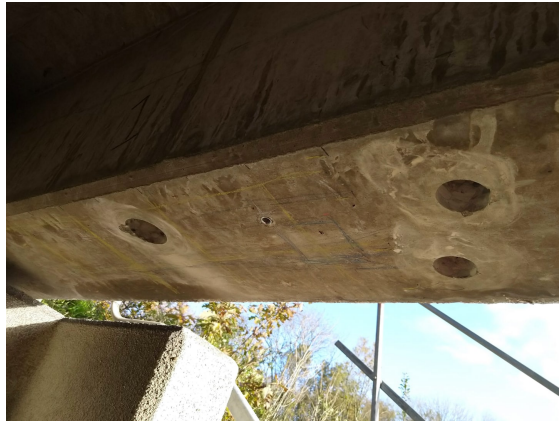
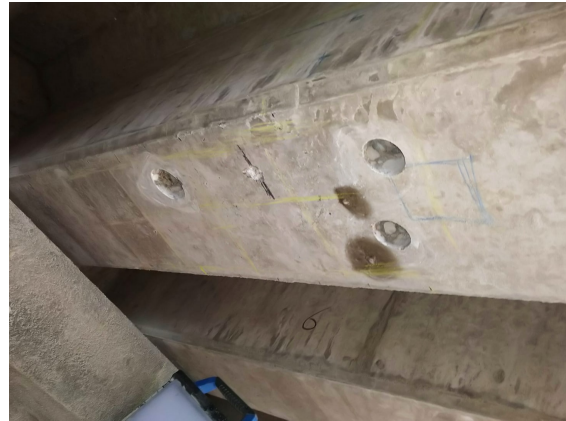
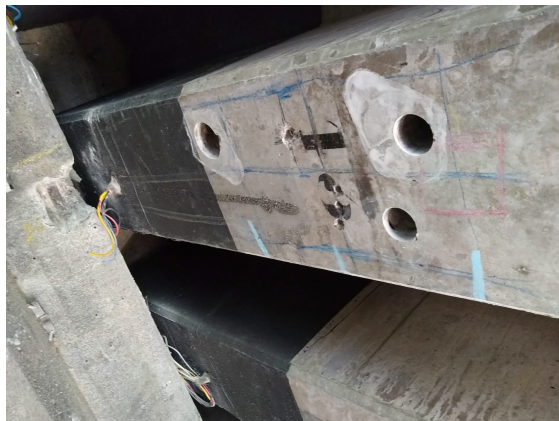
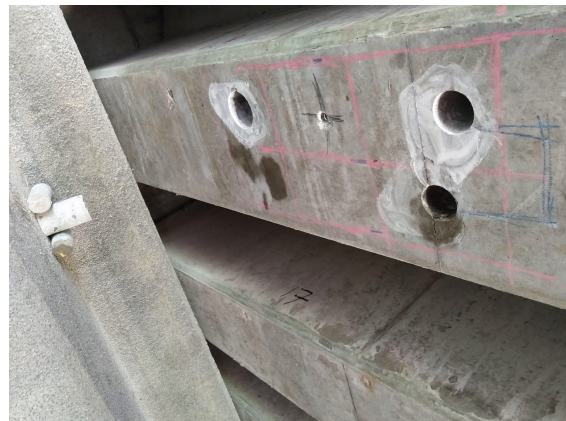
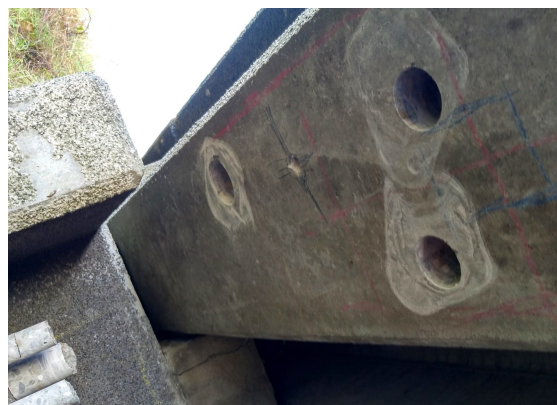
The majority of the cores were drilled on the 15th of November. A total of 28 cores were extracted from STP01, comprising 13 cores from the support beam and 15 cores in total from the five investigated T-beams, with three cores obtained from each beam. The locations of these cores are illustrated in Figures 4.12 and 4.13, along with corresponding in-situ images provided in Figures 4.14 and 4.15. Further details can be found in Appendix E.

Figure 4.14: Location of the cores taken from the T-beams.

Three cores were extracted from the support beam, while one core each was taken from T-beams 1, 7, 13, 18, and 23 (refer to Appendix E for details). The cores were obtained in proximity to the support as can be illustrated in Figure 4.14, with the limitation being the length of the drilling machine.

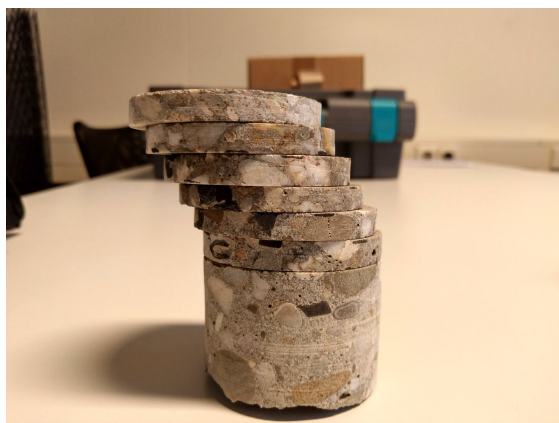
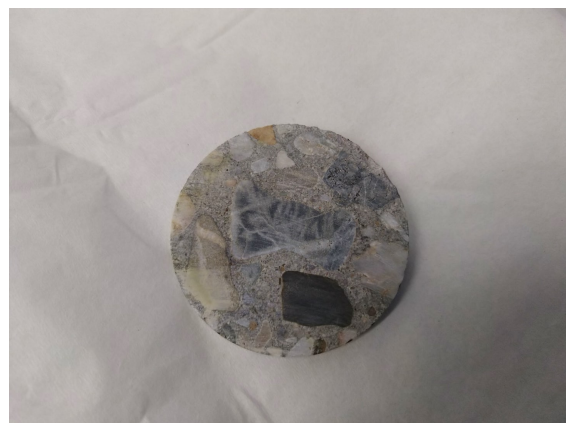
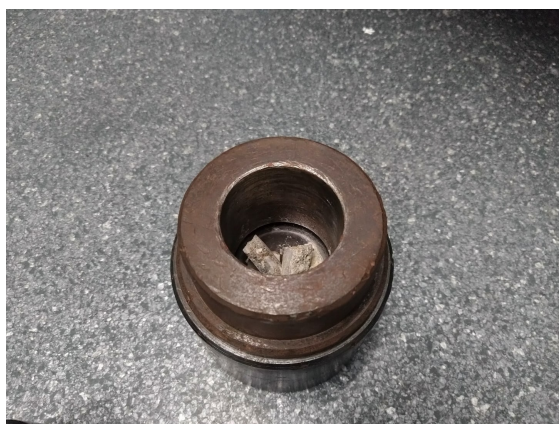
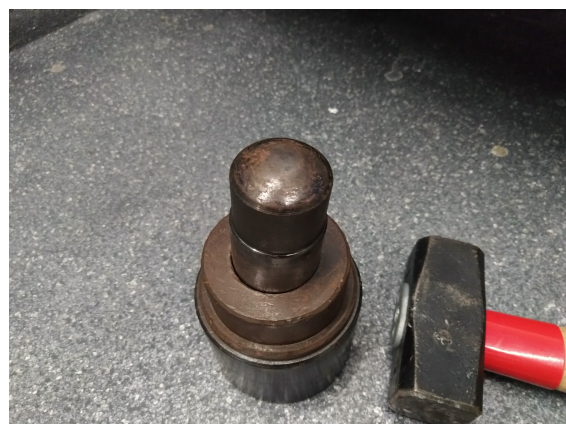
1. The cores are cut into six discs from 10 mm according to CUR recommendation 72. A disc is crushed into smaller pieces using the sample crushing device depicted in Figures 4.16c and 4.16d. Around 30 grams of concrete from a 10 mm core disc are placed in a 400 mL beaker.

Figure 4.16: Preparation of the sample.

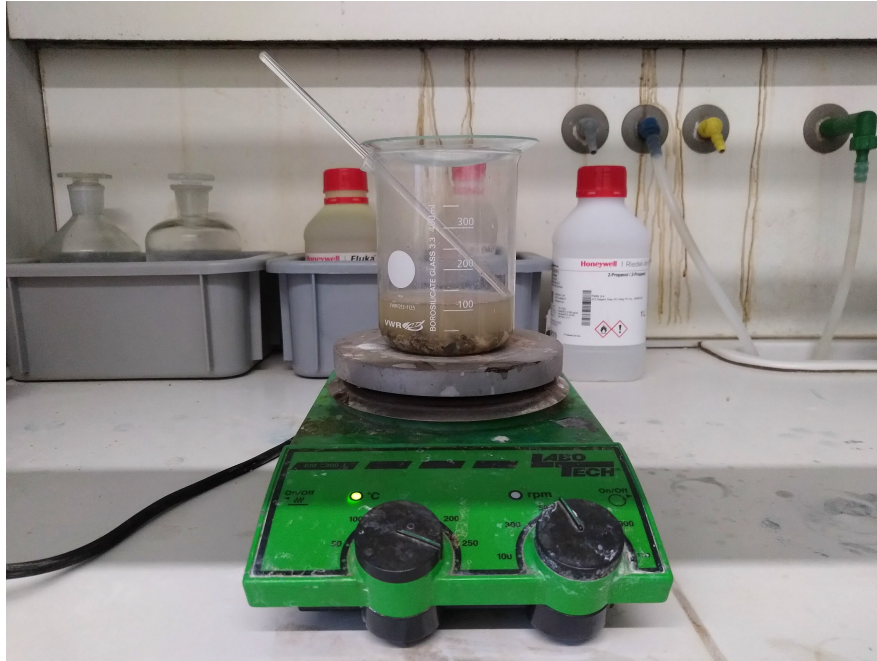
2. In the fume hood, 100 mL of 4M nitric acid is added using a graduated cylinder to the beaker containing the concrete sample. The beaker is covered with a watch glass, placed on a heating plate, and brought to a boil. Subsequently, it is boiled for 5 minutes with occasional stirring using a stirring rod.

Figure 4.17: Boiling the sample in 4M nitric acid.

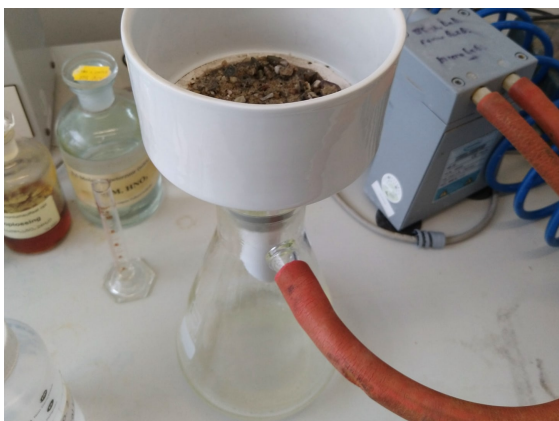
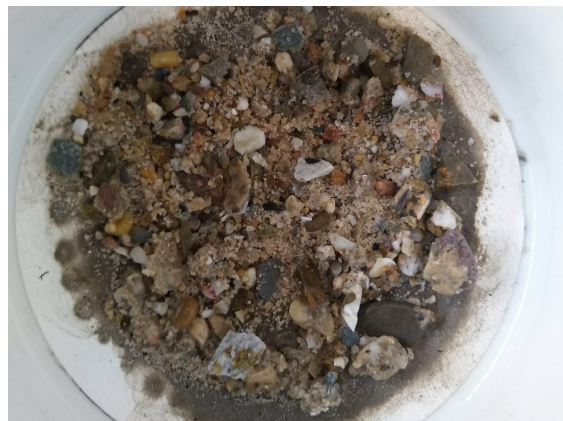
3. The heated solution is filtered through a large Büchner funnel using a 1000 mL filter flask and a membrane vacuum pump. Glass microfiber filter paper with a diameter of 110 mm is employed. The undissolved material is rinsed and quantitatively transferred with a small amount of deionized water. The residue on the filter is washed with four portions of 10 mL 1M nitric acid.

Figure 4.18: Filtering the heated solution using a Büchner funnel (a) and the resulting filter with residue (b).

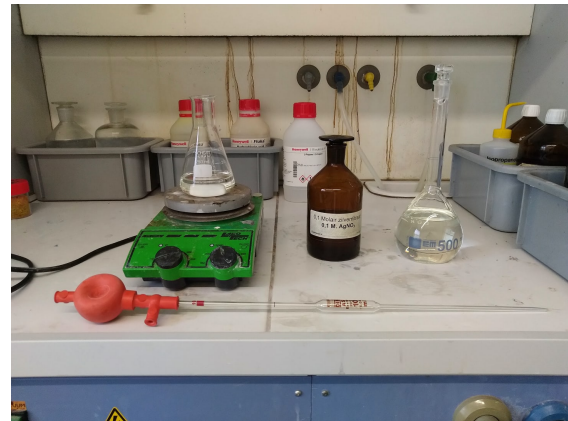
Figure 4.20: Volumetric flask containing the filtrate (a) and adding 0.1 M silver nitrate solution (b).

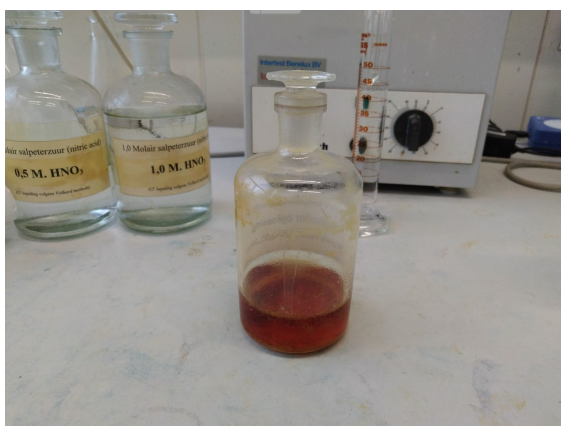
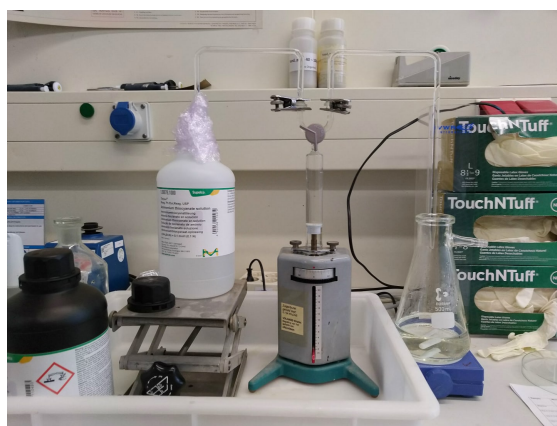
- To the filtrate, 10 mL of a 20% w/w iron(III) ammonium sulfate solution is added. A piston burette is filled with a 0.1 M ammonium thiocyanate solution, and the titration is carried out until a color change occurs from white to orange.

Figure 4.22: Iron(III) ammonium sulfate solution (a) and titration setup (b).

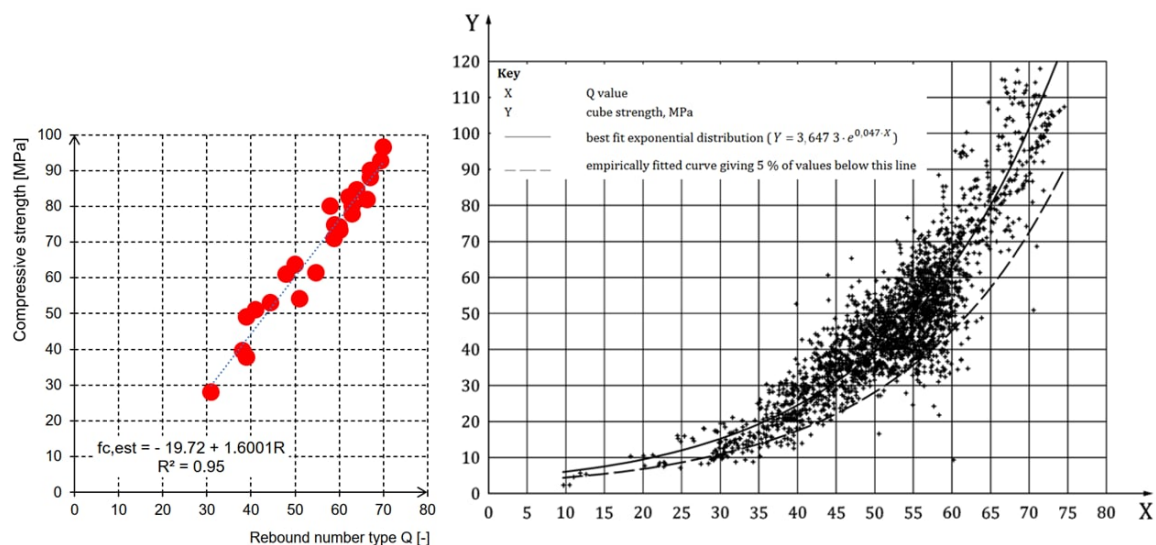
Figure 5.10: Rebound number Q vs cube compressive strength according to Nedeljkovic et al. [91] (left) and CEN/TR 17086 [92] (right).

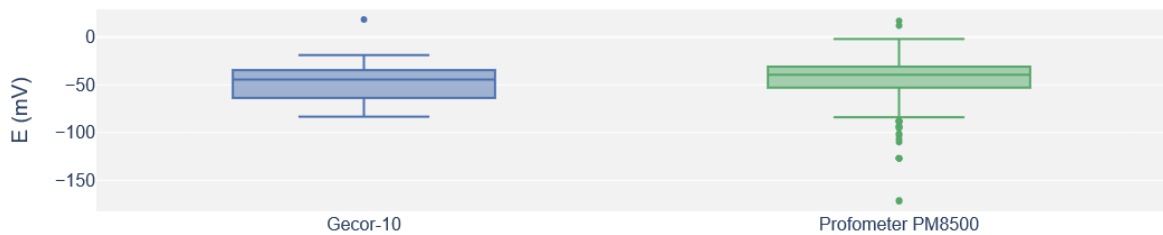
The measurements are presented in a boxplot in Figure 5.13, with Table 5.6 providing the corresponding statistical values. Analysis of this table reveals that both devices are in agreement, showing similar data spreads. However, the Profometer displays more local minima and maxima, which is not surprising given its significantly larger number of data points, exceeding that of the Gecor-10 by more than 12 times.

Figure 5.13: Boxplots of the half-cell potentials measured on the support beam using the Gecor-10 and Profometer PM8500.

- Both the Gecor-10 point electrode and Profometer PM8500 wheel electrode (both Cu/CuSO<sub>4</sub>) show good agreement with each other.
- The potentials measured on the support beam generally show negative values, typically up to around -100 mV. In contrast, the high-strength T-beams predominantly display positive potentials, with some areas exceeding 200 mV. Although the support beam exhibits seven local areas with potentials below -100 mV, none of them drop below -200 mV. Based on the half-cell potential measurements, the probability of corrosion is therefore considered low for both the support beam and the T-beams.

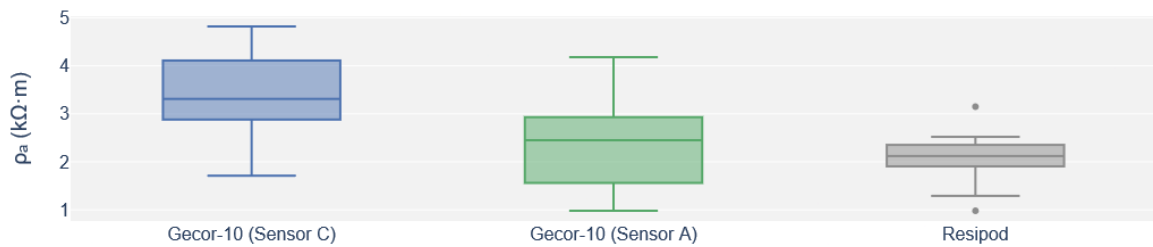
The measurements performed on the support beam are presented in Figure 5.14 and summarised in a boxplot in Figure 5.15, with Table 5.8 providing the corresponding statistical values.

Figure 5.15: Boxplots of the resistivity measured on the support beam using the Gecor-10 and Resipod.

Figure 5.14 illustrates that the Gecor-10 (Sensor C) and the Resipod, both Wenner probes, follow a trend to a certain degree, whereas the method employing the guard ring (Sensor A) shows more random fluctuations. Although all measured values for resistivity are high, indicating a negligible probability of corrosion, the differences between the two Wenner probes call for further investigation. Consequently, additional analysis was carried out in the laboratory, which is outlined in Appendix G. It is worth noting that the method using the guard ring was not further evaluated due to its time-consuming nature. The following conclusions can be drawn based on the in-situ measurements and the laboratory test described in Appendix G:

- The Resipod consistently reports lower resistivities than the Gecor-10, with nearly a factor of 2 difference observed in the laboratory for the non-corroded rebar, as well as in-situ. For the corroded rebar, the discrepancies between the measurements obtained by the two devices are smaller. Nevertheless, the differences are too significant to conclude that both devices fall within the same range of error for assessing the probability of corrosion.

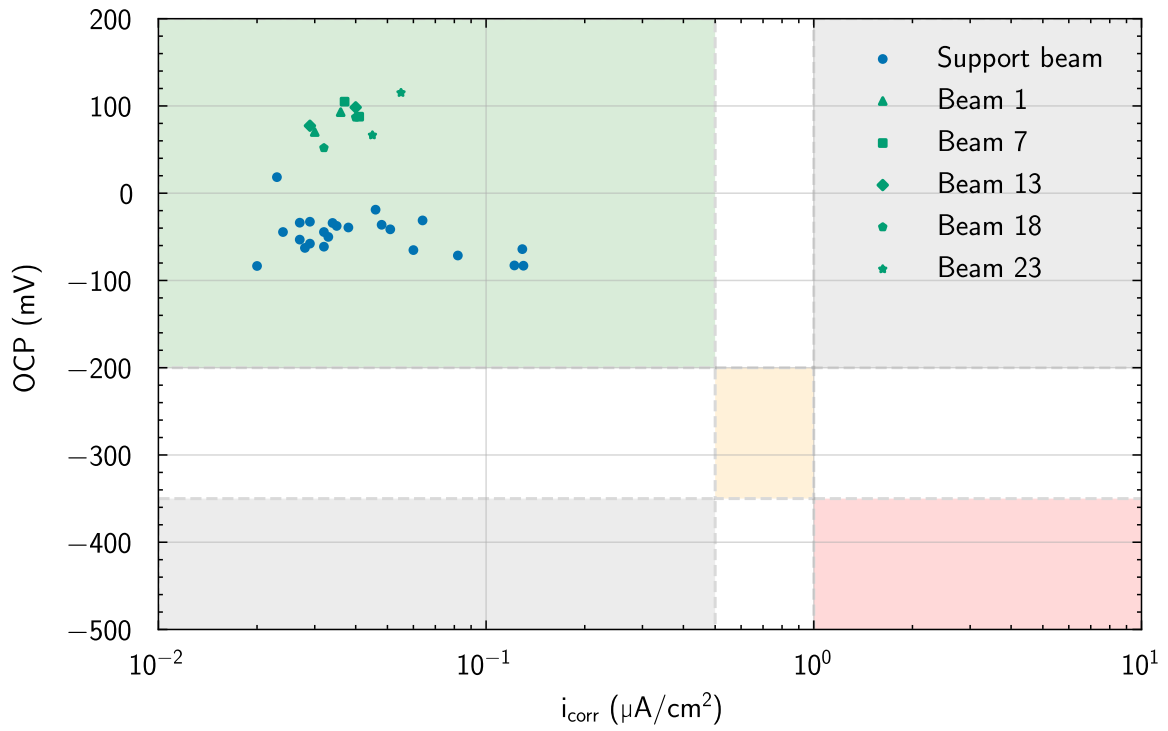
Figure 5.16: Corrosion current density vs OCP for the support beam and T-beams.

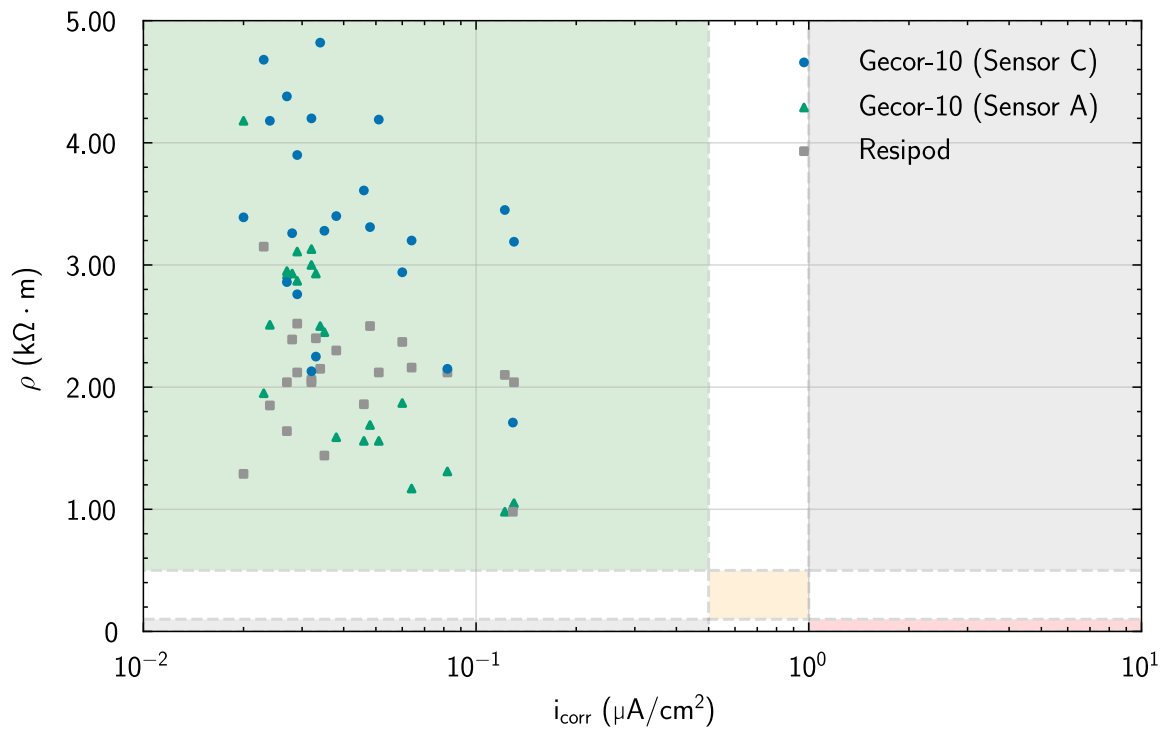
Figure 5.17: Corrosion current density vs resistivity for the support beam.

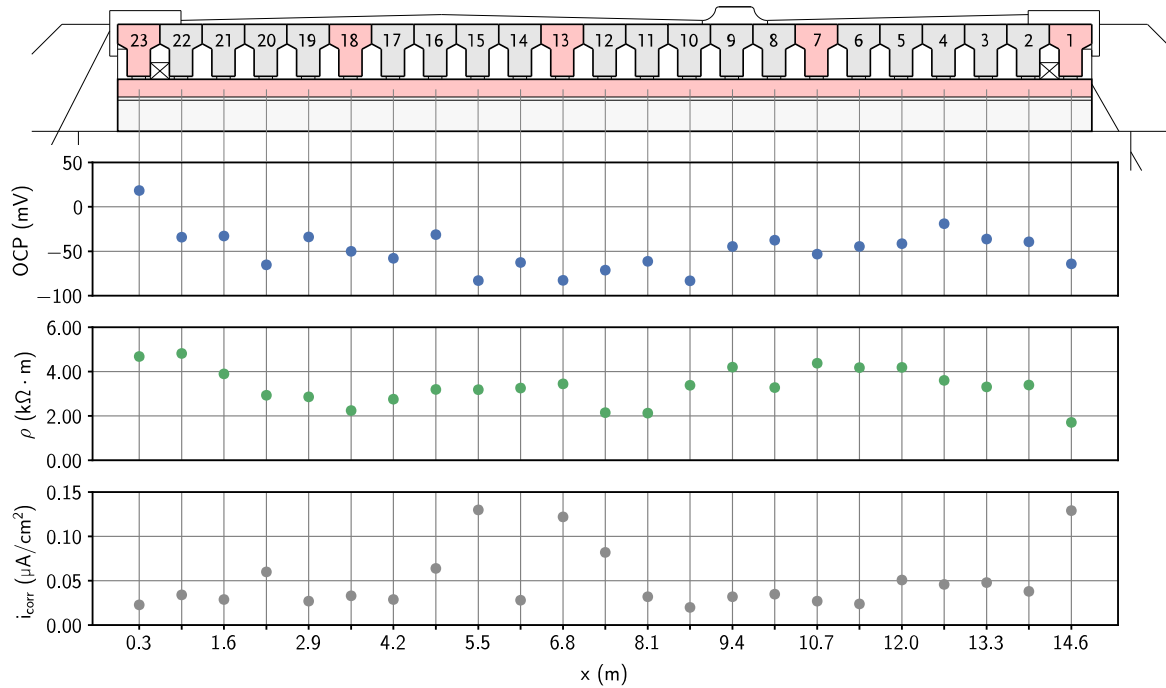
Figure 5.18: Corrosion assessment of the support beam with the Gecor-10.

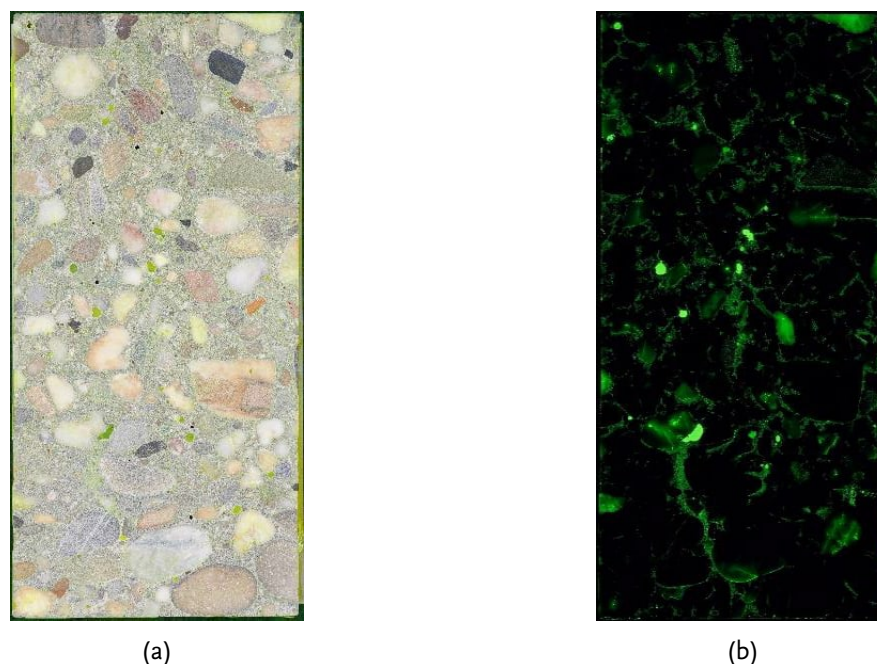
Figure 5.22: Epoxy-impregnated polished section of a core from a beam head under normal lighting conditions (a) and ultraviolet light (b) [93].

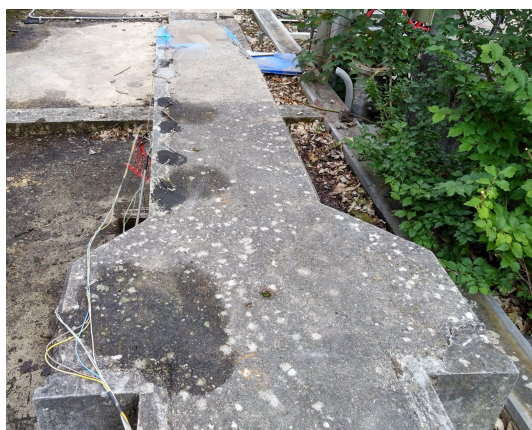
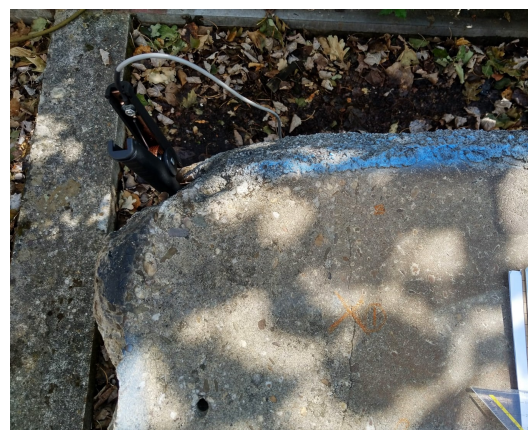
The measurements were carried out on a concrete column that was once part of a parking garage. Five measurement points were placed at half-meter intervals along the face of the column to assess the two primary rebars with a diameter of 22 mm, which will be referred to as the *Top* and *Bottom* rebars hereafter which are in electrical contact. The top rebar is the one shown in Figure B.1b. For each of these points, half-cell potential and current density measurements were performed. Additionally, the resistivity was measured in between the measurement points, where little to no reinforcement was present. The half-cell potential measurements were conducted using Gecor-10's Sensor B with Cu/CuSO<sub>4</sub> electrodes until a stable OCP was recorded. Resistivity measurements were carried out with Gecor-10's Wenner probe (Sensor C). Weather conditions on the day of the measurements were variably cloudy with some rain in the morning prior to the experiment. The measurements were divided in two parts. The first part, referred to as the 'dry' phase, took place around 11 a.m., during which no water was added to the surface of the column or was kept to a minimum, just enough to ensure sensor functionality. The second part, designated as the 'surface wet' phase, was performed at 2 p.m. on the same day, involving thoroughly wetting the surface of the column and waiting around 10 minutes before starting the measurements.

Figure B.1: Parking garage column (a) and rebar clamp (b).

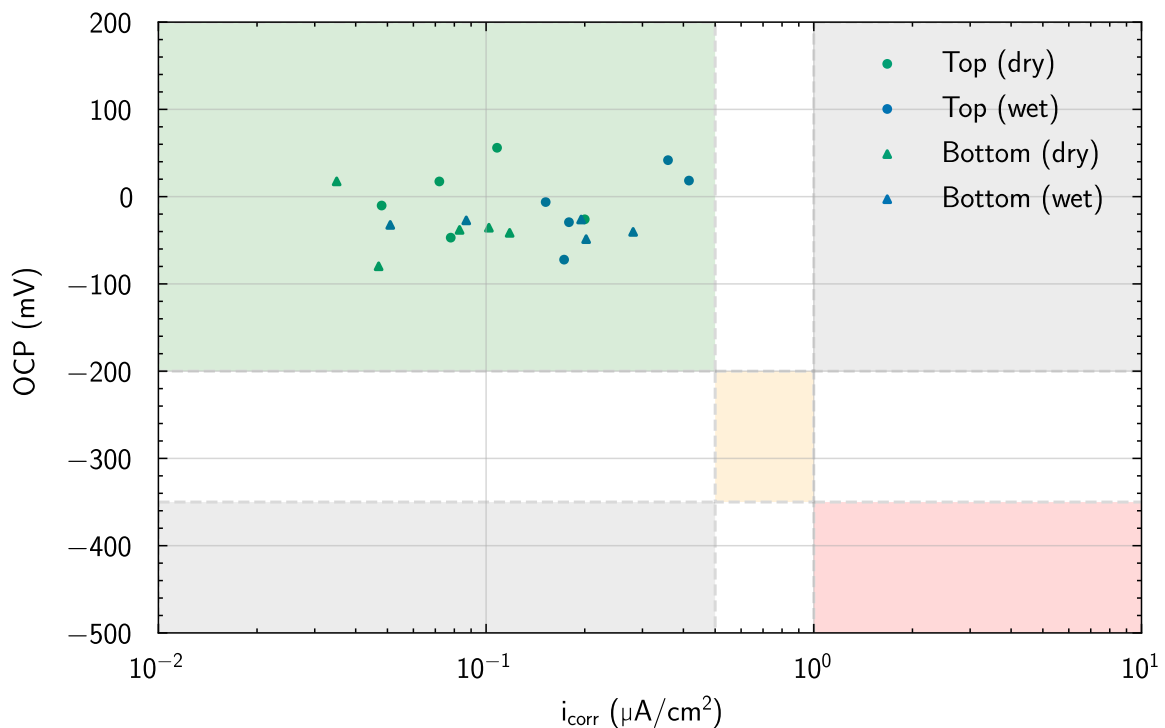
Figure B.2: Corrosion potential (Cu/CuSO<sub>4</sub>) vs corrosion current density.

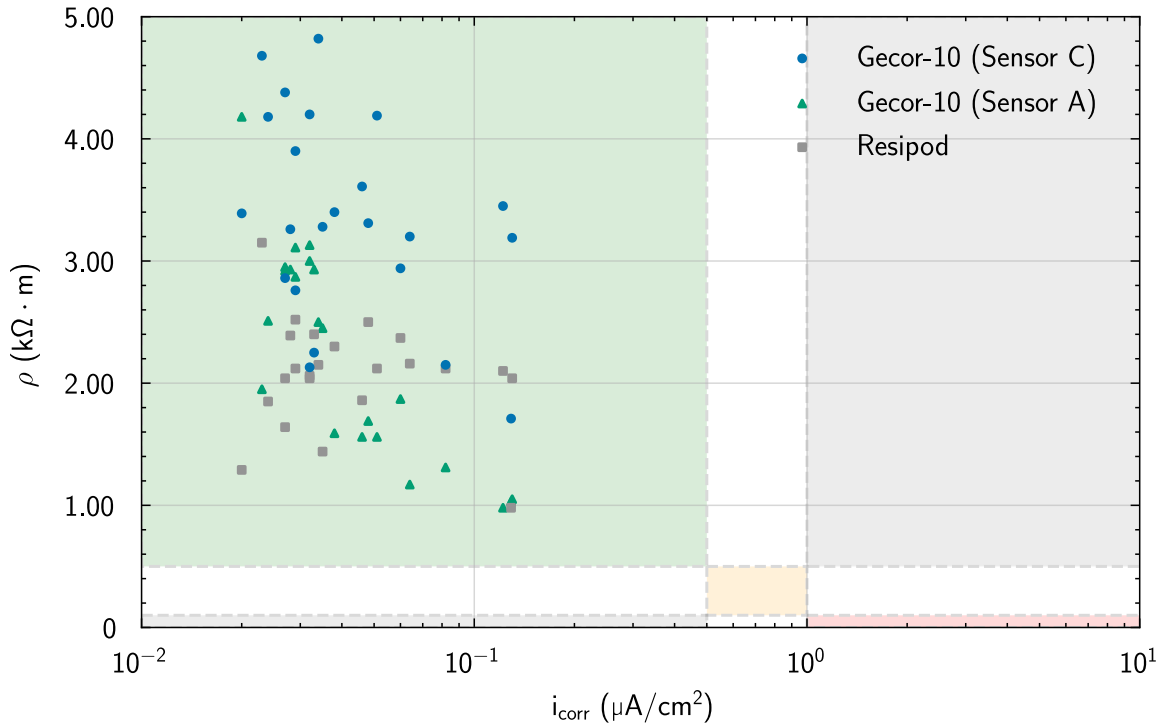
Figure B.3: Concrete resistivity vs corrosion current density.

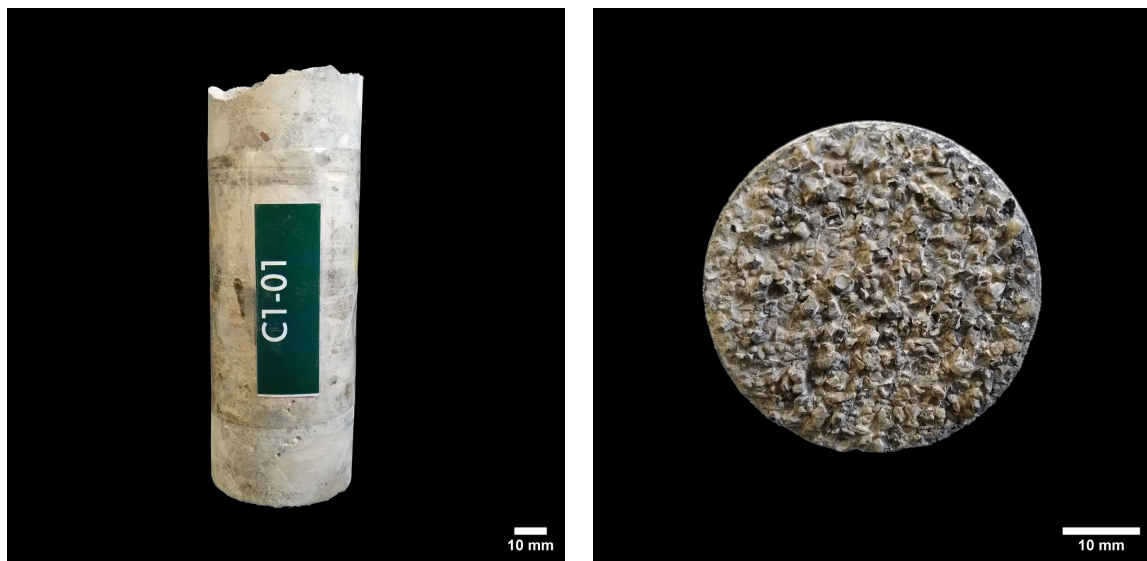
#### C1-01

Date of coring: 15-11-2023  
Part of structure: Support beam  
Diameter: 44 mm  
Minimum length: 115 mm  
Notes: -

Figure E.1: Core C1-01.

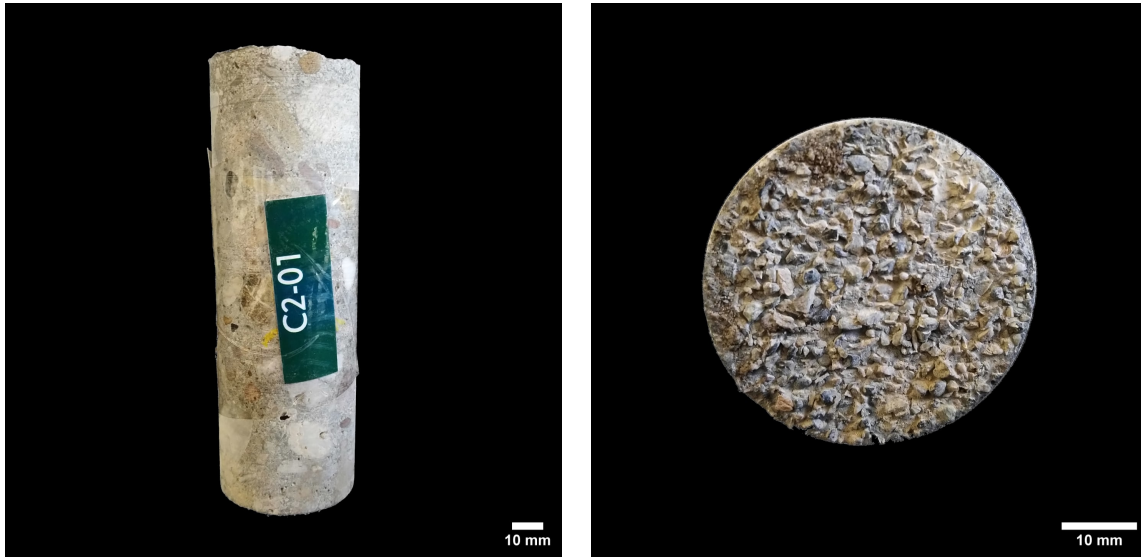
**C2-01**

Date of coring: 15-11-2023  
Part of structure: Support beam  
Diameter: 44 mm  
Minimum length: 132 mm  
Notes: -

Figure E.2: Core C2-01.

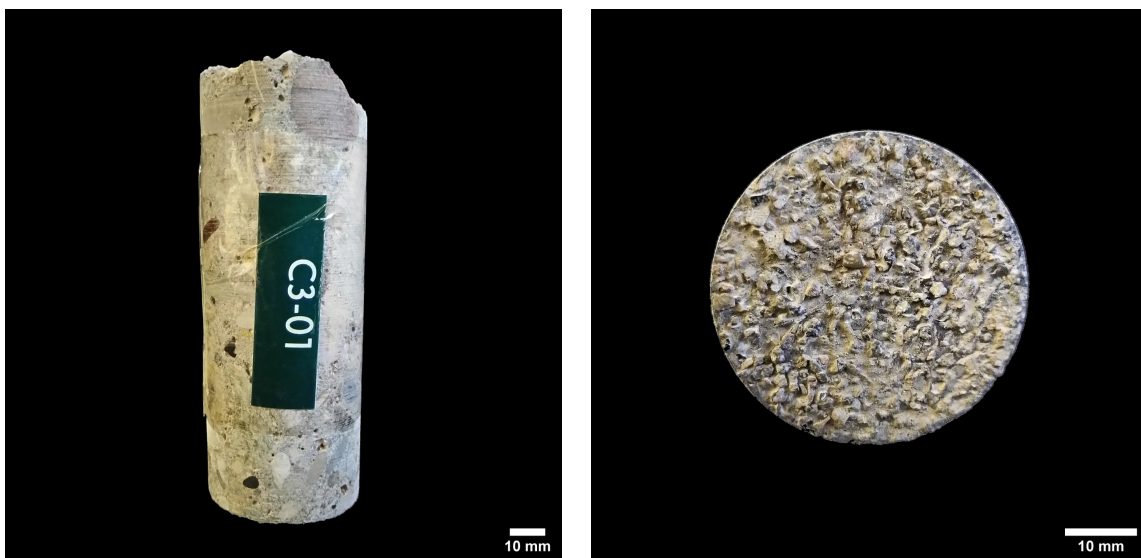
**C3-01**

Date of coring: 15-11-2023  
Part of structure: Support beam  
Diameter: 44 mm  
Minimum length: 108 mm  
Notes: -

Figure E.3: Core C3-01.

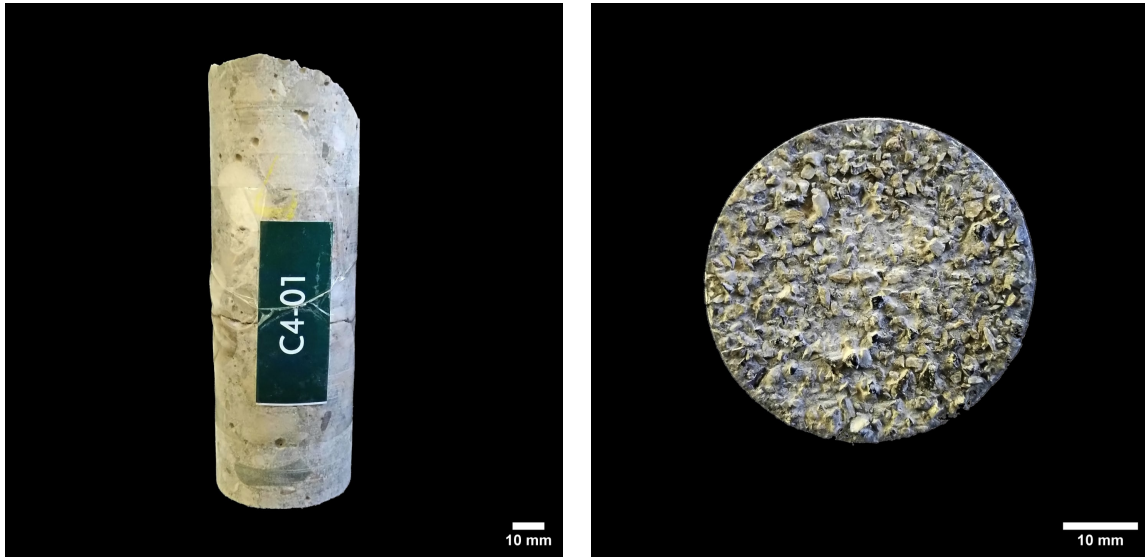
**C4-01**

Date of coring: 15-11-2023  
Part of structure: Support beam  
Diameter: 44 mm  
Minimum length: 115 mm  
Notes: Cracked 55 mm from the surface.

Figure E.4: Core C4-01.

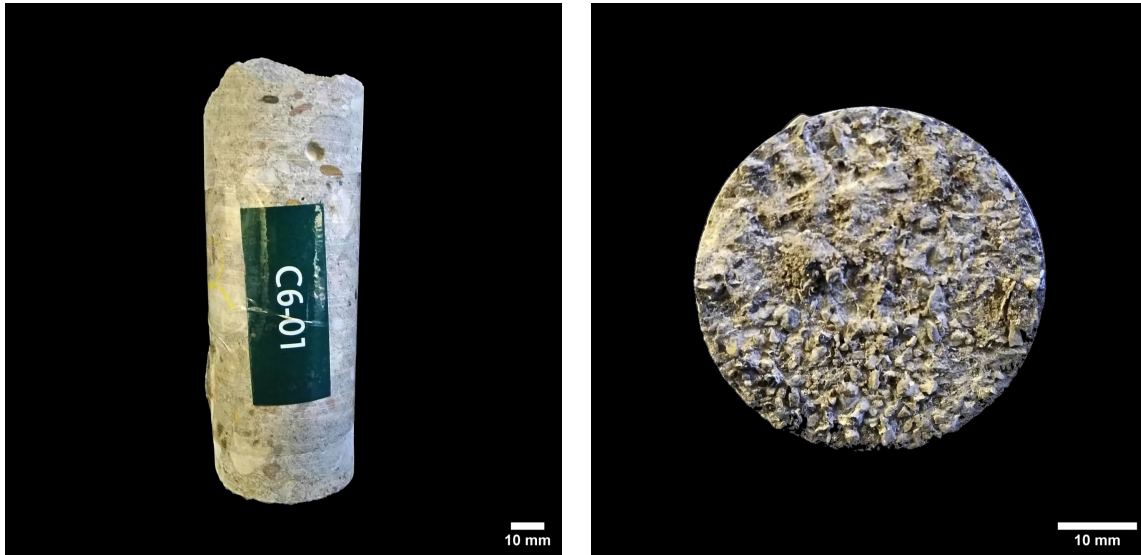
**C6-01**

Date of coring: 15-11-2023  
Part of structure: Support beam  
Diameter: 44 mm  
Minimum length: 105 mm  
Notes: -

Figure E.6: Core C6-01.

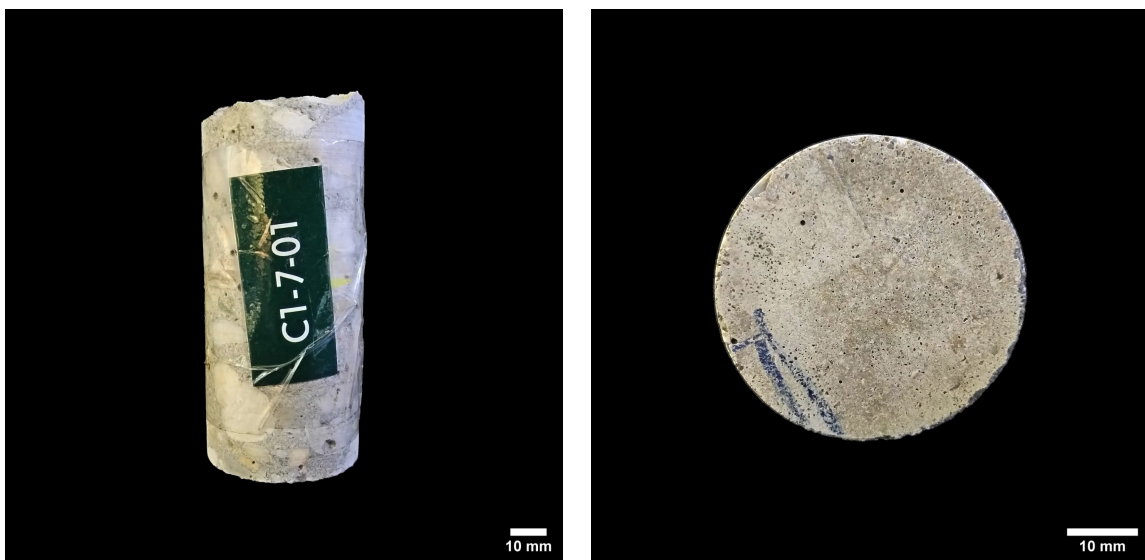
**C1-7-01**

Date of coring: 15-11-2023  
Part of structure: T-beam  
Diameter: 44 mm  
Minimum length: 94 mm  
Notes: -

Figure E.9: Core C1-7-01.

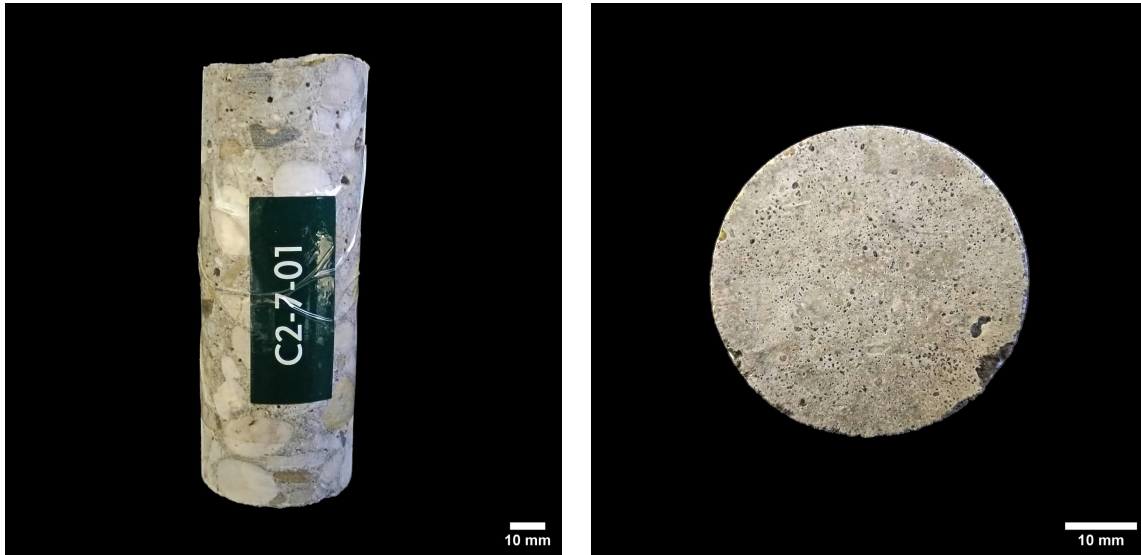
**C2-7-01**

Date of coring: 15-11-2023  
Part of structure: T-beam  
Diameter: 44 mm  
Minimum length: 112 mm  
Notes: -

Figure E.10: Core C2-7-01.

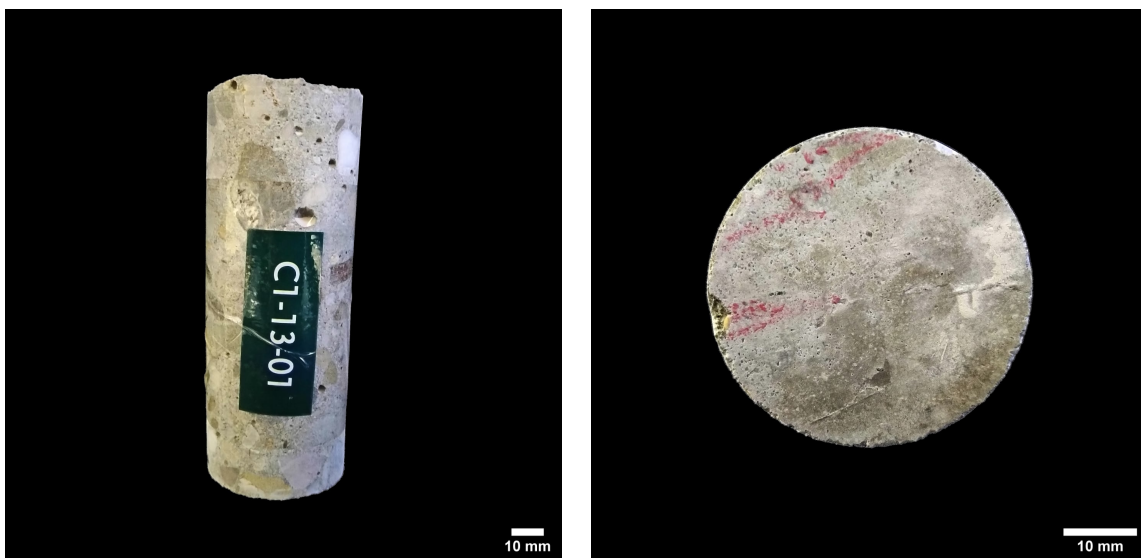
**C1-13-01**

Date of coring: 15-11-2023  
Part of structure: T-beam  
Diameter: 44 mm  
Minimum length: 110 mm  
Notes: -

Figure E.11: Core C1-13-01.

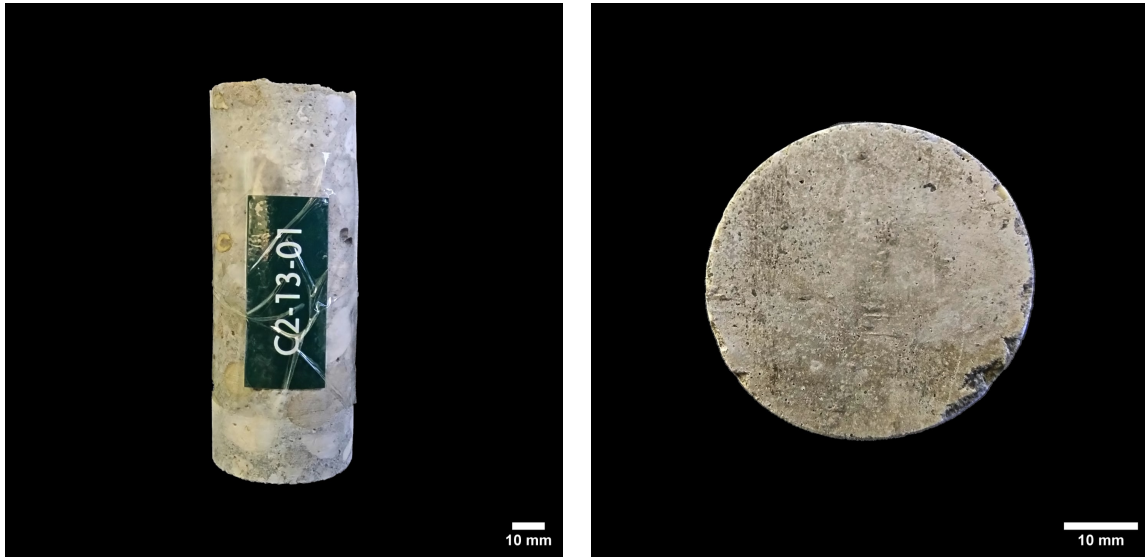
**C2-13-01**

Date of coring: 15-11-2023  
Part of structure: T-beam  
Diameter: 44 mm  
Minimum length: 110 mm  
Notes: -

Figure E.12: Core C2-13-01.

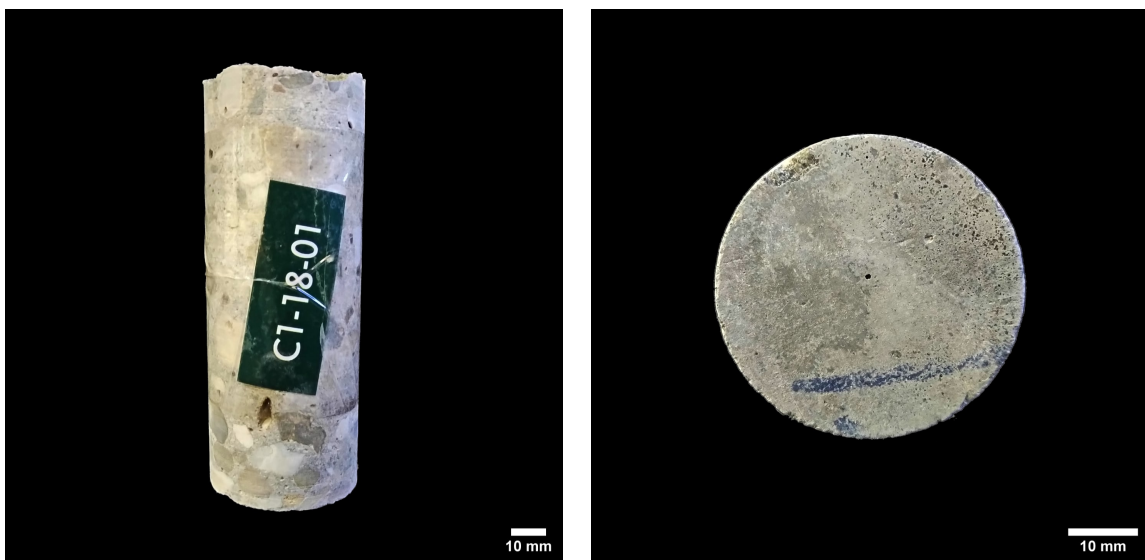
**C1-18-01**

Date of coring: 15-11-2023  
Part of structure: T-beam  
Diameter: 44 mm  
Minimum length: 113 mm  
Notes: -

Figure E.13: Core C1-18-01.
