# Non-destructive material evaluation of a reinforced concrete viaduct: a practical methodology

Gert Wilgenburg

Master's Thesis

**Civil Engineering**

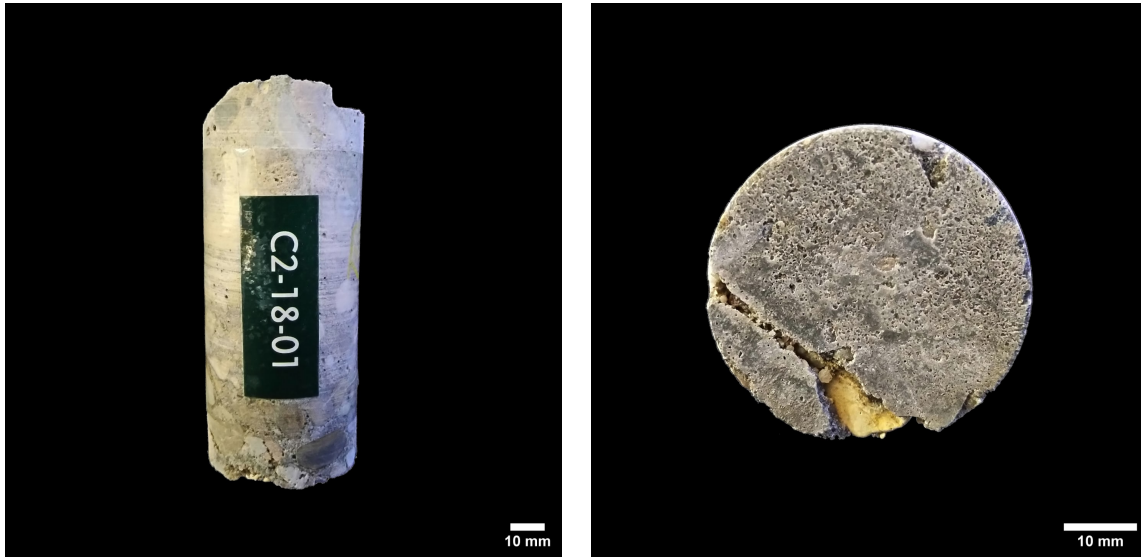
**C2-18-01**

Date of coring: 15-11-2023  
Part of structure: T-beam  
Diameter: 44 mm  
Minimum length: 90 mm  
Notes: -

Figure E.14: Core C2-18-01.

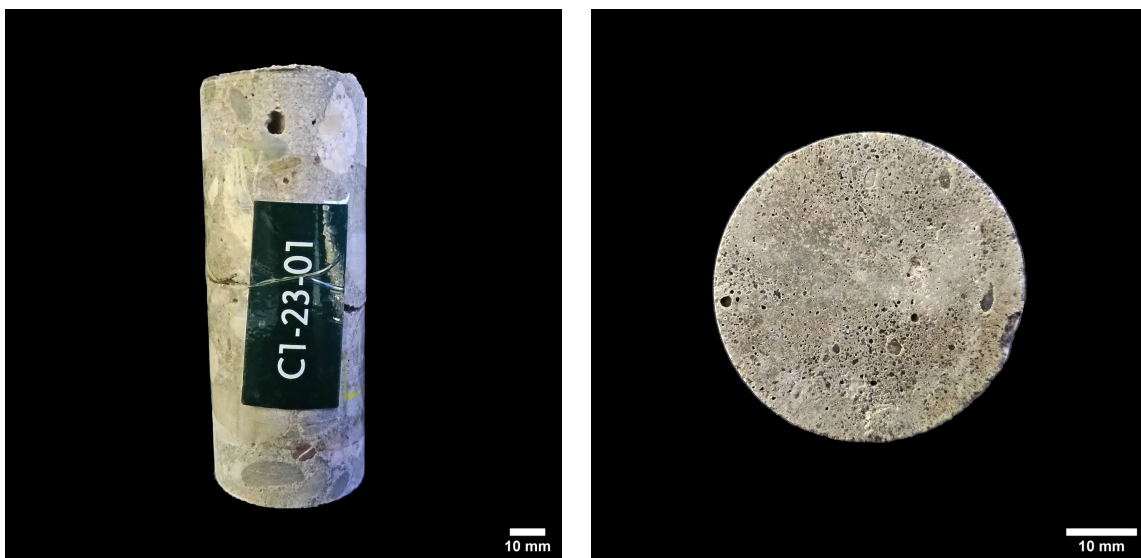
**C1-23-01**

Date of coring: 15-11-2023  
Part of structure: T-beam  
Diameter: 44 mm  
Minimum length: 100 mm  
Notes: Cracked 55 mm from the surface.

Figure E.15: Core C1-23-01.

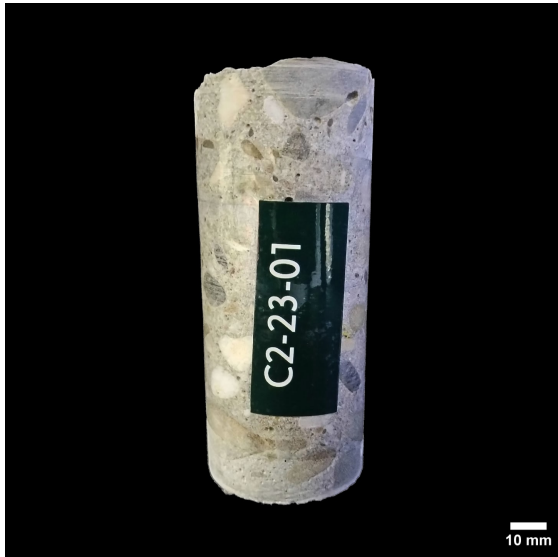
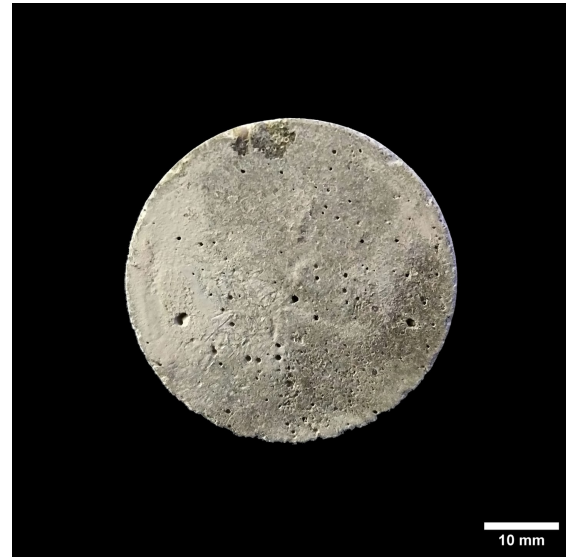
**C2-23-01**

Date of coring: 15-11-2023  
Part of structure: T-beam  
Diameter: 44 mm  
Minimum length: 96 mm  
Notes: -

Figure E.16: Core C2-23-01.

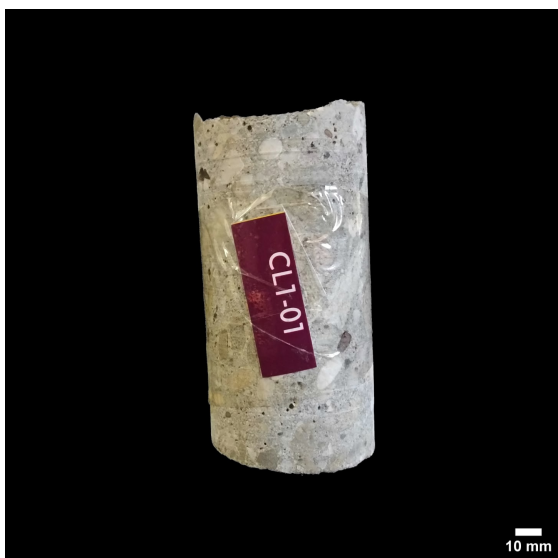
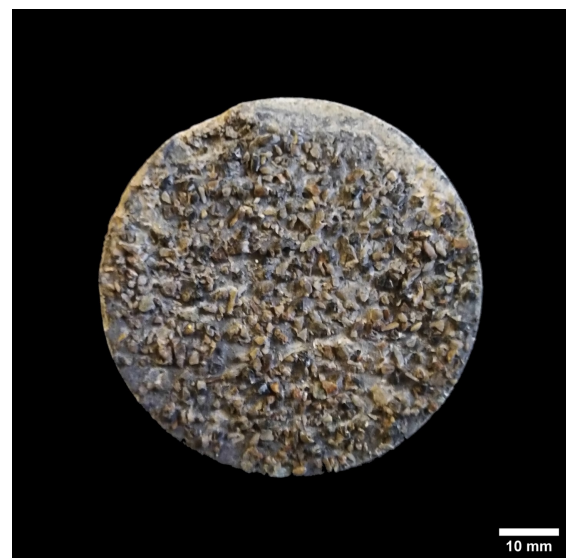
**CL1-01**

Date of coring: 15-11-2023  
Part of structure: Support beam  
Diameter: 64 mm  
Minimum length: 121 mm  
Notes: -

Figure E.17: Core CL1-01.

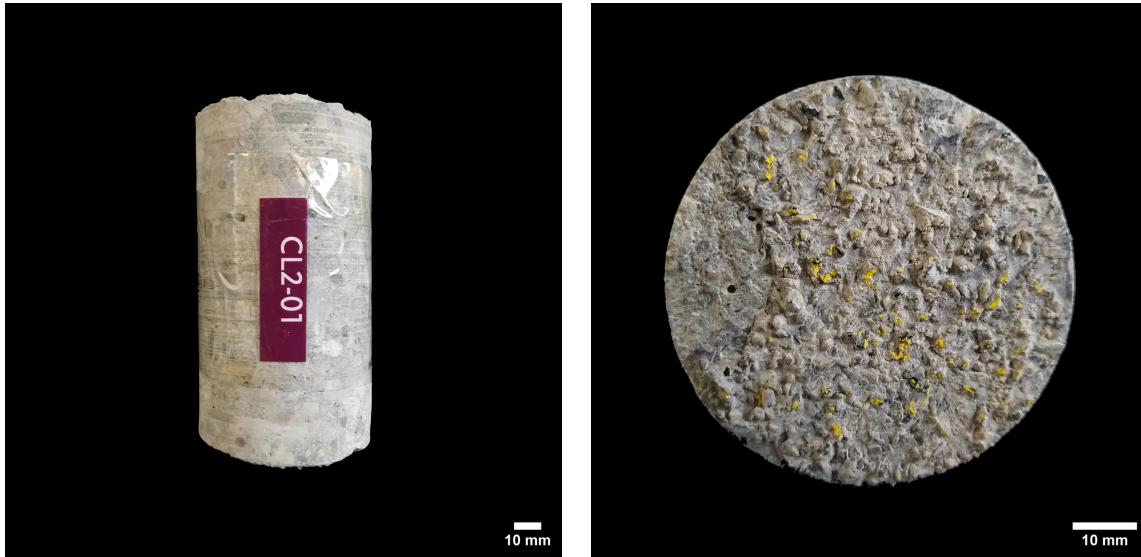
**CL2-01**

Date of coring: 15-11-2023  
Part of structure: Support beam  
Diameter: 64 mm  
Minimum length: 113 mm  
Notes: -

Figure E.18: Core CL2-01.

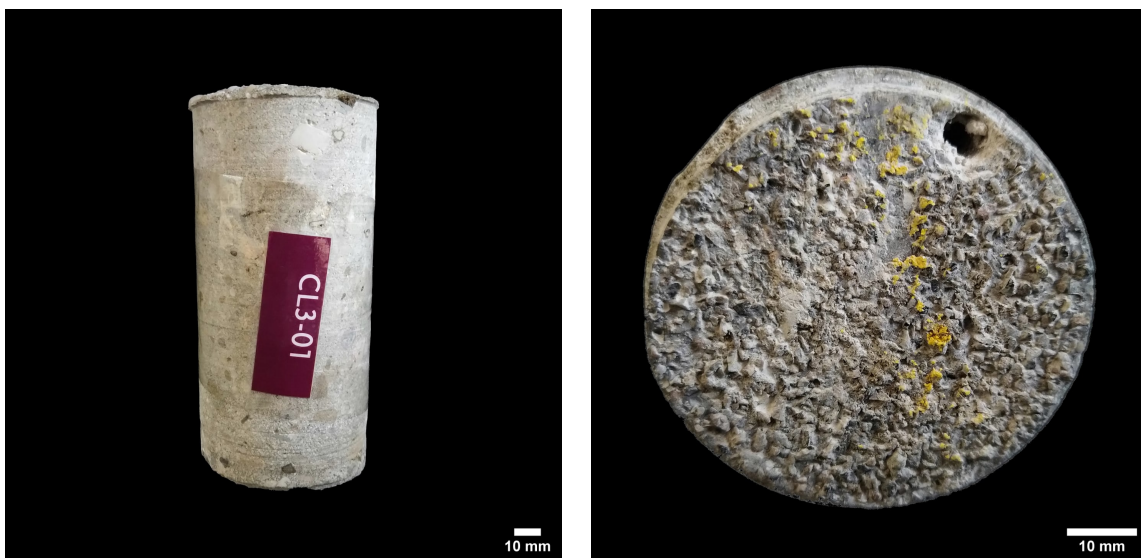
**CL3-01**

Date of coring: 15-11-2023  
Part of structure: Support beam  
Diameter: 64 mm  
Minimum length: 131 mm  
Notes: -

Figure E.19: Core CL3-01.

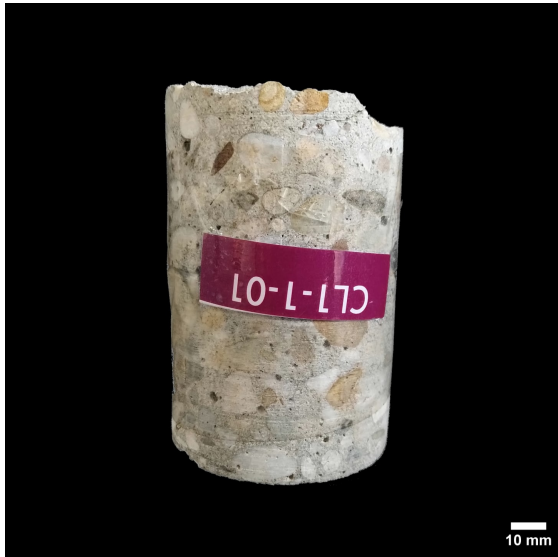
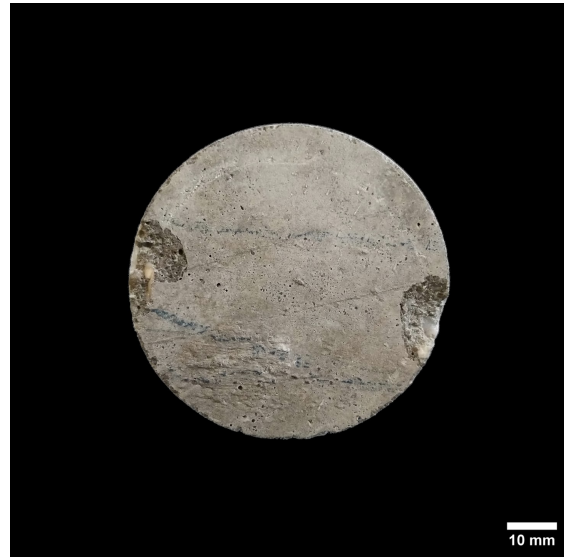
**CL1-1-01**

Date of coring: 14-11-2023  
Part of structure: T-beam  
Diameter: 64 mm  
Minimum length: 87 mm  
Notes: -

Figure E.20: Core CL1-1-01.

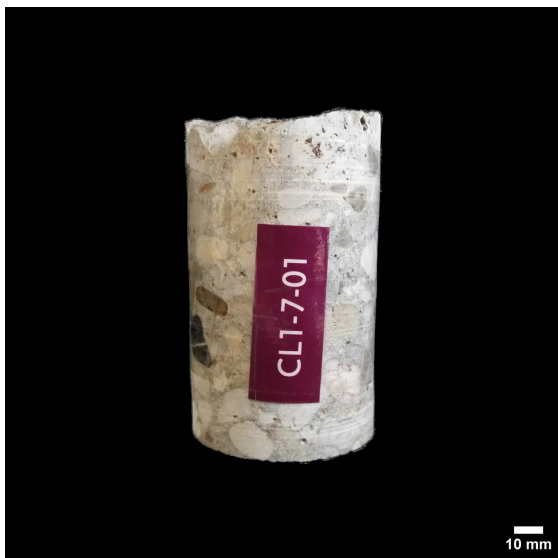
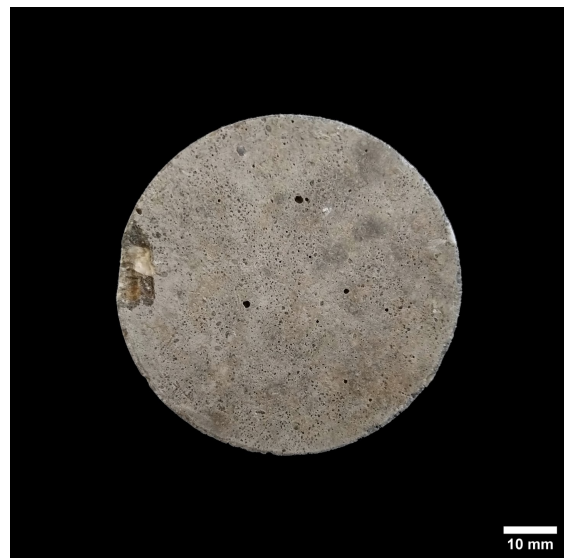
**CL1-7-01**

Date of coring: 15-11-2023  
Part of structure: T-beam  
Diameter: 64 mm  
Minimum length: 100 mm  
Notes: -

Figure E.21: Core CL1-7-01.

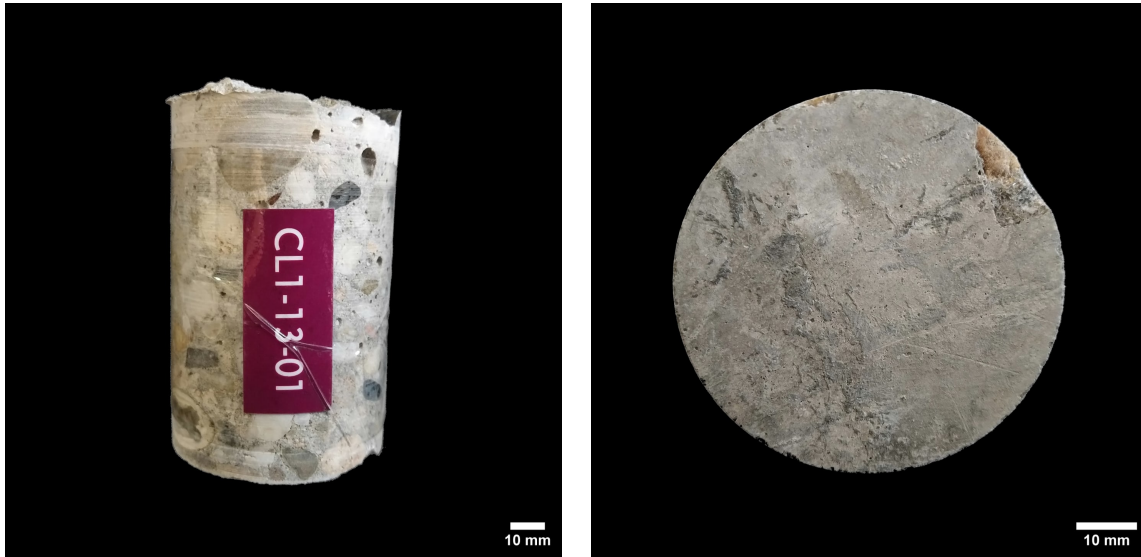
**CL1-13-01**

Date of coring: 15-11-2023  
Part of structure: T-beam  
Diameter: 64 mm  
Minimum length: 93 mm  
Notes: -

Figure E.22: Core CL1-13-01.

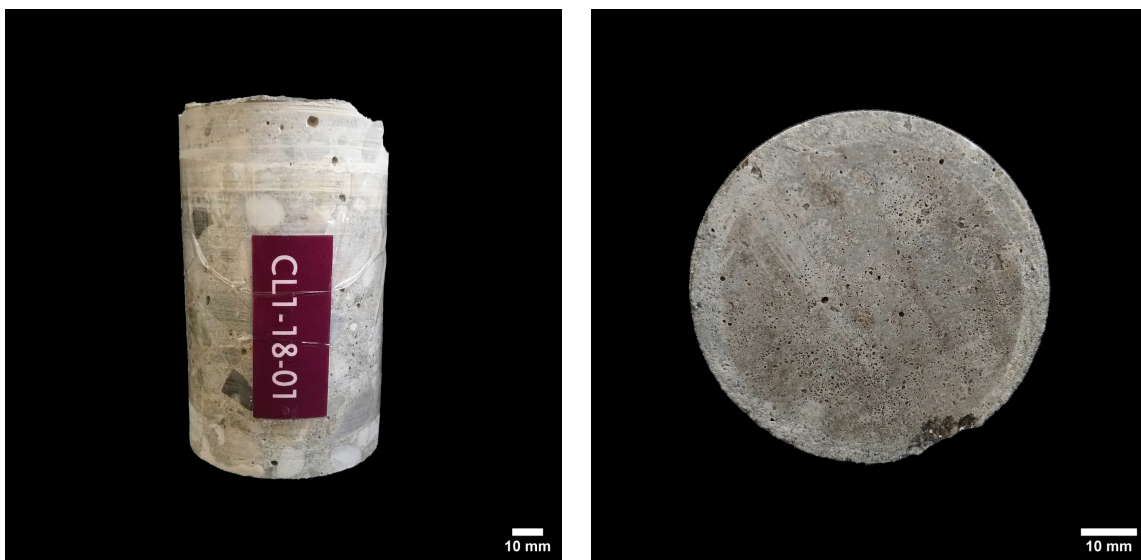
**CL1-18-01**

Date of coring: 15-11-2023  
Part of structure: T-beam  
Diameter: 64 mm  
Minimum length: 91 mm  
Notes: -

Figure E.23: Core CL1-18-01.

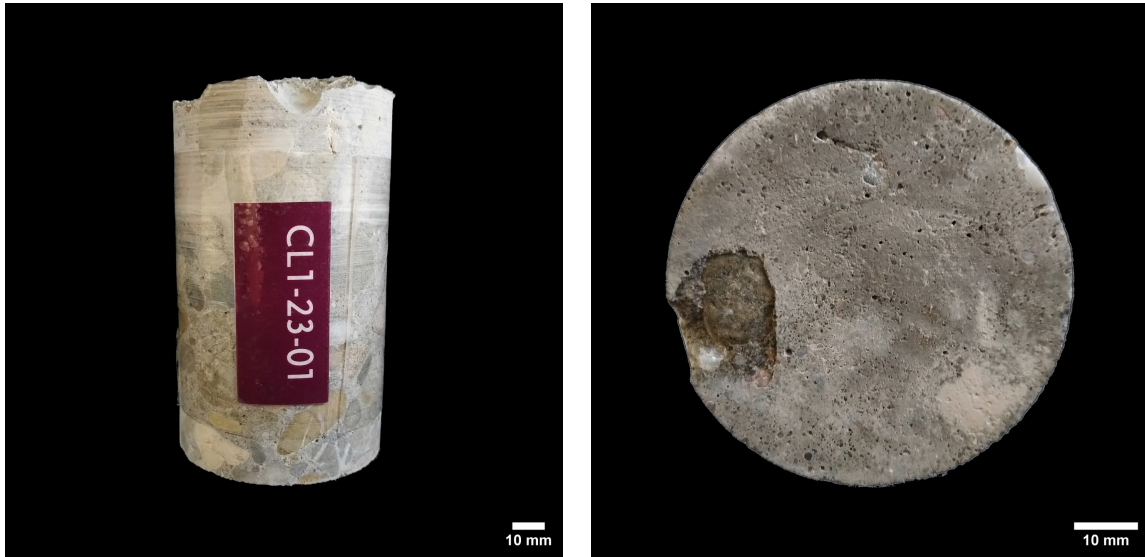
**CL1-23-01**

Date of coring: 15-11-2023  
Part of structure: T-beam  
Diameter: 64 mm  
Minimum length: 94 mm  
Notes: -

Figure E.24: Core CL1-23-01.

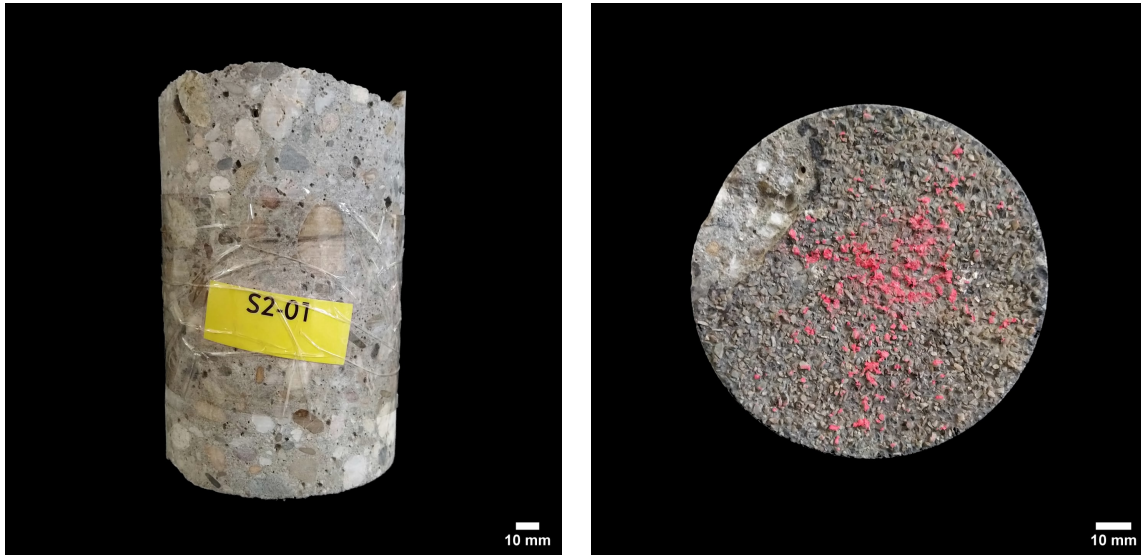
**S2-01**

Date of coring: 14-11-2023  
Part of structure: Support beam  
Diameter: 100 mm  
Minimum length: 138 mm  
Notes: -

Figure E.26: Core S2-01.

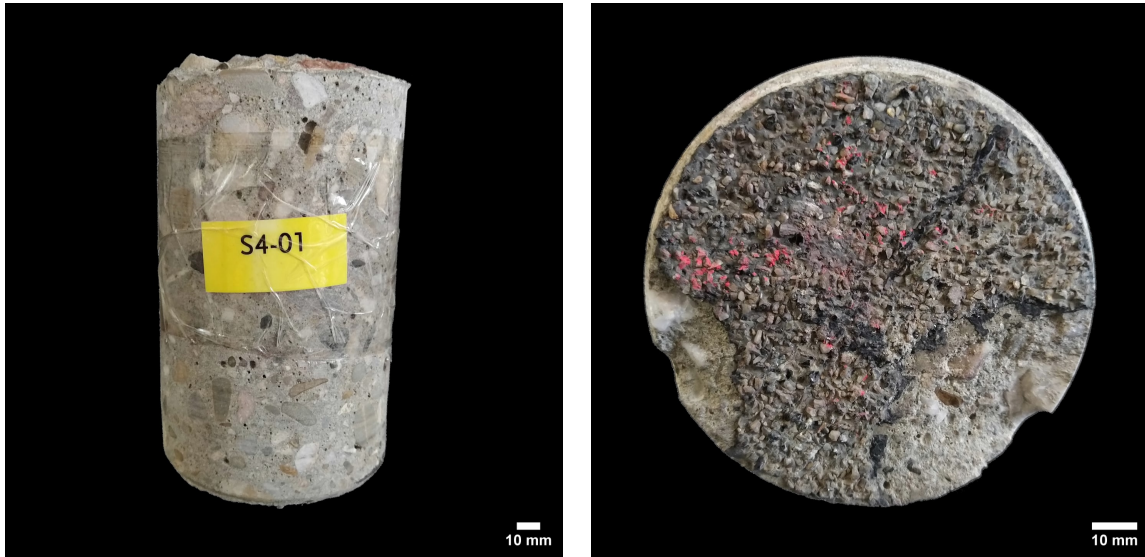
**S4-01**

Date of coring: 14-11-2023  
Part of structure: Support beam  
Diameter: 100 mm  
Minimum length: 150 mm  
Notes: -

Figure E.28: Core S4-01.

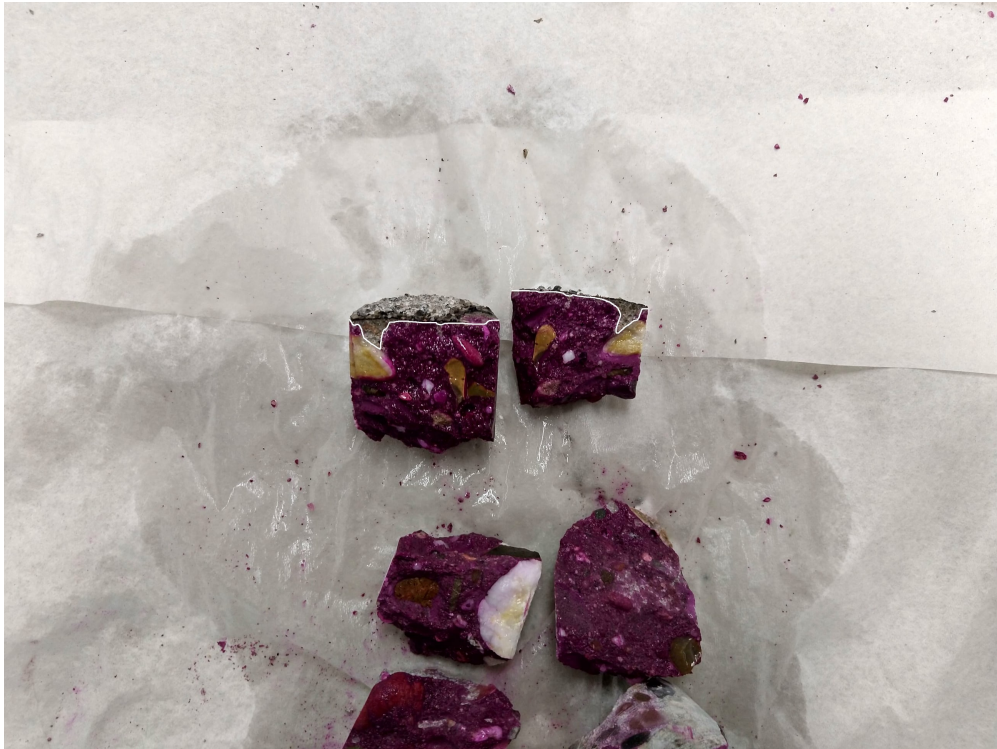
Figure E.29: Carbonation front C1.

Core	$x(t)_{\text{left}}$ (mm)	$x(t)_{\text{right}}$ (mm)
<b>C1</b>	1.5 (max = 9.5)	1 (max = 9.5)
<b>C2</b>	1.5	1
<b>C3</b>	2.5	2
<b>C4</b>	4.5	5
<b>C5</b>	5	5
<b>C6</b>	5	4.5
<b>C1-1</b>	0.5	0.5
<b>C2-1</b>	11 (max = 18)	10 (max = 14.5)
<b>C1-7</b>	0.5	0.5
<b>C2-7</b>	1.5	1.5
<b>C1-13</b>	6.5 (max = 14)	5.5 (max = 16)
<b>C2-13</b>	1.5 (max = 8)	1.5 (max = 10)
<b>C1-18</b>	0.5	0.5
<b>C2-18</b>	2.5	2
<b>C1-23</b>	0 (max = 6.5)	0
<b>C2-23</b>	0.5	0.5

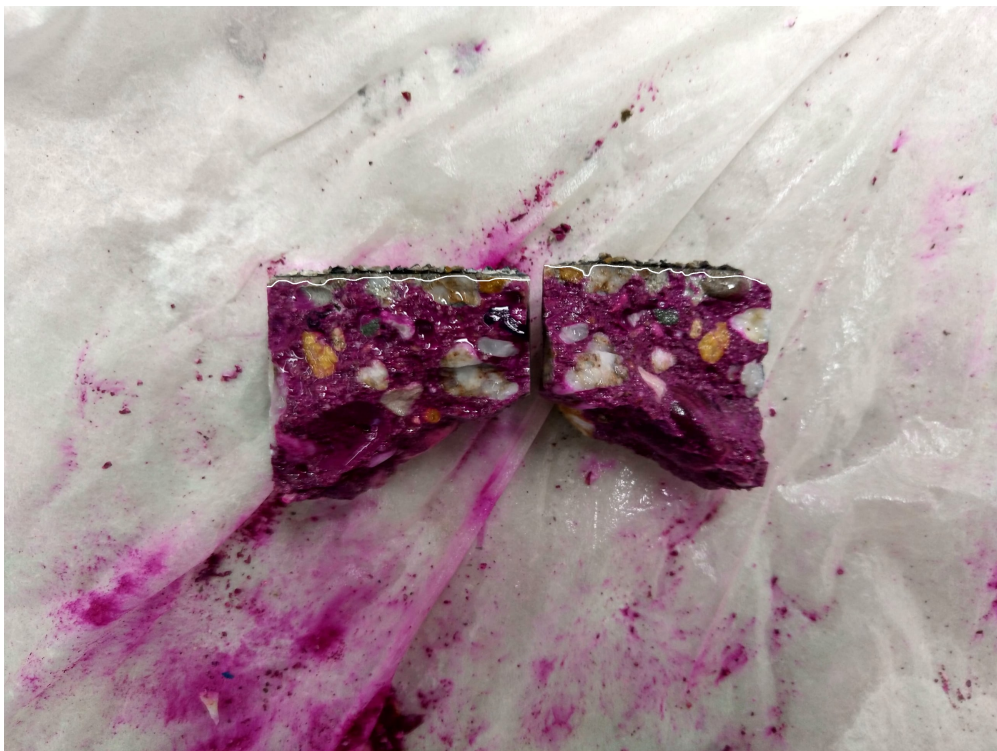
Figure E.30: Carbonation front C2.

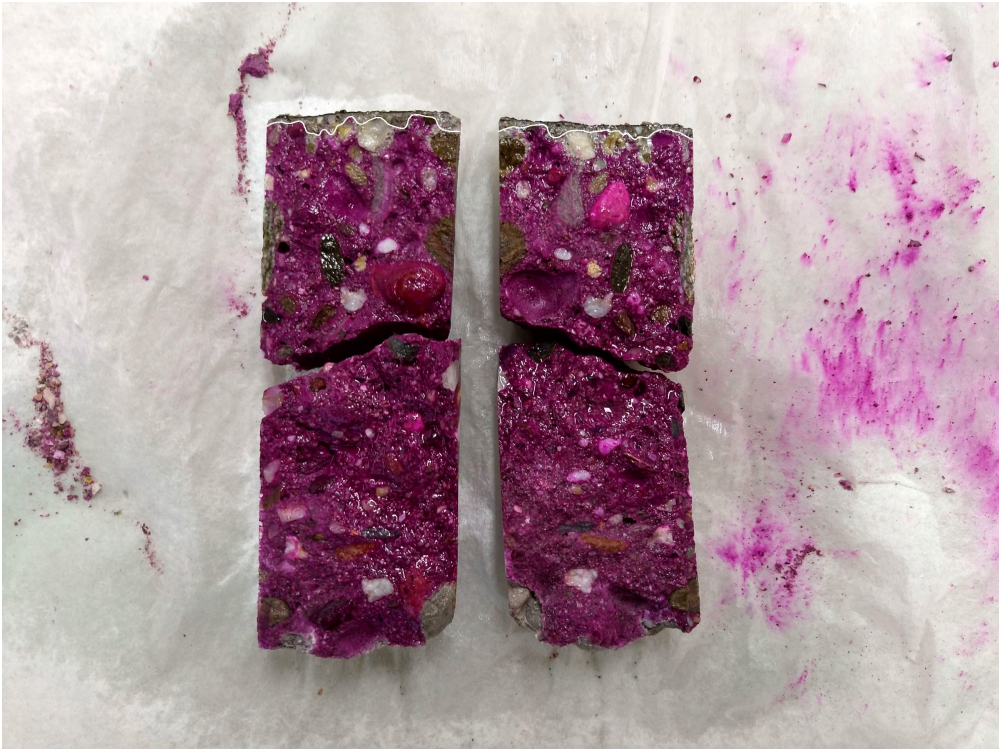
Figure E.31: Carbonation front C3.

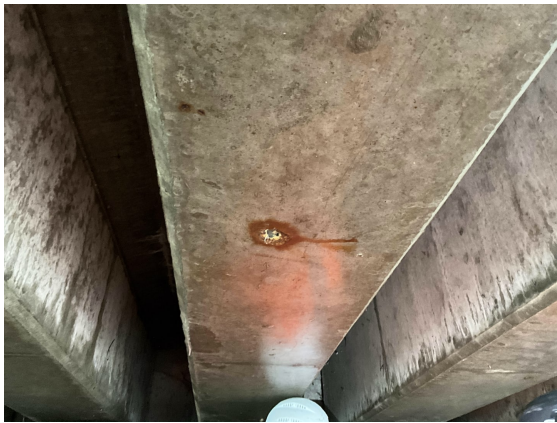
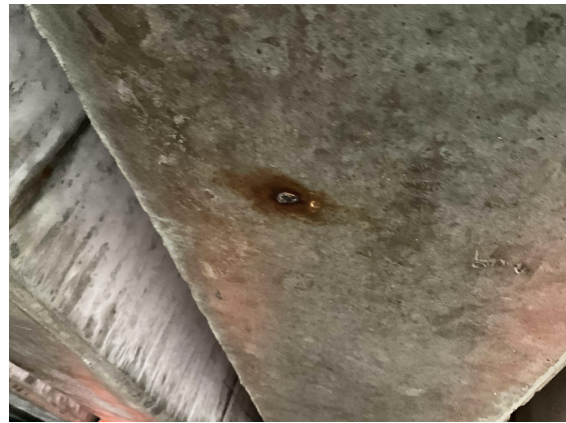
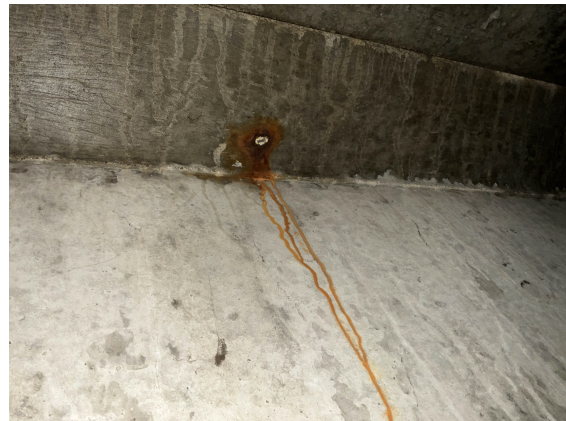
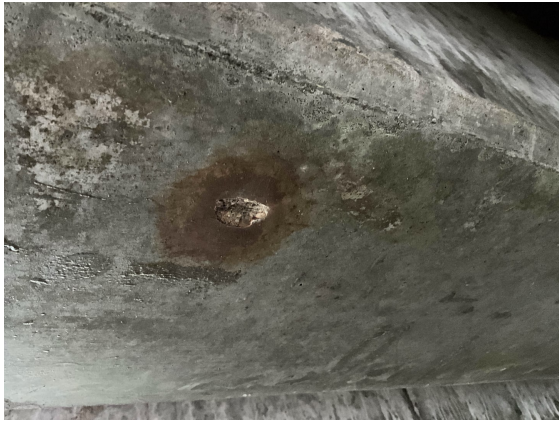
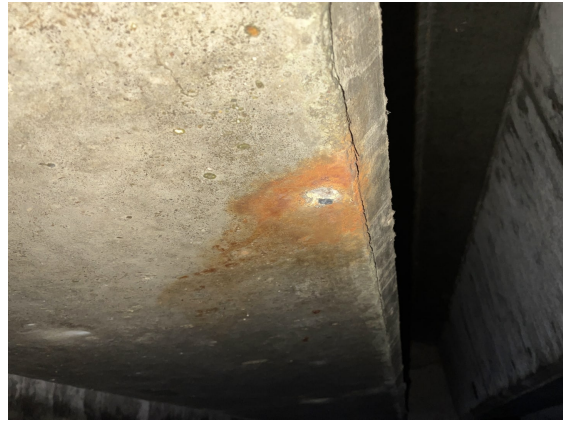
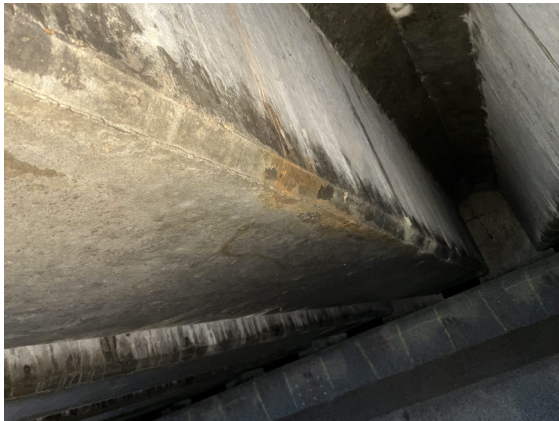
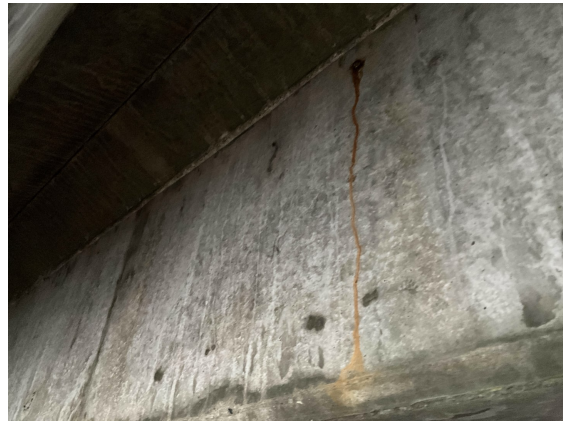
Figure F.1: Minor corrosion damage observed on several beams possibly due to a ferrous aggregate or a loose tie wire.

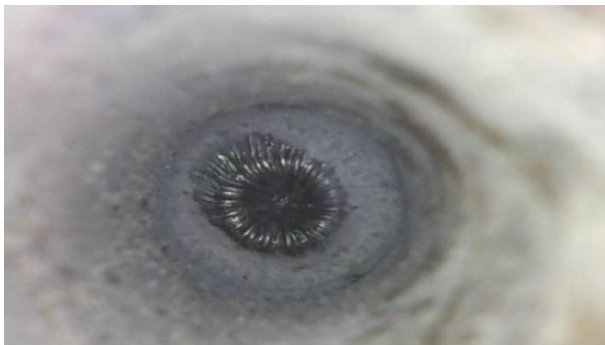
Figuur 4.3: Kijkgat locatie 1-B meetpunt 8.

- Voorspankanaal zichtbaar in elke individuele meting.
- De amplitude van de reflectie van voorspankanaal B varieert in de meting. Ter plaatse van meting 8 is de reflectie het grootst. Indicatie op holte.
- Ter verificatie van een verdachte meting is een kijkgat gemaakt bij meetpunt 8. Geen holte aangetroffen.

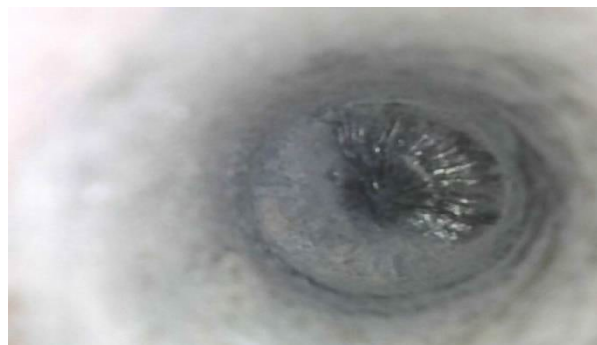
Figuur 4.8: Kijkgat locatie 2-D meetpunt 17.

- Goede reflectie tegen de achterzijde van de doorsnede in nagenoeg de gehele meting.
- Voorspankanaal zichtbaar in elke individuele meting. Op diverse metingen zijn drie voorspankanalen zichtbaar. Deze zijn met rode pijlen aangeduid op meetpunt 13.
- De amplitude van de reflectie van voorspankanaal D varieert nauwelijks. Geen indicatie op holte.
- Indicatie meetpunt 12 gebaseerd op wegvallen reflectie tegen achterzijde. Geen holtes aangetroffen in kijkgat.
- Kijkgat meetpunt 17 betreft referentiemeting niet verdachte locatie.

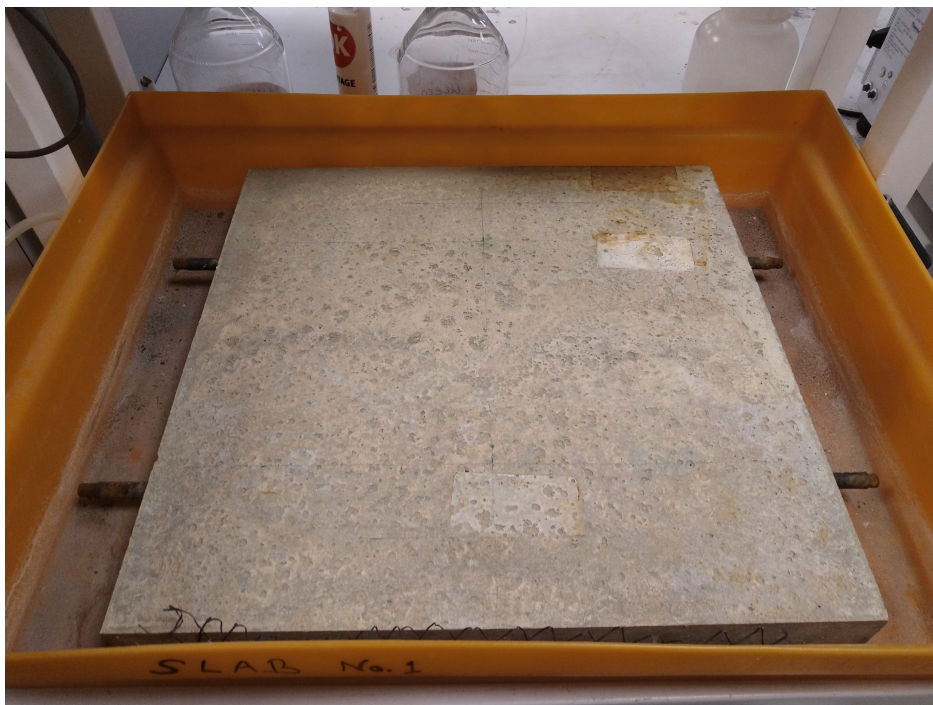
Resistivity measurements were conducted within a controlled laboratory environment on a reinforced concrete OPC slab measuring 60x60 centimeters, which was cast in 2018 (Figure G.1). The slab contains two rebars with a diameter of 12 mm and a cover depth of 25 mm. Notably, the top portion of the slab was subjected to a 5% NaCl solution, resulting in corrosion of the top rebar, while the bottom half was solely exposed to water. Using the Gecor-10 half-cell potential probe to measure the potential yielded the values listed in Table G.1. This underscores the fact that the top rebar is indeed corroding.

Figure G.1: Reinforced concrete OPC slab pre-wetting.

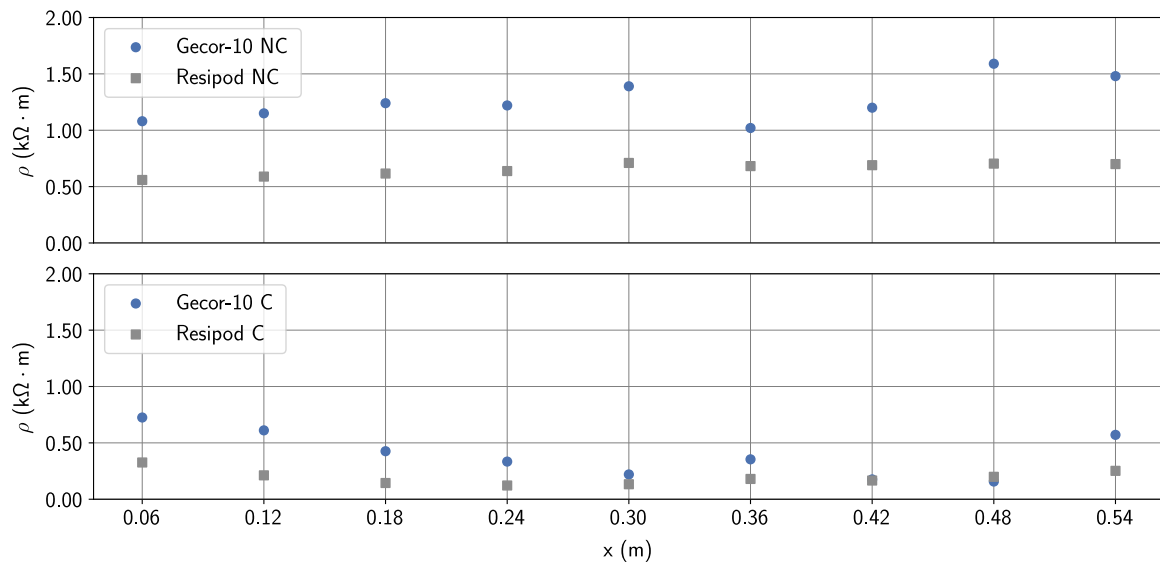
Figure G.2: Distribution of resistivity measurements across the length of the slab for the non-corroded and corroded rebar.
