Widening a harbor basin, demolition of a deep sea quay wall in Rotterdam

Erik Broos, Rob Sibbes, Jarit de Gijt

Abstract: The rapid development in containership dimensions creates a huge challenge for ports. But for one port basin in Rotterdam this challenge was too big. The nautical restrictions for the Amazonehaven would start at such moderate conditions that the basin would be closed for Ultra Large Container Ships (ULCS) about a 100 days a year. As this basin contains more than 60 percent of the deep sea quay length at ECT, Europe's largest container terminal, the Port of Rotterdam Authority decided to widen the basin by demolishing the opposite iron ore bulk quay wall. In this way vessels up to 18.000 TEU have access up to 6 Beaufort wind speed.

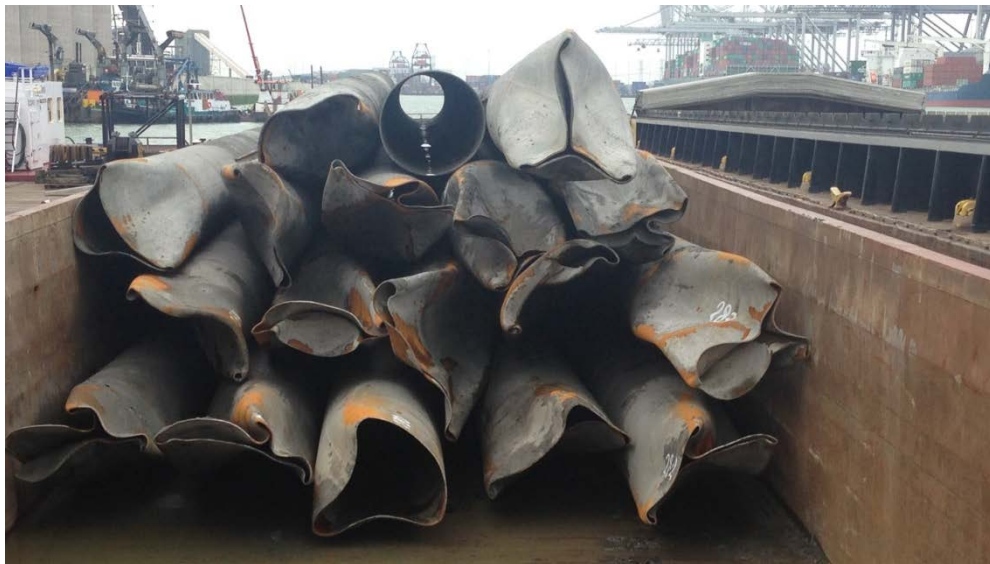
Figure 9: Heavily damaged pile toes

stability. Figure 9 shows piles that were placed next to each other. This cross section did not provide the designed safety. This was further examined by Mourillon (2015), but needs to be studied in more detail.
