Monotonic, cyclic and dynamic behaviour of timber-masonry connections

Mirra, M.; Ravenshorst, G.J.P.; van de Kuilen, J.W.G.

Proceedings of the World Conference on Timber Engineering 2021

MONOTONIC, CYCLIC AND DYNAMIC BEHAVIOUR OF TIMBER-MASONRY CONNECTIONS

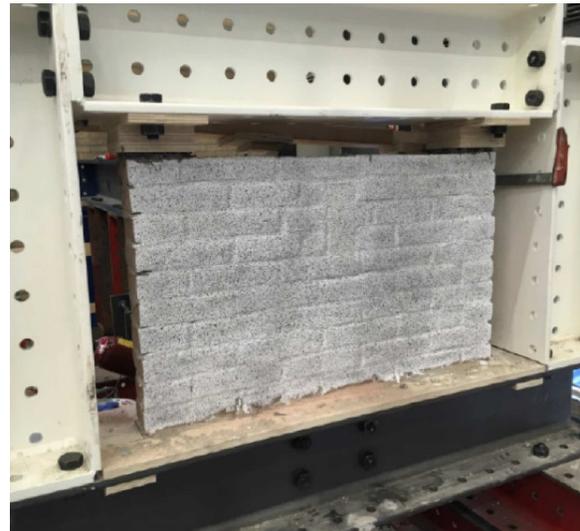
Figure 4: Pattern applied to the wall for digital image correlation technique

Besides these sensors, for configurations E and F, for which very limited relative displacement and more brittle failures were expected, digital image correlation (DIC) technique was used, to have a complete coverage of the samples' response. The adopted DIC system consisted of two cameras, having a resolution of 4096x3000 pixels each. This allowed the detection of out-of-plane and three-dimensional mechanisms, also for dynamic tests. A random pattern with matt black colour was applied to the front side of the wall (Figure 4).

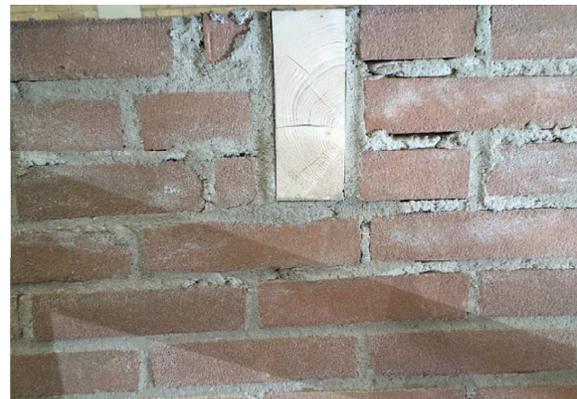
Figure 6: Quasi-static cyclic response of configuration A (a) and joint after testing with no signs of failure (b)

Cyclic tests confirmed the response of the connections observed for monotonic tests. For the purpose of comparison, the graphs of Figures 6-12 are all reported at the same scale. Configuration A (Figure 6) showed again a purely frictional behaviour and a very low force transfer between joist and wall; no signs of failure were detected. It was observed that the strength might be increased when the joist is slightly tilted in the mortar pocket, as it happened for sample A-QS-3.

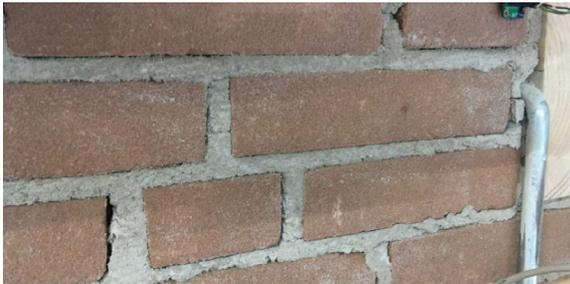
Figure 7: Quasi-static cyclic response of configuration B (a) and joint after testing with limited cracking on the wall (b)

Connection type B (Figure 7) showed a frictional behaviour as well when pushing the connection, since the hook anchor was free to move. Instead, in the opposite loading direction, the wall was also involved in the resisting process, as it happened during the monotonic test, due to the presence of the vertical part of the anchor itself. Although this configuration was an as-built one, its capacity interestingly appeared to be adequate in terms of strength, even if reached only in one of the two loading directions. Sample B-QS-3, unlike the other two, showed a more symmetric response: this occurred because after the first initial cycles with frictional behaviour in the pushing direction, a mortar particle detached from the masonry pocket, remaining clamped between the anchor and the wall, and causing an increase in the transferred load. The failure was caused by the (limited) cracking of the masonry wall around the hook anchor.

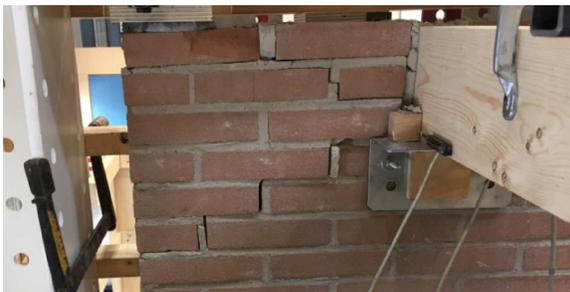
Figure 8: Quasi-static cyclic response of configuration C (a) and joint after testing (b)

Retrofitting option C appeared to be a good compromise between strength and ductility. In the initial phases a quite uniform behaviour among the three tested configurations was obtained. The ultimate strength was increased by more than ten times compared to configuration A. Like for the monotonic test, moderate yielding of the screws was observed; for large displacements, bricks' or mechanical anchors' extraction occurred from the wall, which displayed many cracks after testing.

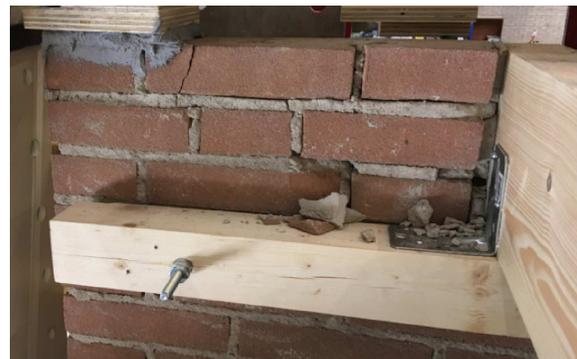
Figure 9: Quasi-static cyclic response of configuration D (a) and joint after testing (b)

Configuration D displayed moderate values of strength and stiffness, with high ductility due to bending and yielding of screws and steel brackets. Like joint type C, for large displacements cracks on the wall occurred, leading to a non-symmetric behaviour (Figure 9).

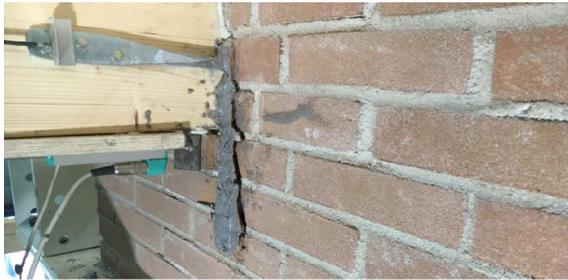
Figure 10: Quasi-static cyclic response of configuration E (a) and joint after testing (b)

Configuration E was developed in order to obtain a very stiff and resistant connection, although renouncing to ductility. This objective was appropriately reached, as can be noticed from Figure 10. The main failure mode was the detachment from the wall of the glued part of the hook anchor, together with limited yielding of the nails connecting it to the joist. Like it was observed during the monotonic test, the failure was not related to the epoxy, but to the cracking of bricks and mortar around the incision.

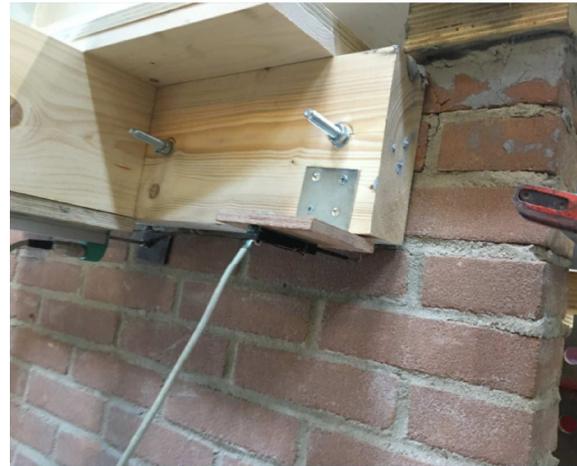
Figure 12: Quasi-static cyclic response of configuration G (a) and joint after testing (b)

Configuration G, designed to be a dissipative option, showed a moderate capacity, linked to high ductility and energy dissipation, caused by yielding and bending of screws and nails and, for large displacements, also by cracking in the walls. Furthermore, the three tested samples displayed a very similar global response, as shown in Figure 12.

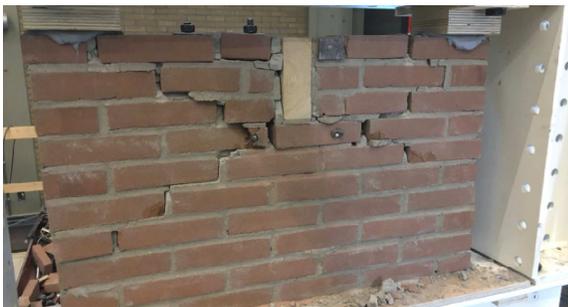
Figure 11: Quasi-static cyclic response of configuration F (a) and joint after testing (b)

Configuration F was designed with the same purpose as option E. In this case, even more strength was retrieved due to the efficient load transfer between joist and wall, and the three specimens exhibited in general a very similar response (Figure 11). No signs of failure were observed in the screws and the timber joist, but a large and distributed crack pattern was visible on the walls.
