Experimental research on salt contamination procedures and methods for assessment of the salt distribution

Construction and Building Materials

The RILEM TC ASC-271 is developing a new laboratory test to assess the durability of porous building materials to salt crystallisation. The test encompasses two phases: salt accumulation and damage propagation. This paper focuses on designing a procedure for the accumulation phase; this is considered successful when salts crystallise at the material's evaporative surface (common situation observed on site) without the occurrence of damage. Two procedures were developed and tested on two limestones with different porosity: (1) capillary absorption of a salt solution followed by drying, and (2) continuous capillary absorption. Sodium chloride or sodium sulphate solutions were used. Several methods for assessing the salt distribution were employed: ultrasonic pulse velocity, drilling/scratching resistance, hygroscopic moisture content, ion chromatography, scanning electron microscopy, and micro X-ray fluorescence. The results enabled the selection of the most effective protocol for the salt accumulation phase.

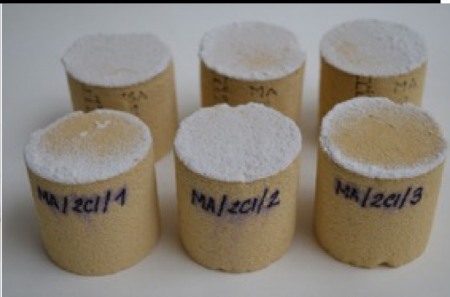
Damage/alteration	Efflorescence	Efflorescence
	Salt efflorescence	Powdery	(micro) cauliflower
	Damage severity	No damage	No damage
	Damage extension	-	-
P1-1W	Photo

Damage/alteration	Efflorescence	Efflorescence
	Salt efflorescence	Powdery (surface) and hollow crust	Powdery
	Damage severity	No damage	No damage
	Damage extension	-	-
P2-2W	Photo

Damage/alteration	Efflorescence	Efflorescence
	Salt efflorescence	Powdery	Powdery
	Damage severity	No damage	No damage
	Damage extension	-	-

Fig. 4. Summary of the macroscopic visual observations on the specimens contaminated with NaCl. Scores of severity of damage: low (+) to high (++++). Scores of extension of damage: small (+) to large (++++ surface area.

Samples contaminated with NaCl with both procedures developed only salt efflorescence, and no visible damage was detected (Fig. 4). The type and amount of salt efflorescence (Fig. 6a) varied according to the procedure followed and type of stone used: a lower amount of NaCl efflorescence developed in the less porous stone (Migné) with procedures P1-1S and P2, but the amount was still slightly higher than for the more porous stone (Maastricht) with procedures P1-1 W and P1-2 W. The results of mass loss (Fig. 7a) can be considered negligible (lower than 0.05 wt%) and confirm the visual observations.

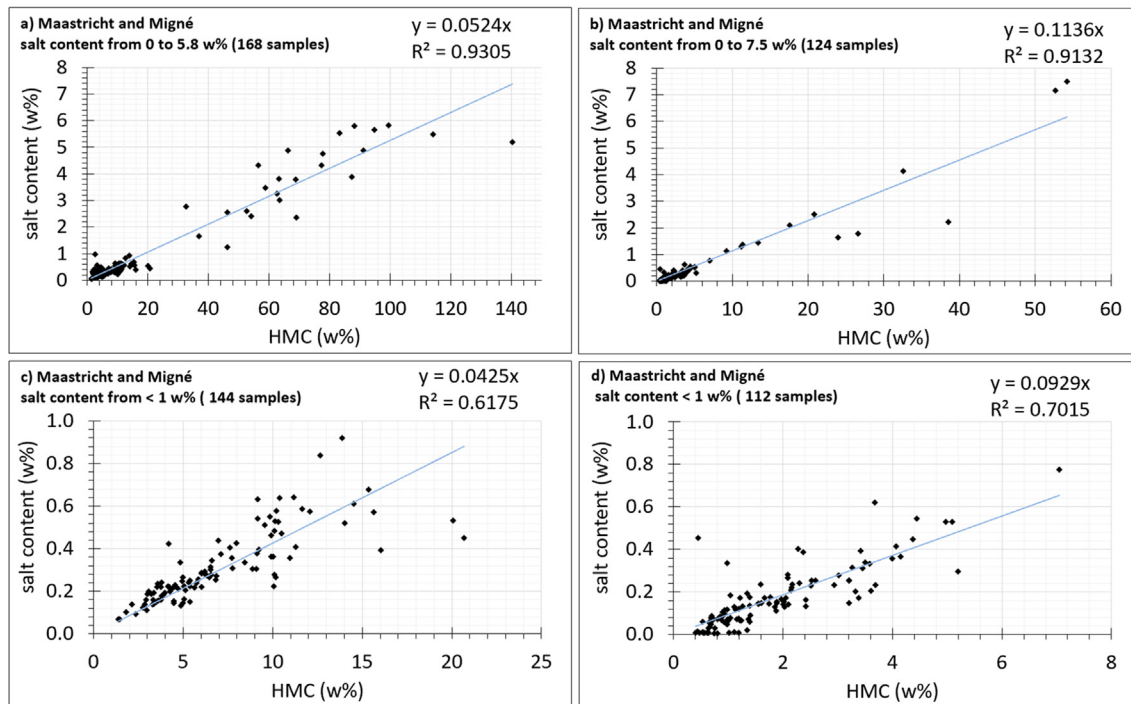
Fig. 11. Correlation between HMC values and salt content (R^2 = coefficient of determination): Maastricht and Migné with NaCl (a) and Na_2SO_4 (b) content (full range detected between 0 and 5.8 or 7.5 wt%) and with NaCl (c) and Na_2SO_4 (d) content below 1 wt%.
