## KATOENVEEM | RESEARCH REPORT

Heritage & Architecture - Rotterdam Harbour Heritage

P1 Research Report Katoenveem - 22 Dec 2016

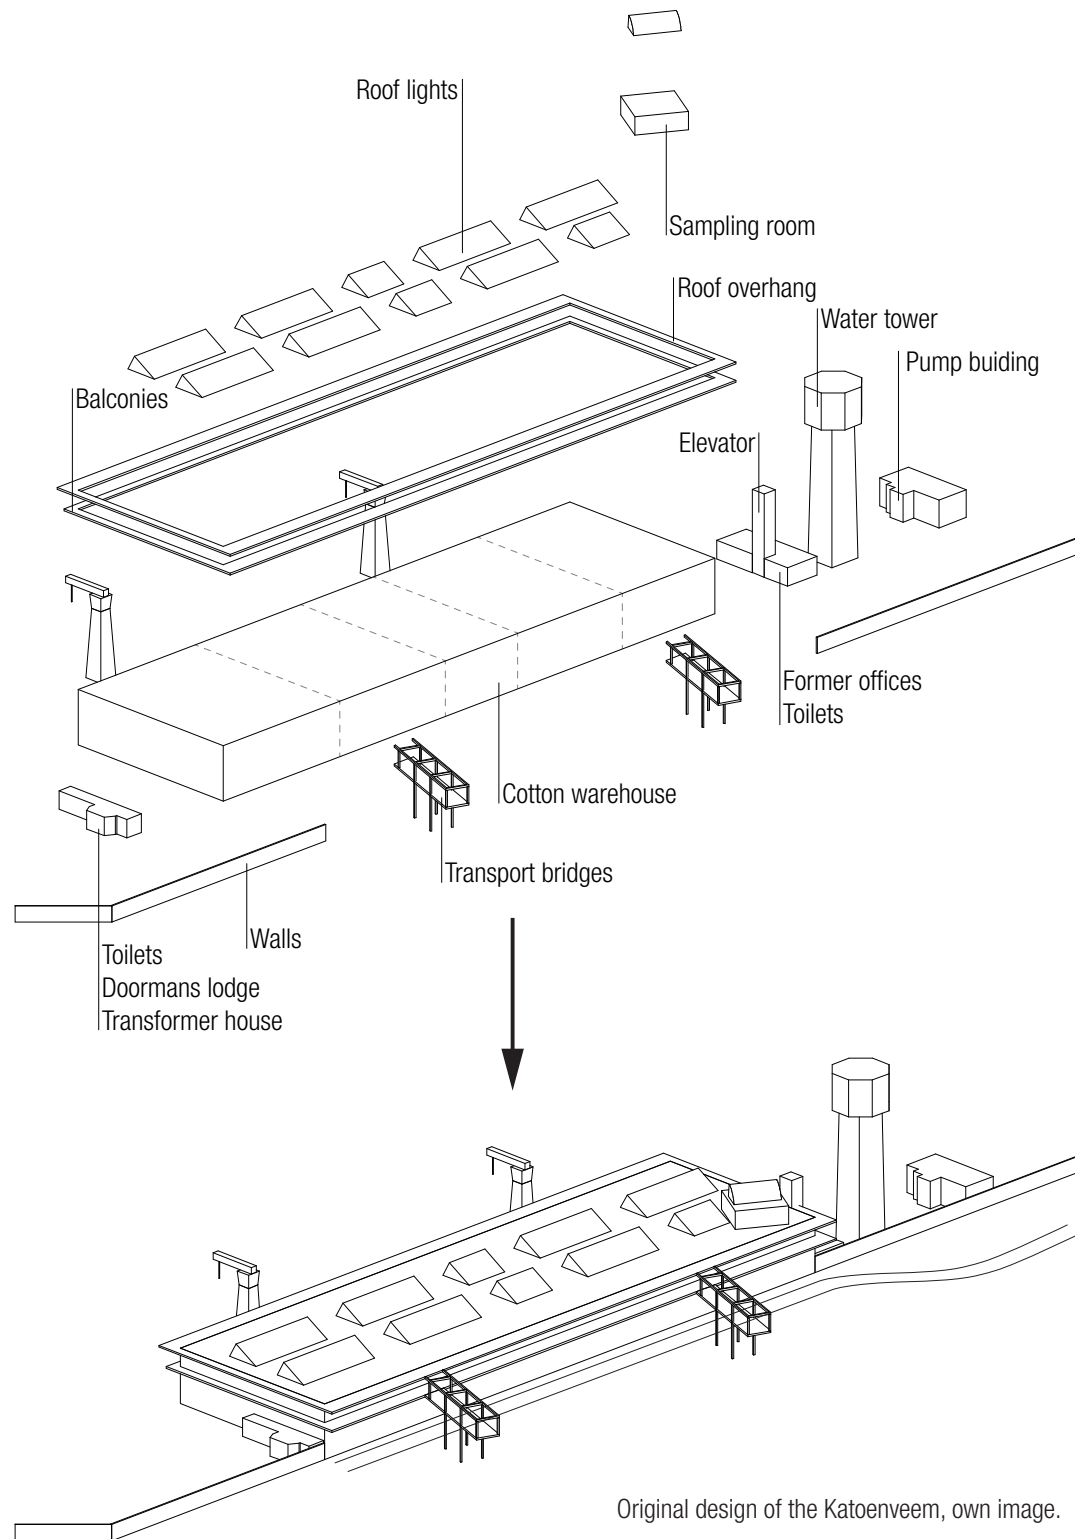
The design of the Katoenveem was considered very innovative at the time it was built. It was not just an ordinary warehouse, but new ingenious techniques and systems were used. The design of the building was fully adjusted to the function of storing and transporting cotton. Therefore, the design of the Katoenveem could be seen as a rectangular, concrete box with all services attached to the building on the outside. Two cranes were constructed to unload the ships in the Keilehaven. Balconies on the outside and walkways on the inside of the building provided space for the workers to move around and control the cotton transport. The sampling room was added on top of the roof to ensure a perfect orientation towards the north. Offices toilets and a transformer house were added to the outside as well, similar to the elevator and the water tower.

By adding these services to the outside of the building, the interior space could be entirely used for cotton storage. This ensured the most efficient process.

The Katoenveem is built in concrete and has four fire walls separating the warehouse in five fire compartments. This was necessary to meet fire regulations at the time. These fire walls also serve as dilations.

Original design of the Katoenveem, own image.

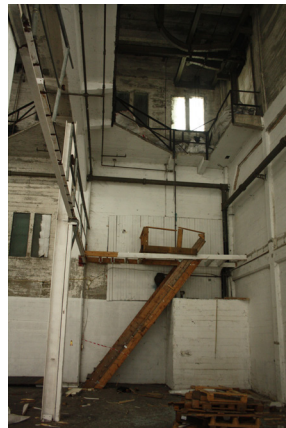
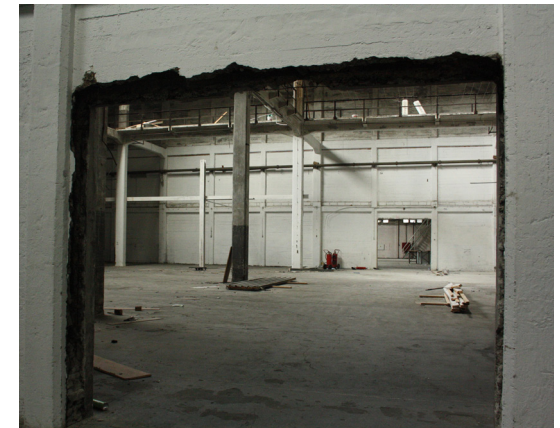
Interventions: addition of a steel structure, closing of the windows and creation of passageways through the fire walls. Photos by students (20-09-2016).

Over time changes have been made tot the building in the facade, the interior and the exterior. Holes have been made in the fire walls, windows have been closed and a plastic cladding on the facade has been added and partly removed again.

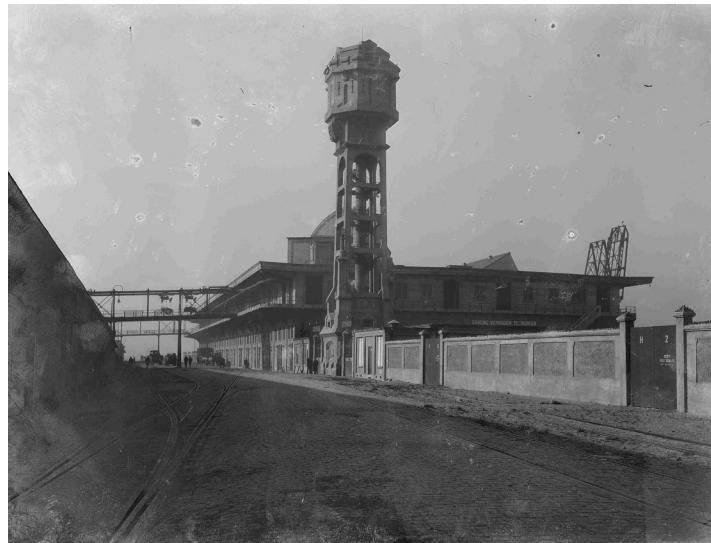
Katoenveem, view from Keilestraat around 1920. Visible are the water tower, railroads, cranes, transportation bridges to warehouses 'New Orleans' and 'Galveston' and the walled outside storage space. Photo from Historisch Centrum Overijssel (retrieved 24-10-2016).

The direct context of the Katoenveem has changed a lot as well. The original design consisted of a warehouse, a water tower, cranes in the harbour, transportation bridged to the warehouses Galveston and New Orleans, railways for transportation of the cotton to Germany and a walled outdoor space used for storage as well. All these elements had a specific function within the whole 'ensemble'. The water tower provided enough water pressure for the sprinkler system to work in case of a fire. The cranes and bridges were connected to the transportation system in the building so the cotton bales could be carried from one building to another.

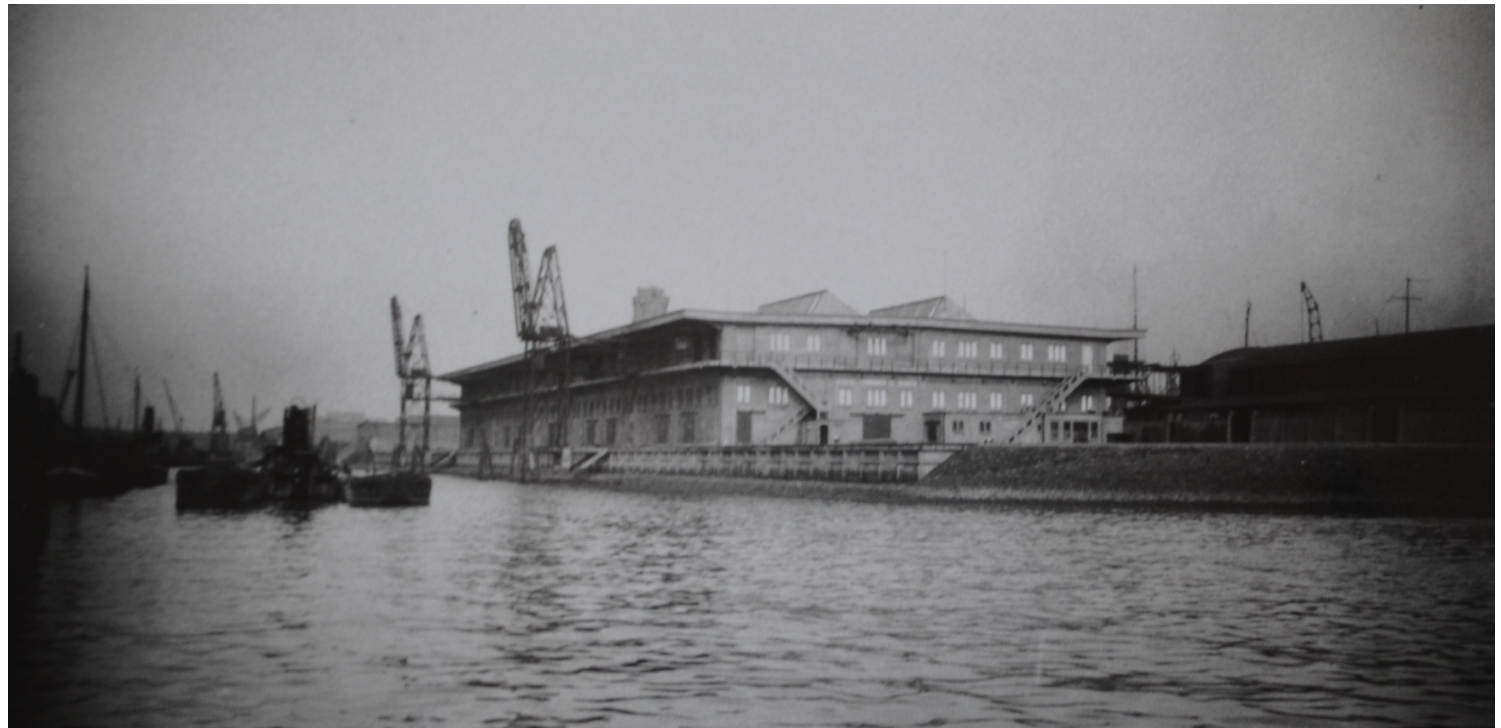
A clear view on the Katoenveem from the Meuse river (1933), photo taken by Gemeentewerken, Stadsarchief Rotterdam (retrieved 12-10-2016)

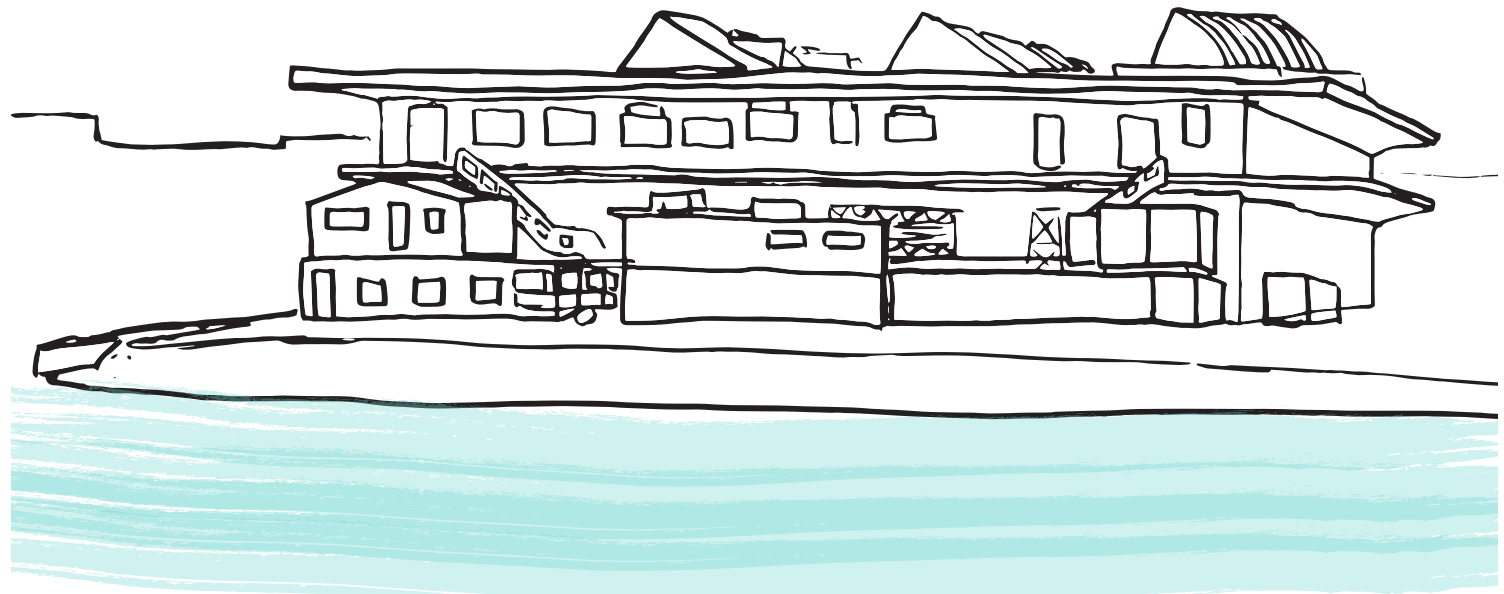
View on the Katoenveem from the Meuse river (2016). Containers and other stuff is blocking the view on the facade, own image

When looking at the Katoenveem from the Meuse river we can recognize its contours. However, nothing of the original process of cotton shipping is visible anymore. No ships enter the harbour anymore to unload their goods. Furthermore, containers and other stuff is blocking the view towards the Katoenveem, providing a troubled and disturbed sight. It is no longer visible what the function of the warehouse was, and no activity can be seen anymore. Also, the facade facing the Meuse river has been changed to some extent. Windows have been enlarged and doors have been added and removed because of a new function.

22 The image that comes to mind when viewing the Katoenveem from this position is one of an empty concrete structure in a poor condition. The relationship it once had with its context and the water is not noticeable anymore. Also the relationship with the other warehouses is lost.

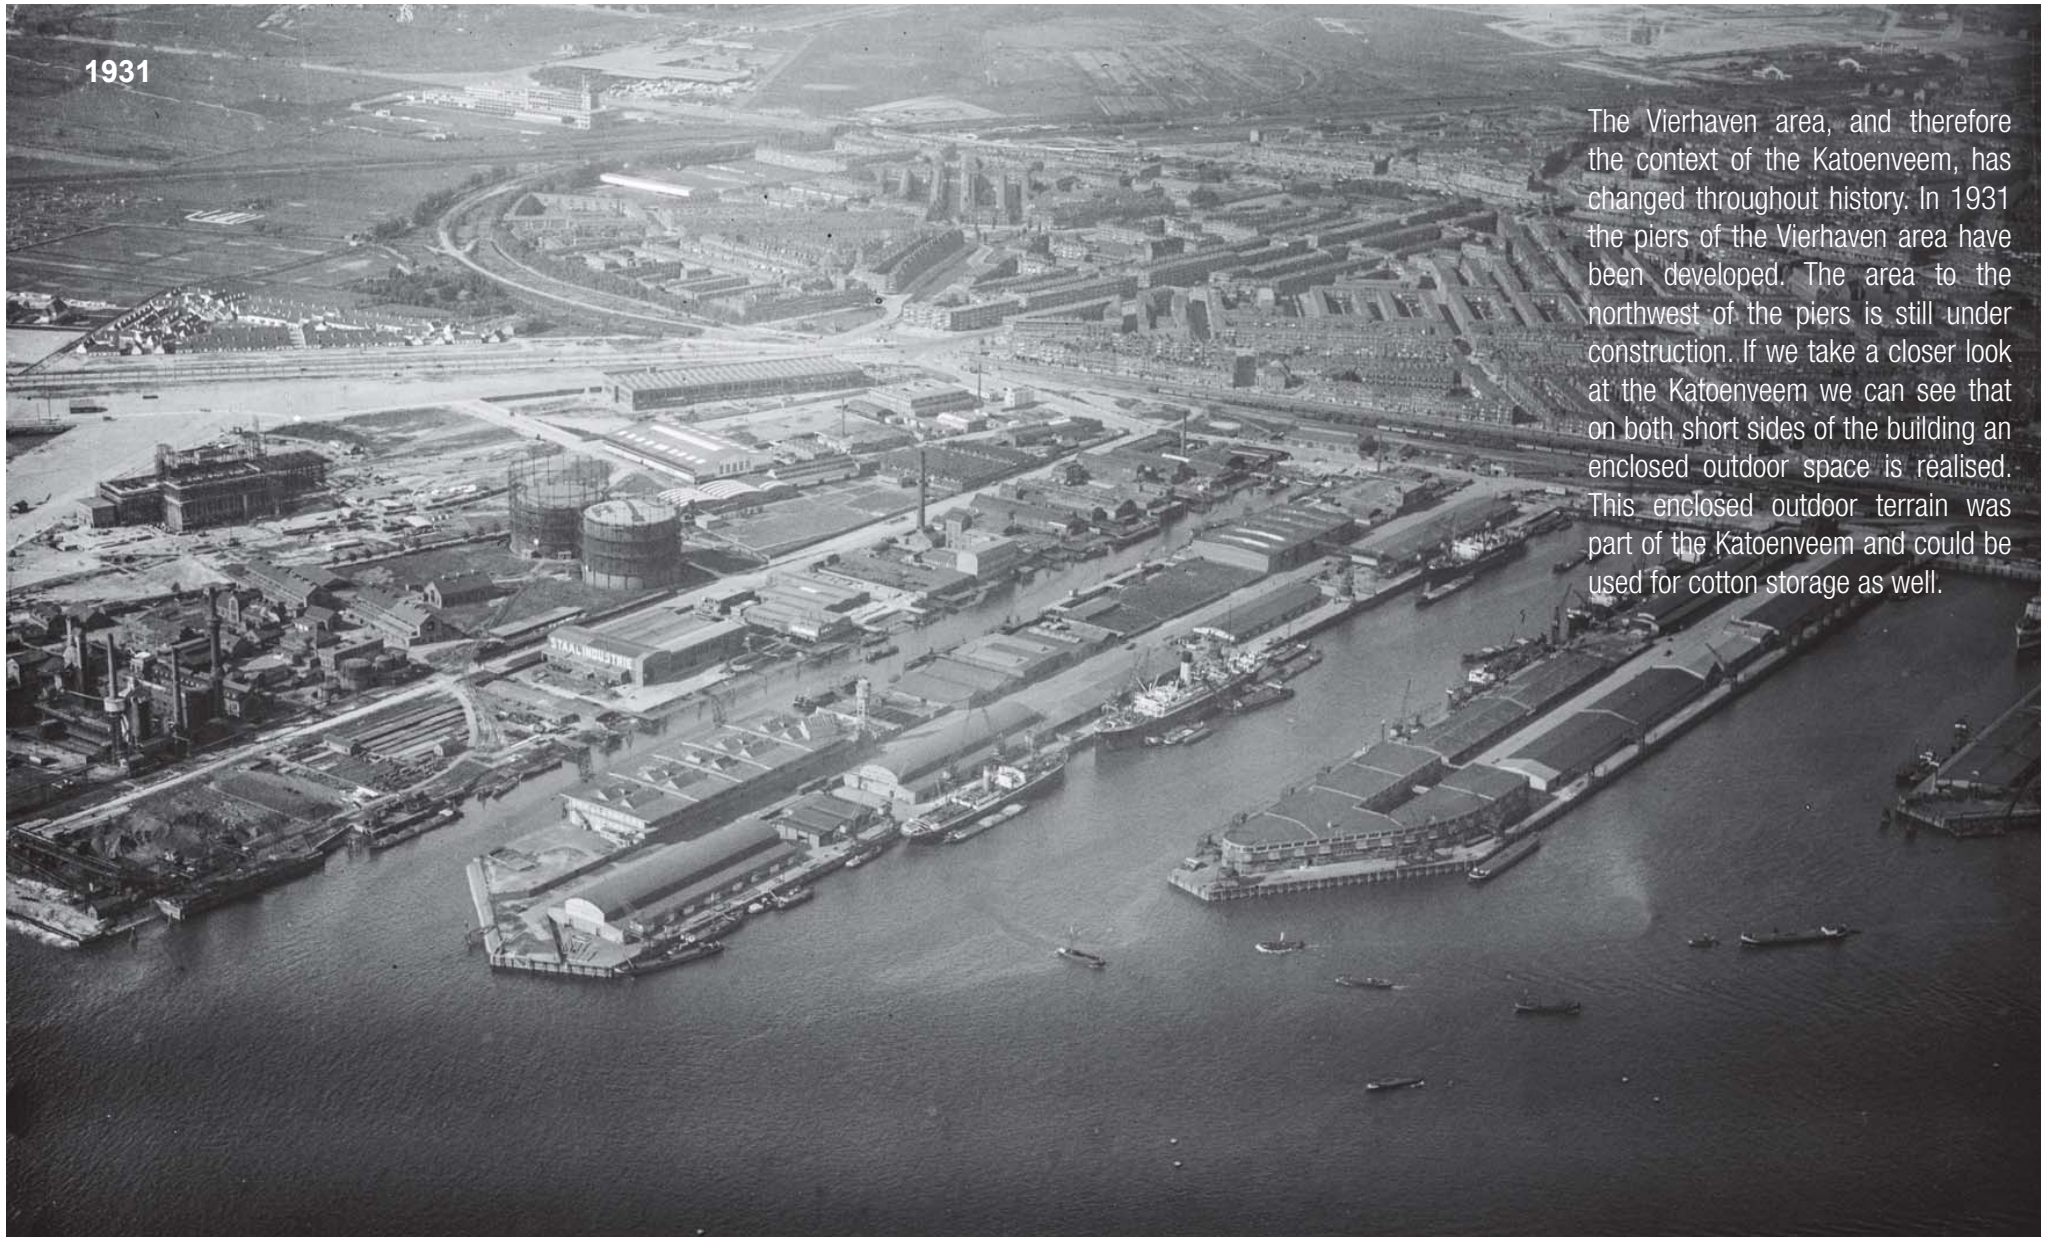
The Vierhaven area, and therefore the context of the Katoenveem, has changed throughout history. In 1931 the piers of the Vierhaven area have been developed. The area to the northwest of the piers is still under construction. If we take a closer look at the Katoenveem we can see that on both short sides of the building an enclosed outdoor space is realised. This enclosed outdoor terrain was part of the Katoenveem and could be used for cotton storage as well.

Aerial view on the Keilehaven, Lekhaven and IJsselhaven in 1931, showing the Katoenveem on the left. The transporting bridges to the warehouses across the street have been removed already. Presumably this was done in 1926, when these warehouses were sold and their names changed. The activity in the water is visible through the ships in the harbour. In the background residential areas are developing, KLM Aerocarto / Aviodrome copyright (retrieved 23-09-2016).

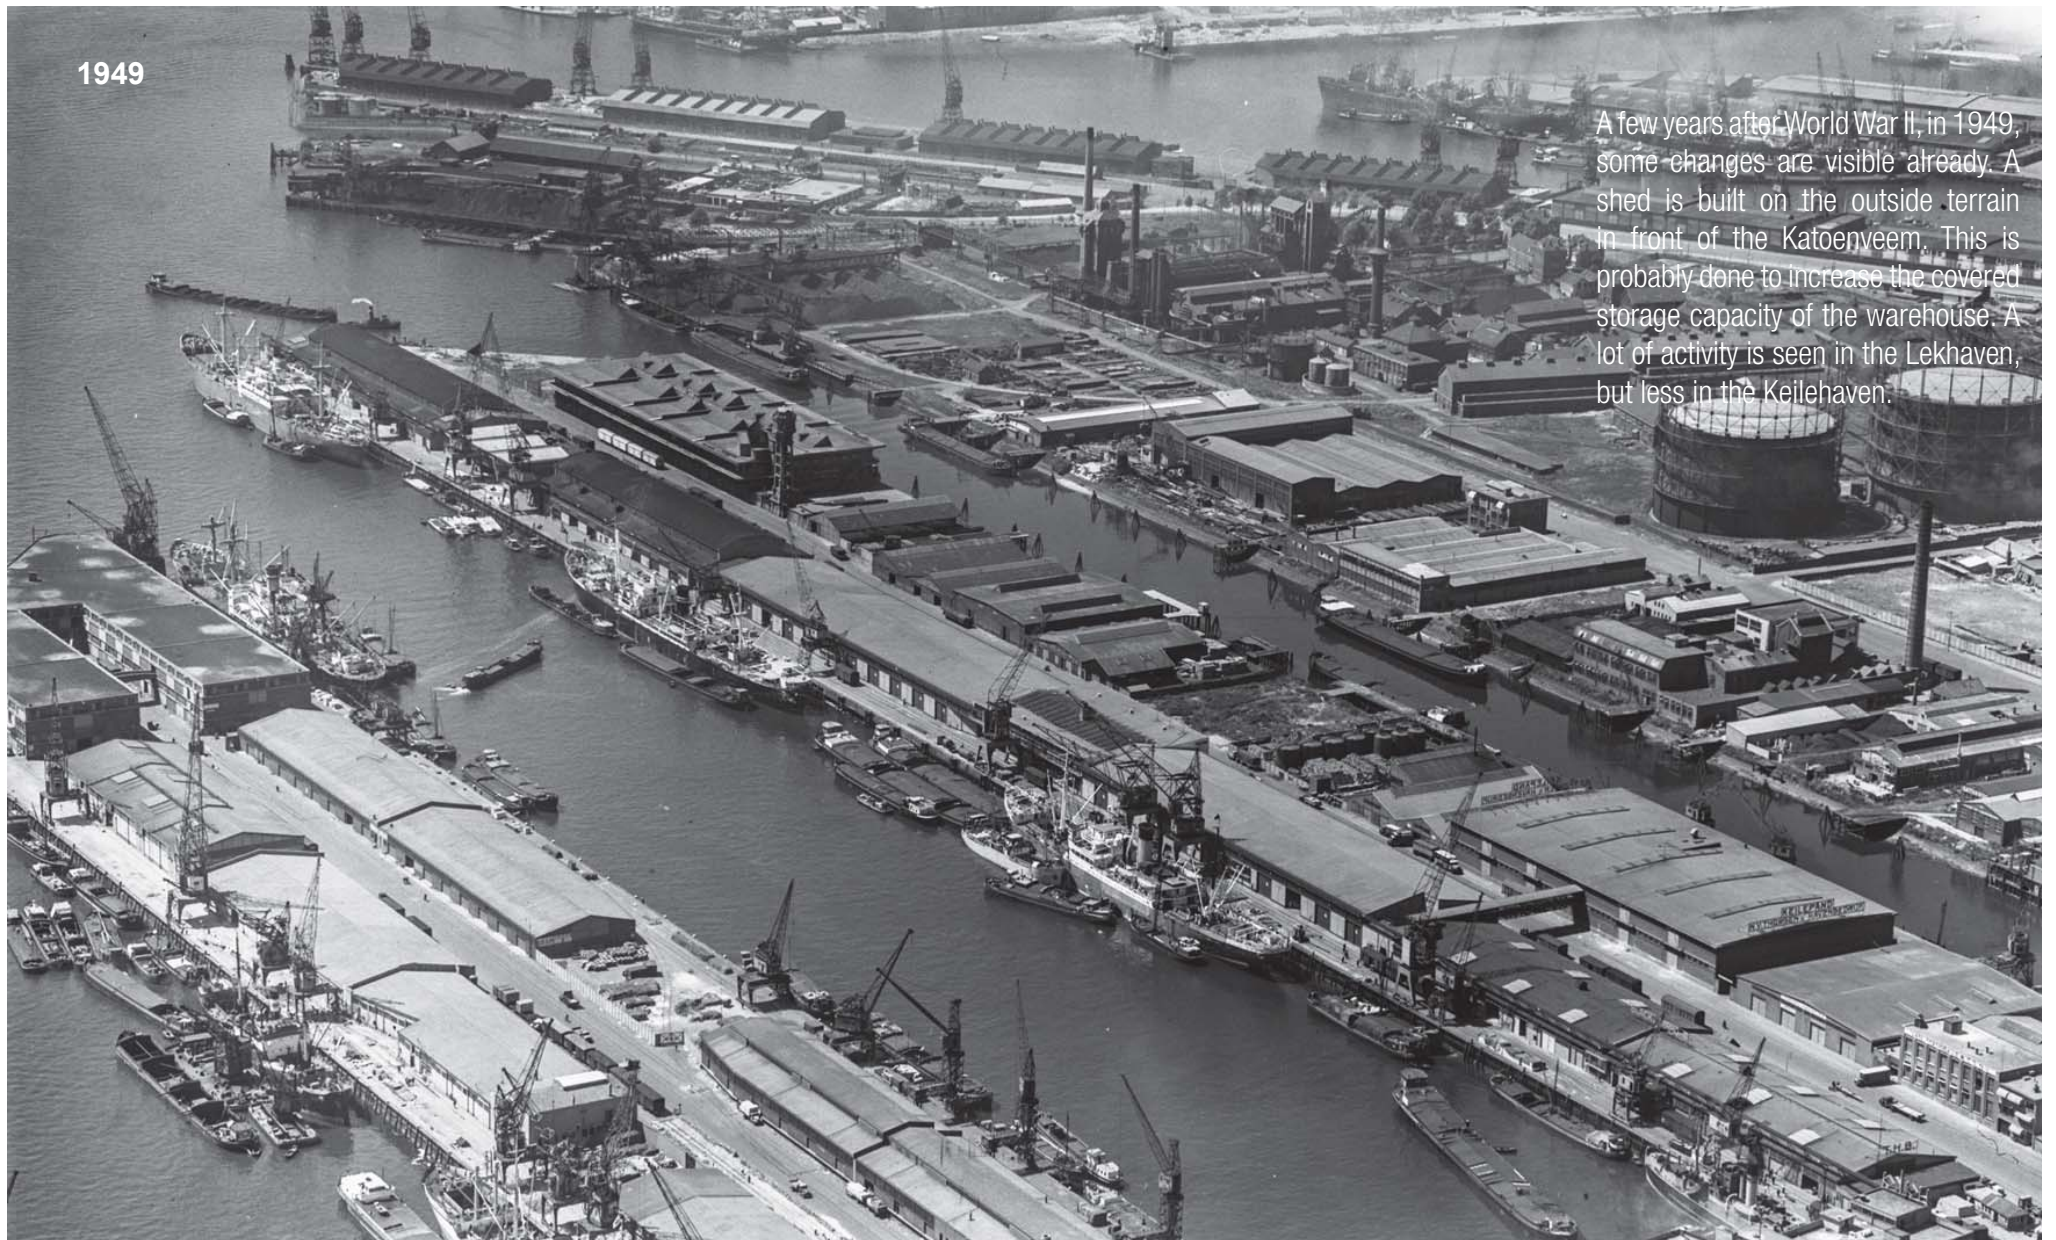
Aerial view on the Keilehaven and Lekhaven in 1949. A shed has been build upon the outdoor terrain next to the water tower. The transporting bridges to the neighbouring warehouses were demolished in 1926, KLM Aerocarto / Aviodrome copyright (retrieved 23-09-2016).

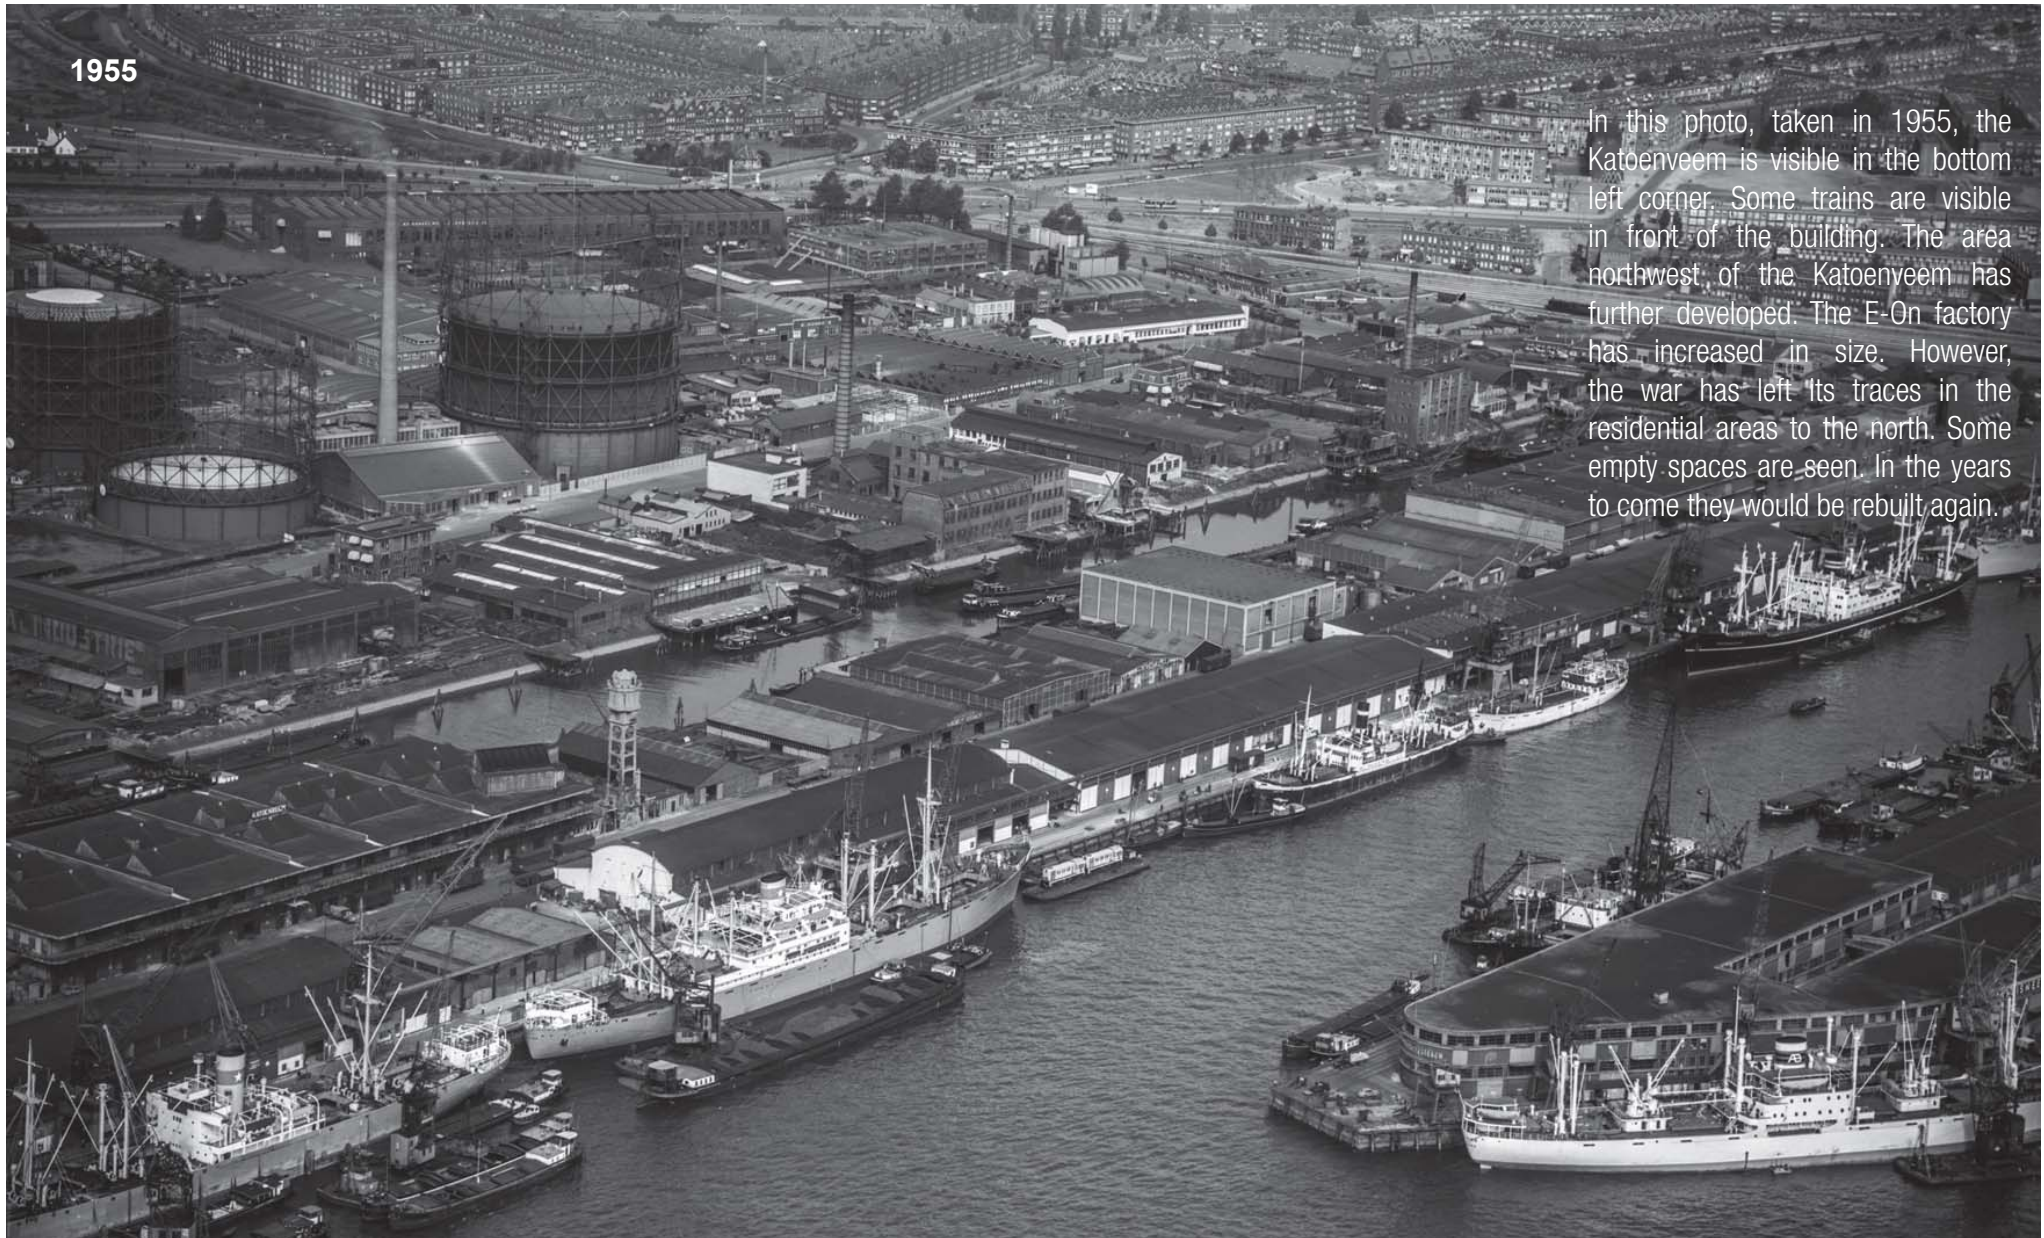
In this photo, taken in 1955, the Katoenveem is visible in the bottom left corner. Some trains are visible in front of the building. The area northwest of the Katoenveem has further developed. The E-On factory has increased in size. However, the war has left its traces in the residential areas to the north. Some empty spaces are seen. In the years to come they would be rebuilt again.

Aerial view on the Keilehaven and the Lekhaven, with the Katoenveem and its walled outside space on the left, KLM Aerocarto / Aviodrome copyright (retrieved 23-09-2016).

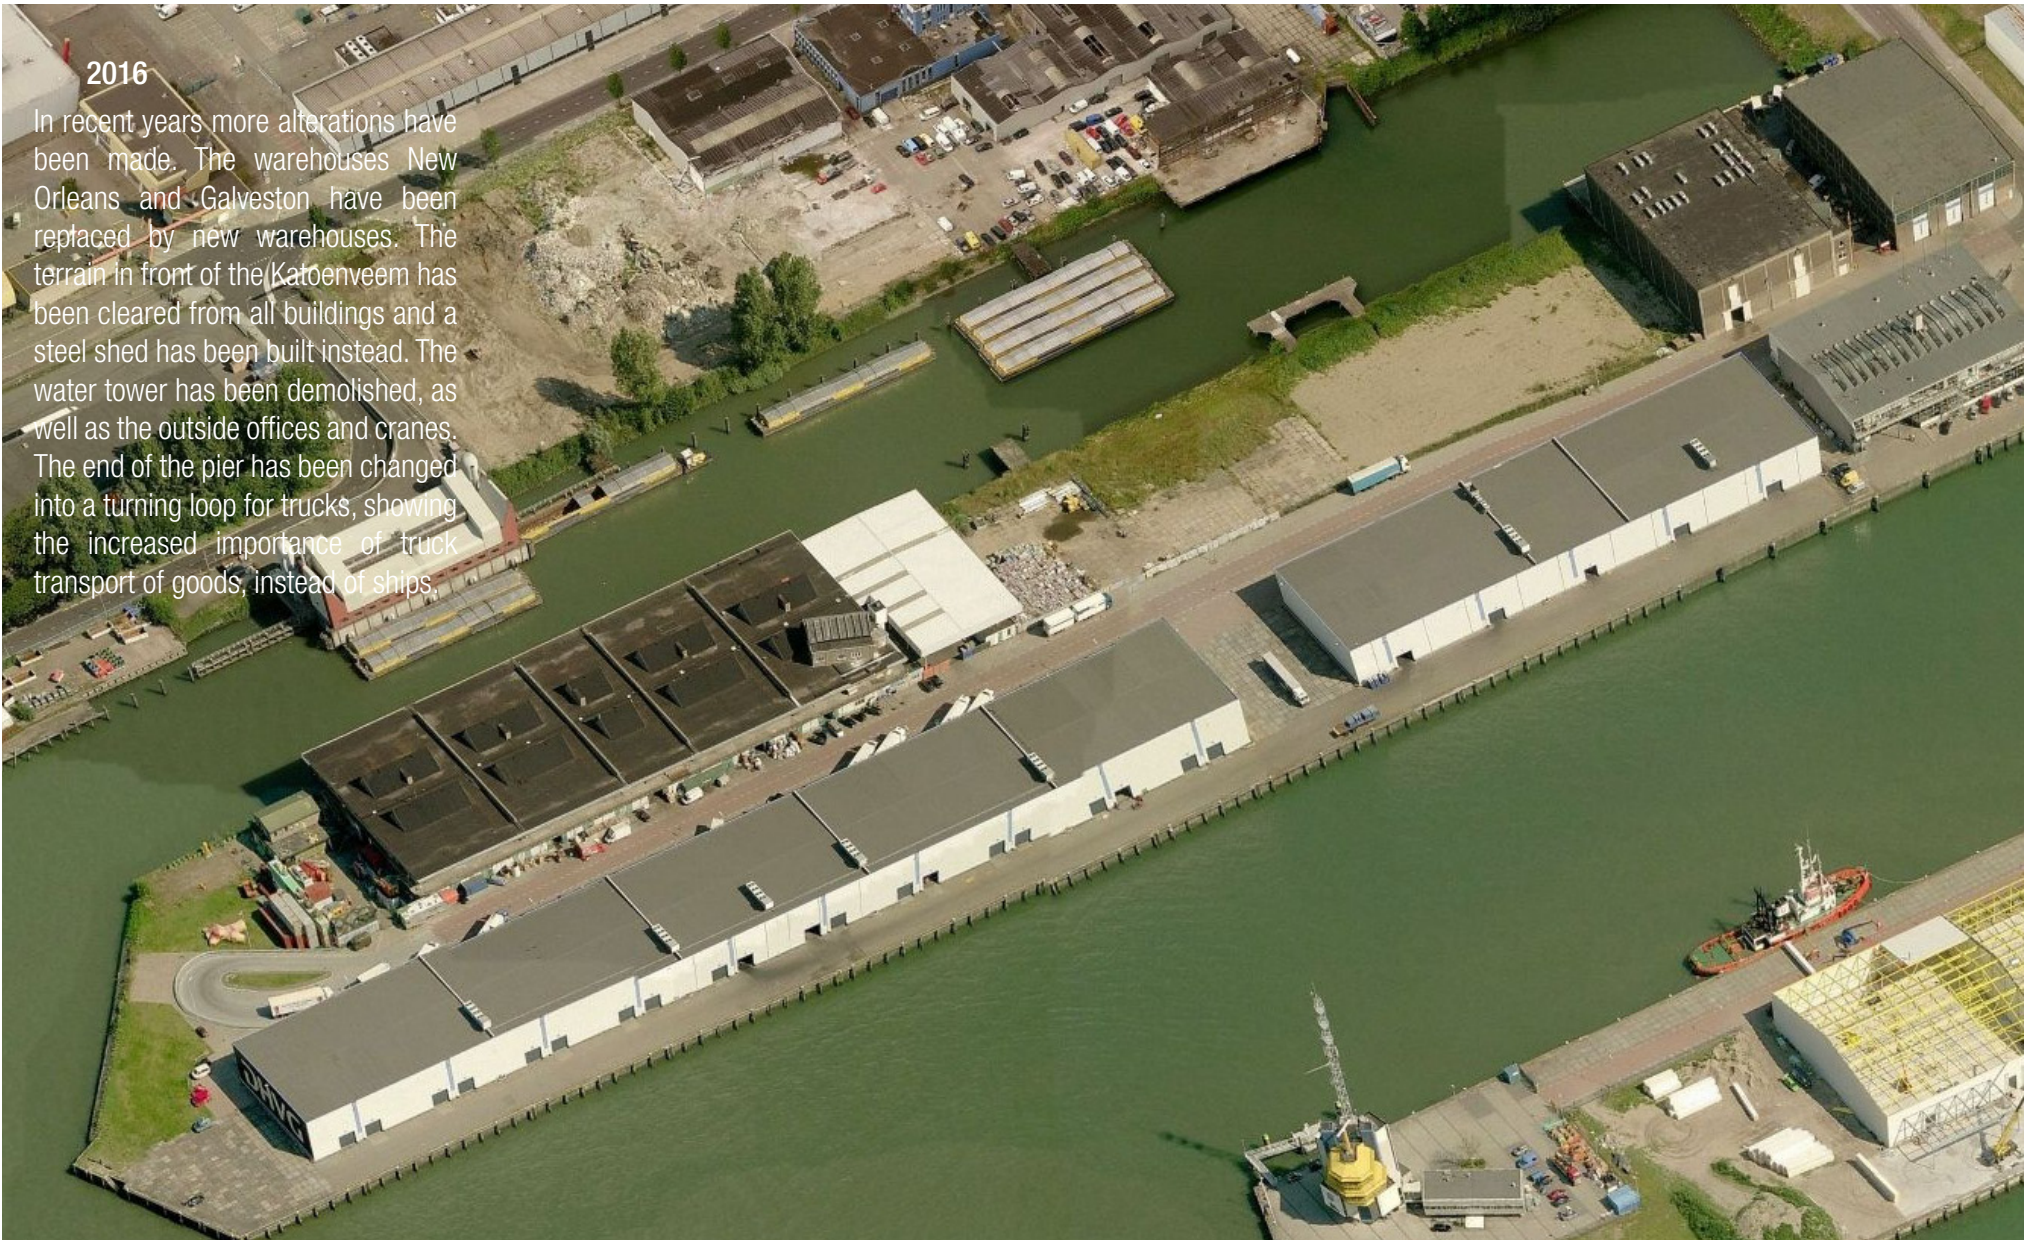
In recent years more alterations have been made. The warehouses New Orleans and Galveston have been replaced by new warehouses. The terrain in front of the Katoenveem has been cleared from all buildings and a steel shed has been built instead. The water tower has been demolished, as well as the outside offices and cranes. The end of the pier has been changed into a turning loop for trucks, showing the increased importance of truck transport of goods, instead of ships.

Aerial view on the Katoenveem and the Keilestraat (2016), Bing maps (retrieved 24-10-2016).

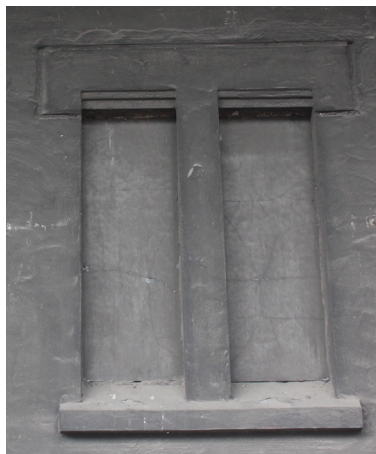
Closed windows, own photo (2016)

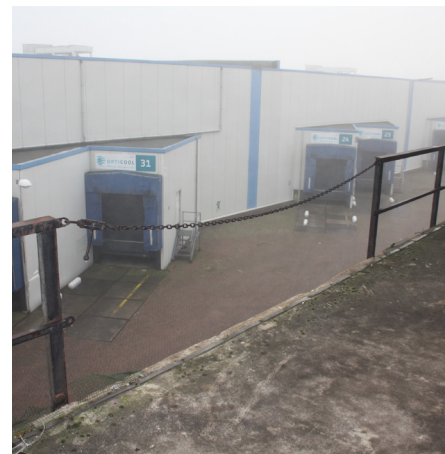
Railing with inexplicable openings, own photo

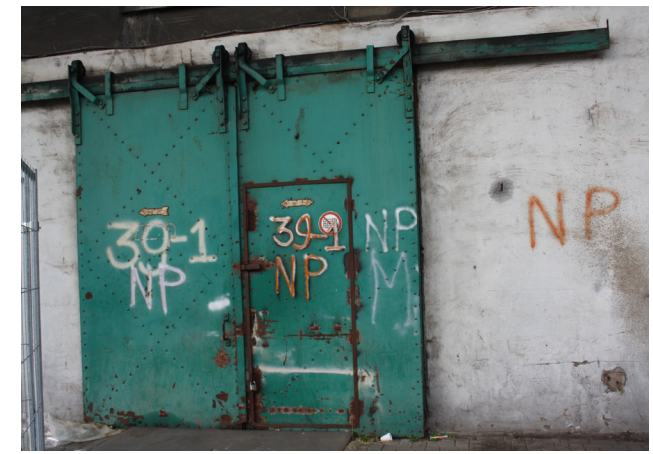
Large steel sliding doors on the ground floor, own photo (2016)

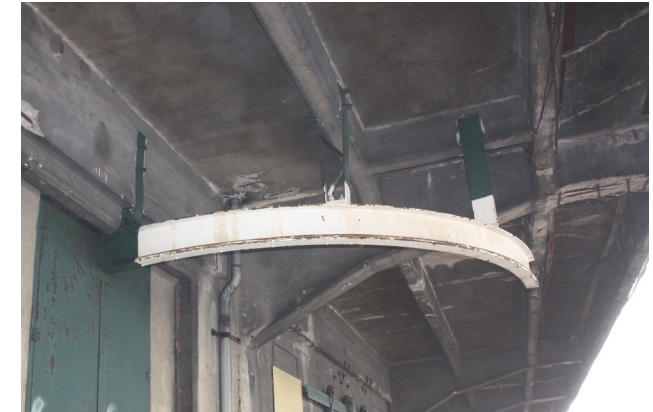
The only piece of the external part of the transit system left, own photo

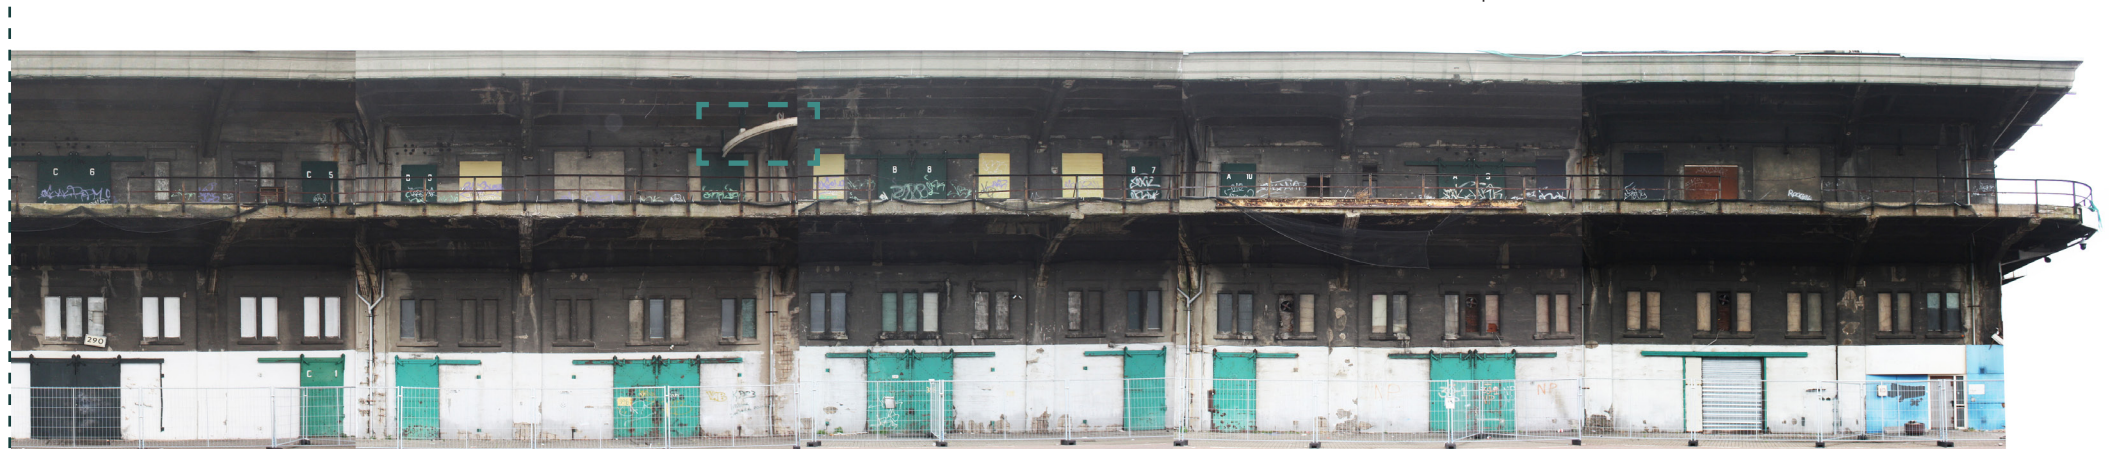
Facade of the Katoenvem in October 2016. The strong rhythm, created by the doors, windows and construction is clearly visible, own photo

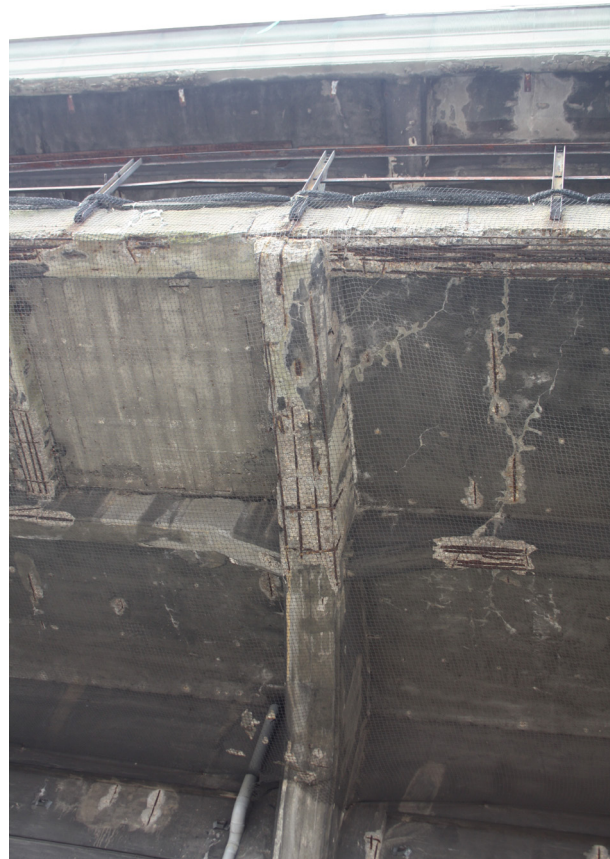
Holes in the balcony for loading the cotton onto the trains have been closed. This reduces the way we 'read' the function by looking at the facade, own photo (2016).

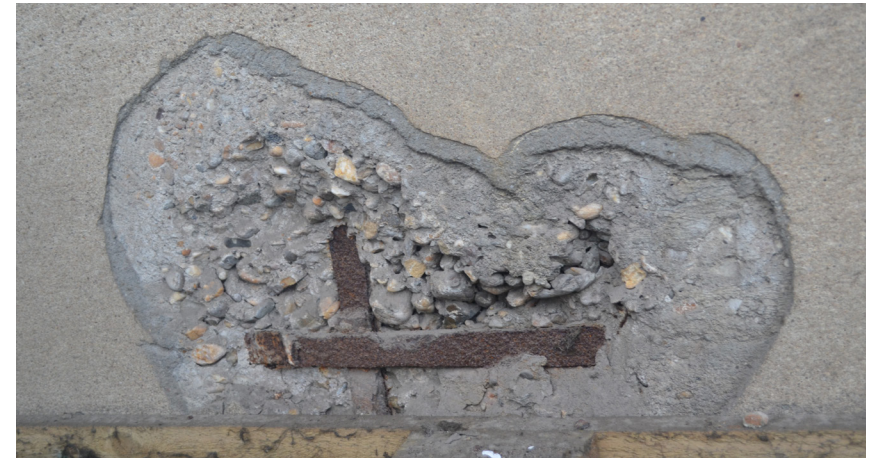
Throughout history the facade has deteriorated. Carbonation has caused parts of the concrete all over the facades to detach from the structure. Also, because of the thin concrete cover, the concrete falls off more easily. The steel reinforcement is being exposed as a result, which causes the steel to oxidate. The steel reinforcement expands and consequently more and more concrete breaks off. Nowadays, the norms for the minimum cover of concrete are much higher. The poor condition of the Katoenveem shows the age of the building. It is an industrial building that was designed for its function only. In the past this function could be more or less read by looking at the facade. The tailor made transit system was hanging from the roof and cotton bales would be transported along this system. Nowadays this transit system is no longer there, except for one small part in the southeast facade. Also, there have been holes in the balcony to load the cotton into the trains, but these have been closed later.

Damaged part of the facade. The different layers are clearly visible: steel reinforcements, concrete with a high amount of aggregates and two layers of surface finish, own photo (2016).

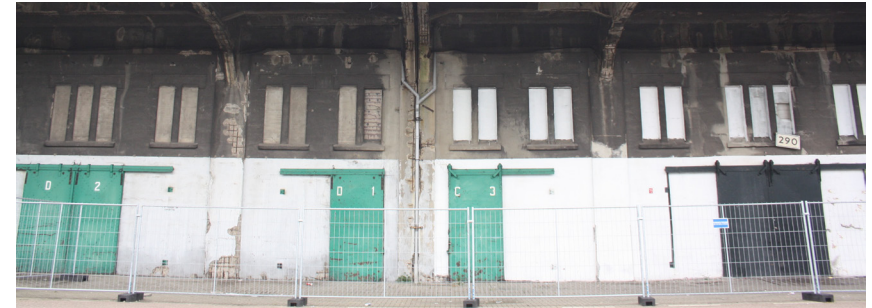
The bottom part of the ground floor has been painted white, own photo (2016).

The material and colour of the facade depend on the different elements. Every element used to have its own material and colour. Nowadays some of the glass has been replaced by a different material and a part of the ground floor has been painted white.

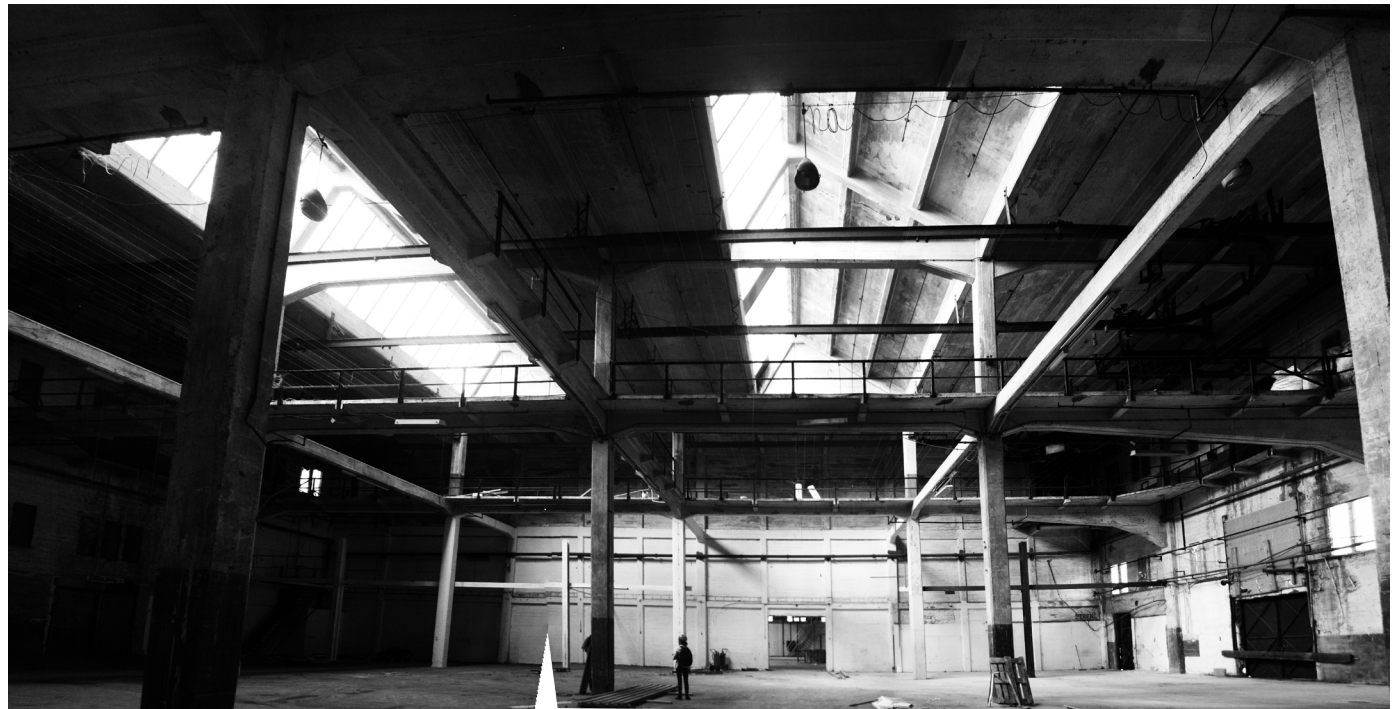
A great portion of the daylight entered the building through the roof lights, creating a pleasant space for working, own image (2016).

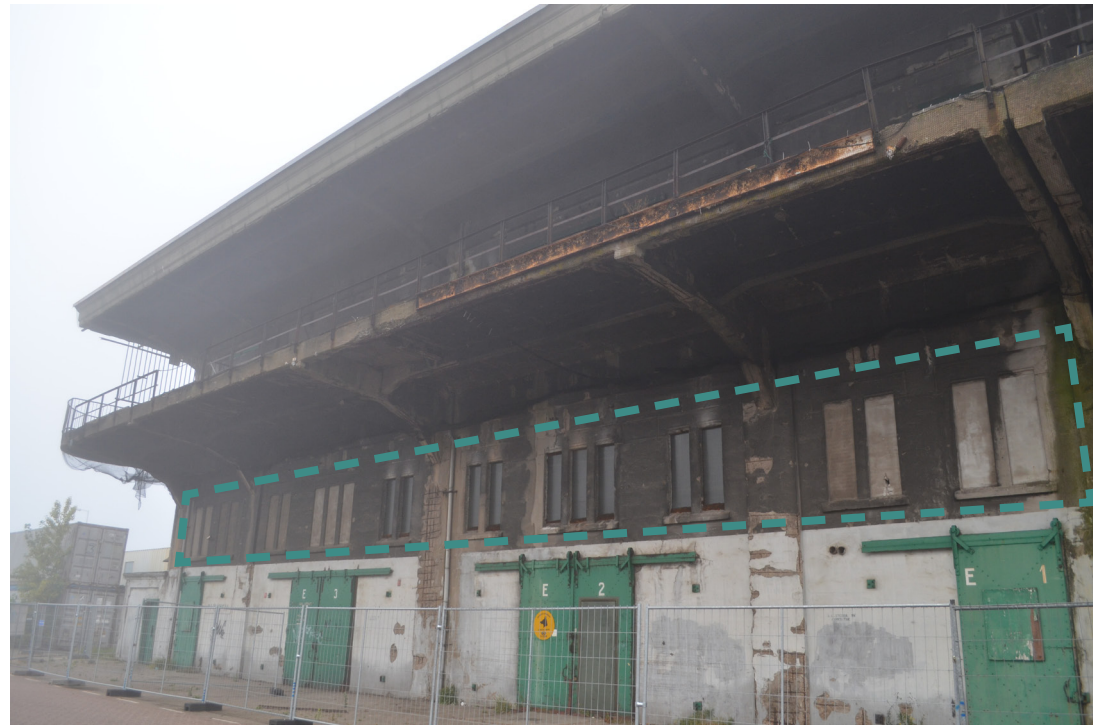
Windows under the balcony. Many of them are closed, own photo (2016).

However, when being inside the space is surprisingly light because of the light entering through the roof lights. These roof lights are not visible from the outside of the building. The closed windows in the facade are less obvious because enough light already enters the building.

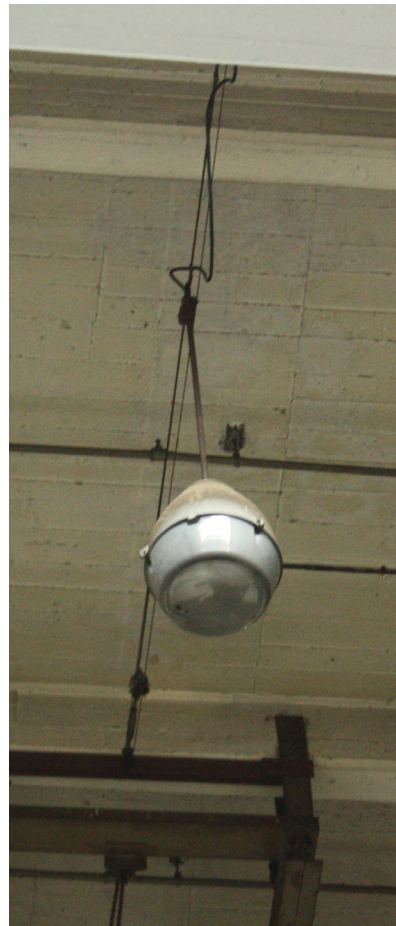
Lighting fixtures in the Katoenveem could be moved, own photos (2016).

When visiting the building, I hardly noticed the light fixtures inside the building. The large amount of daylight takes away the need for electrical lighting. The grand roof lights draw your sight upwards, to the sky. The light that comes through disseminates across the compartments and illuminates most of the space. Together with the doors and windows in the facade I can imagine that during the day enough light entered the building to ensure a safe and pleasant working area.

The absence of sufficient amount of lighting fixtures prognosticates the building was only in use during the day. Presumably the lighting could be switched on in darker (parts of) days, to compensate the lack of daylight.
