## KATOENVEEM | RESEARCH REPORT

Heritage & Architecture - Rotterdam Harbour Heritage

P1 Research Report Katoenveem - 22 Dec 2016

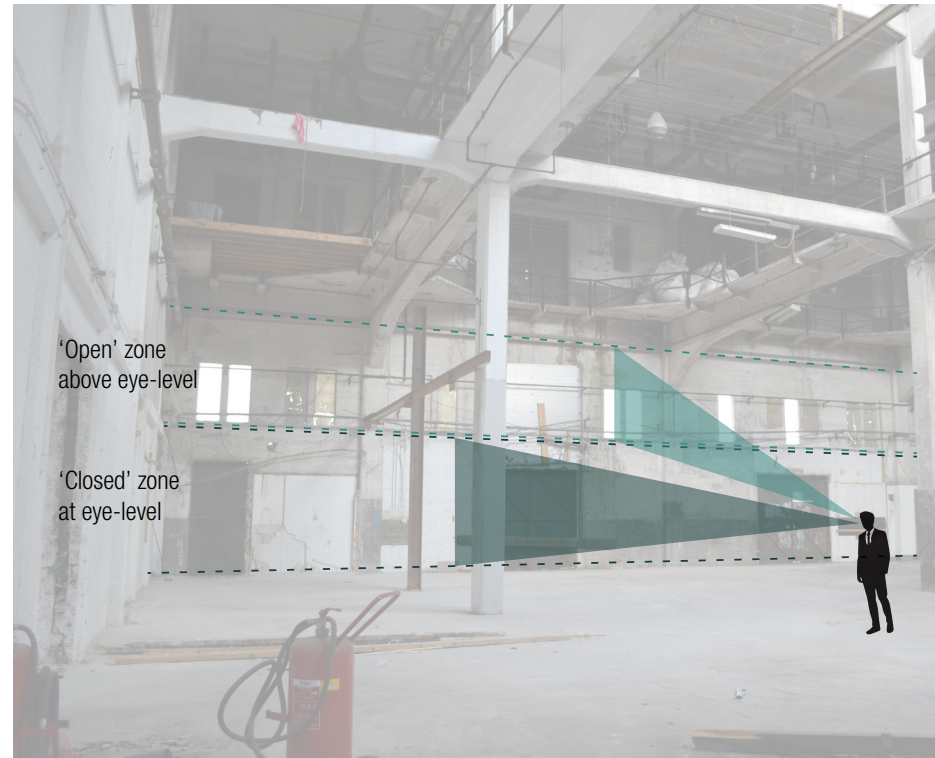
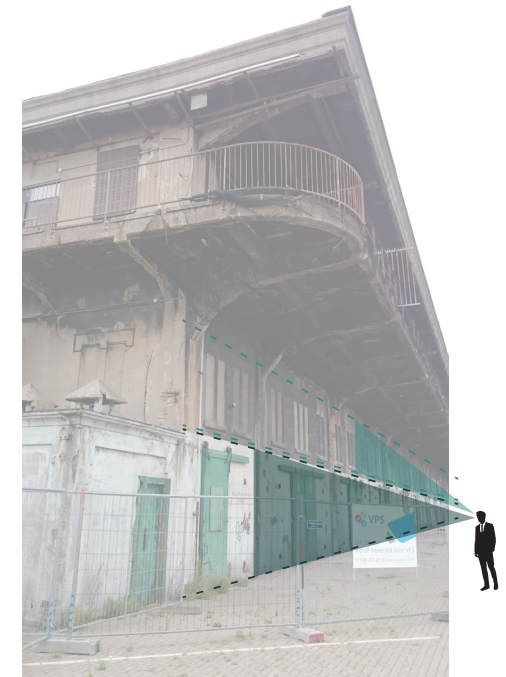
In the current situation an 'open' and 'closed' zone can be distinguished in the facade, own image (2016).

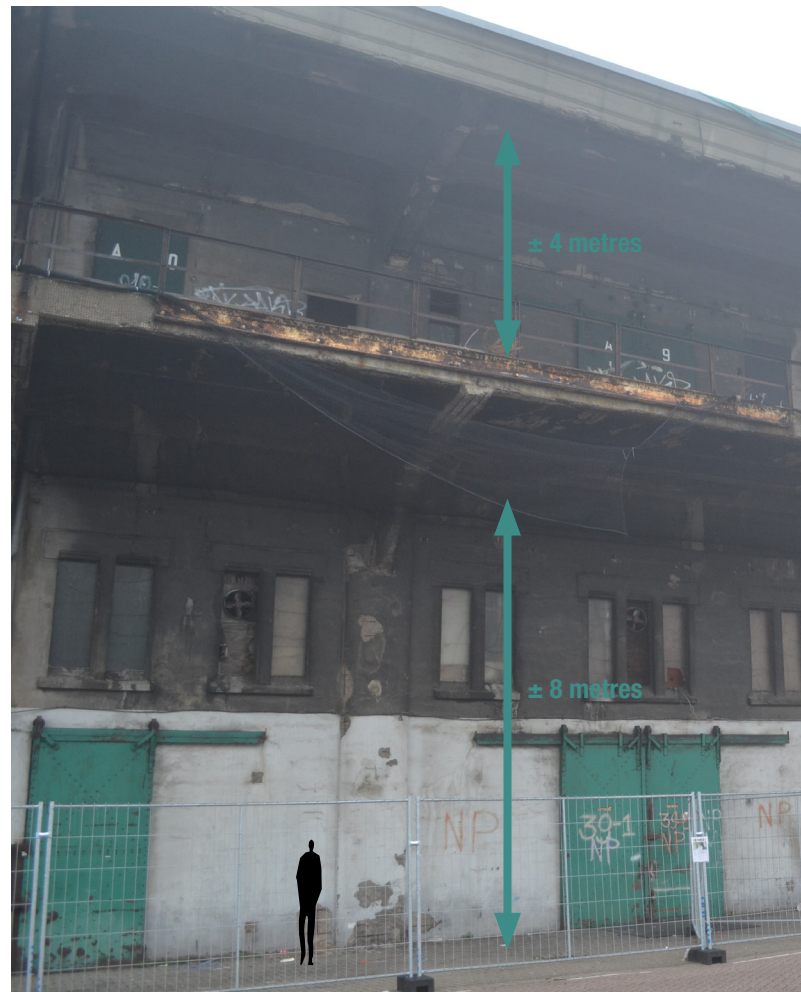
The difference in height creates different atmospheres underneath the balconies and the roof. The space in between the balcony and the roof has a more human scale than the space under the balcony on the ground floor, which is used for trains to be loaded with cotton, own photo (2016).

From the outside it looks as if the Katoenveem is a warehouse with two floors of which one is higher than the other. The ground floor has a height of approximately 8 metres, whereas the first floor is about 4 metres high. However, when standing inside, the compartments are experienced as one high space. This is because the first floor is no continuous floor. The voids in the floor are bigger than the actual floor area, so the first floor is experienced as walkways on top of the concrete construction. This gives the experience of one high space stretching from the ground floor to the roof, with bridges going through this space to connect both sides of the building.

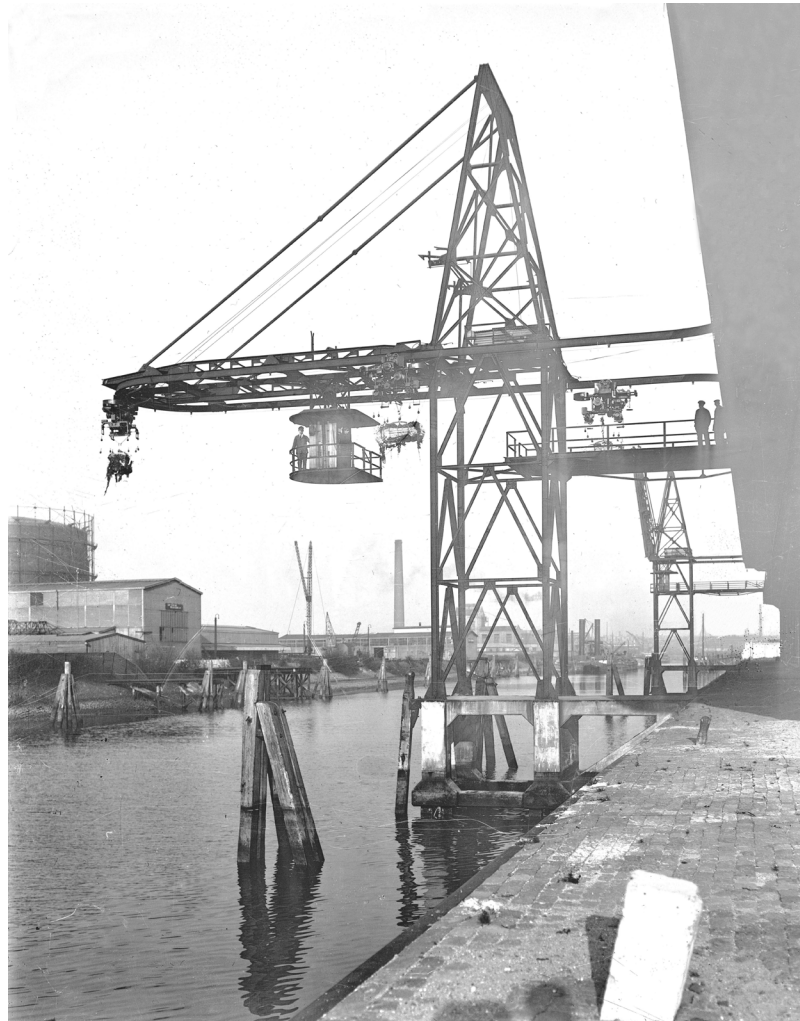
The cranes were connected to the transit system inside the Katoenveem, Historisch Centrum Overijssel (retrieved 24-10-2016)

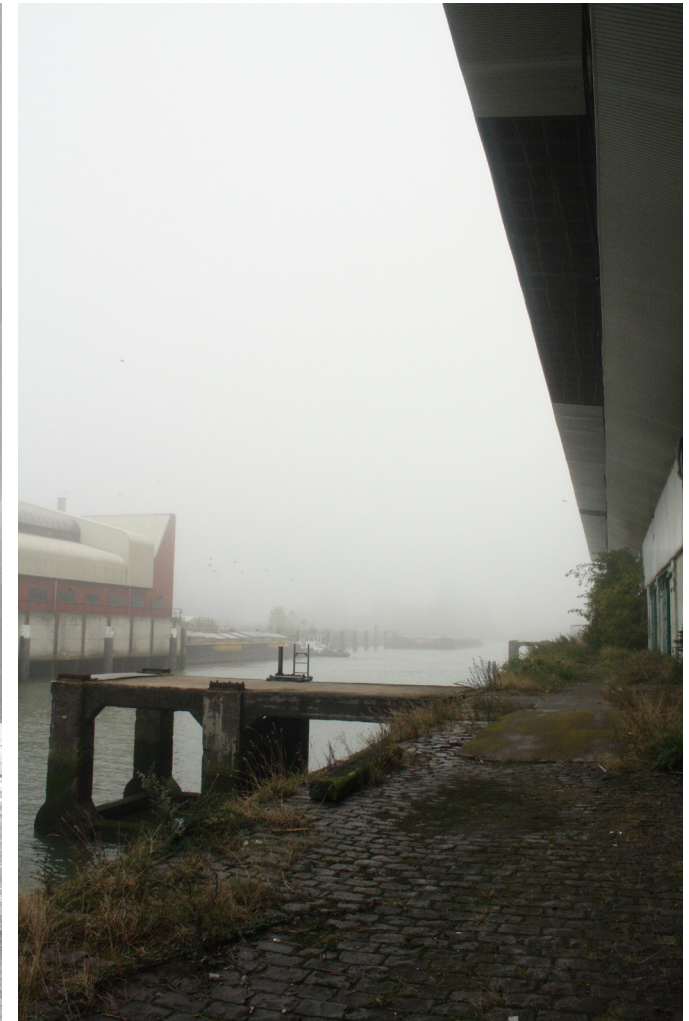
The cranes were removed in 1966, just like the wooden structures in the water to prevent the ships from hitting the cranes. The cobblestones on the quay, that remind of a harbour area, are still partly present, own photo (2016)

Some of the cobblestones on the quayside still remain from the past. This pavement reminds of the harbour quaysides dating back to the period of the Katoenveem. The wooden structures in the water to prevent ships from hitting the cranes is also removed. When visiting this side of the building nowadays it feels abandoned and dilapidated. The warehouse has literally lost its connection with the water, a connection that now can only be guessed from the very few remains.

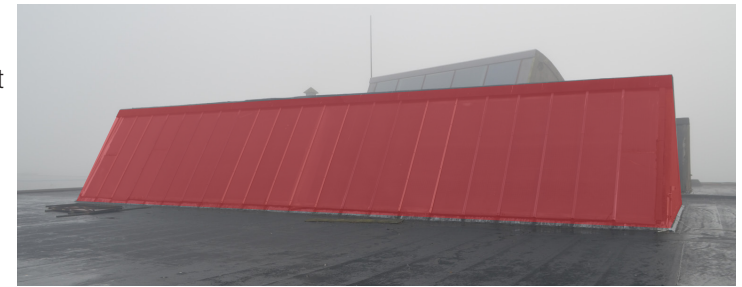
The roof lights are also valued highly, since they provided the major part of daylight needed in the building to function. They are characteristic for the building, and they are seen in other warehouses of the time as well, own photo (2016).

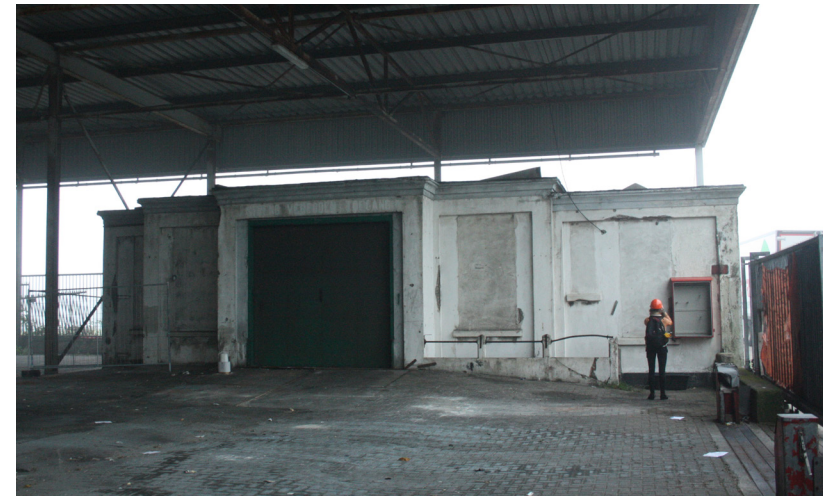
The pump station is still present next to the Katoenveem, although it has lost its original function. It has a medium value, because on the one hand it was an important link in the building complex, together with the water tower. However, it has lost its function, own photo (2016).

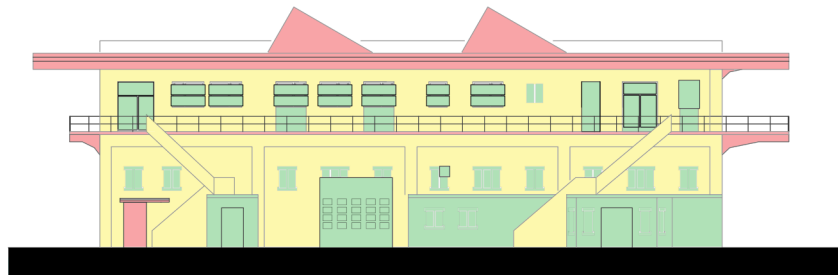
South-west facade

This page shows the value maps of the short facades. These facades have changed the most, presumably to fit new functions that have been allocated through the building over time. Large overhead doors have been added. In order to do this, a hole has been cut in the facade. This hole cuts through the original windows, that have been closed.

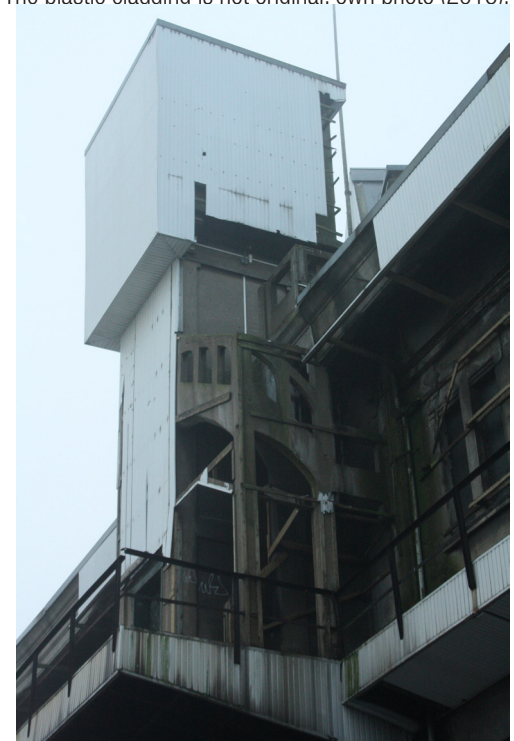
The original balconies have a high value because they are essential to the original function and design of the Katoenveem.

They were essential for the shipping of the cotton in and out of the building. The roof overhang was designed to hang the transit system. At the same time it kept the cotton dry when loading it into the trains, own photo (2016).

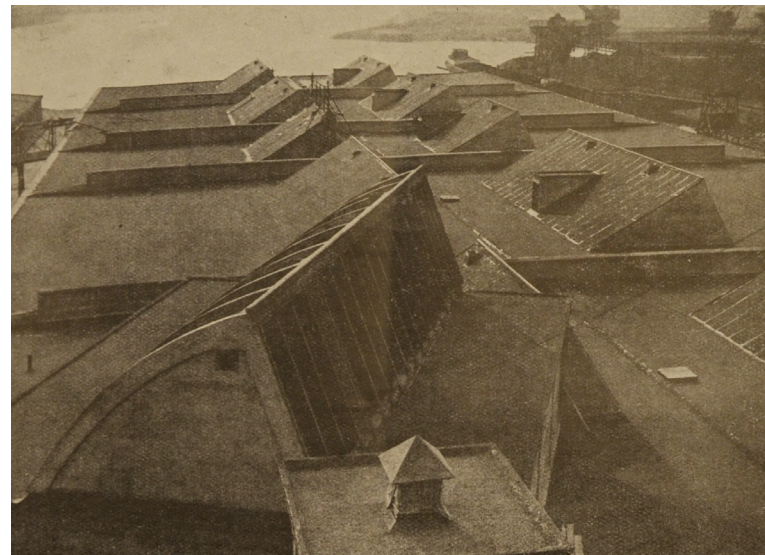
The sampling room on the roof of the building has a high value. It was needed as a part of the process of the cotton trade. Cotton samples would be tested to determine the quality and price of the cotton. The design of this sampling room was fully adjusted to this process, own photo (2016).

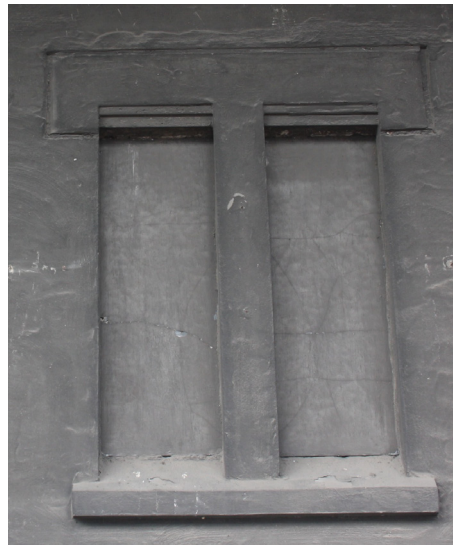
The north west facade is valued as seen in the image below. A great part of the facade has a medium value because of the overall appearance of the facade. The rhythm and organisation of the facade are essential to the building. The concrete and cement on the facade is falling off in many places. The glazing is broken or replaced in many cases and therefore has a low value.

Most of the windows are filled in with brick or wood, and the original glazing is broken in many cases. This gives the glazing a low value, own photo (2016).

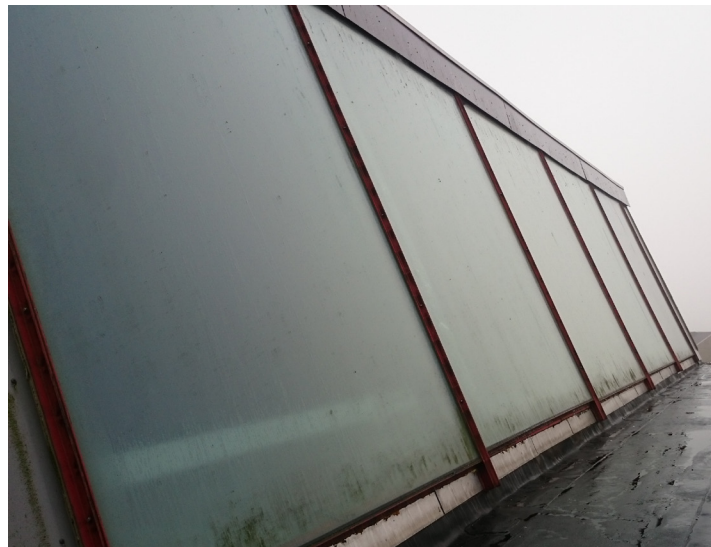
The roof lights have a high value, but the glazing is valued as low. The glazing is in many occasions not original and broken. The roof lights provide a large amount of daylight that was needed for the building to function, own photo (2016)

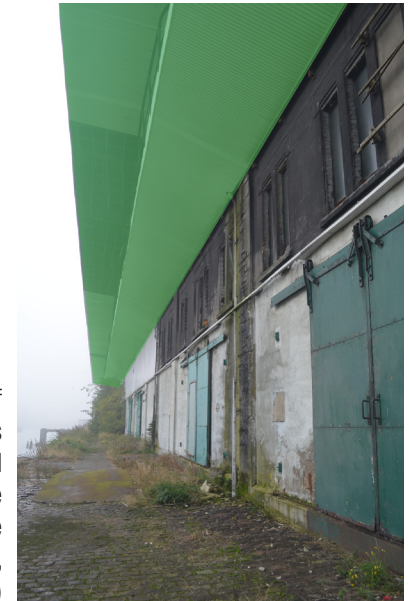
The plastic cladding on parts of the facade have a low value. This cladding is not original and hides all the characteristic elements of the original facade. Some parts of the cladding have been removed already, own photo (2016)

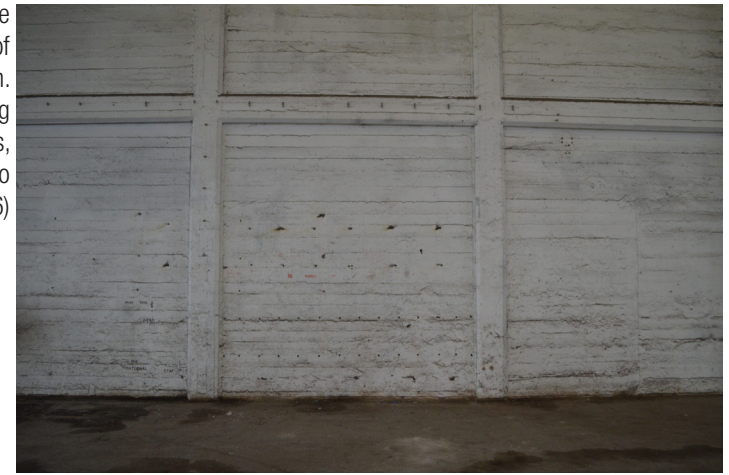
The fire walls have a high value because of the importance of the fire protection of the cotton. Without these fire walls the building could not have existed. Besides, they organise the building into compartments, own photo (2016)

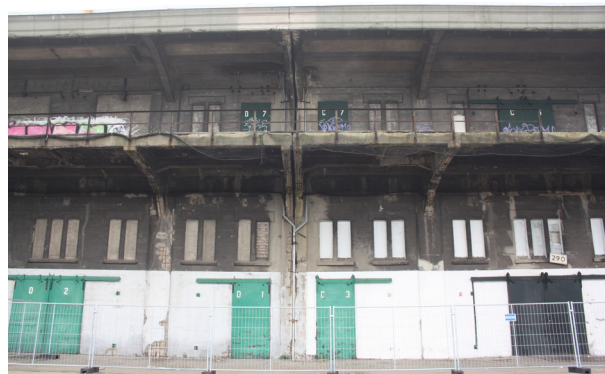
The facades of the building have a medium value. On one hand they are structured in a way to support the function of the building. On the other had they are damaged quite heavily and changes have been made already, own photo (2016).

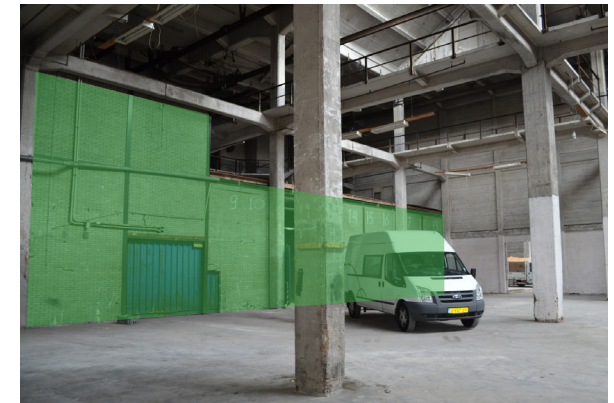
The new addition to the interior has a low value because it is not original and not in the same style and material as the rest of the building, own photo (2016).

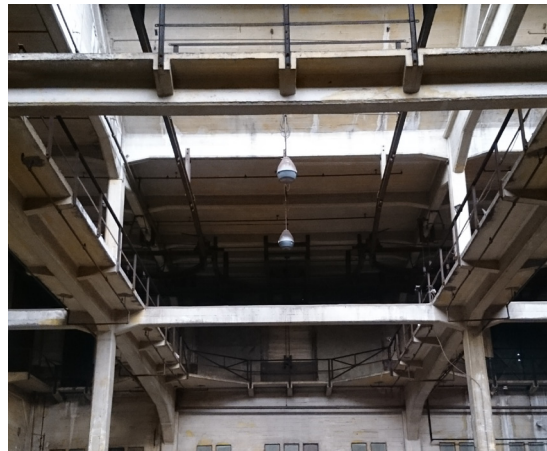
The walkways on the first floor are valued highly. They show how the building used to function, own photo (2016)

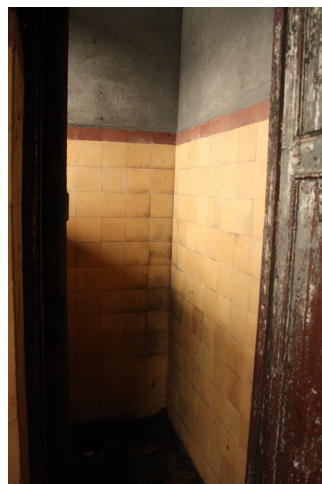
The toilets are given a low value. They are not a typical element for the use of the building. Besides, the toilets have been removed and are just empty spaces now, own photo (2016)

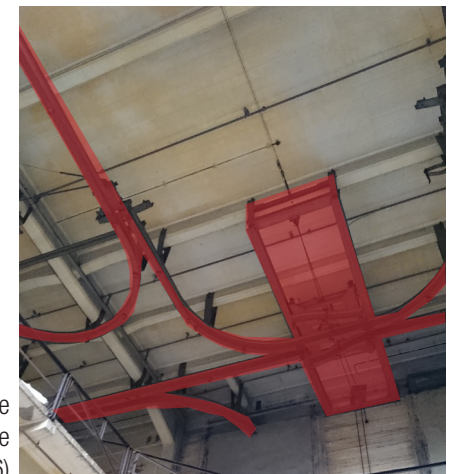
The transit system has a high value because of its importance to the original function, own photo (2016)

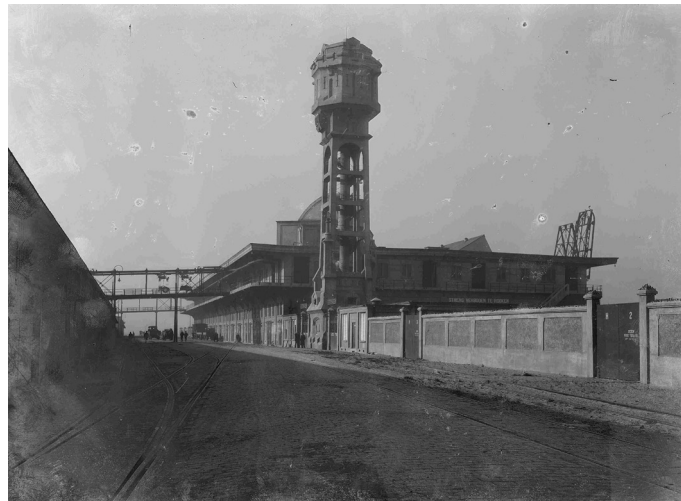
Image 2: Katoenveem in 1921, just after completion. Visible are the water tower, transporting bridges, cranes on the waterfront and outside wall. Source: Historisch Centrum Overijssel

connected to two other warehouses by means of a bridge. Furthermore, two cranes on the waterfront made it possible to load and unload ships in the harbour. By approaching the building in the 20's, people create a certain image in their mind, a cognitive map. The function of the building was immediately clear at first glance. Bales of cotton 'flew' in and out of the building and ships and trains were loading and unloading constantly (see image 2). The building was part of a vivid and dynamic environment.

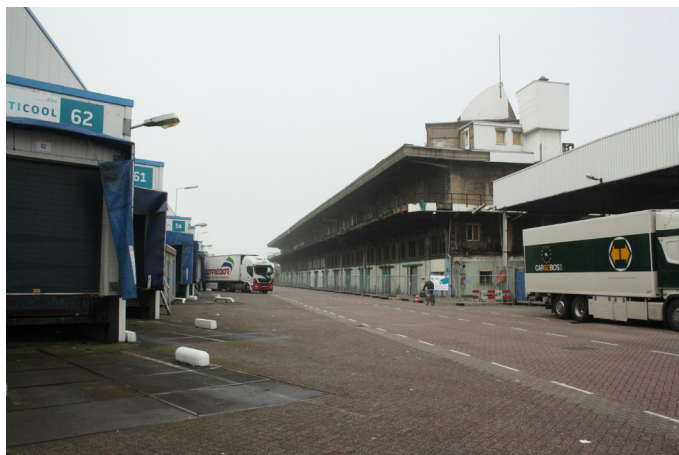
Image 3: Katoenveem in 2016. Original characteristic elements were demolished over time. A totally different picture remains. Photo taken by Alexia Ntella.

Throughout the years the Katoenveem has changed a lot. Many parts on the exterior have been removed, and the building has deteriorated (see image 3). The cognitive map that we create by looking at it is very different than the one of the original situation. The old function of the building is no longer clear at first glance. The Katoenveem is hidden behind a steel shed, and the neighbouring warehouse dominates the site. It almost seems as if the Katoenveem is no longer 'wanted' by the area. Architectural elements such as the water tower and transport bridges were designed features that helped people in creative an image of the building in their minds. By demolishing these components this image changes.
