## **BresDefender**

### **A potential emergency measure to prevent or postpone a dike breach**

FLOODrisk 2020 - 4th European Conference on Flood Risk Management

# BresDefender: A potential emergency measure to prevent or postpone a dike breach.

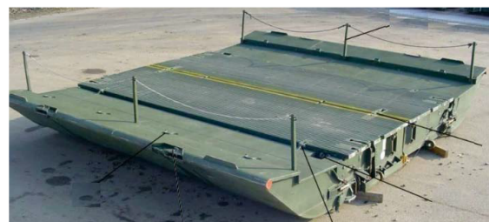
Finally, a new emergency response strategy is proposed here, BresDefender, literally translated BreachDefender. This is an emergency response strategy which can be applied to stop or postpone the breaching process of a dike until stage III in the breach formation process. In its current conception the BresDefender intervention strategy is a floating pontoon, normally used by the military to construct temporary floating bridges (Figure 5). A single element has a length of 6.94 meters, a height of 8.13 meters and a weight of 5450 kilograms. The advantage of the pontoon is the possibility to transport the pontoon over water and to place the BresDefender completely from the water. A prototype has been successfully tested during the crisis training exercise *Alert 2014*. Preliminary research has shown that the BresDefender has a positive effect on the breach formation process (Elsing, 2018). It is expected that the BresDefender is able to locally increase the dike height to block the overflowing water, in case of a local reduced crest height.

**Figure 5.** Floating pontoon bridge which is here proposed as BresDefender
