Lessons learned from data analytics, applied to the track maintenance of the dutch high speed line

Lessons learned from data analytics, applied to the track maintenance of the Dutch high speed line

2 CASE HSL-ZUID

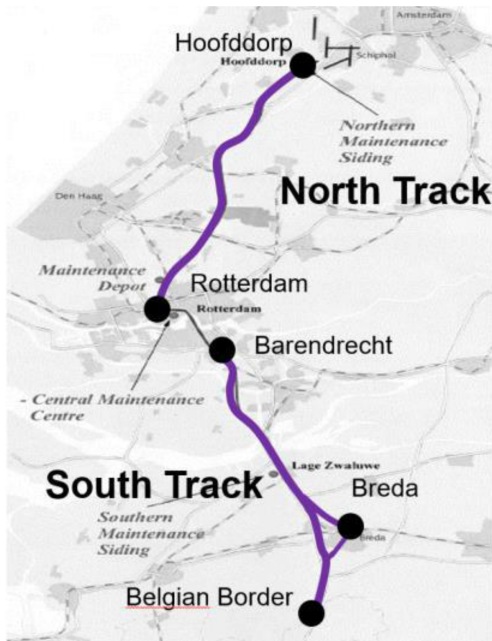
Figure 1. Overview of the HSL-Zuid (Schalk, 2016).

The HSL-Zuid is one of the latest additions to the Dutch railway network and the first high-speed passenger line of the country. The line consists of two parts of about 50 km double track, the first part runs from Schiphol Amsterdam airport to Rotterdam and the second part from Rotterdam to the Belgian border with switches halfway to the city of Breda. From the Belgian border the track continues to Antwerp in Belgium. An overview of the track is shown in Figure 1.

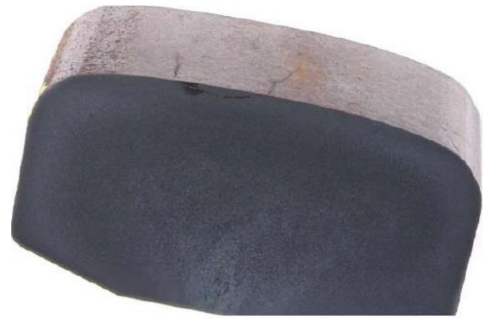
During a visual inspection along the track in November 2014, some severe damages in the form of cracks in the rails were found. These were not detected by the regular measurements. These findings indicated that the monitoring programme was not sufficient as it did not detect these cracks in an early stage and the monitoring programme seemed therefore not tailored for the requirements of the HSL-Zuid. Also these serious defects occurred after only a few years of commercial operation of the HSL-Zuid with very low service usage. These findings resulted in a large track inspection where additional areas were found with the same kind of defects, so-called hotspots. Pieces of the rails were taken out for further investigation, which concluded that the rails themselves were according specifications and without irregularities, ruling out fabrication errors. A picture of a piece of damaged rail is shown in Figure 2.

Also, the defects were classified by experts as studs. These show similarities with squats in their external appearance. However, the cracks do not grow deep into the rail but often grow towards the gauge corner of the rail (Stuart L Grassie, Fletcher, Hernandez, &

Figure 2. Picture of the examined damaged of the HSL-Zuid. The cracks do not grow into the rail but stay relatively close to the surface (Schalk, 2016).

Summers, 2011). Also well developed studs can result in spalling out (S.L. Grassie, 2015). These defects at the HSL-Zuid only were found at the (harder) heat treated 350HT rails which are located only among the curves of the track. The straight track among the HSL has a softer 260 rail grade. According to (Wilson, Kerr, Marich, & Kaewunruen, 2012) from Australian experiences, studs indeed seem to be more prevalent on harder rail grades than softer ones. Their occurrence described in (S.L. Grassie, 2012) shows that hotspots of studs often occurred in track sections related to high tractive efforts and that they were only occurring in open areas, which can be linked to the need of moisture in order for the defects to grow. Also, as the track was relatively lightly loaded (<30 MGT since the start of operations), it was unexpected that such damages could occur. (Steenbergen, 2016) shows that these defects can indeed occur very early in the assets' lifecycle with cumulative loading of the rails from 15 MGT.

The damages found had severe effects on the rail infrastructure as they were well-developed (up to 5 mm of depth). This resulted in the deployment of additional unforeseen grinding campaigns to remove the cracks and about 20 kms of rail renewals, 20 years earlier than the expected assets lifecycle.

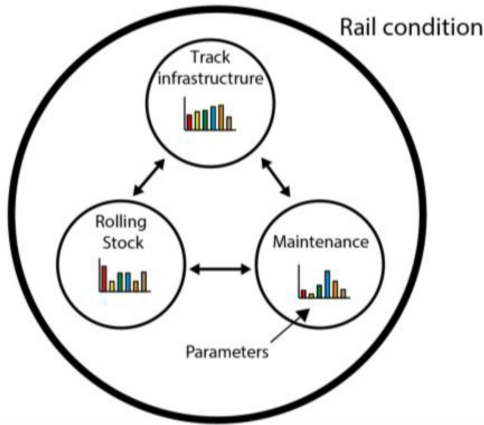
Figure 3. The approach is based on the principle of the rail condition being the result of the interaction between sets of parameters of track infrastructure, rolling stock and maintenance (Schalk, 2016).

A bottom-up approach is next presented, which is based on data from both rolling stock, track infrastructure and maintenance. This data is shown in (sets of) parameters representing the track infrastructure and types of rolling stock, together with the condition of the asset assessed (rails). The approach is suitable for evaluating a whole network, track or track section. The rail condition is approached as the interaction between sets of maintenance-, track infrastructure- and rolling stock parameters as shown in Figure 3. The processed parameters have been chosen based on relevance according to literature regarding the occurrence of
