Use of InSAR data for building deformation monitoring

to obtain the degree of Master of Science
at the Delft University of Technology,
to be defended publicly on Monday December 17, 2018 at 15:00 PM.

How and under what conditions can the InSAR data contribute to monitoring of buildings adjacent to quay walls?

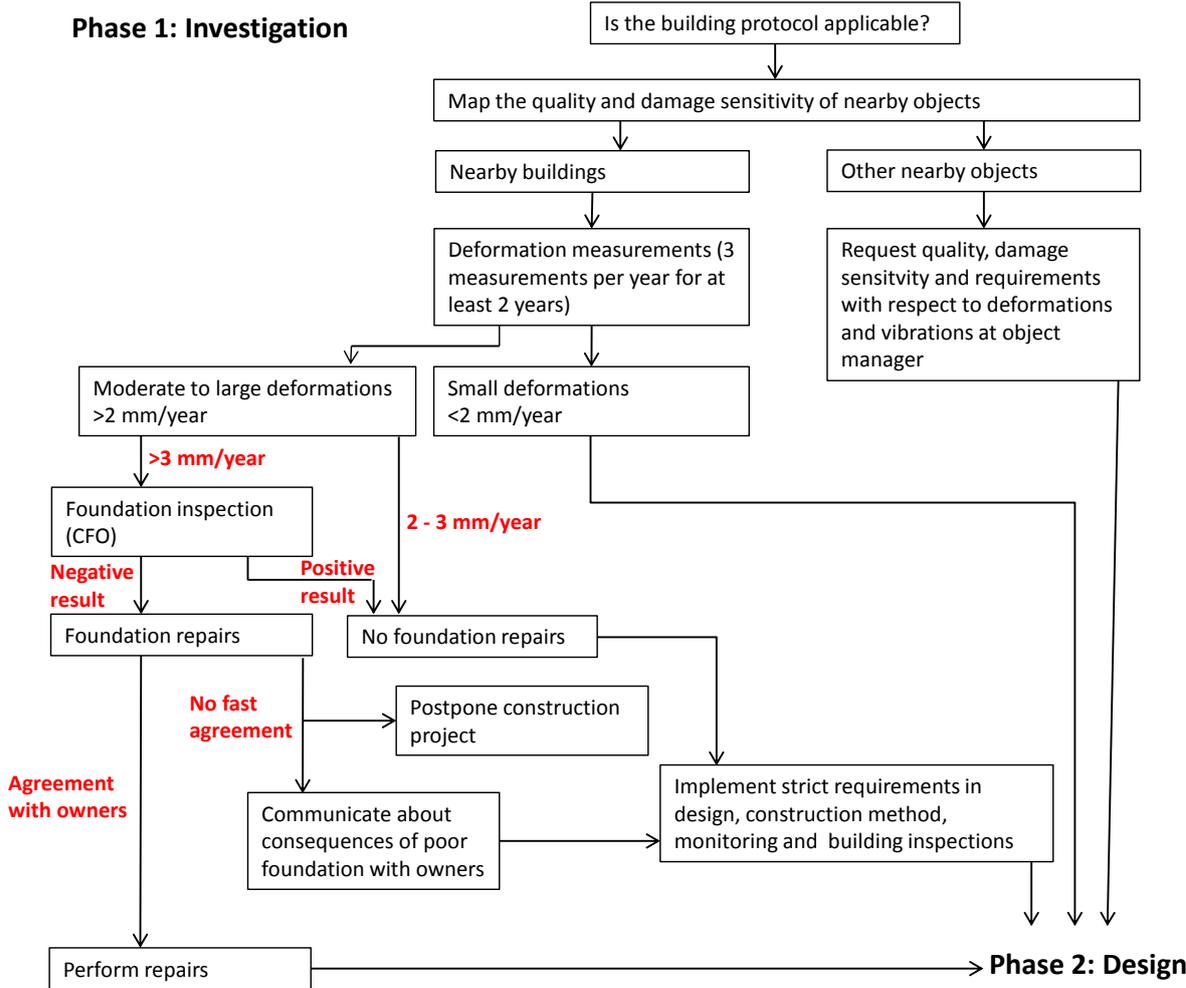
Figure 2.2: Flow chart of phase 1 of the building protocol [10]

The first phase is summarized in the flow chart shown in figure 2.2. First, it needs to be determined whether the building protocol needs to be applied for a certain project. Application of the protocol is necessary when nearby objects are within the influence zone of the construction. As a rule of thumb, objects within 20 m of the construction are considered to be influenced by the construction activities. Extra care should be taken in case of special geotechnical circumstances such as excavations near pile foundations and shallow foundations, earth retaining structures and a decrease of the groundwater table. In addition, construction projects in historic city centres are always considered to be of influence on objects close by.

For all objects within the influence zone, the quality and damage sensitivity need to be determined. For buildings, this means deformations measurements need to be done for two to five years. The required monitoring time depends on the type of quay wall replacement. For combi walls two years of monitoring is required as this is considered to be a robust replacement method. For the traditional replacement five years of monitoring is required. To monitor the deformations, levelling benchmarks need to be installed with a center-to-center distance of 6 meter with at least one benchmark for each building. The measurements need to be referenced to multiple stable reference points to achieve an accuracy of +/- 0.5 millimetre.

The next step in the investigation phase is based on the results of the deformation measurements. Buildings with less than 2 millimetre deformation per year are considered to be of low risk with regard to damage. Moderate deformations, i.e. 2 - 3 millimetre per year, require adjustments in the design, execution and monitoring of a construction project. Where large deformations are measured, i.e. more than 3 millimetre per year, a foundation inspection needs to be carried out. The inspection should provide detailed information about the current condition of the building. When the condition of the foundation is unsatisfactory according to the inspection, foundation repairs are necessary.

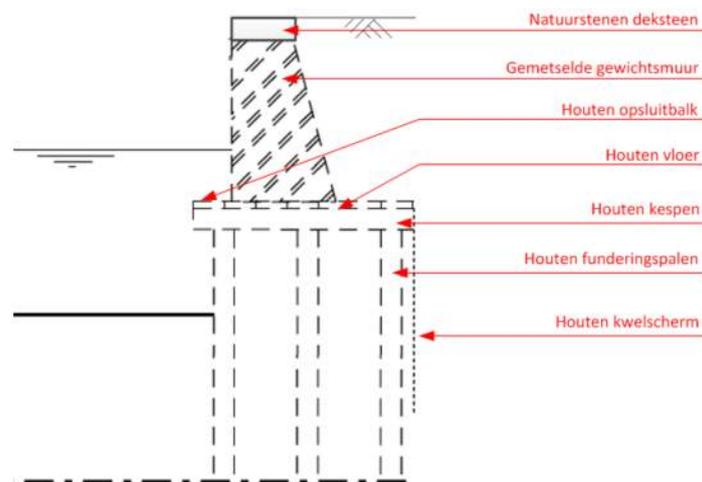
Figure 2.3: Brick gravity wall with a wooden pile foundation [4]

Not only have these quay walls reached their designed life time, the wooden foundation has also been affected by dry rot caused by bacteria. Besides, old quay walls are frequently affected by seepage of groundwater. Often no seepage screens were installed during construction. This has led to excessive flow of groundwater beneath the quay wall. [4]

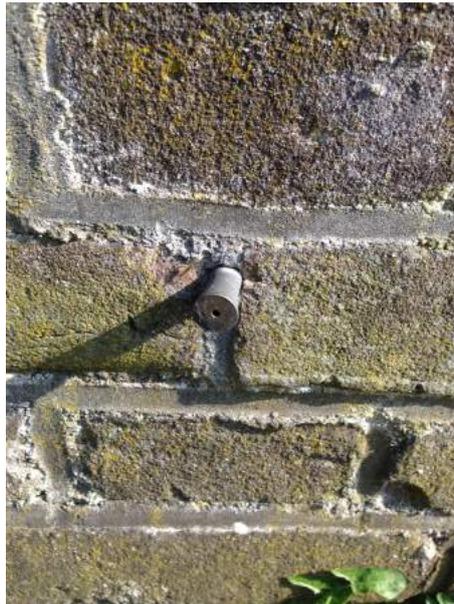
Figure 3.1: levelling benchmarks on a building of the Spoorsingel in Delft

In levelling, an optical instrument is used to manually measure the height difference between two points with levelling rods. Only the vertical heights are measured in levelling. By repeated measurements the vertical deformation with respect to the reference point can be monitored in time. Levelling benchmarks (bolts) are often installed on the walls of buildings for long-term monitoring of settlements. Figure 3.1 shows such a benchmark. In an extensive monitoring project, the manual measurements of levelling benchmarks are often used as a backup for the total stations [33]. These measurements are conducted every few weeks or months. For Leica levelling equipment a standard deviation of 0.3 mm/km can be achieved [18].

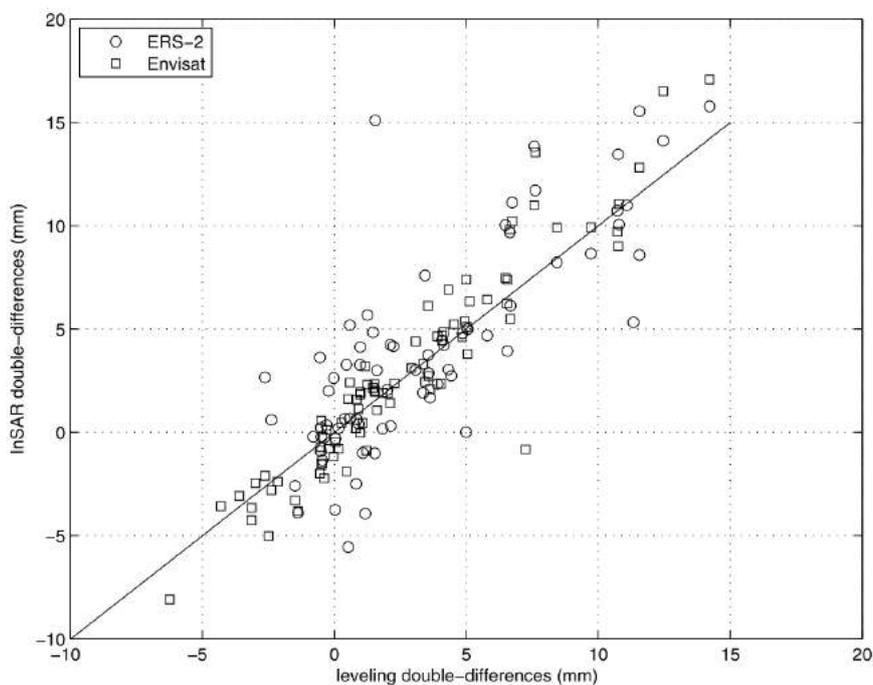
Figure 4.5: Plot of levelling and InSAR double-differences [26]. A correlation of 94% was found between levelling and Envisat and a correlation of 79% and 84% was found between levelling and ERS-2 before and after outlier removal respectively [26]

The InSAR double-differences are corrected for sub-pixel position. The sub-pixel position is the position of the persistent scatterer in the resolution cell [26]. The InSAR displacements are also converted to vertical displacements assuming the corner reflectors don't displace in a horizontal direction. The results show that double difference displacements from levelling, ERS-2 and Envisat are very comparable [26]. The double-difference displacements are shown in a plot in figure 4.5. The calculated correlation between levelling and ERS-2 and Envisat is 79% and 94% respectively. After outlier removal, which is applied when the standard deviation of the double difference is exceeded, the correlation between levelling and ERS-2 increases to 84%. The calculated double-difference displacement precision for ERS-2 and Envisat is 3.0 mm and 1.6 mm respectively.

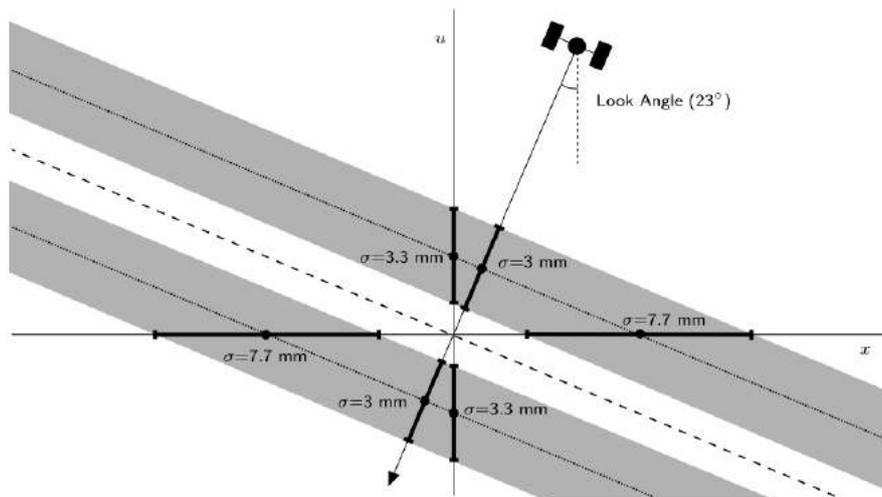
Figure 4.6: Figure indicating the deformation precision in horizontal and vertical direction based on a 3 mm precision in the line of sight [29]

Additionally, the horizontal precision in other directions as the direction perpendicular to the orbit track is shown in figure 4.7. Again an Envisat satellite with a 23° look angle and a 3 mm precision in the line of sight is used. Also, an orbit heading of 193° is used [29]. As can be expected, the precision degrades towards the direction of the orbit track which is almost north-south. From these results it can be concluded that horizontal deformations can only be measured accurately in a roughly east-west direction [29].

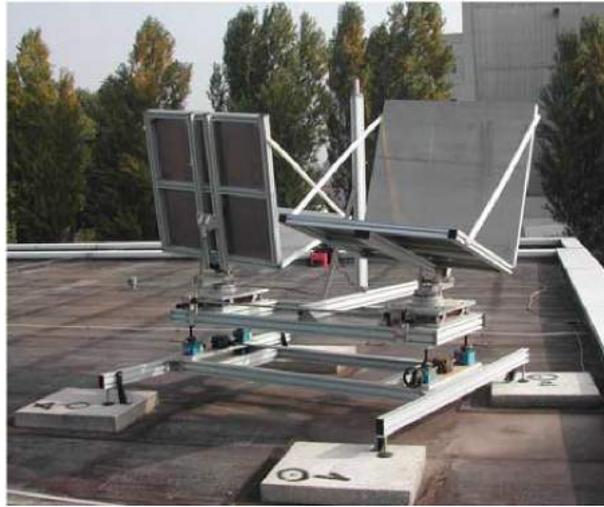
Figure 4.8: Assembly of mobile reflectors [19]

team. The results show a standard deviation of the error of 0.75 mm and 0.58 mm for vertical and horizontal deformation respectively. It should be noted that the measurements are obtained under favourable conditions. The atmospheric delay is hardly present due to the short distance between the two reflectors. Also, the artificial reflectors provide very stable and strong reflections.

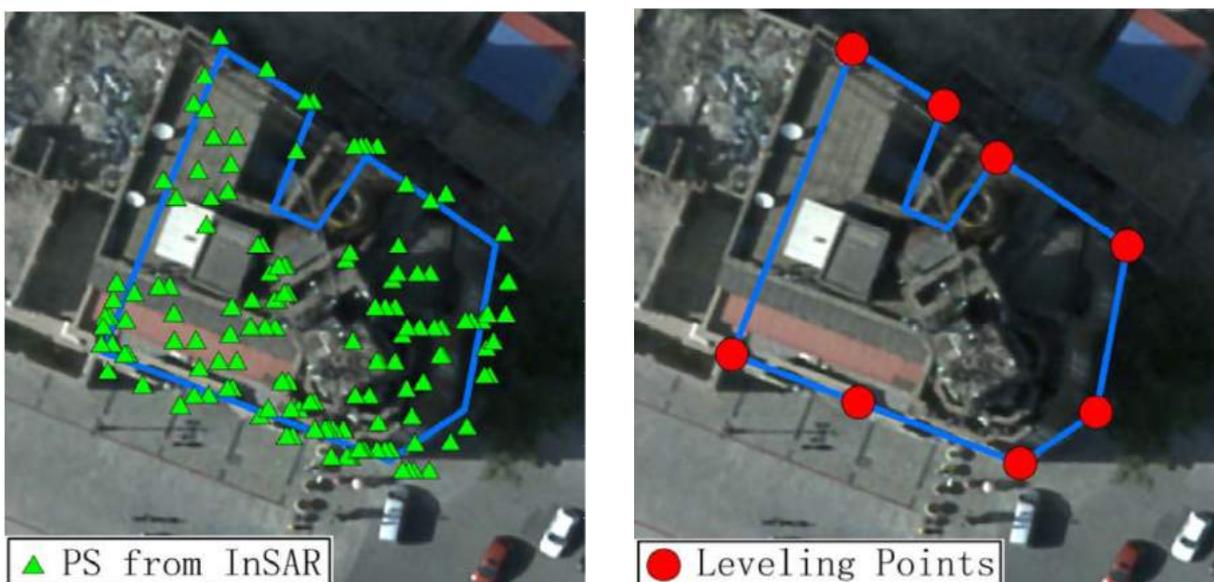
Figure 4.9: Location of PS (left) and location of levelling points (right) on the Bohai Building

Yang et al. [46] focussed on the validation of InSAR data with regard to building deformation. TerraSAR-X images obtained between May and December 2014, were used to monitor the vertical deformation of two large buildings in Tianjin in China; the Bohai Building and the China Theater. Levelling points were installed on these buildings and monitored using optical levelling. The InSAR data was converted to vertical displacements assuming no horizontal deformation occurred. The positions of the PS and the levelling points of the Bohai Building are shown in figure 4.9. For comparison, the PS displacements are interpolated to determine the PS displacement at the location of the levelling points. Inverse distance interpolation was used for this purpose. Subsequently, the difference between the two measurement techniques was calculated at every levelling point. The standard deviation of the error was found to be 1.11 mm and 1.14 mm for the Bohai Building and the China Theater respectively.

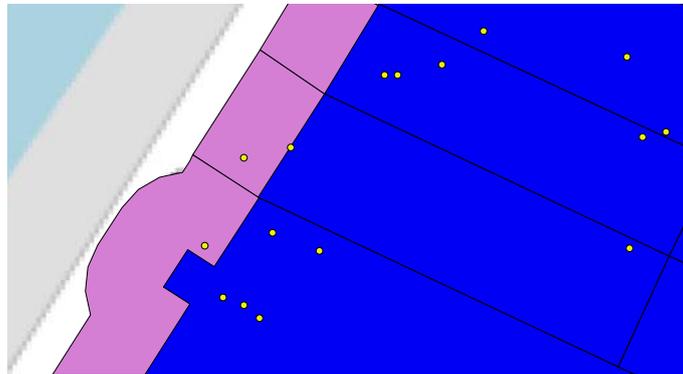
Figure 5.2: InSAR points (yellow) and 2 meter buffer area (pink) around several buildings (blue) to account for the location precision of the InSAR data

To analyze the deformation behaviour of the observed buildings, buildings with levelling benchmarks installed, are also inspected for available InSAR data. As the location precision of the InSAR points is given to be 1-2 meters [41], all points located within 2 meters of the buildings are selected. Because only high points are selected, it is likely that these points originate from the buildings as well. This is depicted in figure 5.2. Points located outside any building but within 2 meter distance, are allocated to the nearest building.

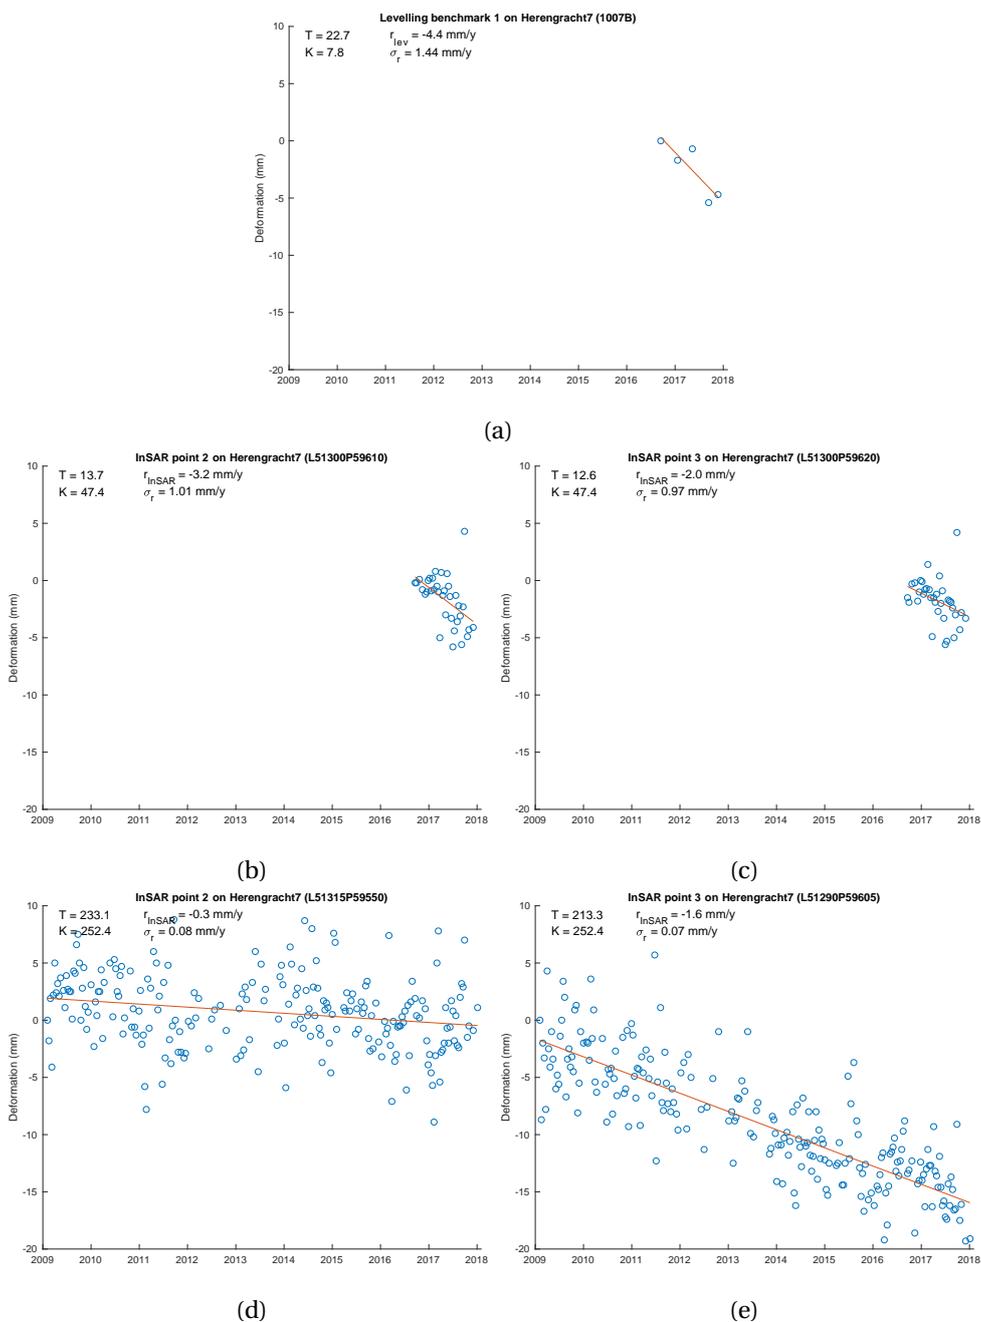
Figure 5.4: Deformations of a levelling benchmark (top), two InSAR points from the asc_2y dataset (middle) and two InSAR points from the asc_9y dataset (bottom) located on Herengracht 7

Some of the deformation time series on Herengracht 7 from levelling and the 2 year and 9 year InSAR datasets are shown in figure 5.4. The only levelling benchmark present on this building provides high deformations between September 2016 and November 2017, resulting in a deformation rate of -4.4 mm/year. However, the test statistic of the linear deformation is higher than the critical value indicating the observations can not be explained by the measurement variance and the deformation model. The deformation rates from the 2 year InSAR dataset are lower, although the deformation rate standard deviation is higher. The 9 year InSAR points give lowest deformation rates with large deformation variance.

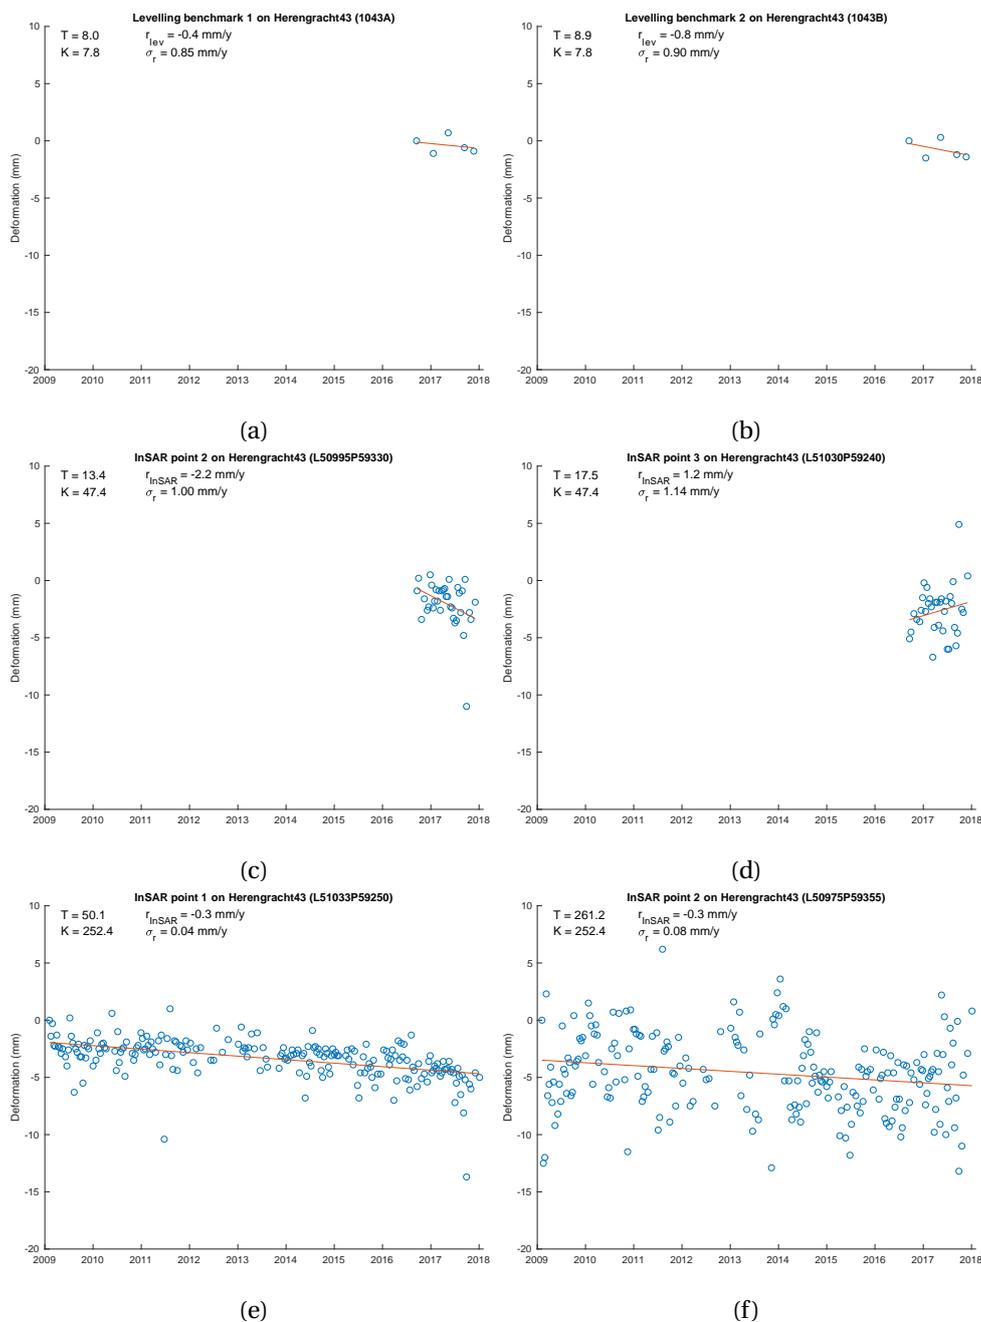
Figure 5.5: Deformations of two levelling benchmark (top), two InSAR points from the asc_2y dataset (middle) and two InSAR points from the asc_9y dataset (bottom) located on Herengracht 43

Several deformation time series from the different datasets are shown in figure 5.5. The levelling benchmarks provide low deformations. A deformation rate of -0.4 and -0.8 mm/year is calculated. However, the hypothesis of linear deformation in time for the levelling benchmarks needs to be rejected according to the overall model test. It is hard to distinguish a linear trend in the time series from the 2 year InSAR dataset, where deformation rates of -2.2 and 1.2 mm/year are calculated. The two InSAR points from the 9 year InSAR dataset both give a deformation rate of -0.3 mm/year. However, InSAR point 2 must be disregarded as the overall model test suggests errors in the observations or in the deformation model.

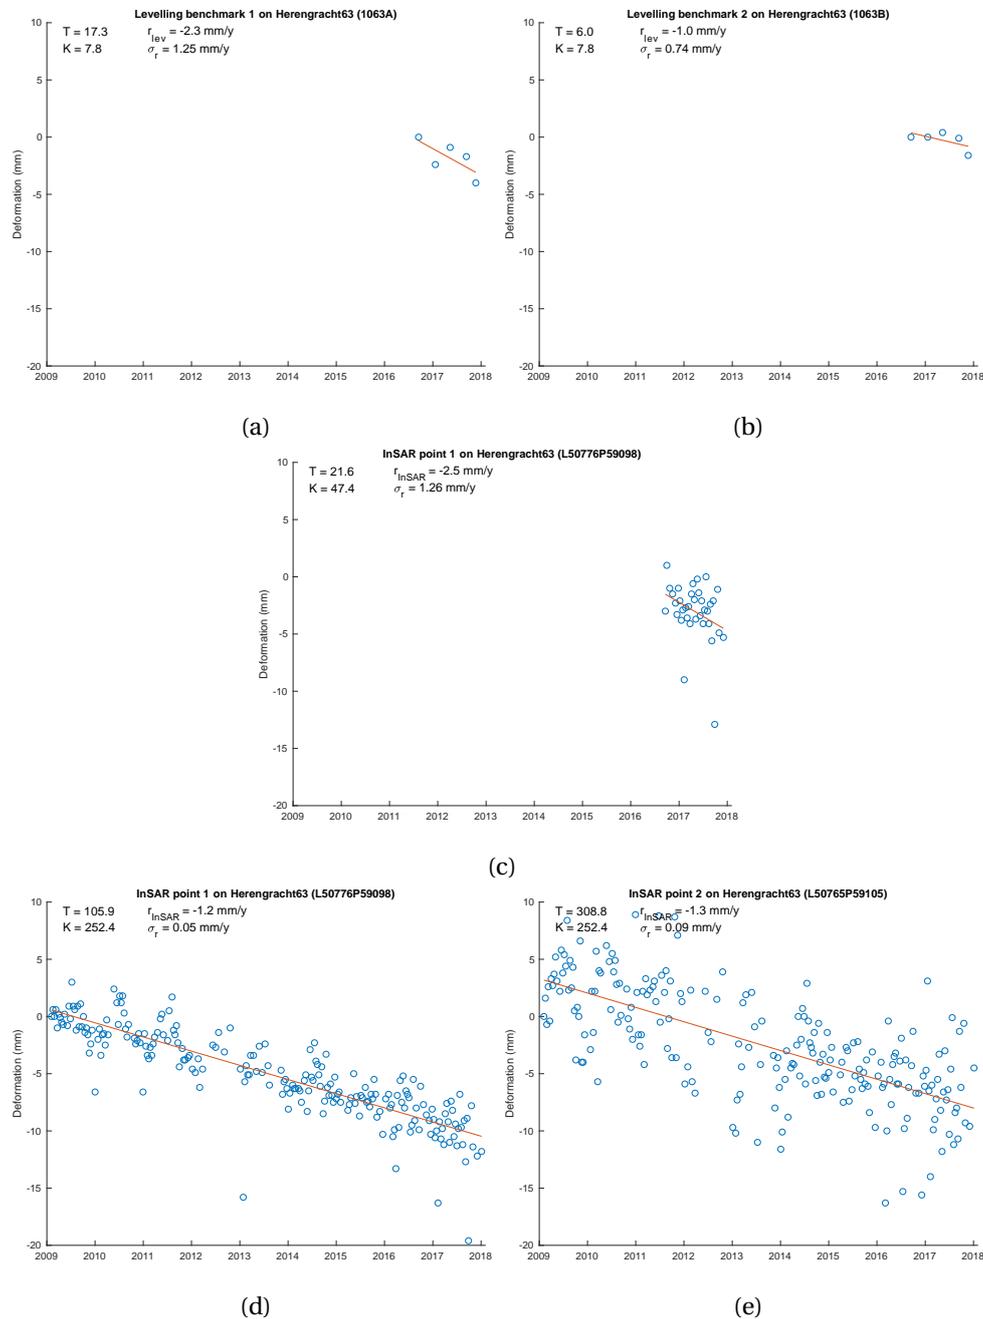
Figure 5.6: Deformations of two levelling benchmark (top), one InSAR point from the asc_2y dataset (middle) and two InSAR points from the asc_9y dataset (bottom) located on Herengracht 63

The levelling benchmarks give deformation rates of -2.3 and -1 mm/year but the null hypothesis of linear deformation must be rejected for the first levelling benchmark. Although a linear trend can hardly be observed in the 2 year dataset, a deformation rate of -2.5 mm/year is found. For the 9 year InSAR dataset, rates of -1.2 and -1.3 are calculated. The difference in quality of these two InSAR point is obvious. Based on the test statistic T , the deformation model of InSAR point 2 needs to be rejected.

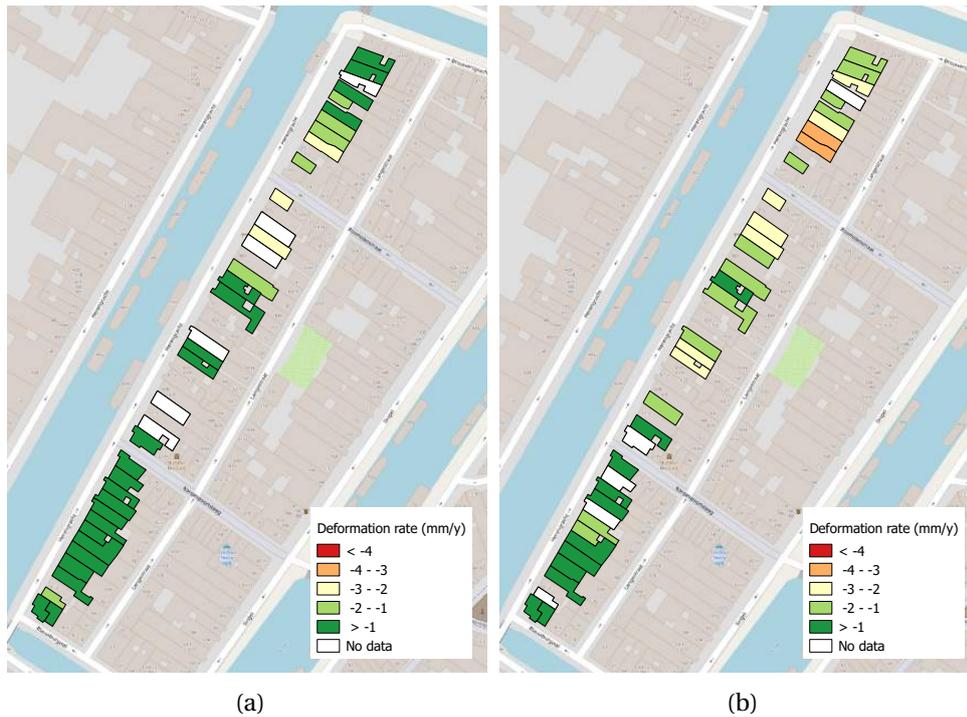
Figure 5.8: Average building deformation rate along Herengracht from levelling data (left) and InSAR data (asc_2y) (right) between September 2016 and November 2017

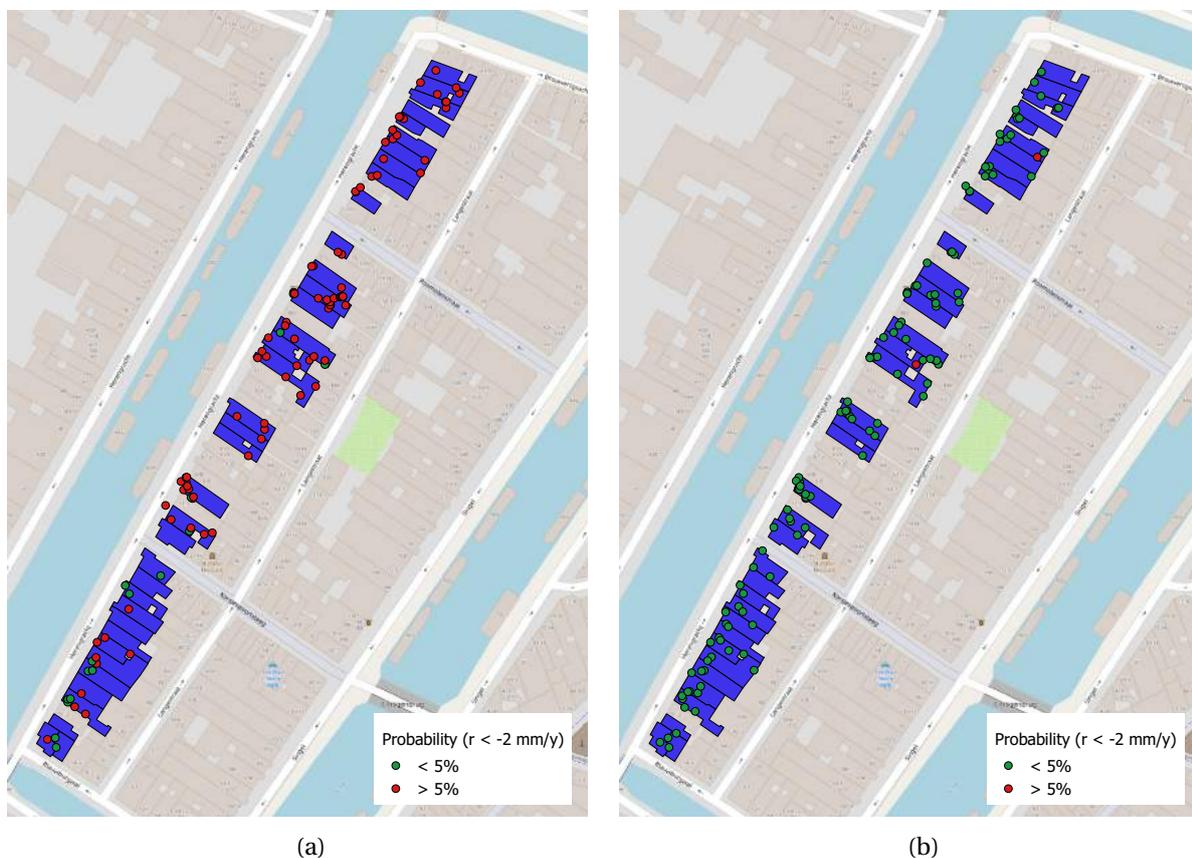
Figure 5.12: Probability of a deformation rate of more than -2 mm/y based on the calculated σ_r of each InSAR point for InSAR data between September 2016 and November 2017 (left) and InSAR data between February 2009 and January 2018 (right)

The probability map of the asc_2y dataset with observations between September 2016 and December 2017, is depicted in figure 5.12a. The probability map of the asc_9y dataset with observations between February 2009 and January 2018, is shown in figure 5.12b. Deformation time series with a probability smaller than 5% are indicated in green and time series with a probability larger than 5% are indicated in red. As can be seen in the figure 5.12a, the 2 year dataset does not provide high confidence regarding exceedance of the -2 mm/y deformation rate threshold. On the other hand, the 9 year dataset in figure 5.12b gives much certainty about a deformation rate of -2 mm/y.

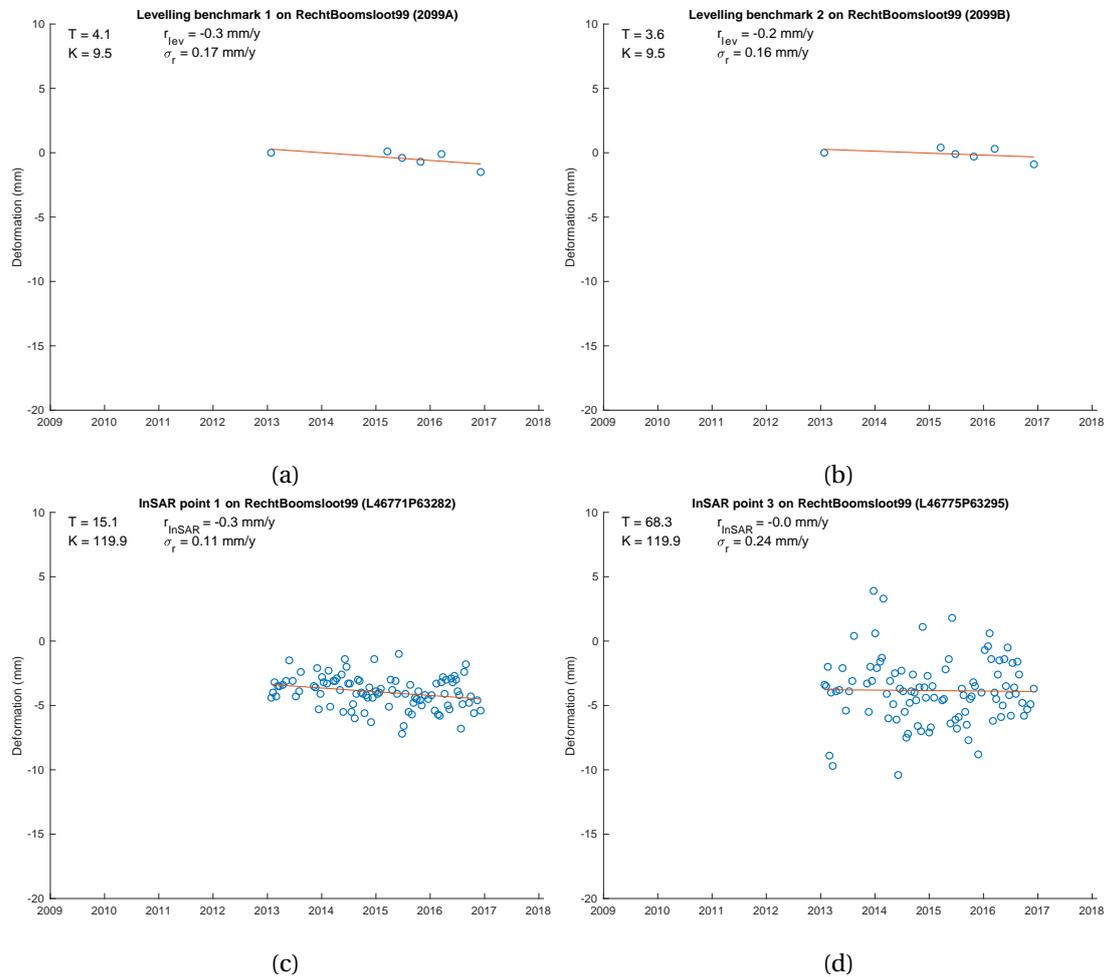
Figure 5.13: Deformations of two levelling benchmark (top) and two InSAR points from the asc_9y dataset (bottom) located on Recht Boomsloot 99

Some of the results of Recht Boomsloot 99 are given in figure 5.13. Both the levelling and InSAR give small deformations between 2013 and 2016. The deformation variance is larger for InSAR point 3 compared to InSAR point 1. Nevertheless InSAR point 3 still satisfies the overall model test due to the specified measurement variance.

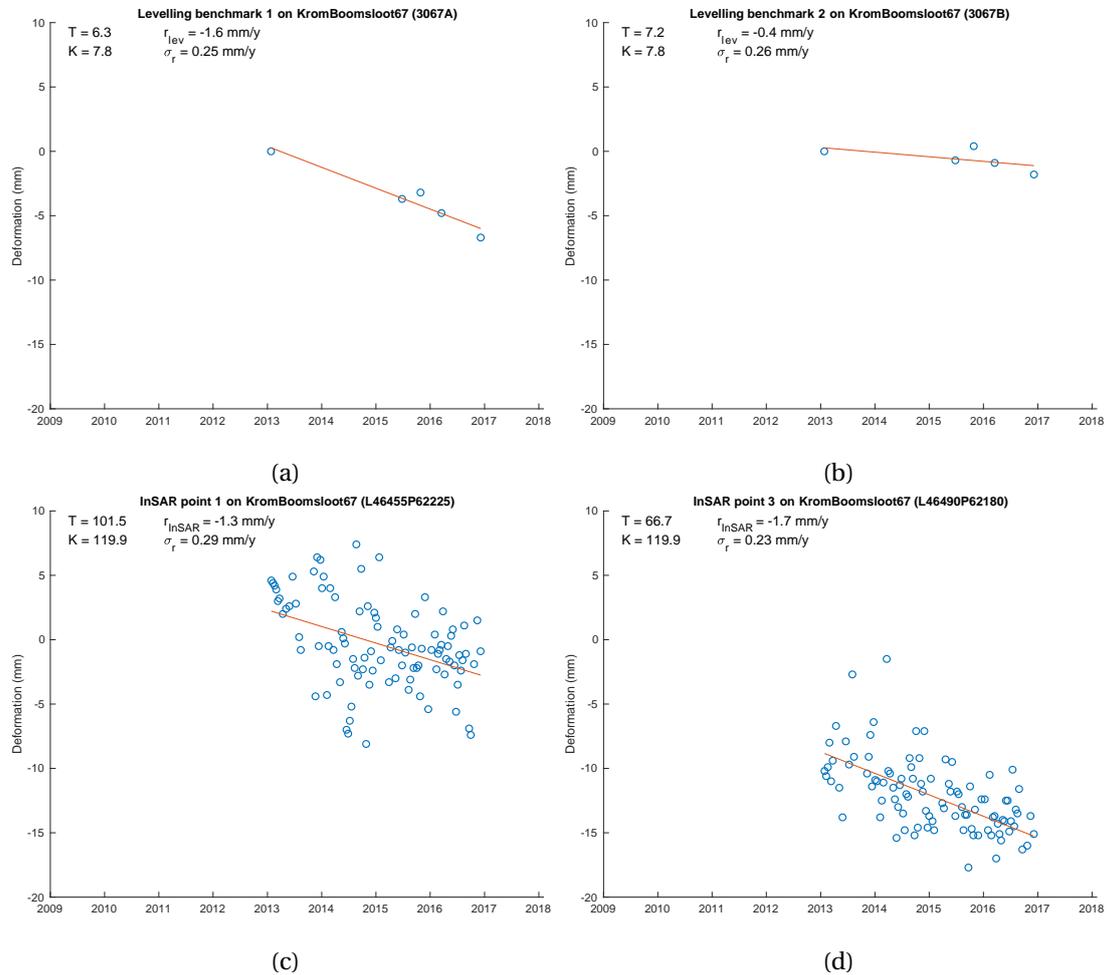
Figure 5.14: Deformations of two levelling benchmark (top) and two InSAR points from the asc_9y dataset (bottom) located on Krom Boomssloot 67

Figure 5.14 shows the deformations from levelling and InSAR for Krom Boomssloot 67. A difference of roughly 5 millimeter between the two levelling benchmarks is present in roughly four years. The two InSAR points show similar deformation rates as levelling benchmark 1. Both InSAR points sustain the linear deformation in time according to the overall model test.

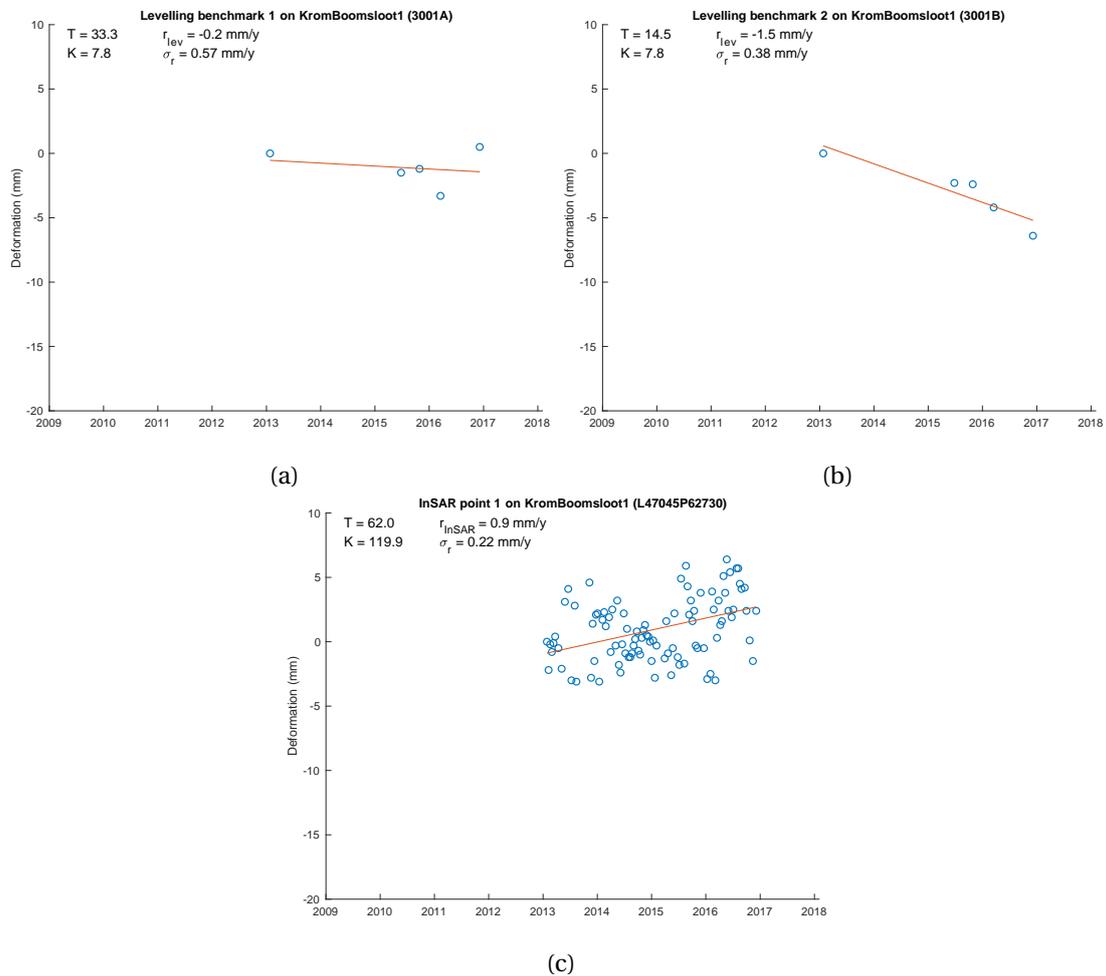
Figure 5.15: Deformations of the two levelling benchmark (top) and one InSAR points from the asc_9y dataset (bottom) located on Krom Boomssloot 1

The deformation time series found for Krom Boomssloot 1, are given in figure 5.15. No clear deformation pattern can be observed for levelling benchmark 1 while benchmark 2 seems to follow a linear deformation in time. Nevertheless, the linear deformation model is rejected for both levelling benchmarks due to the defined measurement variance of 0.5^2 . The InSAR point shows large variance in deformation. A positive deformation rate of 0.9 mm/year as a result.

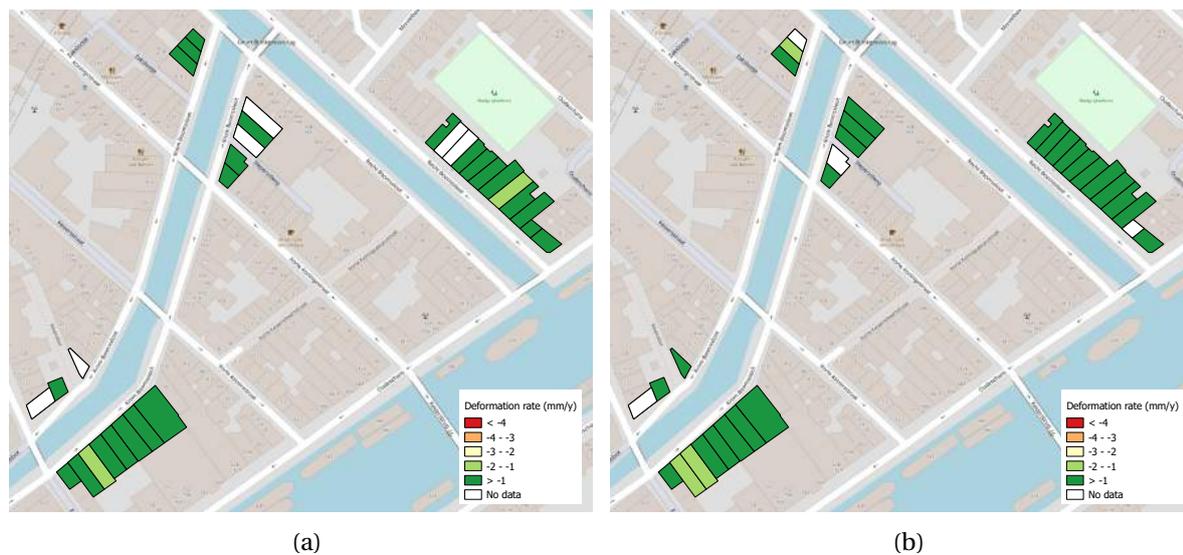
Figure 5.17: Average building deformation rate along the Recht Boomssloot and Krom Boomssloot from levelling data (left) and InSAR data (asc_9y) (right) between January 2013 and December 2016

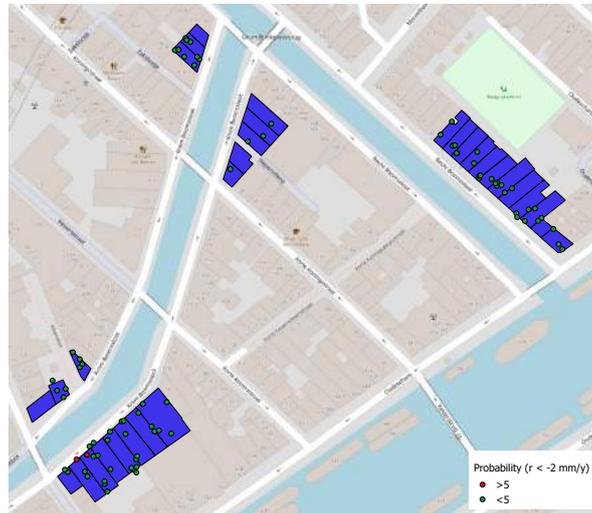
Figure 5.19: Probability of a deformation rate of more than -2 mm/y based on the calculated σ_r of each InSAR point for InSAR data between January 2013 and December 2016

In figure 5.19 a probability map is presented of the InSAR points located on the considered buildings of Recht Boomssloot and Krom Boomssloot. The map indicates whether the probability of a -2 mm/y deformation rate is more or less than 5%. The method to obtain this probability from the deformation time series is described in section 5.1.1.5. Only two InSAR points provide deformations which could indicate a deformation rate of more than 2 mm/y.

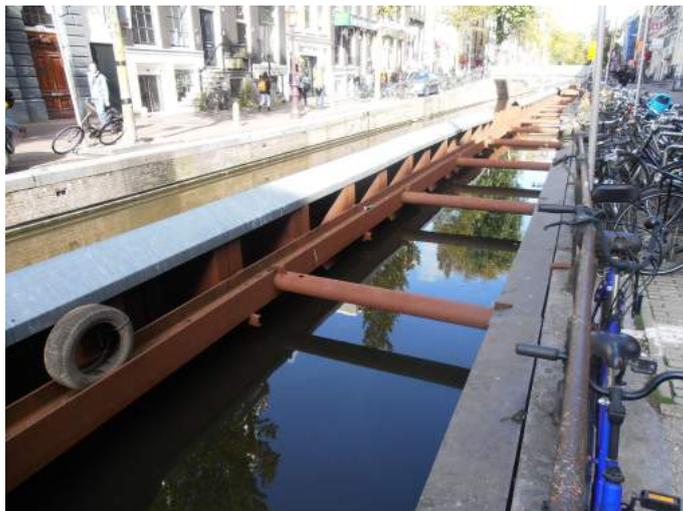
Figure 5.21: Temporary sheet pile construction at the Oudezijds Achterburgwal

During the first phase of the project, a large deformation was observed for some of the buildings in this area. One of the suggested reasons for this large deformation was leakage of the building pit [6]. After foundation inspection, some buildings turned out to have a shallow foundation [6]. Also, large settlements for buildings in phase 2 of the project were observed, even before any construction activities were undertaken in this area. Phase 1 was finalized in March 2013 [2]. It was decided to postpone phase 2 of the replacement project to allow for further foundation inspection and repairs of the affected buildings [6]. Due to the bad conditions of the quay wall in phase 2, a temporary sheet pile construction was installed in June and July 2013 [44]. This construction is still present in October 2018, as shown in figure 5.21. Phase 2 of the replacement will be executed on short notice.

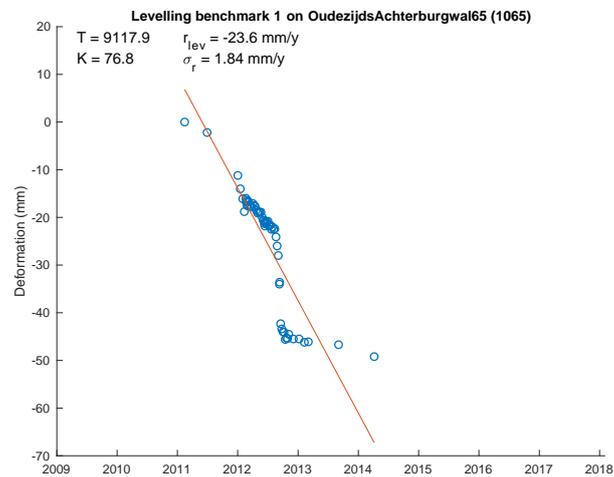
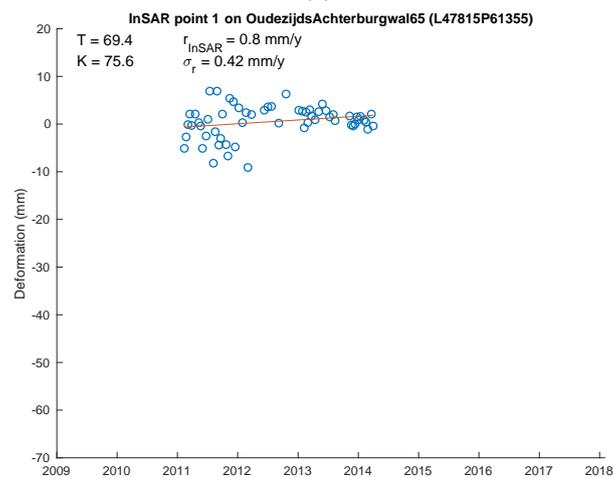
Figure 5.22: Deformations of the levelling benchmark (top) and the InSAR point (bottom) located on Oudezijds Achterburgwal 65

The levelling benchmark in figure 5.22a shows a deformation of about 45 millimeter in 2011 and 2012. The linear deformation model fitted through the measurements is clearly rejected. Therefore the shown deformation rate and variance, r_{lev} and σ_r , should be neglected. The only InSAR point located on this building, figure 5.22b, shows a large amount of noise between 2011 and halfway 2012. Less noise is present from 2012 onwards. No large deformations are observed for the InSAR point. According to the overall model test, the linear deformation model is accepted.

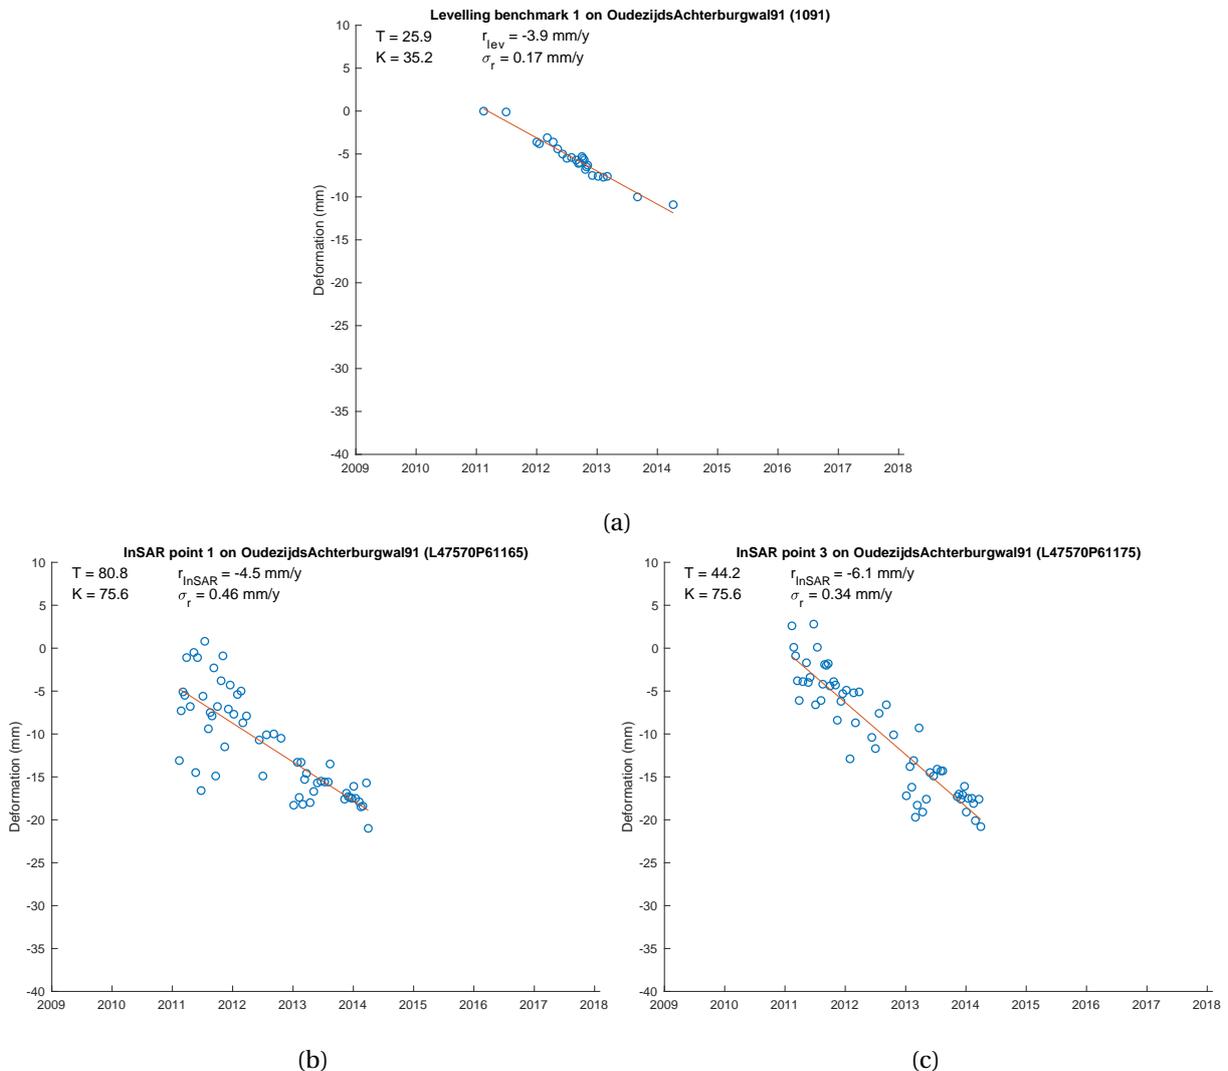
Figure 5.23: Deformations of the levelling benchmark (top) and two InSAR points (bottom left and right) located on Oudezijds Achterburgwal 91

The levelling benchmark on this building indicates large settlements between 2011 and 2014, as shown in figure 5.23a. The linear deformation model is accepted and a deformation rate of -3.9 mm/y is calculated. Compared to the levelling benchmark, a similar deformation rate of -4.5 mm/y is observed for InSAR point 1 in figure 5.23b. However this InSAR point is rejected as the calculated test statistic T is higher than the critical value K . In figure 5.23c, a slightly larger rate of -6.1 mm/y is found for InSAR point 3. The linear deformation model for this point is accepted according to the overall model test.

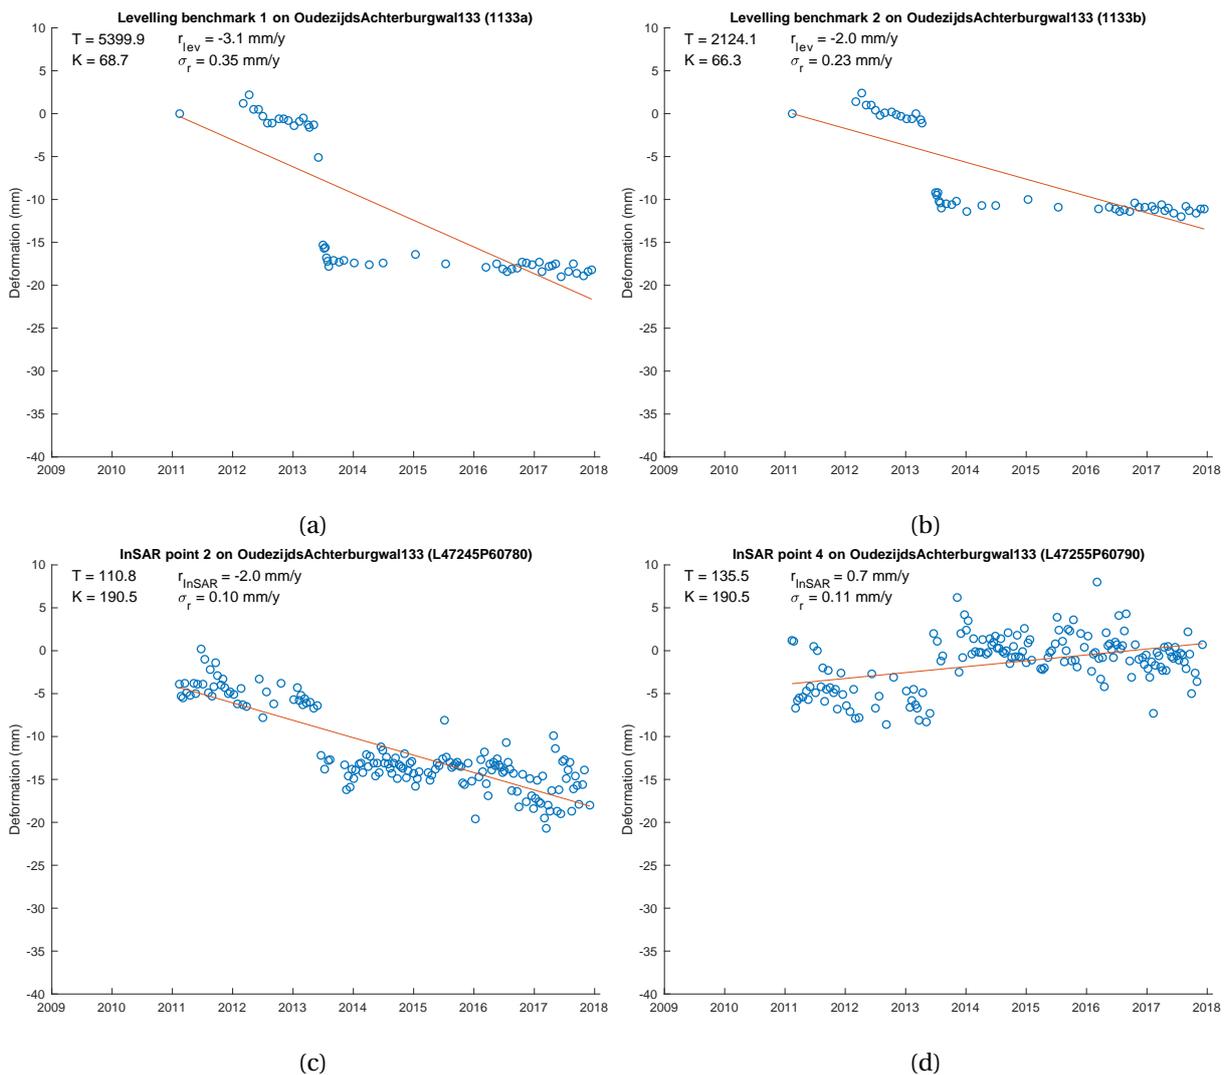
Figure 5.24: Deformations of two levelling benchmark (top left and right) and two InSAR points (bottom left and right) located on Oudezijds Achterburgwal 133

Eleven InSAR points are located on this building. Several of these points show an upward deformation in 2013, as shown for InSAR point 4 in figure 5.24d. Other InSAR points, such as InSAR point 2 in figure 5.24c, show a downward deformation in 2013. The deformation rate of the InSAR points seem to be lower as well after 2013. Despite the presence of a deformation shift for both InSAR points, the linear deformation model is accepted according to the overall model test.
