Use of InSAR data for building deformation monitoring

to obtain the degree of Master of Science
at the Delft University of Technology,
to be defended publicly on Monday December 17, 2018 at 15:00 PM.

How and under what conditions can the InSAR data contribute to monitoring of buildings adjacent to quay walls?

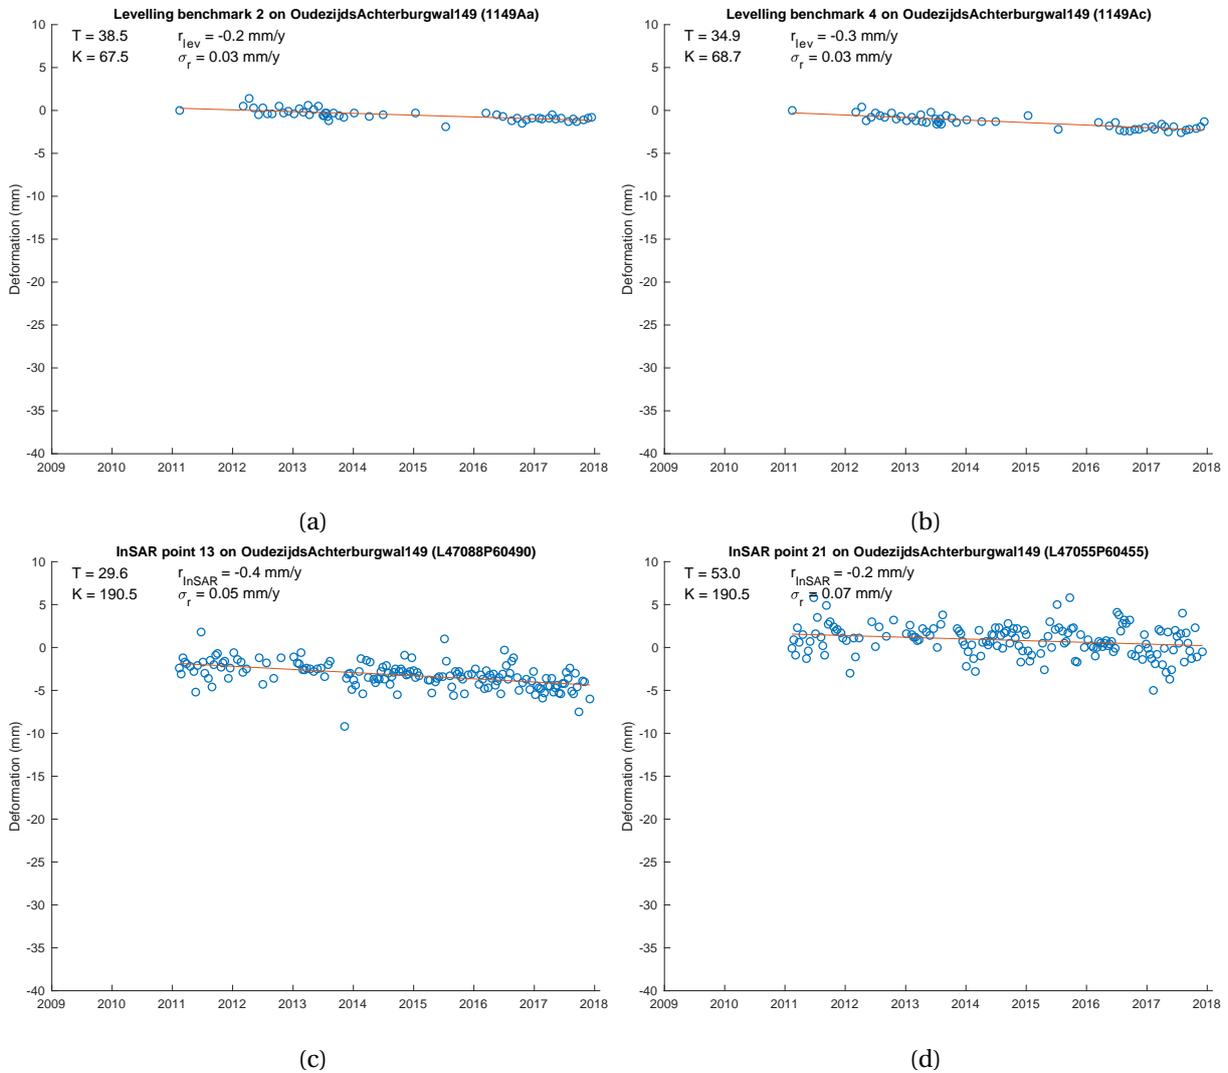
Figure 5.25: Deformations of the two levelling benchmark (top left and right) and two InSAR points (bottom left and right) located on Oudezijds Achterburgwal 149

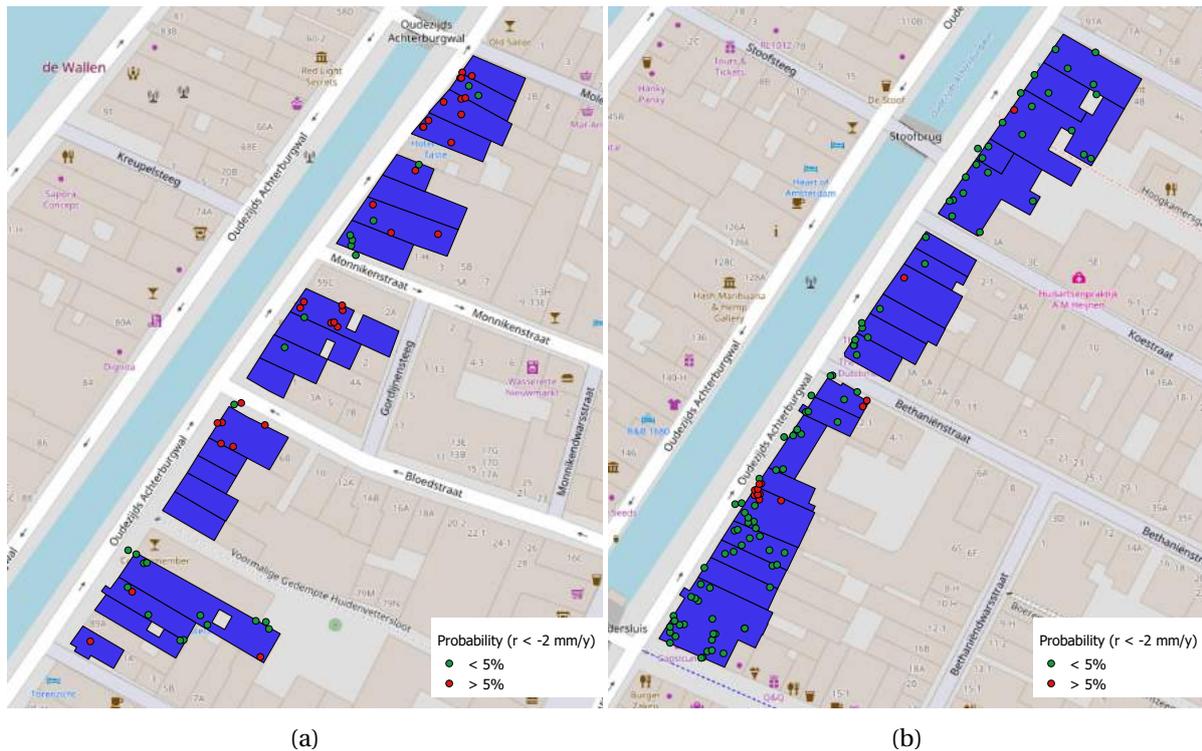
Figure 5.30: Probability of a deformation rate of more than -2 mm/y based on the calculated σ_r for each InSAR point of buildings in phase 1 (left) and phase 2 (right)

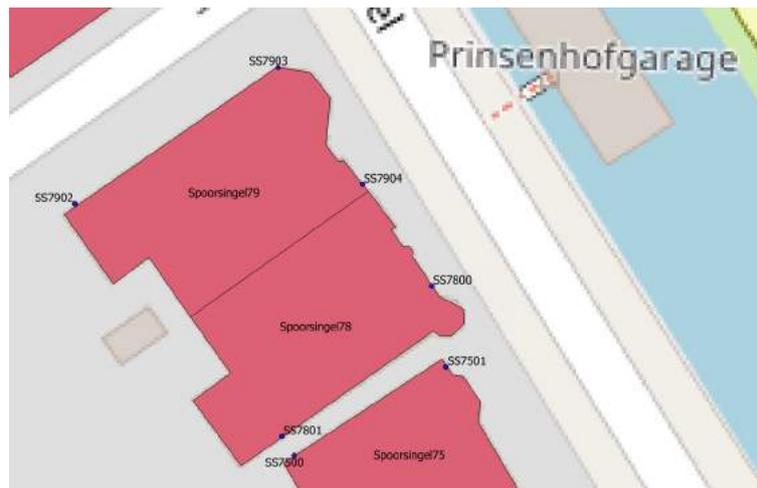
Figure 6.4: Location of the levelling benchmarks on Spoorsingel 78 and 79

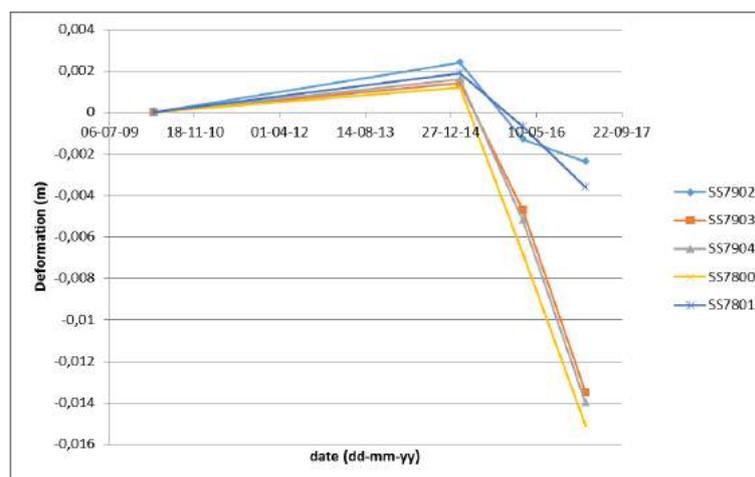
Figure 6.5: Deformations observed at the levelling benchmarks indicated in figure 6.4 on Spoorsingel 78 and 79

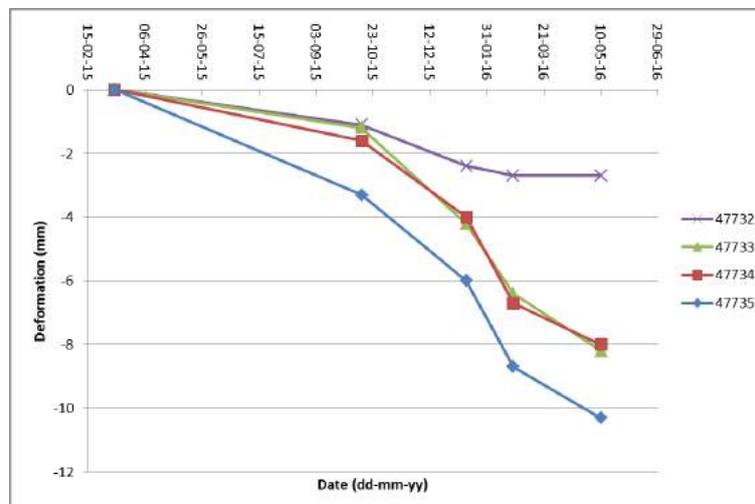
Figure 6.7: Vertical deformation of the mini prisms located on Spoorsingel 78 and 79

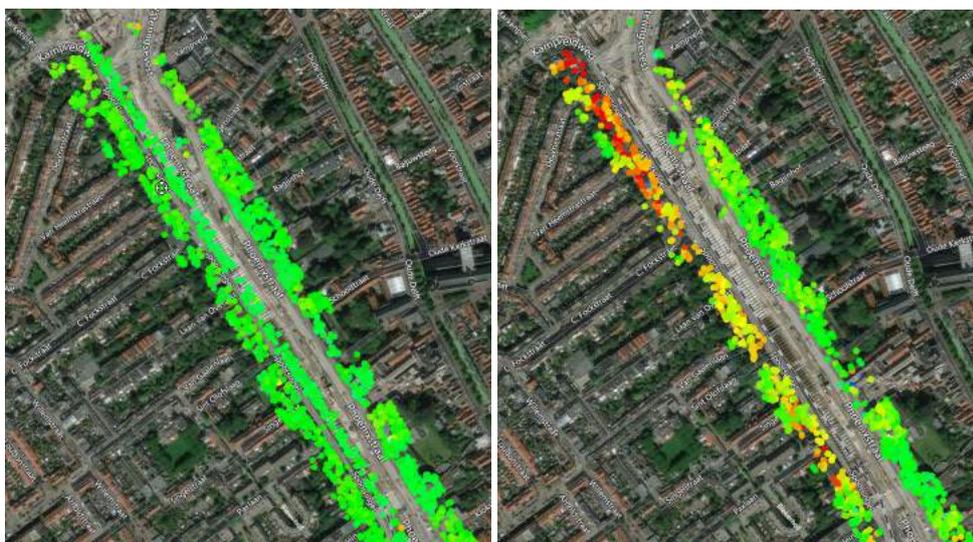
Figure 6.8: Deformation rates close to the underground parking facility of the 9 year InSAR data (left) and the 2 year data (right) of the ascending and descending tracks. Green, yellow, orange and red points indicate deformation rates higher than 0, 3, 5 and 8 mm/year respectively.

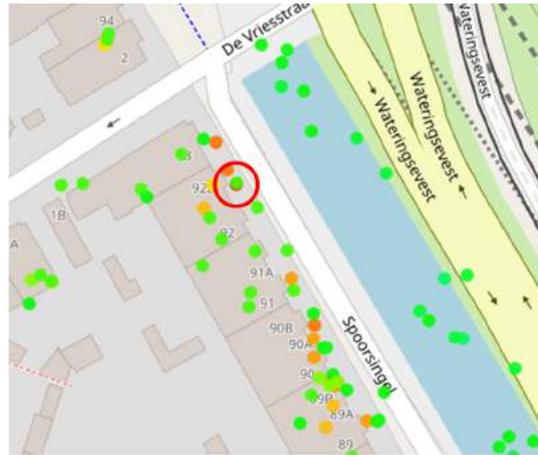
Figure 6.9: InSAR data points in the northern part of the project area of the descending track of both the 2 year and 9 year dataset. A data point is indicated in both datasets which has almost exactly the same position.

To analyse the difference between the 9 year and 2 year data, one point is selected in the dsc_9y and dsc_2y datasets as shown in figure 6.9. As the figure shows, the position of the points in both datasets is almost the same. Therefore it is likely that both points represent the same scatterer. The deformations of these points is shown in figure 6.10. The 2 year dataset, figure 6.10b, shows a constant deformation in 2016 and 2017 with, in total, about 19 mm of deformations. The deformation in this dataset is increasing, which is expected, due to the construction activity. In figure 6.10, the 9 year dataset shows an abrupt change in deformation. This upward shift can be attributed to the phase ambiguity of the InSAR data. The deformation rate, which is based on the line fitted through the observations, is consequently incorrect. Considering the 15 mm phase shift (half a wave length) in the 9 year dataset, similar deformations can be derived from both InSAR datasets. The 2 year dataset is used for further analysis.

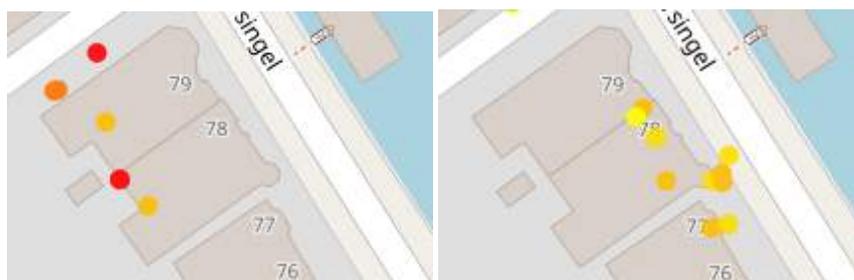
Figure 6.12: InSAR points on buildings Spoor singel 78 and 79 of the ascending (left) and descending (right) track

The northern part of the ascending and descending track of the 2 year dataset is shown in figure 6.11a and figure 6.11b respectively. Due to the right-looking characteristic and the almost polar orbit of the TerraSAR-X satellite, the ascending dataset contains reflection points located mainly on the southwest side of the buildings and the descending dataset contains reflection points located on the northeast side. The figures clearly show larger deformation rates for the ascending track than for the descending track. The difference between the ascending and descending track is also clearly visible when looking at building Spoorsingel 78 and 79 specifically, as shown in figure 6.12.

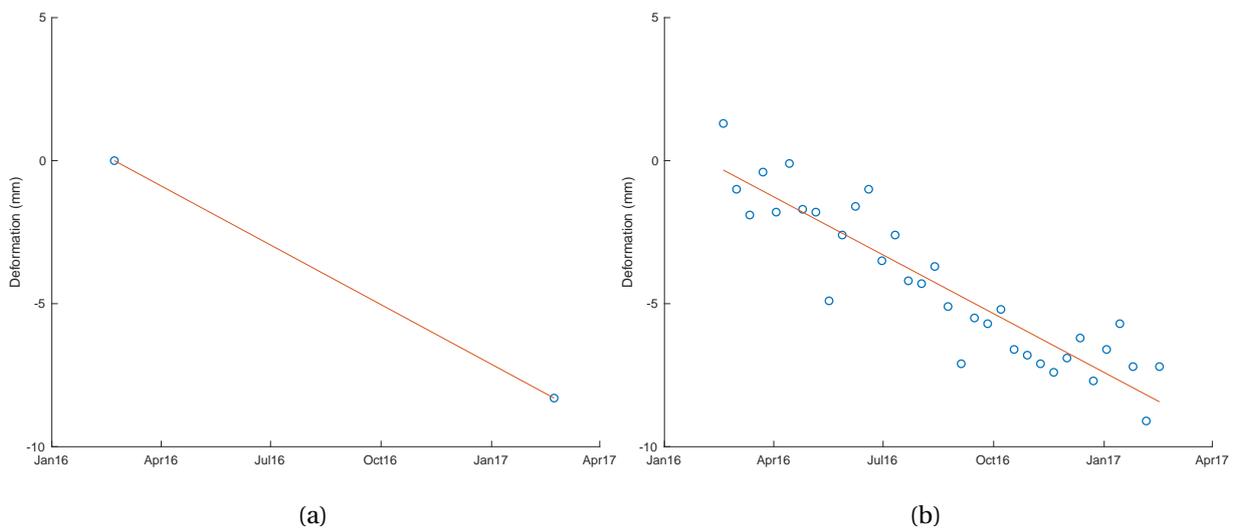
Figure 6.14: Deformations of a levelling point (left) and an InSAR point (right) and the linear line fitted through the data using least-squares

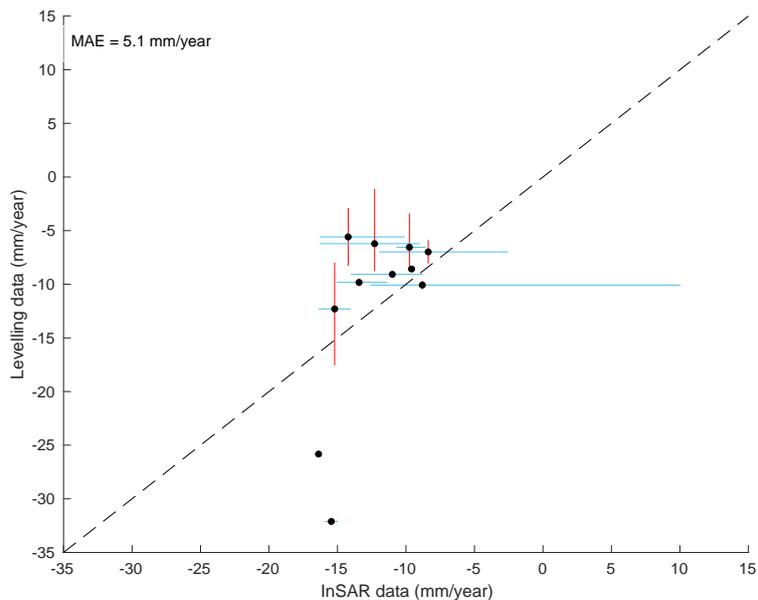
Figure 6.15: Graph of calculated deformation rates from the levelling data (left) and the ascending track of the InSAR data (right) (asc_2y), between February 2016 and February 2017

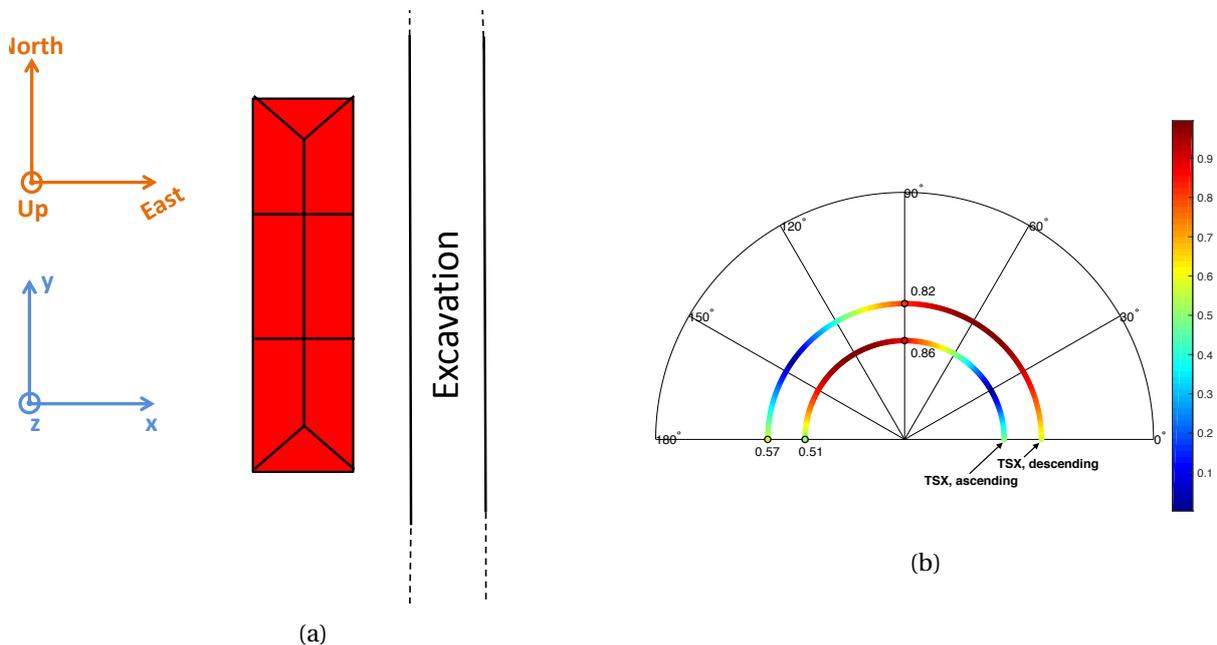
Figure 6.18: Row of houses for $\beta = 0^\circ$ and the corresponding sensitivity circle (right), in the East,Up-plane

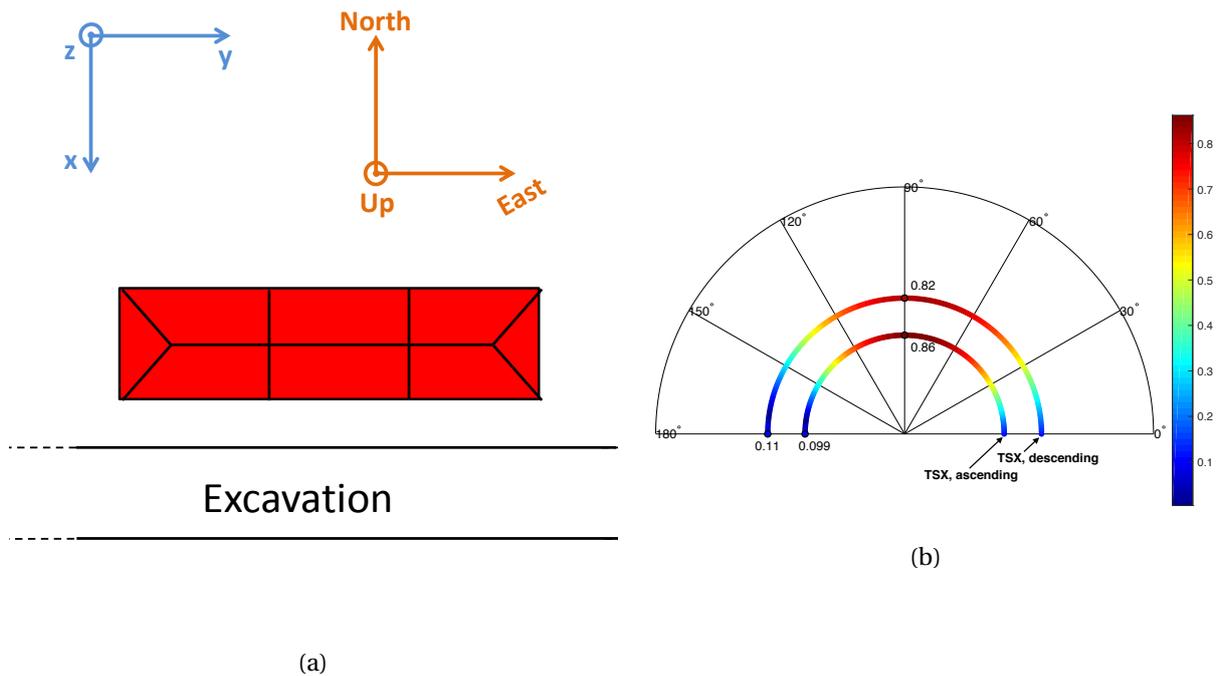
Figure 6.19: Row of houses for $\beta = 90^\circ$ and the corresponding sensitivity circle (right), in the North,Up-plane

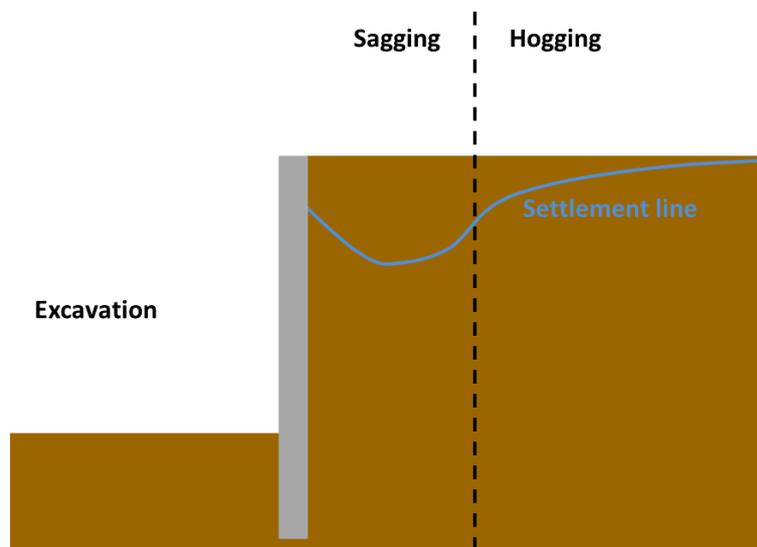
Figure 6.20: Expected settlement profile near the excavation

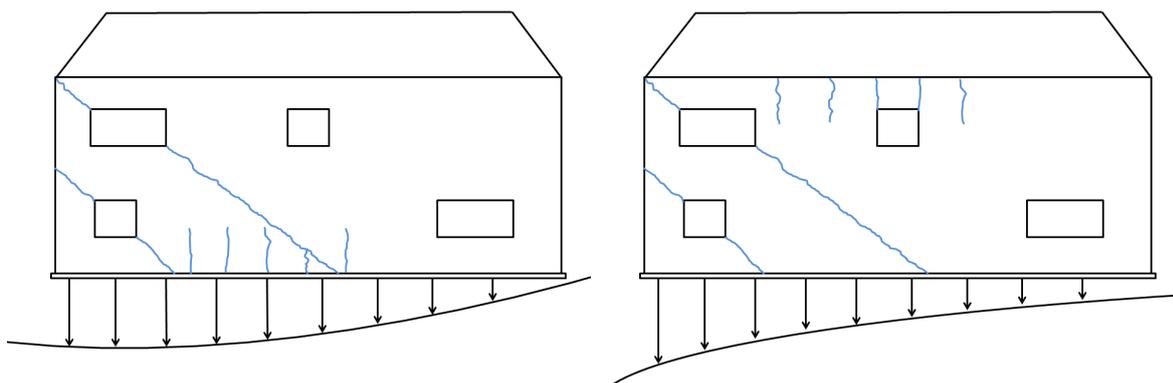
Figure 6.21: Side view of a building in a sagging zone (left) and a hogging zone (right). Vertical cracks and diagonal cracks due to bending and shear deformation are indicated in blue.

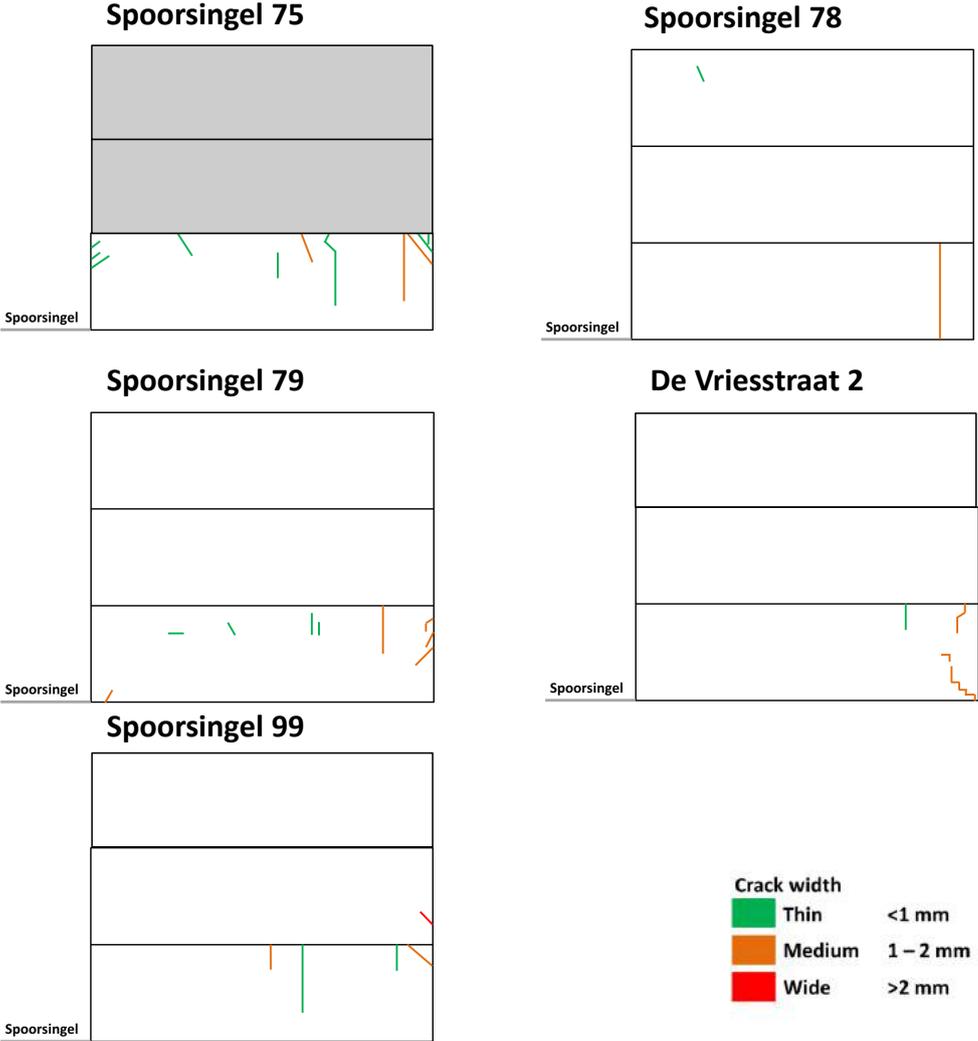
Figure 6.23: Overview of the observed cracks in all walls perpendicular to the underground parking facility, of the five buildings along the Spoorsingel

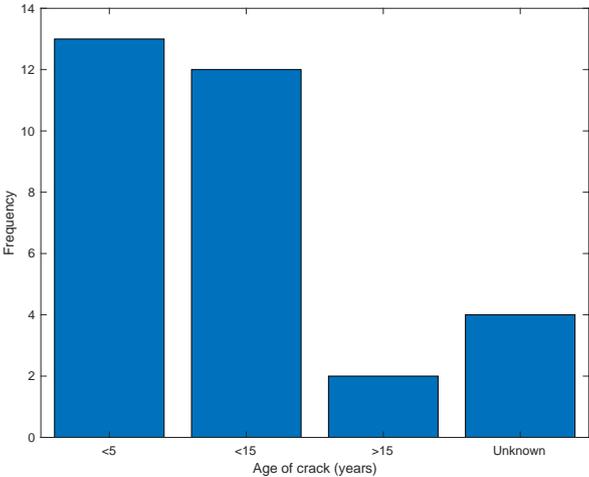
Figure 6.24: Age of the observed cracks on the walls transverse to the underground parking facility

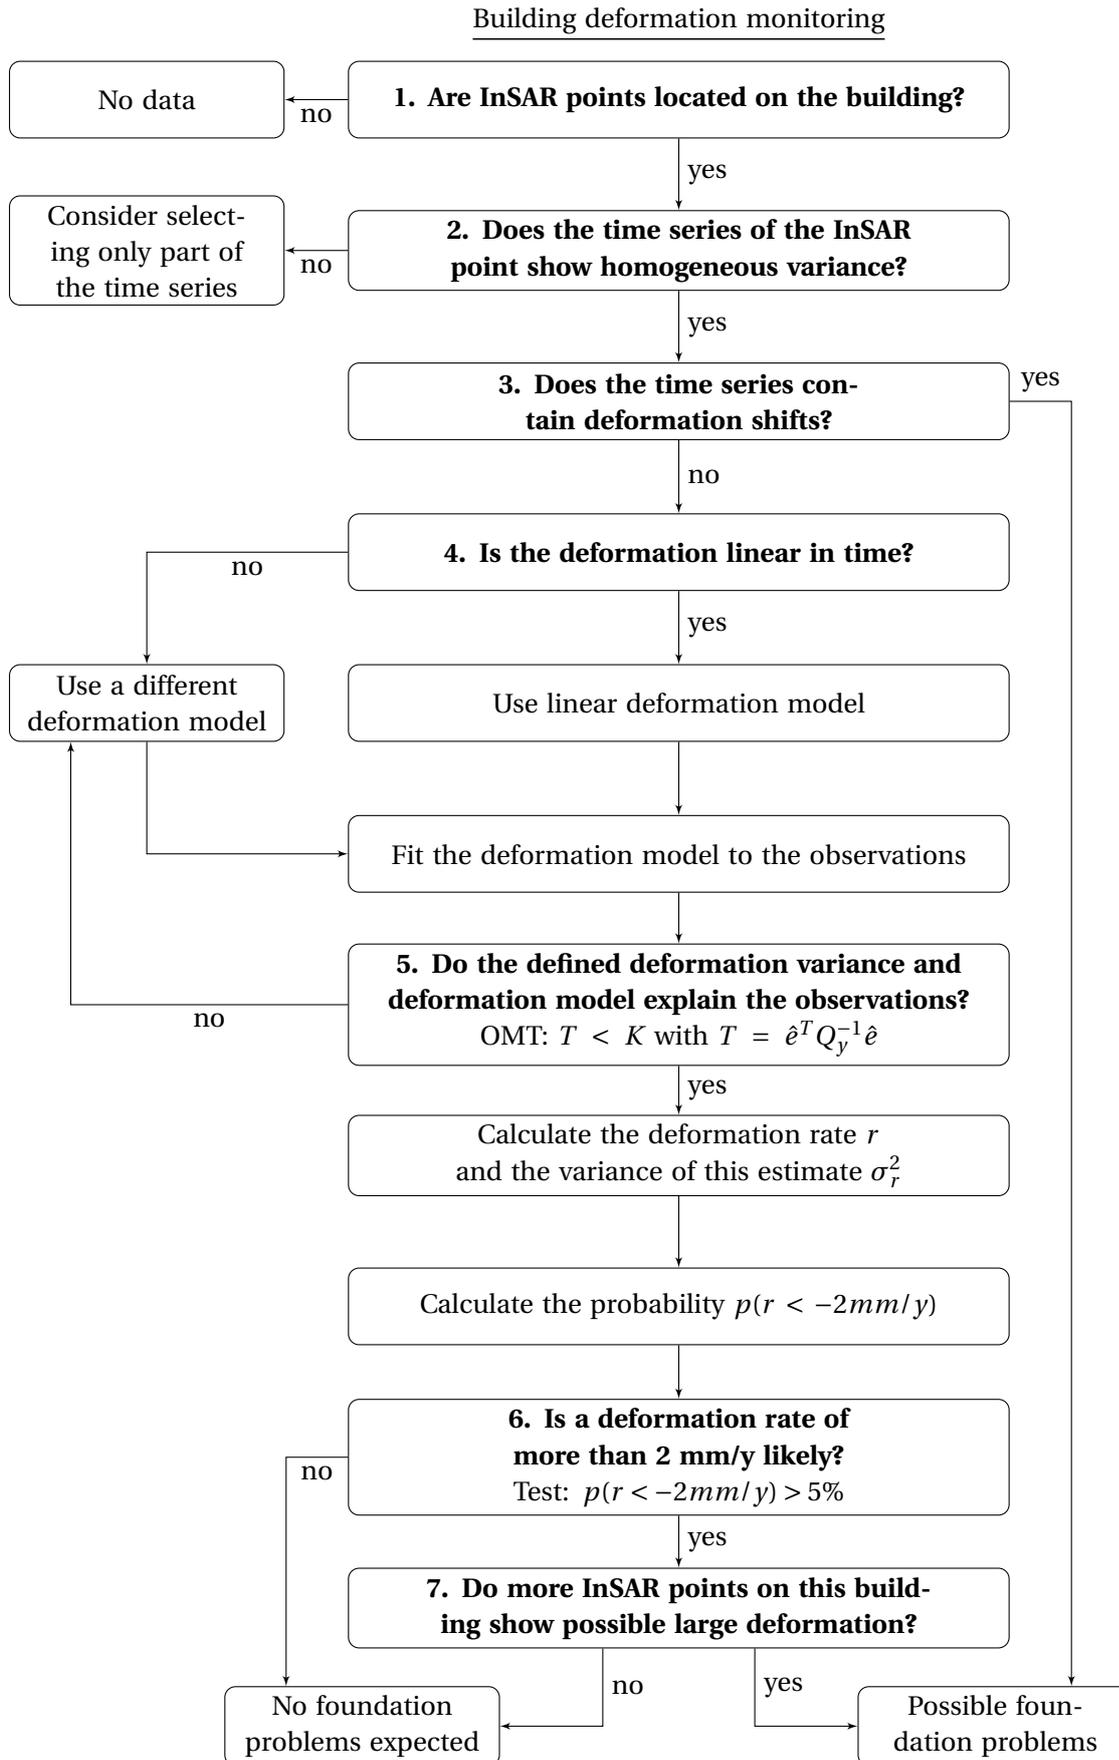
Figure 7.1: Recommended flowchart for use of InSAR in building monitoring

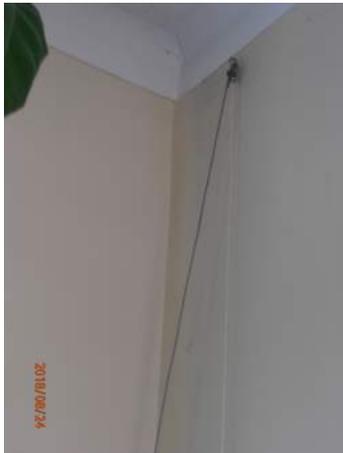
Location 2

Development: At most 5 years old

Additional information: -

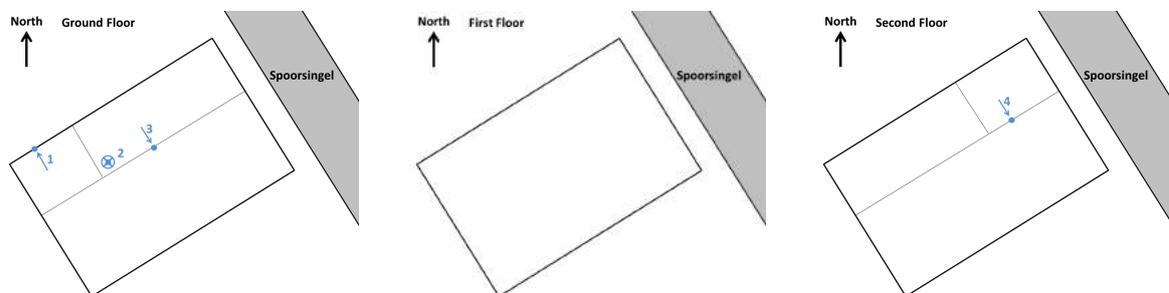
Figure A.6: Location of the observed damage on the ground floor (left), first floor (middle) and second floor (right)

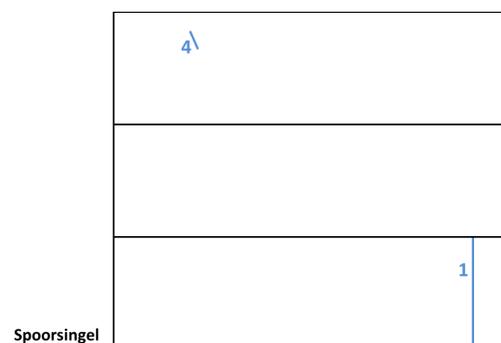
Figure A.7: Indication of cracks in the walls orthogonal to the parking garage

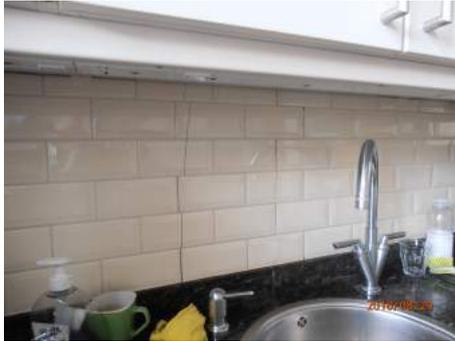
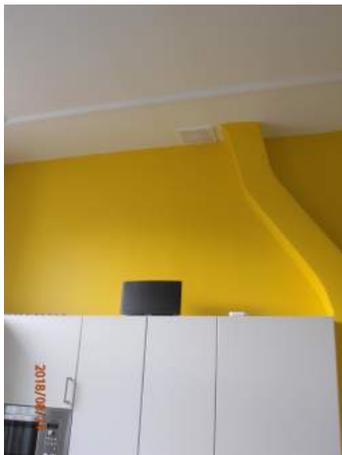
Development: More than 15 years old

Additional information: Crack over the whole height of the wall and continues on the floor. Crack has lengthened and widened in the last 15 years.

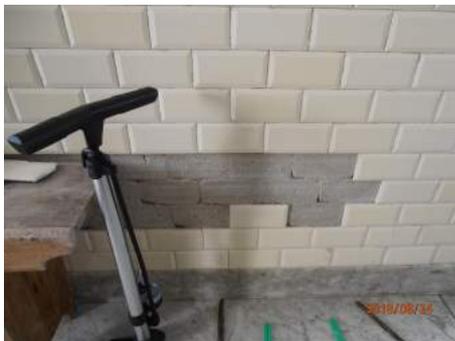
Location 3

Orientation of the wall w.r.t. the north: 60°

Development: At most 5 years old

Additional information: Tiles have come off the wall

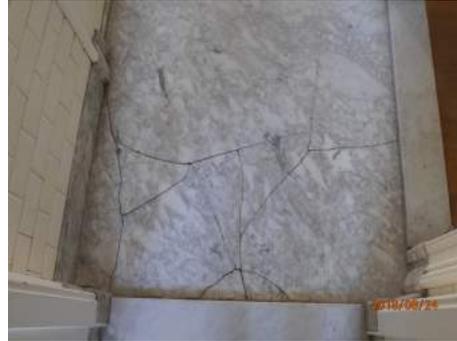
Location 2

Size: 2 mm

Development: More than 15 years old

Additional information: Cracks are located on the floor

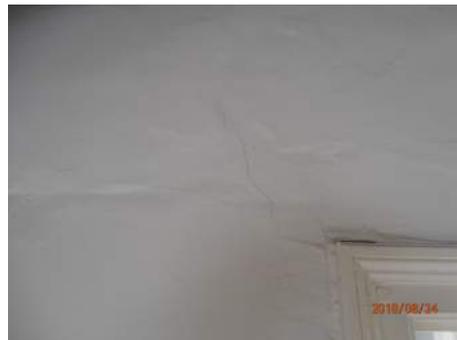
Location 4

Orientation of the wall w.r.t. the north: 60°

Development: At most 15 years old

Additional information: Only room that wasn't replastered 15 years ago

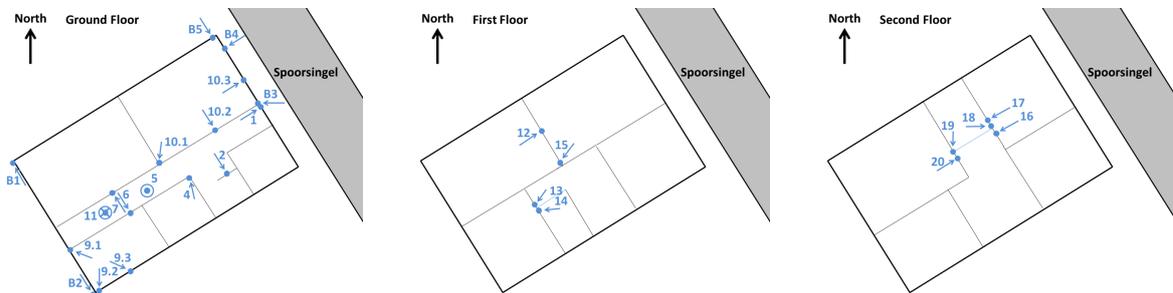
Figure A.9: Location of the observed damage on the ground floor (left), first floor (middle) and second floor (right)

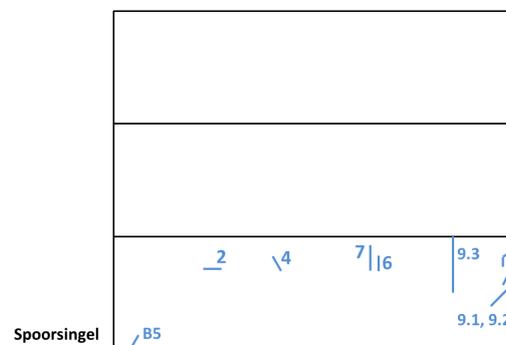
Figure A.10: Indication of cracks in the walls orthogonal to the parking garage

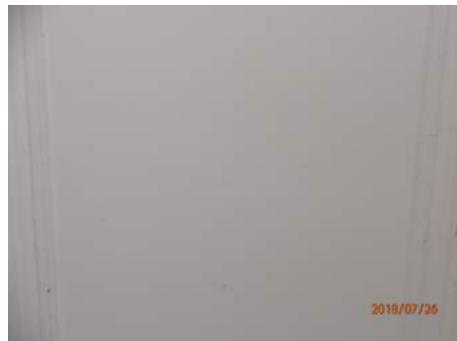
Location 5

Size: <1 mm

Development: At most 15 years old

Additional information: Crack is located on the ceiling.

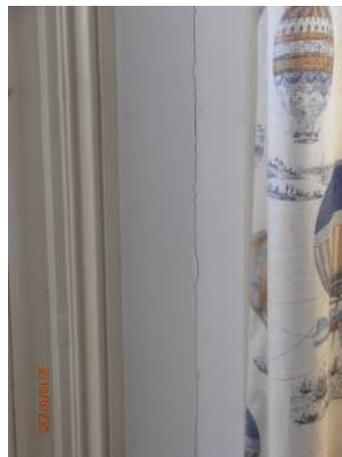
Location 11

Size: 3 mm

Development: More than 15 years old

Additional information: Cracks are located on the floor. The floor has become more uneven in the last few years

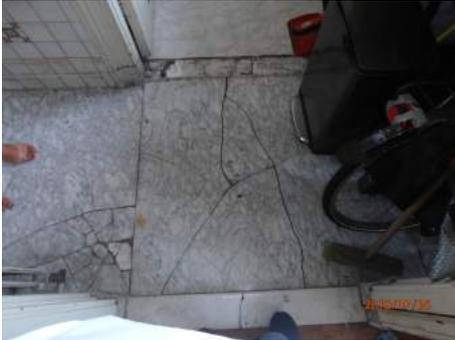
Location 13

Orientation of the wall w.r.t. the north: -30° Angle w.r.t. the horizontal: 10° Size: <1 mm

Development: At most 15 years old

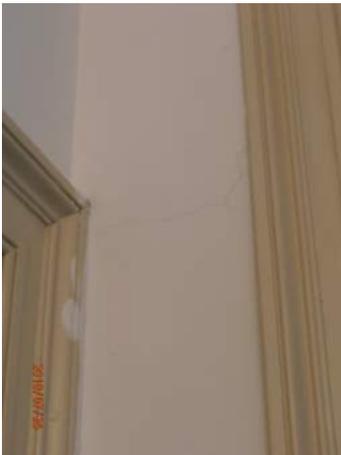
Location 12

Orientation of the wall w.r.t. the north: -30° Angle w.r.t. the horizontal: 50°

Development: At most 15 years old

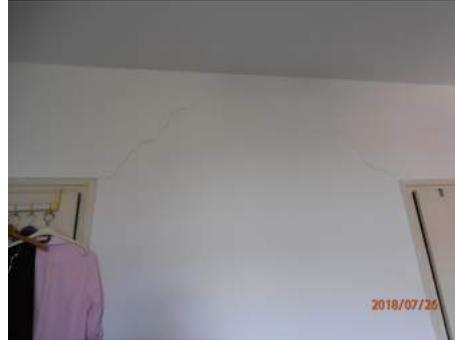
Location 14

Orientation of the wall w.r.t. the north: -30° Angle w.r.t. the horizontal: 10° Size: <1 mm

Development: At most 15 years old

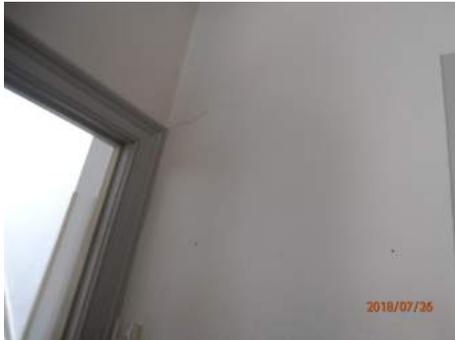
Location 16

Orientation of the wall w.r.t. the north: -30° Angle w.r.t. the horizontal: 10°

Development: At most 15 years old

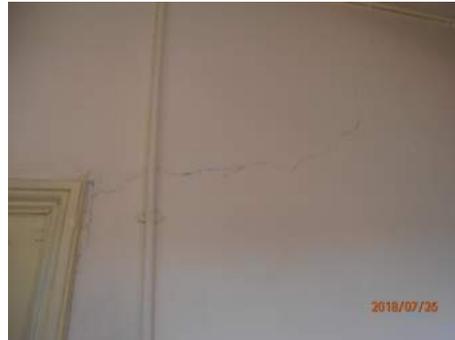
Location 17

Orientation of the wall w.r.t. the north: -30° Angle w.r.t. the horizontal: 0°

Development: At most 15 years old

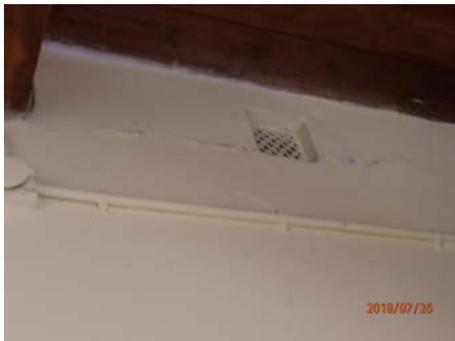
Location 18

Orientation of the wall w.r.t. the north: -30° Angle w.r.t. the horizontal: 10°

Development: At most 15 years old

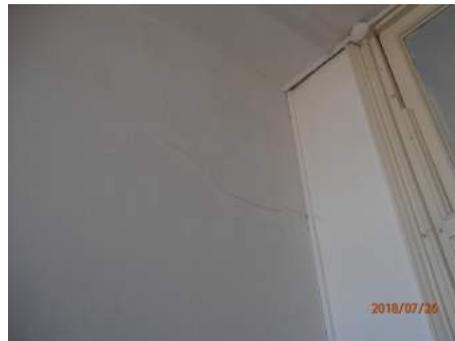
Location 19

Orientation of the wall w.r.t. the north: -30° Angle w.r.t. the horizontal: 90° Size: <1 mm

Development: At most 15 years old

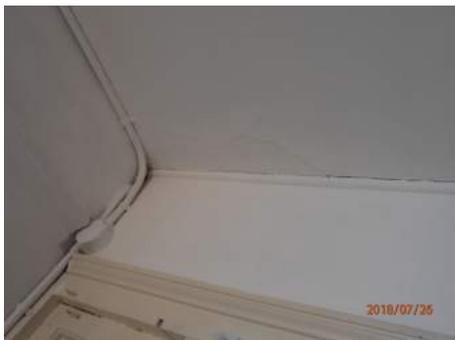
Location 20

Orientation of the wall w.r.t. the north: -30° Angle w.r.t. the horizontal: 70°

Development: At most 15 years old

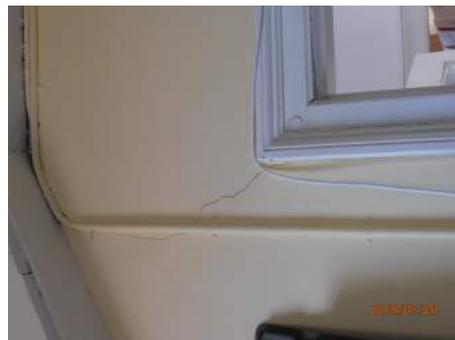
Location B1

Orientation of the wall w.r.t. the north: 60°

Development: At most 15 years old

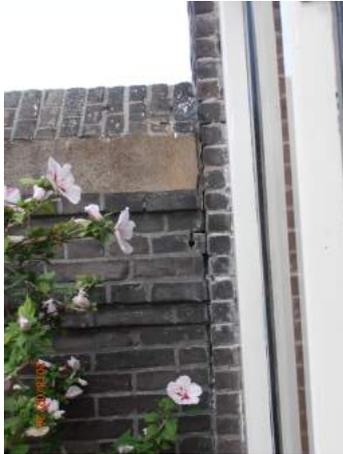
Location B2

Orientation of the wall w.r.t. the north: 60°

Development: At most 15 years old

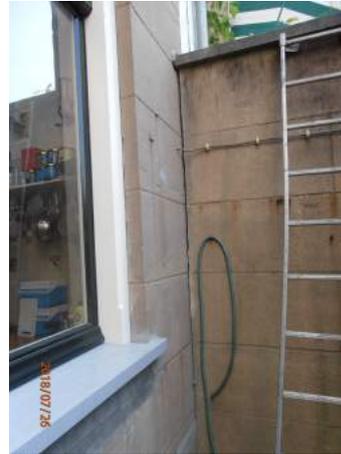
Location B3

Orientation of the wall w.r.t. the north: -30° Angle w.r.t. the horizontal: 40°

Development: At most 15 years old

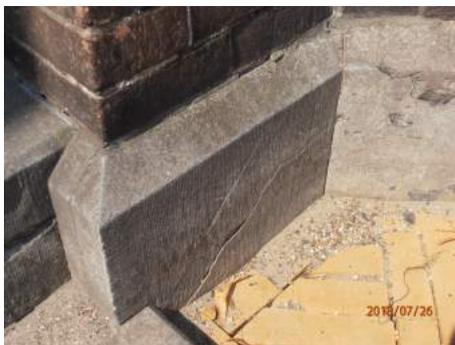
Location B4

Orientation of the wall w.r.t. the north: -30° Angle w.r.t. the horizontal: 50°

Development: At most 15 years old

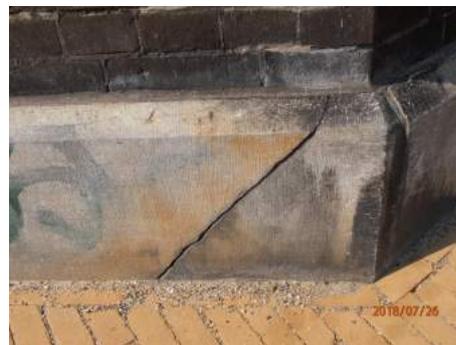
Location B5

Orientation of the wall w.r.t. the north: 60° Angle w.r.t. the horizontal: 60°

Development: At most 15 years old

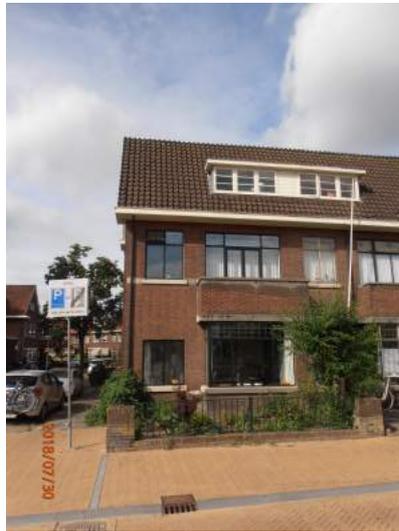
Figure A.11: De Vriesstraat 2

Figure A.11 shows De Vriesstraat 2. The damage survey was conducted on 30-07-2018. The house was built in 1933 [8]. The location of the damage is shown in figure A.12. Pictures and specifications of the damage are shown in the next few pages. A few cracks have formed in the last five years. The age of several cracks was unknown. The cracks in the walls orthogonal to the parking garage are shown in figure A.13.

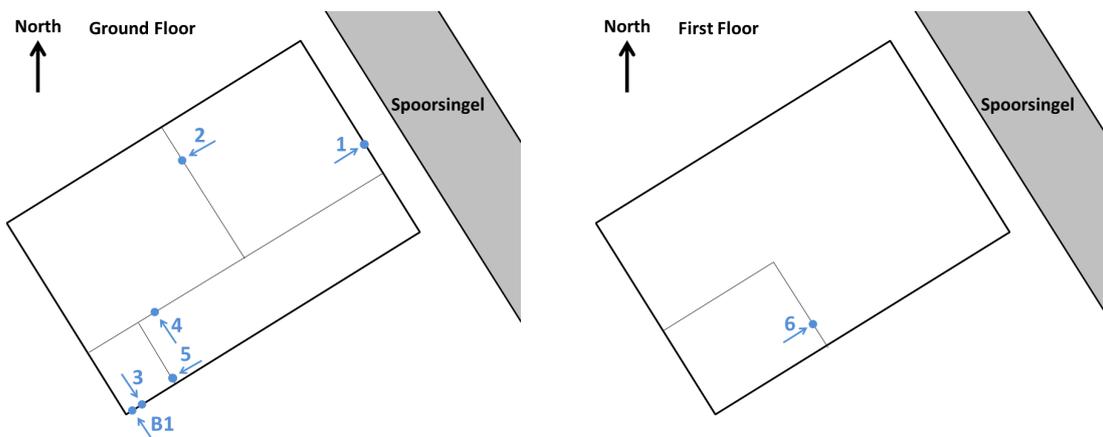
Figure A.12: Location of the observed damage on the ground floor (left) and first floor (right)

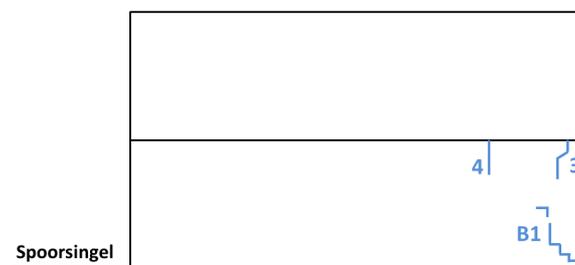
Figure A.13: Indication of cracks in the walls orthogonal to the parking garage

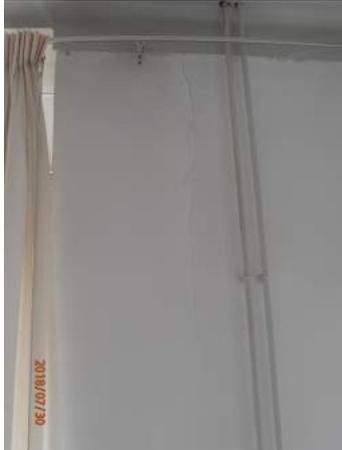
**Location 2**

Orientation of the wall w.r.t. the north: -30°

Development: At most 10 years old

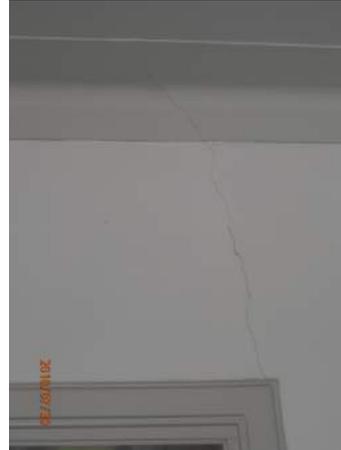
**Location 3**

Orientation of the wall w.r.t. the north: 60°

Development: At most 5 years old

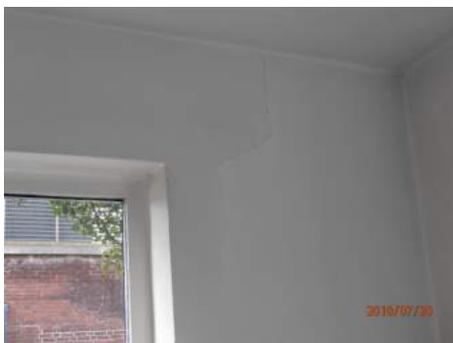
**Location 4**

Orientation of the wall w.r.t. the north: 60°

Development: At most 15 years old

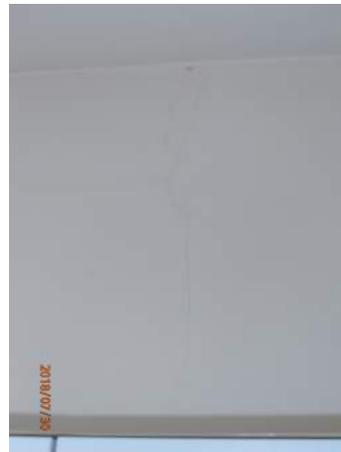
Location 5

Orientation of the wall w.r.t. the north: -30°

Development: Unknown

Additional information: Crack at the corner of the ceiling with the wall

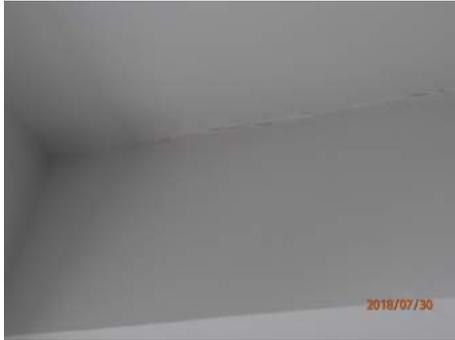
Location 6

Orientation of the wall w.r.t. the north: -30°

Development: Unknown

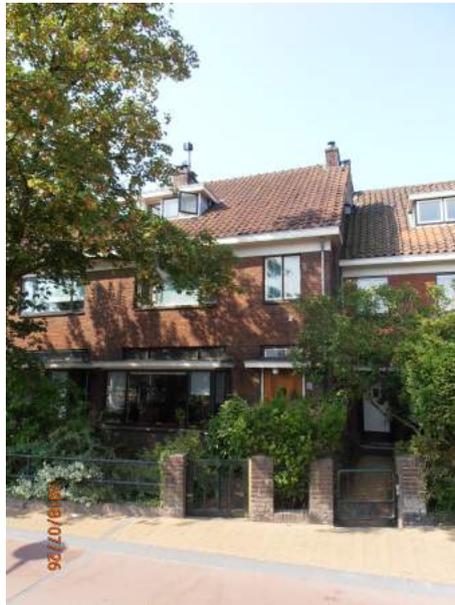
Figure A.14: Spoorsingel 99

Figure A.14 shows Spoorsingel 99. The damage survey was conducted on 25-07-2018. The house was built in 1933 [8]. The location of the damage is shown in figure A.15. Pictures and specifications of the damage are shown in the next few pages. The cracks in the walls orthogonal to the parking garage are shown in figure A.16. The age of several cracks is unknown. Several damages have occurred in the last five years. Most damage is found in the back part of the building. The damage at location 5 is most likely caused by large vibrations during demolition of the railway viaduct.

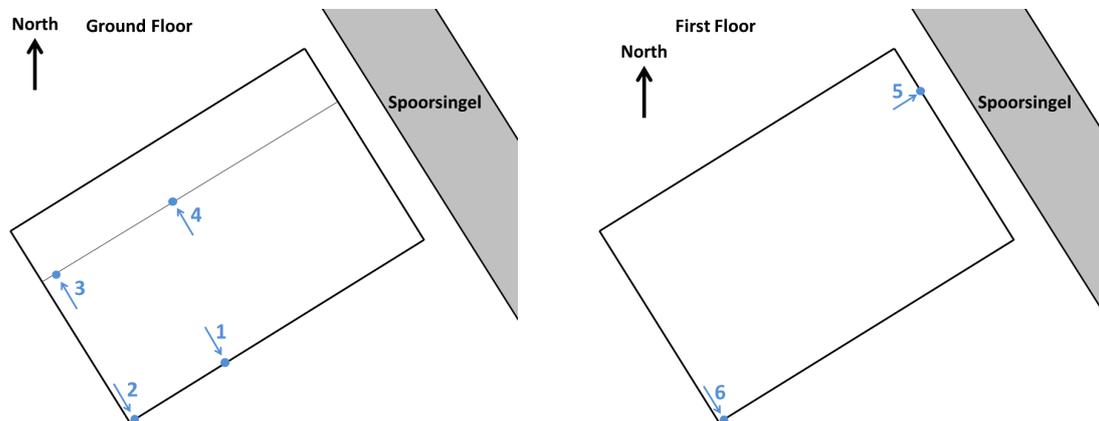
Figure A.15: Location of the observed damage on the ground floor (left) and first floor (right)

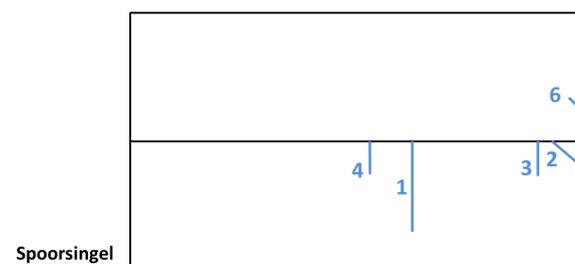
Figure A.16: Indication of cracks in the walls orthogonal to the parking garage

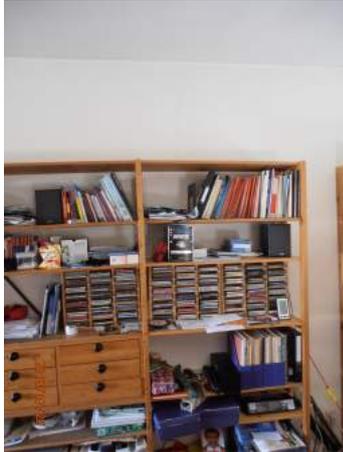
**Location 2**

Orientation of the wall w.r.t. the north: 60°

Additional information: Crack has widened in the last 5 years

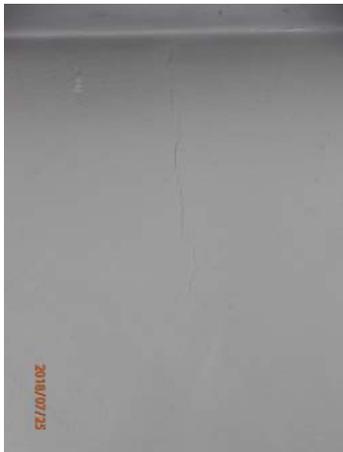
**Location 4**

Orientation of the wall w.r.t. the north: 60°

Additional information: Crack has widened in the last 5 years

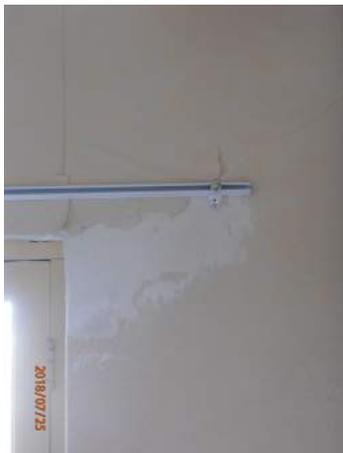
**Location 6**

Orientation of the wall w.r.t. the north: 60°

Development: At most 5 years old
