Effects of composition on the durability and weathering of flat glass

Glass Structures and Engineering

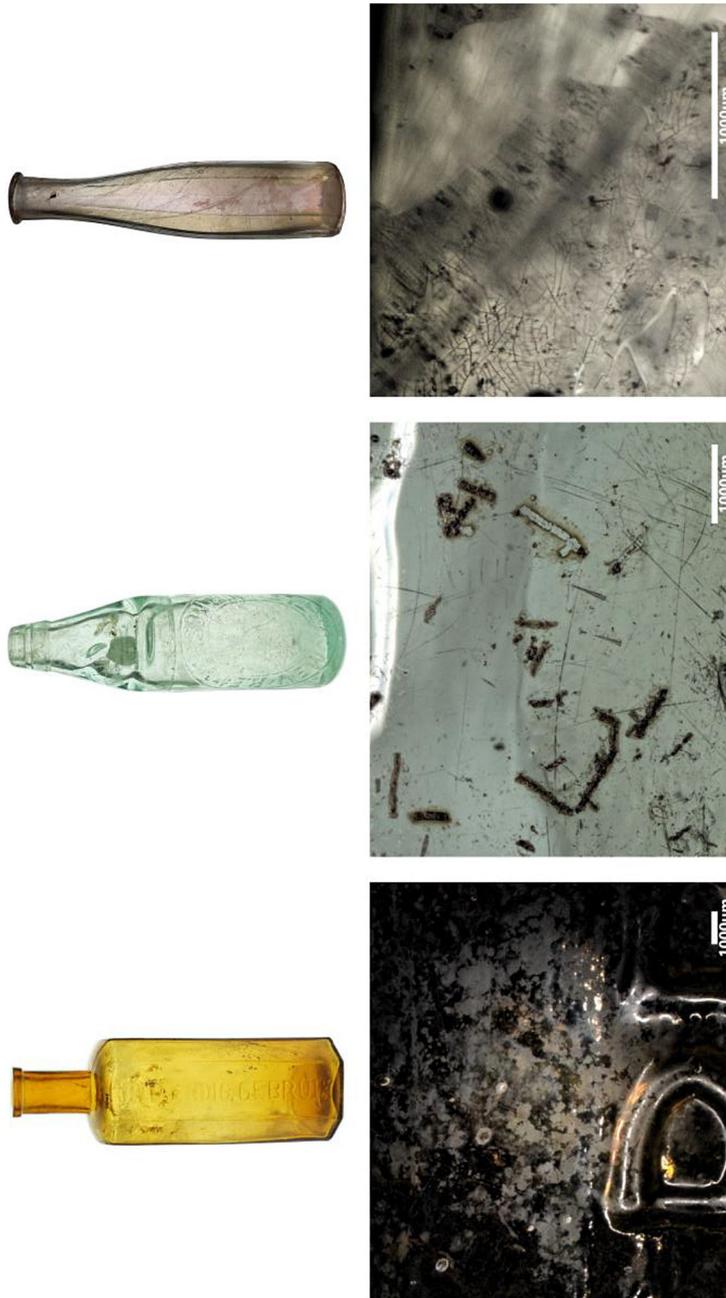
Fig. 1 Antique weathered bottles exposed to ambient conditions and their respective sidewalls observed with a digital microscope

Glass is regarded as a stable and inert material compared to other materials, such as ceramics and metals; however, when in contact with water in either liquid or vapour phase, it is vulnerable to deterioration. A particular type of surface defect, occasionally found on glass after humidity exposure and temperature variations, is referred to as “weathering”. Visual characteristics of weathering include a greyish appearance, haziness, iridescence, pitting, and different types of crystal formation. Examples of weathered bottles are exhibited in Fig. 1.

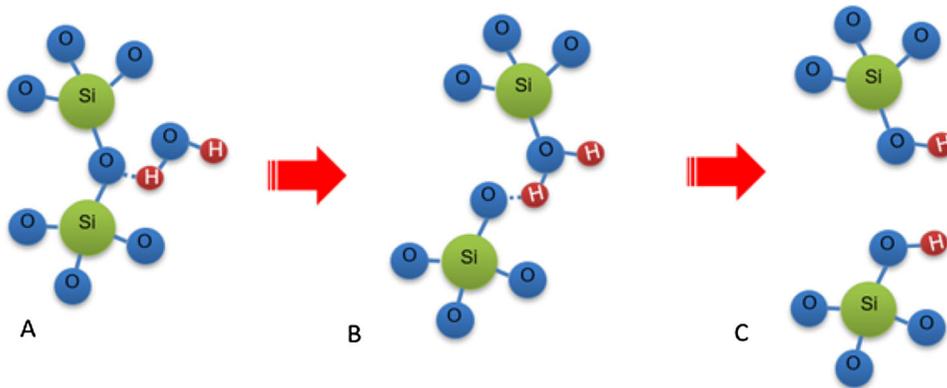
Fig. 2 The stress corrosion mechanism

When an existing flaw in the glass network is exposed to liquid water or atmospheric moisture, the presence of a tensile stress can lead to slow crack growth. The stress corrosion mechanism causes a strength decrease of silicate glasses in the presence of water molecules (Fig. 2a) due to a hydrophilic attack on stretched Si–O–Si bonds (Fig. 2b), which leads to the breakage of these bonds, according to reaction 2, and thus creates an increased opening in the glass (Fig. 2c). Due to this increased opening, the water can penetrate deeper into the glass network and attack the

next bond. As shown in Eq. 4, deeper cracks lead to higher stress concentrations. Therefore, the strength of the glass is not only dependent on the type of surface defect present, but also the duration of the tensile stress and the reaction rate. Consequently, measurements of the durability of glass to attack by water are intrinsically related to the testing conditions, such as time, temperature, and relative humidity.

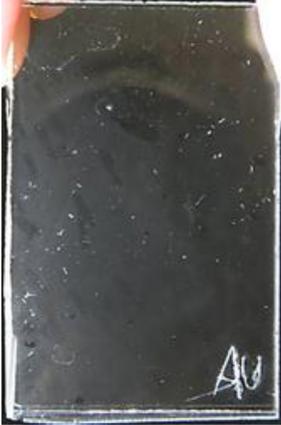
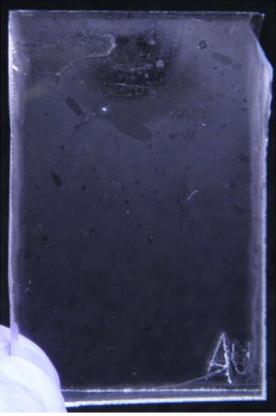
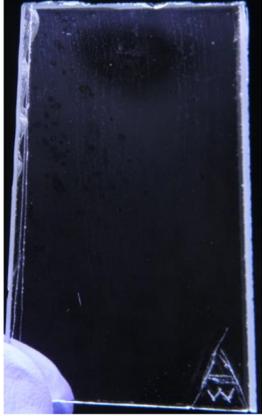
Group 1

Table 4 Visual appearance and haze rating of the samples after 4 weeks and 8 weeks of weathering in 75%RH/50°C

4 weeks, unwashed samples B, good, one side	8 weeks, unwashed samples C, fair, one side	8 weeks, washed samples C, fair, one side
Group 2

The appearance of the unwashed samples after weathering for 4 weeks and 8 weeks and the appearance of the washed samples after 8 weeks is shown in Table 4. The weathering is visible as a whitish haze on the surface. The bright white specks are dust particles loosely adhered to the surface.

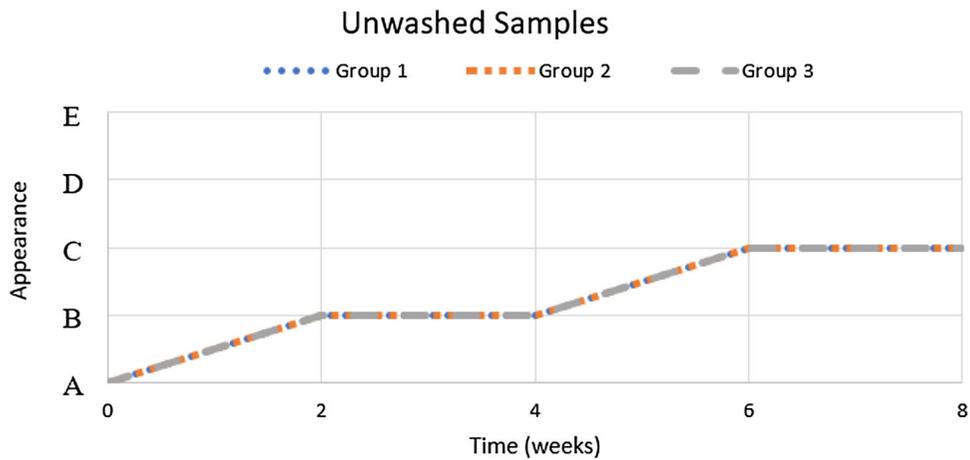
Fig. 3 Visual appearance versus time for unwashed samples

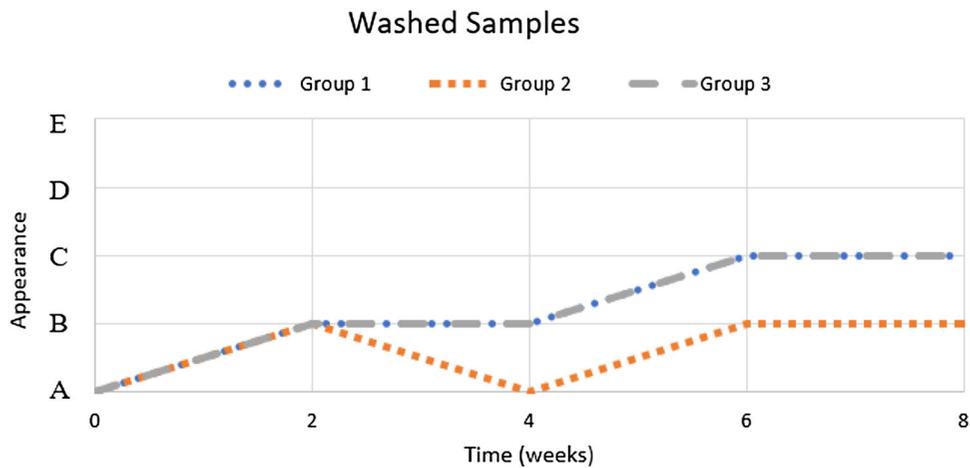
Fig. 4 Visual appearance versus time for washed samples

The effect of the periodic removal of the weathering products was evident for group 2, as shown in Fig. 4. In the 2nd week of the test, the sample exhibited a good condition and was washed. In the 4th week of the test, the appearance of the sample was excellent like at the beginning of the test. After the 8 weeks, the washed sample exhibited a good condition, while the unwashed sample of the same group exhibited a fair condition. For Groups 1 and 3, no significant difference in haze rating was observed between the washed and unwashed samples.

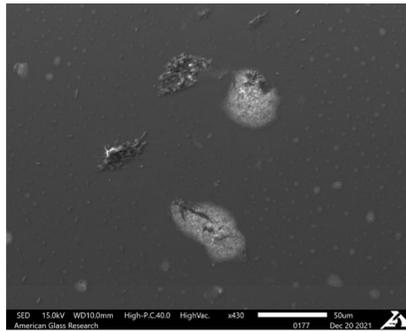
Fig. 5 Scanning electron microscope (SEM) images and EDX analysis of samples from Group 1 weathered for 8 weeks in 75%RH/50 °C. Except for the photo h), all photos are of unwashed samples

a) Low magnification SEM image of the surface.

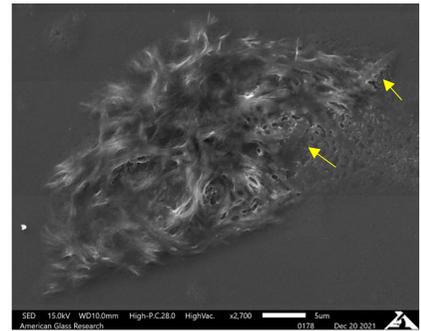
b) Magnified SEM image of a surface feature.

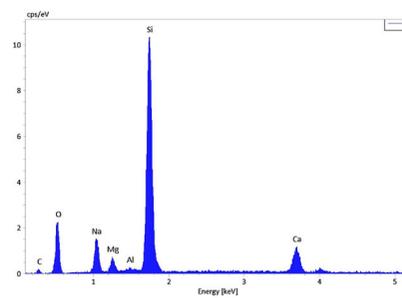
c) EDX spectra of the background glass shown in b).

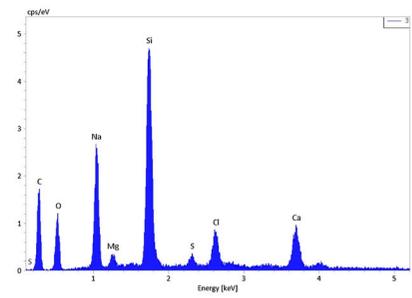
d) EDX spectra of the crystalline structure shown in b).

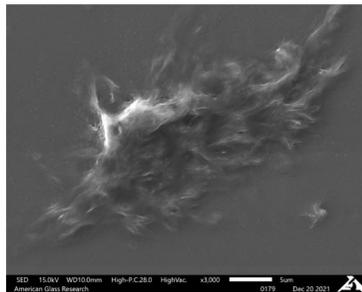
e) Magnified SEM image of a surface feature.

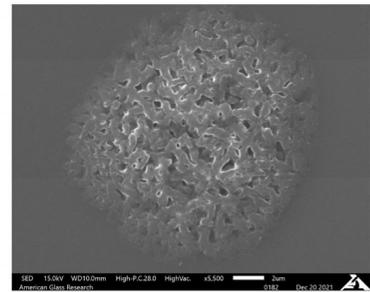
f) Magnified SEM image of a surface feature.

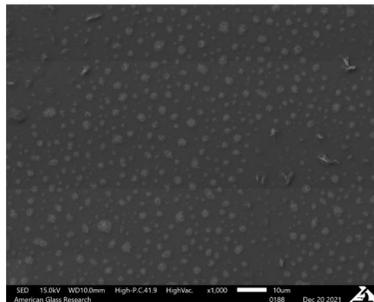
g) Magnified SEM image of unwashed surface.

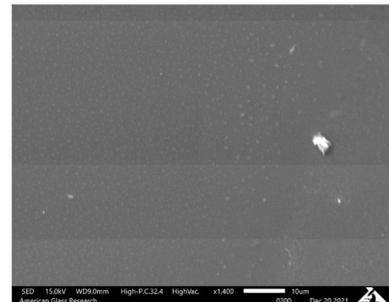
h) Magnified SEM image of washed surface.

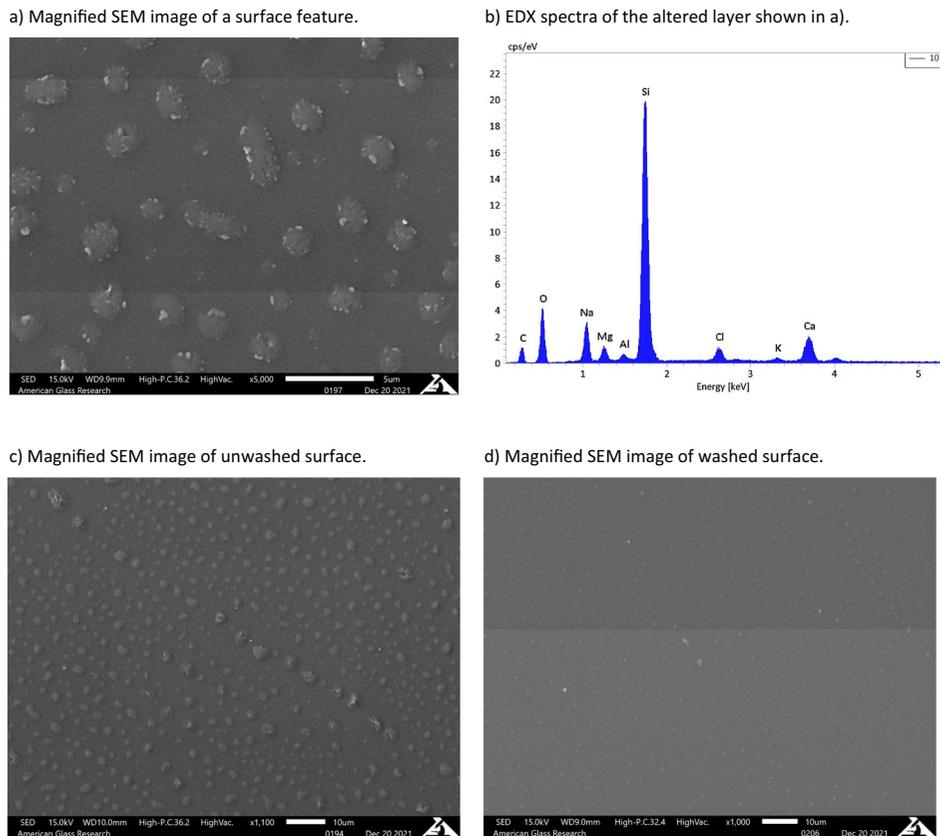
Fig. 6 Scanning electron microscope (SEM) images and EDX analysis of samples from Group 2 weathered for 8 weeks in 75%RH/50 °C. Except for the photo d), all photos are of unwashed samples

Figure 6 shows microscopy images of the samples of group 2. In contrast with group 1, in which large crystalline deposits were identified, smaller weathering products were found in group 2. A prevailing surface feature, which is shown in Fig. 6a, was identified for this group. This structure exhibited the format of

droplets and an EDX spectrum similar to the altered layer identified in group 1, predominantly with Na, Si, and O, as shown in Fig. 6b. As in group 1, the presence of these elements suggests that the droplets may have been formed through leaching reactions and the presence of Cl suggests the possible formation of salts. These droplets were organized in linear patterns, as shown in Fig. 6c. One possibility is that they could be related to the tin concentration on the glass surface, which is determined by the float process, or related to other stages of the manufacturing processes. However, further research is required to verify the origin of these patterns.

for this group the washing process enables significant improvement of the surface condition, removing most of the droplets.

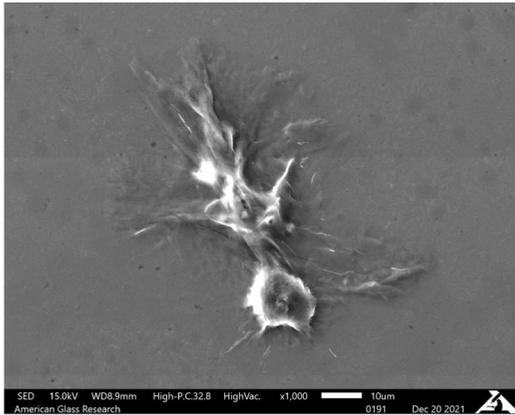
a) Magnified SEM image of a surface feature.

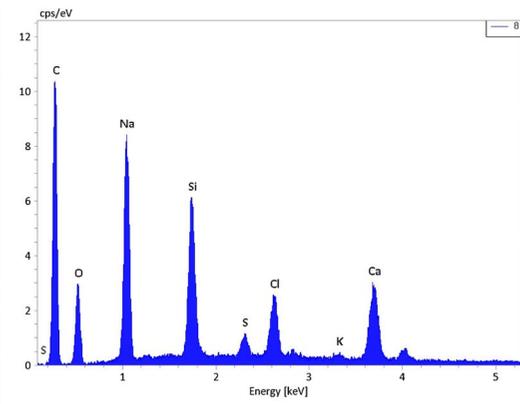
b) EDX spectra of the crystalline structure shown in a).

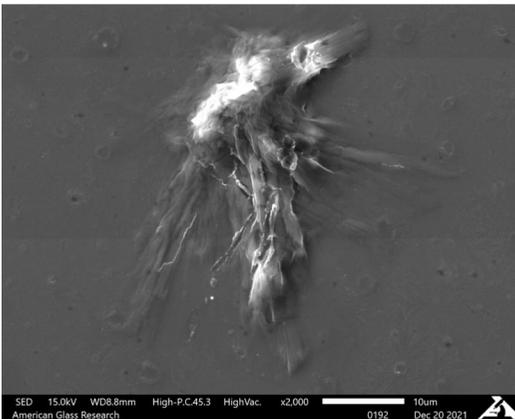
c) Magnified SEM image of a surface feature.

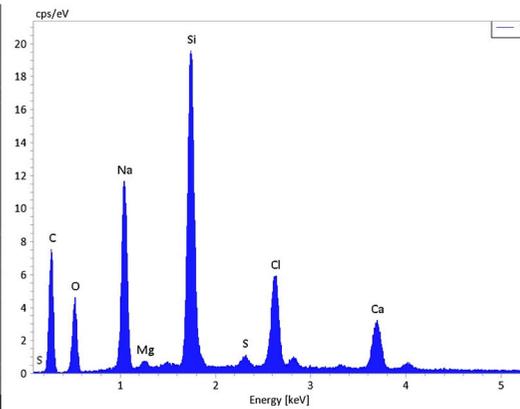
d) EDX spectra of the crystalline structure shown in c).

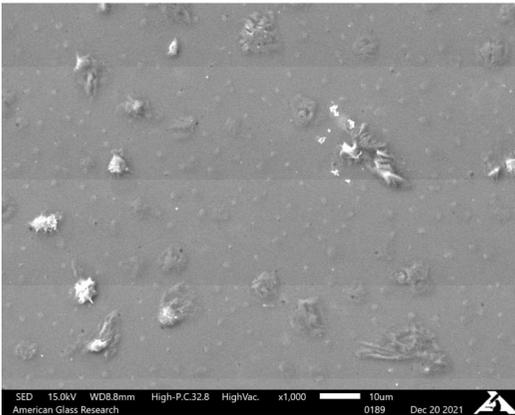
e) Magnified SEM image of unwashed surface.

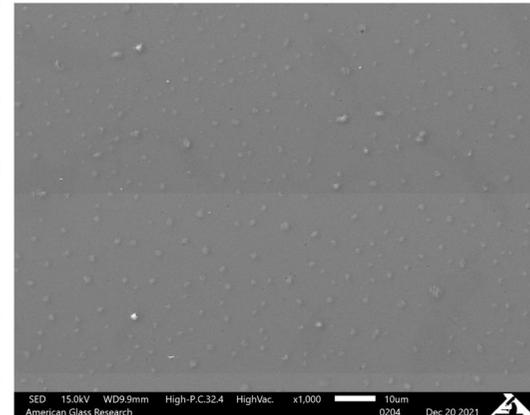
f) Magnified SEM image of washed surface.
