RILEM TC 277-LHS report

lime-based mortars for restoration—a review on long-term durability aspects and experience from practice

Groot, Caspar; Veiga, Rosario; Papayianni, Ioanna; Van Hees, Rob; Secco, Michele; Alvarez, José I.; Faria, Paulina; Stefanidou, Maria

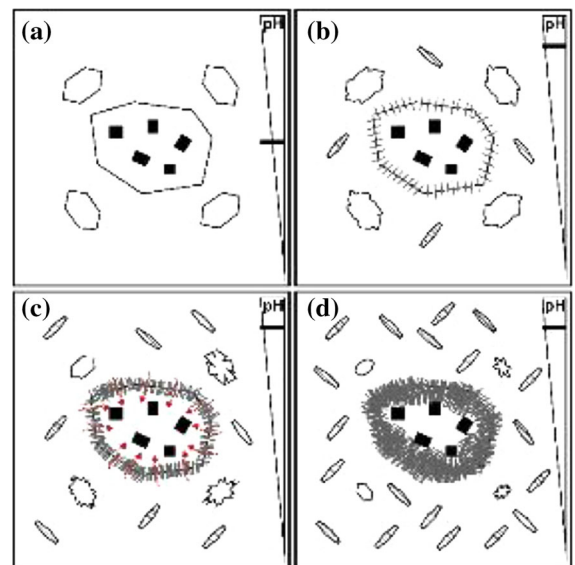
Fig. 2 Scheme of the pozzolanic reaction process: **a** Initial state (portlandite crystals depicted as hexagonal polygons, pozzolanic particle depicted as a large polygonal shape with non-reactive mineral constituents in black); **b** Initial dissolution period (C-S-H crystals depicted as grey lines, C-A-H crystals depicted as elongated textured polygons); **c** Induction period (red dashed arrows indicating water diffusion through osmosis); **d** Main reaction period

form hydrated reaction products (calcium silicate and calcium aluminate hydrates) with marked binding properties related to their crystalline structure [44]. Pozzolanic reaction processes can be subdivided into three reaction stages (Fig. 2) [45], namely initial

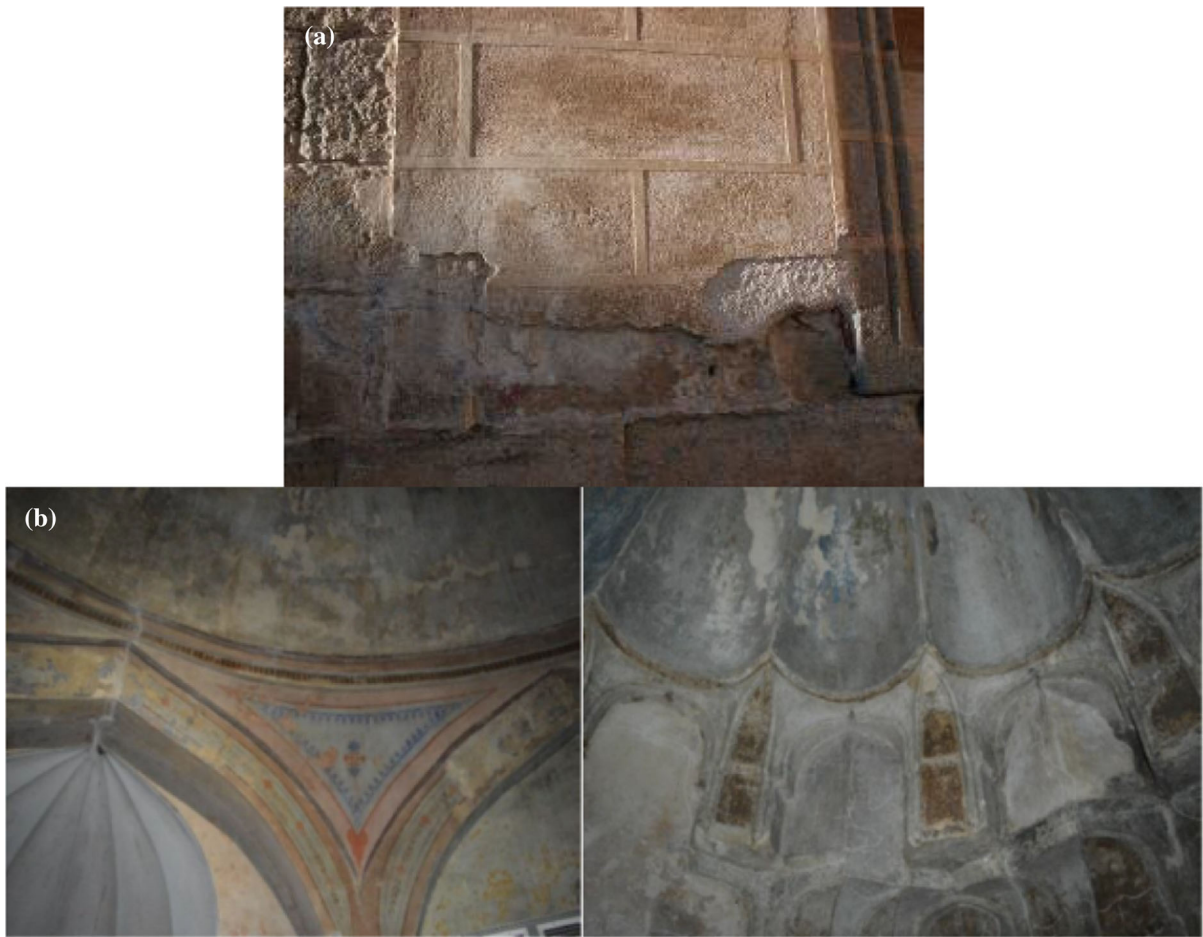
Fig. 3 **a** Durability of air lime render imitating stone over stone masonry in Évora Cathedral, in Portugal (seventeenth century); **b** Interior of Pasa Hamam, Thessaloniki (1530 AD), with well-

preserved air lime renders ($\text{CaO} \geq 55\%$) although soluble salt content was high $\geq 1\%$

Many ancient constructions, all over the world, are composed of masonry with air lime mortars, thus proving the high durability and fitness for use of this material [74–79]. Due to their low modulus of elasticity, air lime mortars can follow the movements of the structures with minor cracking, also ensuring optimal adhesion. Furthermore, the high porosity and water vapour permeability of the mortars allow quick drying of walls, with evaporation of internal moisture to the exterior, thus contributing to a healthy internal environment and to the good condition of the walls. The slow hardening mechanism by carbonation ensures an improvement of performance along time and contributes, together with the self-healing properties, related with dissolution–recrystallization cycles of calcium carbonate, to a high durability, if destructive actions (by nature or by human activity) do not occur (Fig. 3).

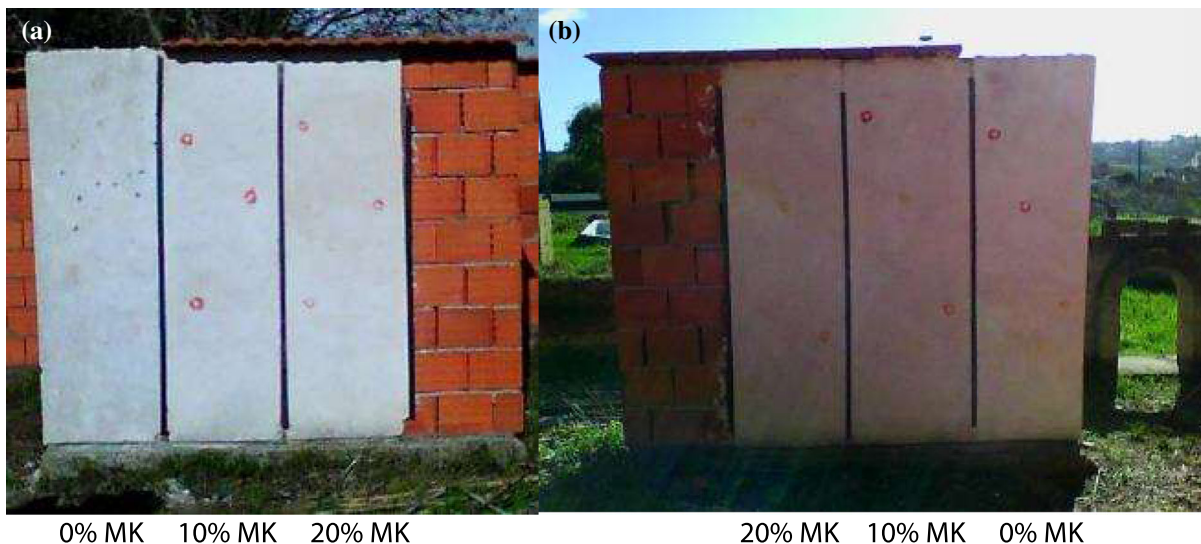
Fig. 4 Experimental pure air lime renders and air lime-metakaolin (MK) renders (marked with the percentage of MK replacing lime) after 7 years of natural exposure **a** South and **b** North, in a semi-urban environment 3 km from the Atlantic Ocean

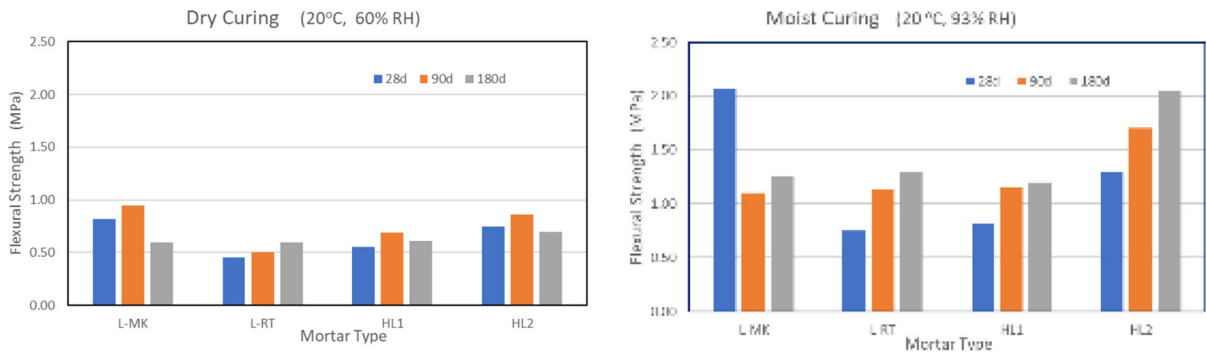
Fig. 9 Flexural strengths values for Lime-Metakaolin (L-MK), Lime-Rhenish trass (L-RT), and two types of Natural Hydraulic Lime (HL1 and HL2) mortars, for 2 curing conditions: dry curing and moist curing (adapted from [58])

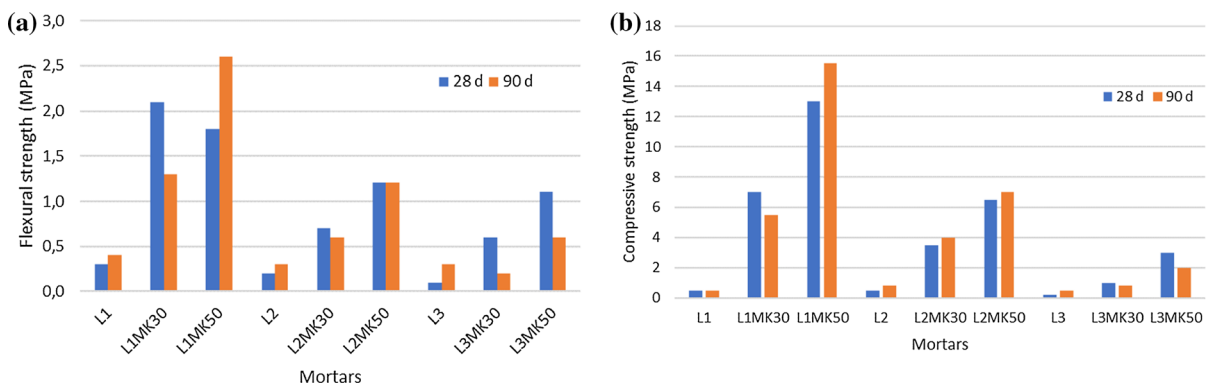
Fig. 10 Flexural a) and compressive b) strengths of air lime-metakaolin mortars with ratio b/a 1:1, 1:2 and 1:3 (wt) and ratio MK/L 0, 0.3 and 0.5 (adapted from [68])

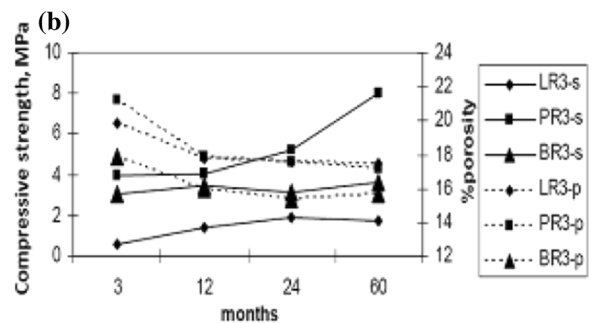
Fig. 12 **a** Evolution of compressive strength (-s) and porosity (-p) in mortars of binder/aggregate ratio 1/1(R1); **b** Evolution of compressive strength (-s) and porosity (-p) in mortars of binder/

aggregate ratio 1/3(R3). L: Hydrated lime CL90, P: Lime-natural ground pozzolan (1:1) (by mass), B: Lime:pozzolan:brick dust (1:0.5:0.5)

mortars of comparable ratio. Indicative results of compressive strength are reported in Fig. 12. It seems that strength evolution is in general stabilized at the age of 12 months. The slight differences in strength with age (up or down) are related rather with microcracking due to drying shrinkage of specimens.

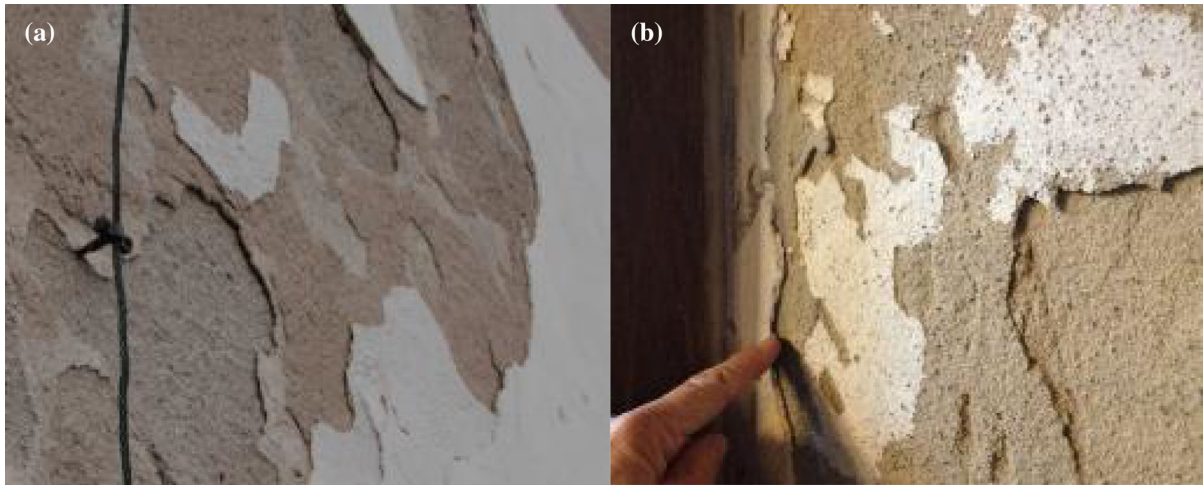
Fig. 17 Typical forms of layering in renders and plasters. Separate render layers coming off due to freezing temperatures in a saturated and porous render (a), [110]; similar damage, due to salt crystallization in a plaster, applied on a wall with capillary rising damp (b)

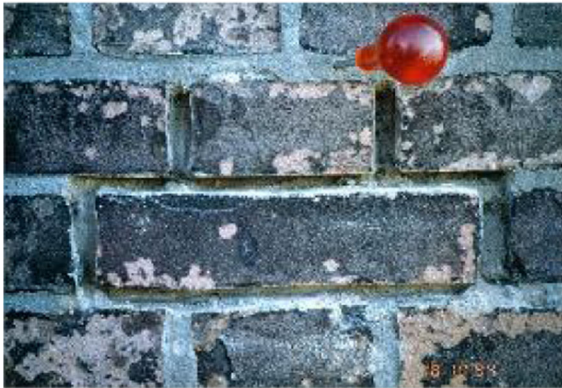
Fig. 18 Weak, decayed trass lime re-pointing

In this case indeed the lime reacted only with carbon dioxide from the air. Lime converted into calcium carbonate is no longer available for the trass-lime reaction. As the trass did not react, it acts just as a filler and a very weak mortar results.

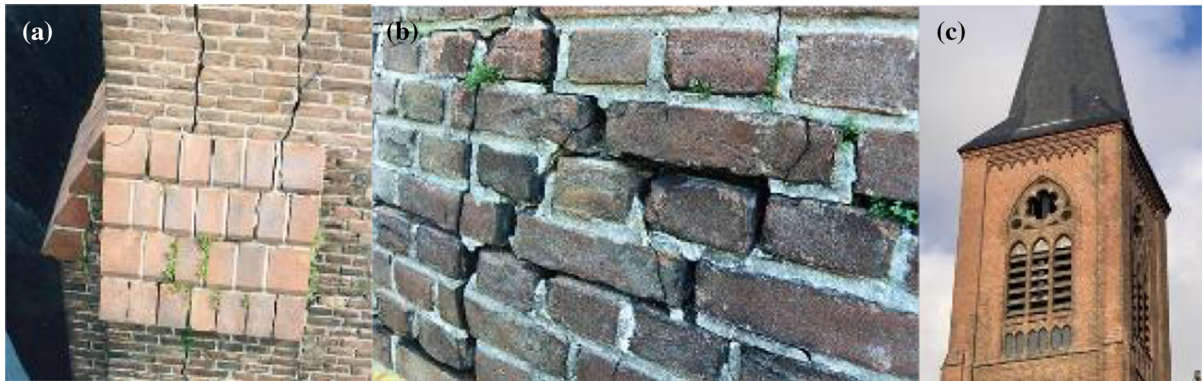
Fig. 19 Cracks in masonry, caused by expansion of bedding mortar, deeper in the wall section, due to formation of thaumasite (a); push out of the pointing is a secondary effect (b); situation several years after repair: no recurrence (c)

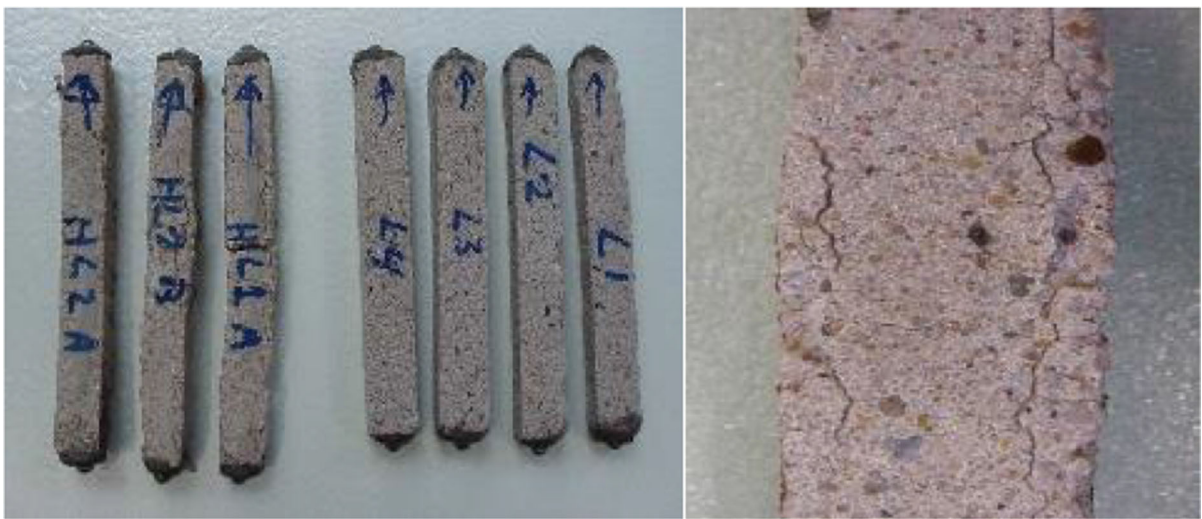
Fig. 20 Mortar prisms after 15 weeks in sulfate solution. Natural Hydraulic Lime based (NHL) specimens with clear expansion and deformation and Hydrated lime based (CL)

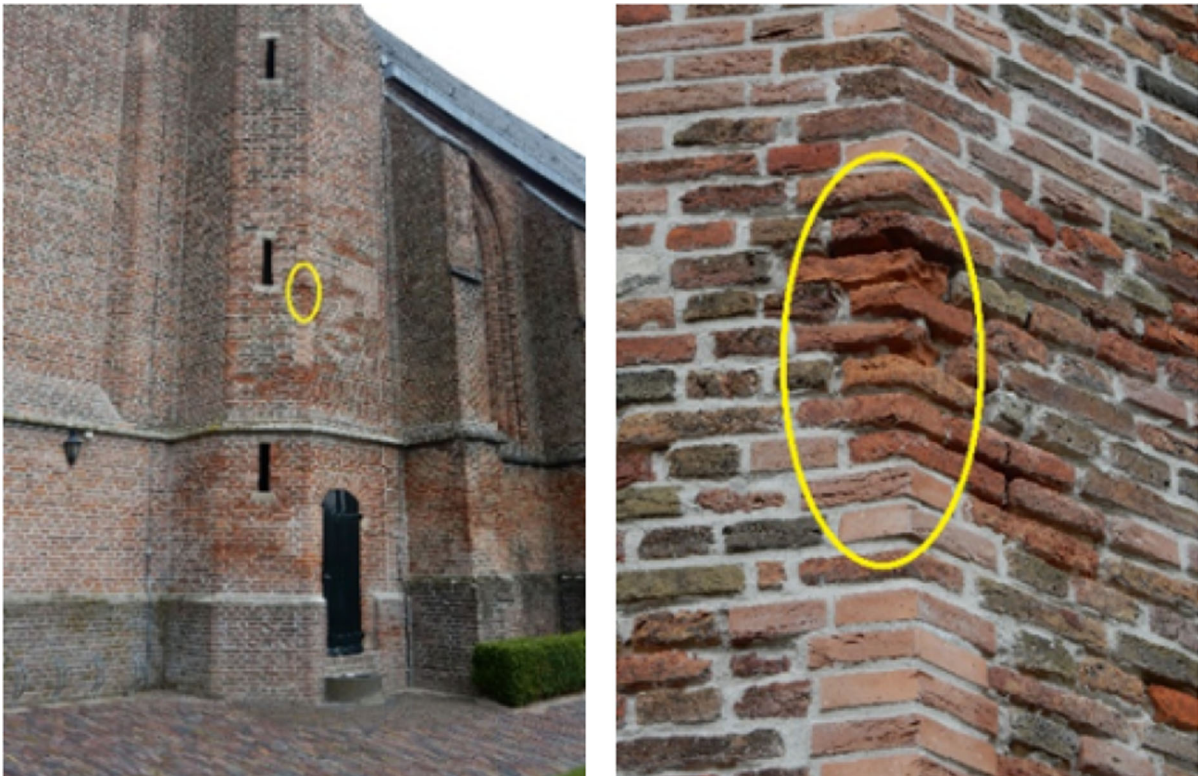
Fig. 21 Situation of the damage in 2016. Left, the reddish parts of the masonry indicate where the repointing is damaged. Right, detail of one of the spots with damaged repointing

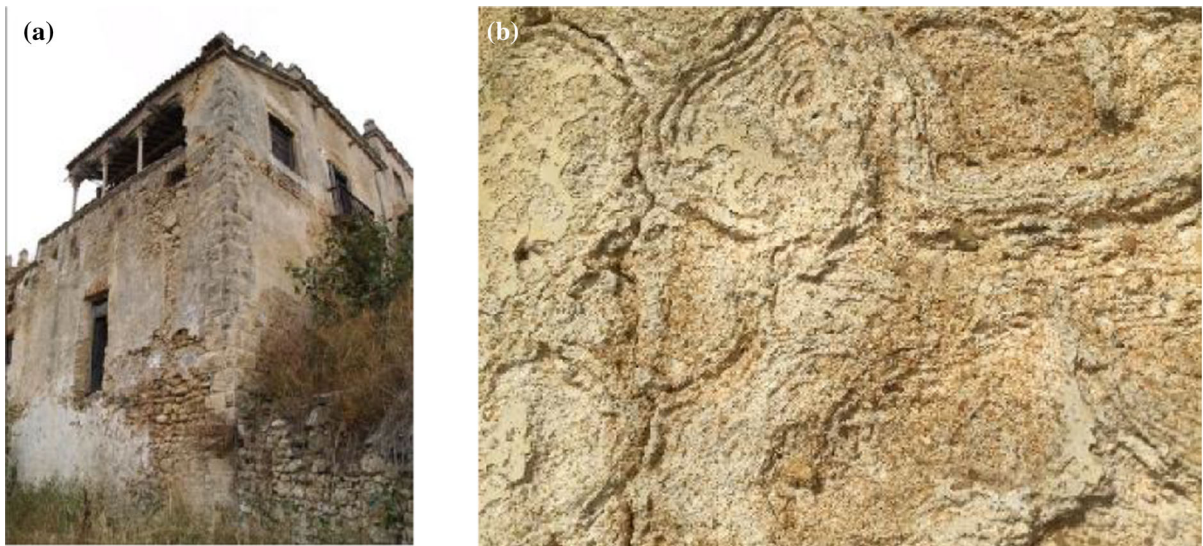
Fig. 27 Valflores Palace in St. Iria da Azoia, Loures, Portugal (a), and Liesegang phenomenon in a rendered façade (b)

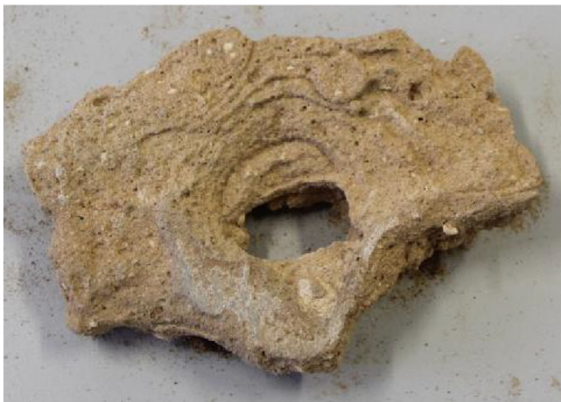
Fig. 28 Deep circular erosion on a render sample of Valflores Palace

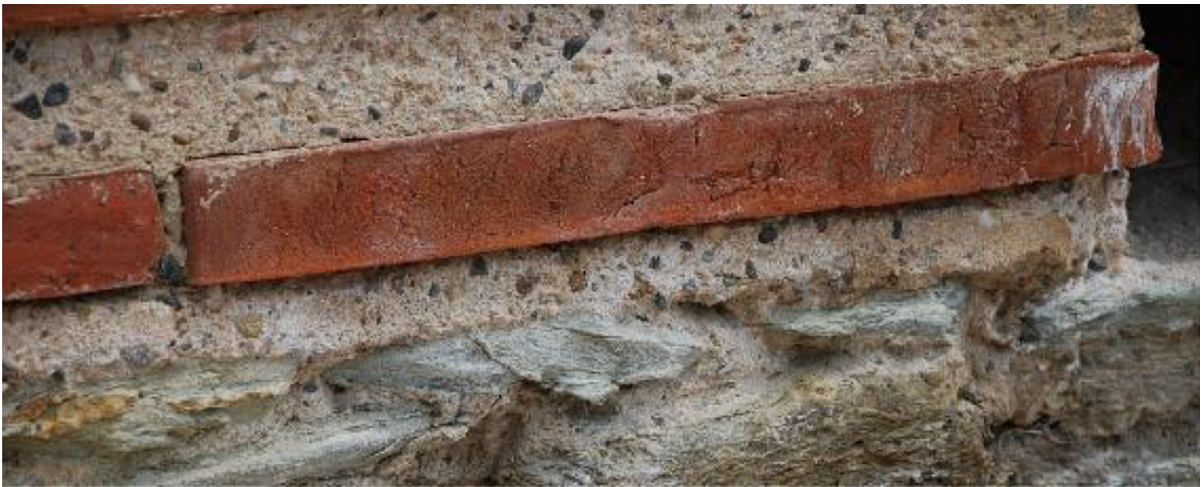
Fig. 30 Repair mortar in a mix structural system of Galerius Palace in Thessaloniki, Greece
