Durability of an UHPFRC under mechanical and chloride loads

Matos, Ana Mafalda; Chaves Figueiredo, Stefan; Nunes, Sandra; Schlangen, Erik; Barroso-Aguiar, José L.

Construction and Building Materials

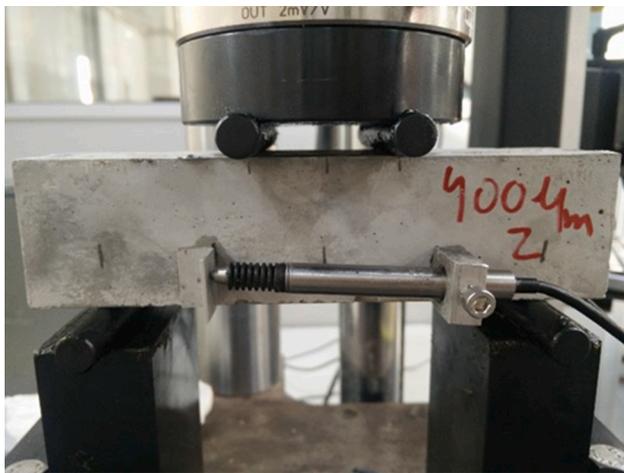
**Fig. 1.** Four-point bending test.

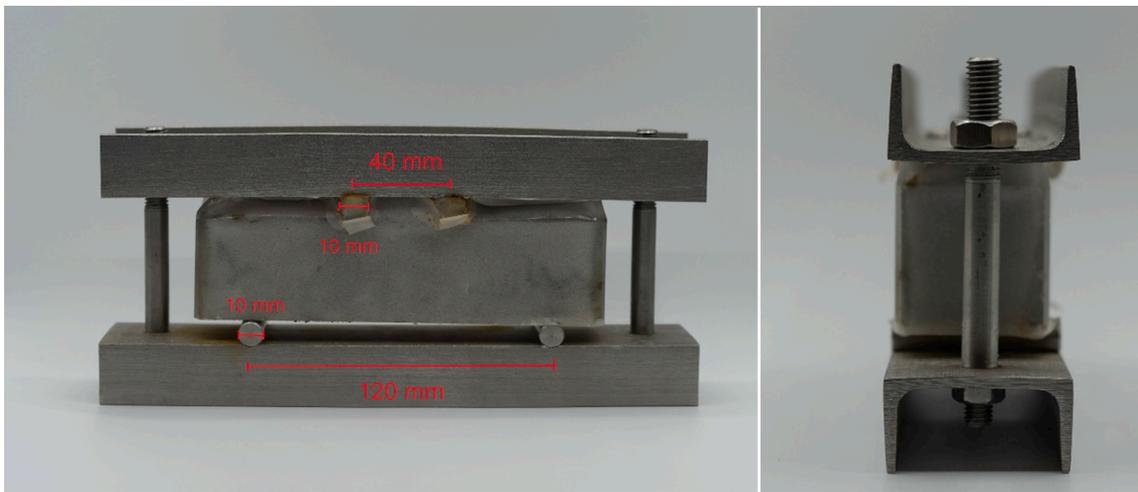
Fig. 2. Illustration of the loading device.

“3.0%-300-i” specimens, i.e., predefined COD_{load} = 300 μm, were subjected to chloride rich environment under loading. For that purpose, a stainless-steel frame designed by the authors was used to keep the COD_{load}. The specimens were unloaded, but LVDTs were not removed while they were allocated on a stainless-steel frame, as shown in Fig. 2. The specimens were then re-loaded up to COD_{load} of 300 μm using threaded rods tightened by a torque wrench. Conserving the LVDTs on the specimen allowed achieving the target COD again. Afterwards, LVDTs were removed prudently, and the frame sustained the target COD. Thus, “3.0%-300-i” specimens were subject to wetting–drying chlorides cycles in a loaded state.

Before initiating the wetting–drying cycles, all prisms side and compression surfaces were sealed using waterproof tape to ensure the chloride penetration only through the cracked surface, as can be seen in Figs. 2 and 3. It must be noted that it was impossible to protect the loaded surfaces of specimens kept in the stainless-steel frame (3.0%-300-i).

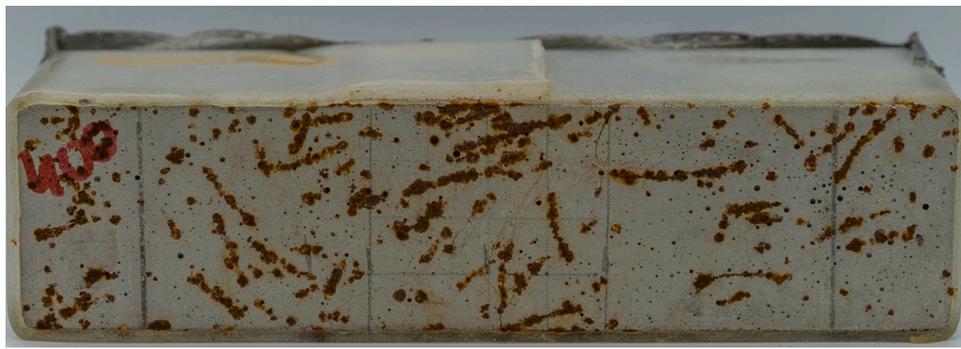
Fig. 3. Tensile surface of specimen "3.0%-400-5" after cracking.

After 28 days water curing, a matrix was marked on the tensile face of some specimens of each COD group (40 mm, in between the two loading points) as shown in Fig. 3 and detailed in Fig. 4 and Table 4. This aimed to simplify the crack pattern characterisation (width and numbering) since in UHPFRC usually, multiple cracking occurs before reaching peak load. The matrix is formed by three horizontal lines (A, B and C, shown in Fig. 4 and Table 4) and 4 columns (segments 1, 2, 3 and 4, shown in Fig. 4 and Table 4). All cracks crossing the lines (A, B or C) were counted and measured. Thus, in each quadrant (1, 2, 3 or 4) there is $N_{i \dots n}$ cracks (see Table 4).

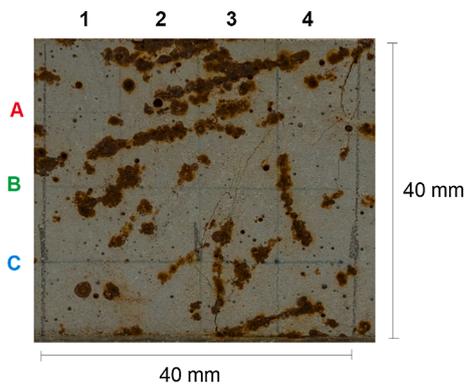
Fig. 4. Schematic matrix for crack opening measurement, the specimen "3.0%-400-5".

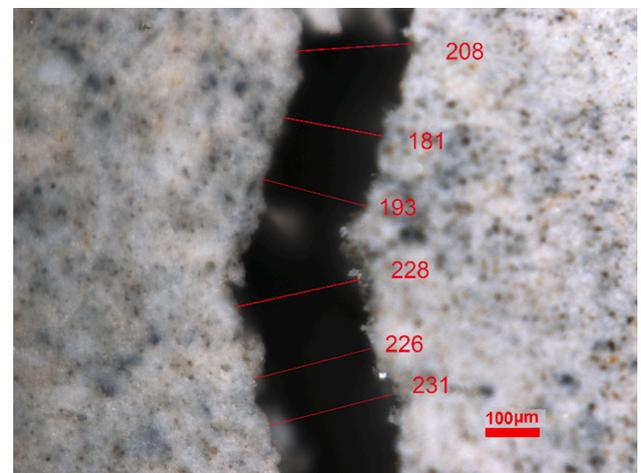
Fig. 5. Typical photo made from the measurement of one crack width (specimen "3.0%-400-5", localisation in the matrix: A-4).

The crack number and width were observed and measured utilising a Microscope Multizoom Nikon AZ100 with an objective Nikon-AZ Plan Fluor 5 × and photographed with a PC and a DS-U2 digital camera. An example of a photo of a crack is shown in Fig. 5. Six crack-width measurements were performed for each crack crossing lines A, B or C, as exemplified in Fig. 5, using image analysis software (ImageJ). Each crack is represented by the median of crack width (see the scheme of Table 4 and measures on Fig. 18). On loaded specimens, kept inside the frame, it was impossible to perform the crack pattern characterisation.

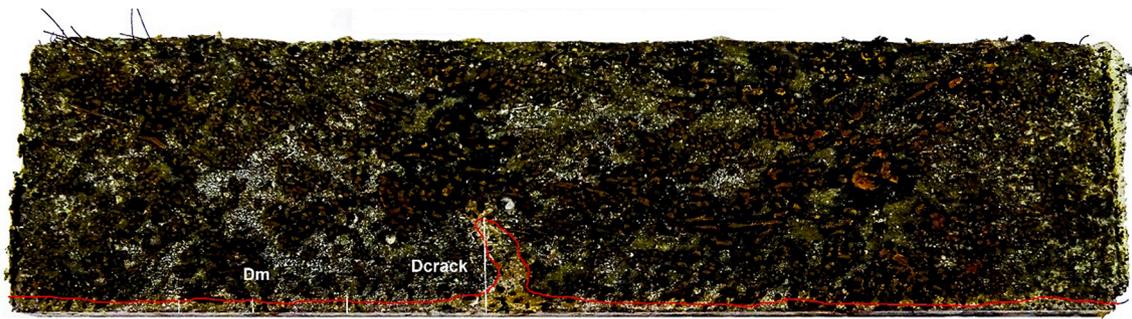
Fig. 6. Chloride penetration profiles on a cracked specimen (“3.0%-350-5”).

For cracked specimens, two regions of chloride penetration depth could be distinguished, the penetration in the non-cracked zone (D_m) and the penetration in the main crack zone (D_{crack}), as indicated in Fig. 7 on section 2.7. D_{crack} was located where a macro-crack was found in between the two loading points. In the cracked specimens (3.0%-350-i and 3.0%-400-i), a localised and significant chloride penetration (between 10 and 17 mm) was observed close to the macro-crack. On the other hand, more uniform penetration occurred in reference specimens or healthy areas of cracked specimens (roughly 2–3 mm).

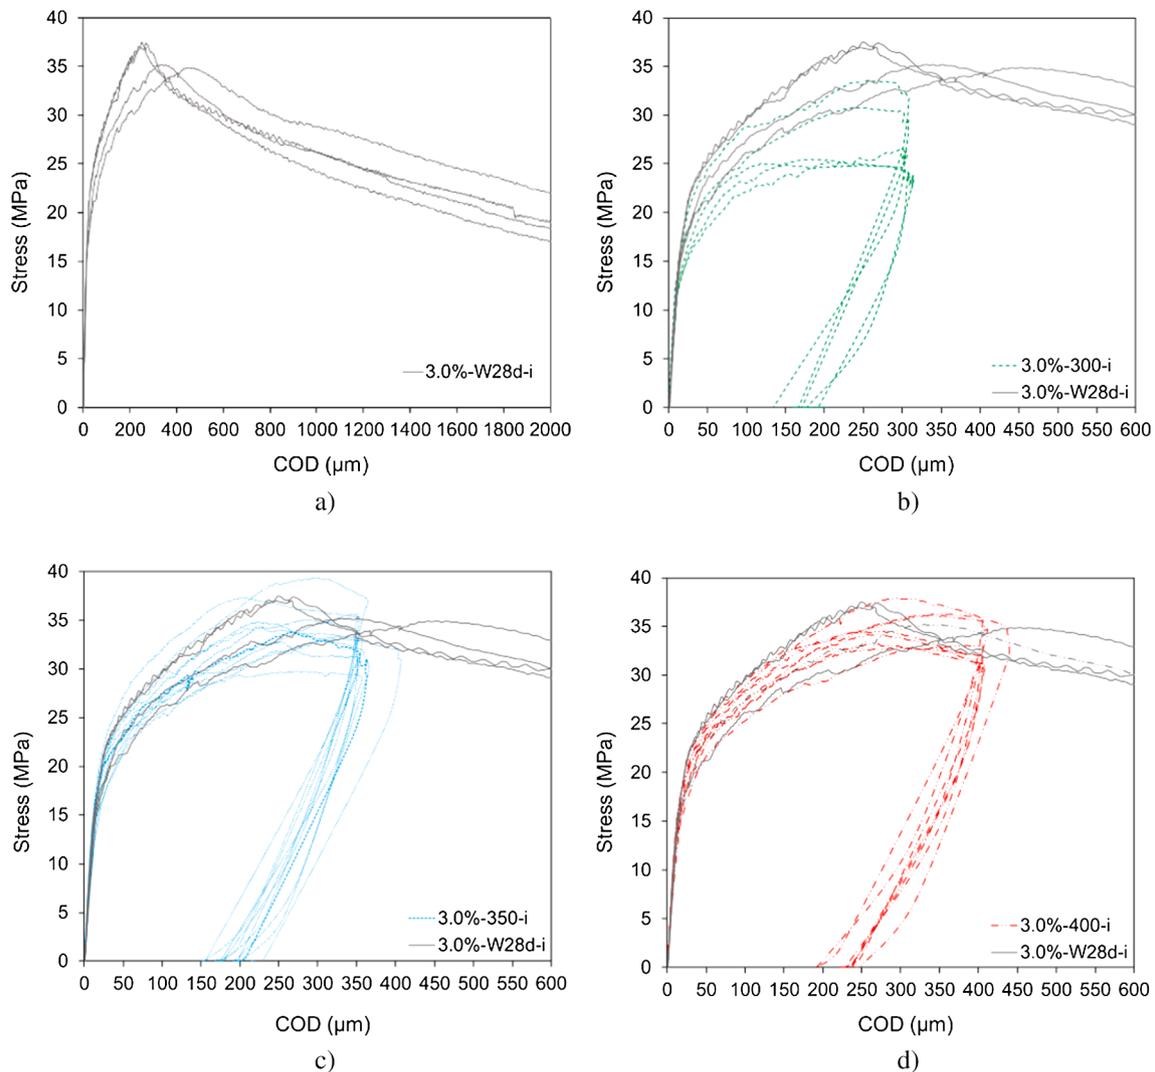
Fig. 7. a) Four-point bending load–displacement relationship after 28 days of wet curing and Load–displacement curves obtained at 28 days while establishing target CODs: b) $COD_{load} = 300 \mu m$, c) $COD_{load} = 350 \mu m$ and d) $COD_{load} = 400 \mu m$.

Figure 7-b, -c and -d depict the load–displacement curves obtained

while establishing target COD_{load} and the curves of specimens tested under four-point bending up to the beginning of softening region, at 28 days (grey lines). These curves are also depicted in Fig. 7-a up to the end of the test. As can be seen, the goal values of COD_{load} were reached with a rational approximation ($\pm 15\%$) concerning all tested specimens. Table 7 in Appendix B presents data regarding each specimens main cracking parameters, i.e., maximum load achieved during the cracking procedure ($F_{cr, max}$) and the values of COD_{load} and COD_{res} . COD_{res} obtained after unloading as a function of COD_{load} are represented in Fig. 8, showing a significant linear relationship between these two parameters. This trend corroborates with previous studies [30,39] and also with previous studies carried out by the authors [44], which were also depicted in the Fig. 8.

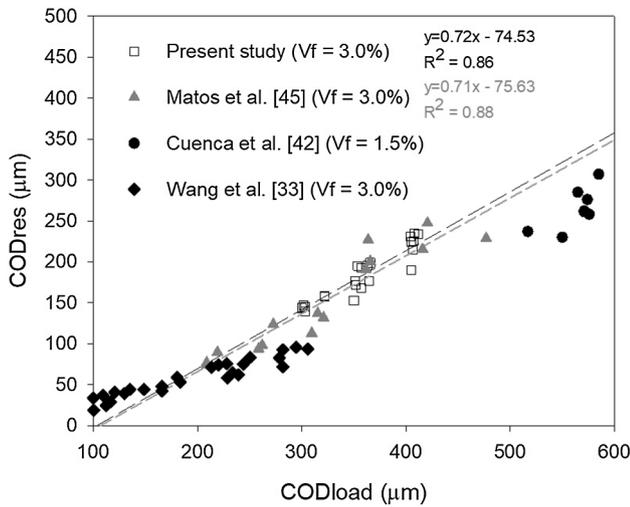
Fig. 8. Relation between COD_{load} and COD_{res} .

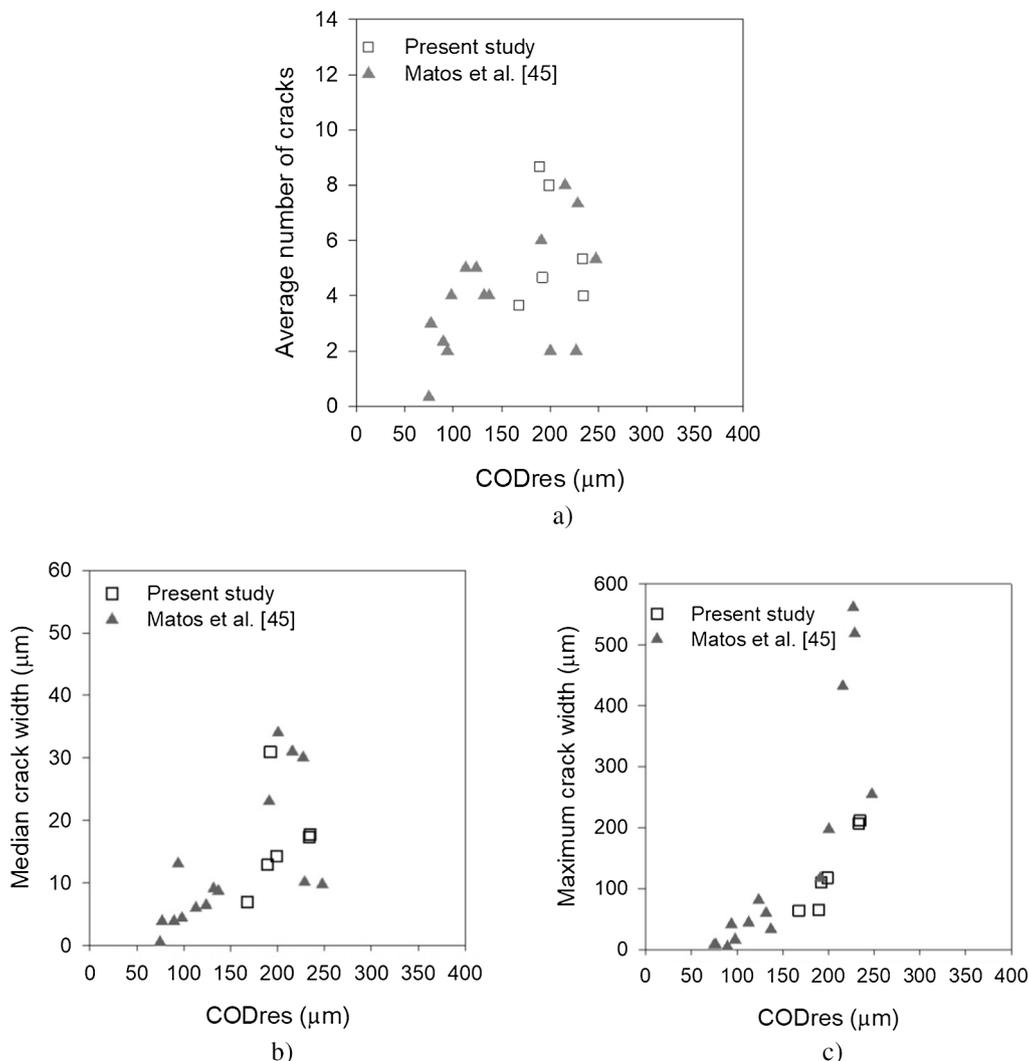
Fig. 9. Crack pattern parameters: a) Average number of cracks over 40 mm; b) Median crack width; c) Maximum crack width.

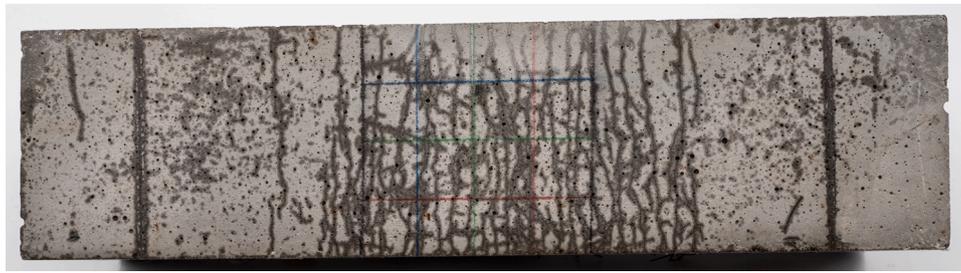
Fig. 10. Multiple micro-cracking formations in flexural harding stage (micro-cracks revealed by alcohol spayed on the surface).

Before the peak load is reached, i.e., the flexural hardening stage, multiple cracking formations occur, not visible to human eyes, without the appearance of any significant visible crack, as depicted in Fig. 10. A macro-crack forms after the peak load, i.e., the softening stage begin, as illustrated in Fig. 11. The average peak forces F_{max} achieved after 28 and 379 days of water curing were 19.3 ± 0.6 and 19.1 ± 1.7 kN, respectively. Usually, when higher peak stresses are reached, more brittle behaviour in the softening region occurs (lower post-peak ductility) [48]. Fig. 12-b shows that some of the “3.0%-W379-i” specimens exhibit higher initial stiffness, which might be due to further microstructure development with increasing curing time.

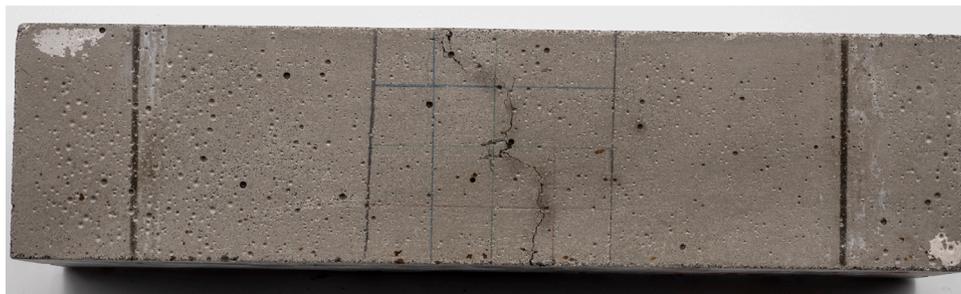
Fig. 11. Macro crack formation in softening stage (valid result).

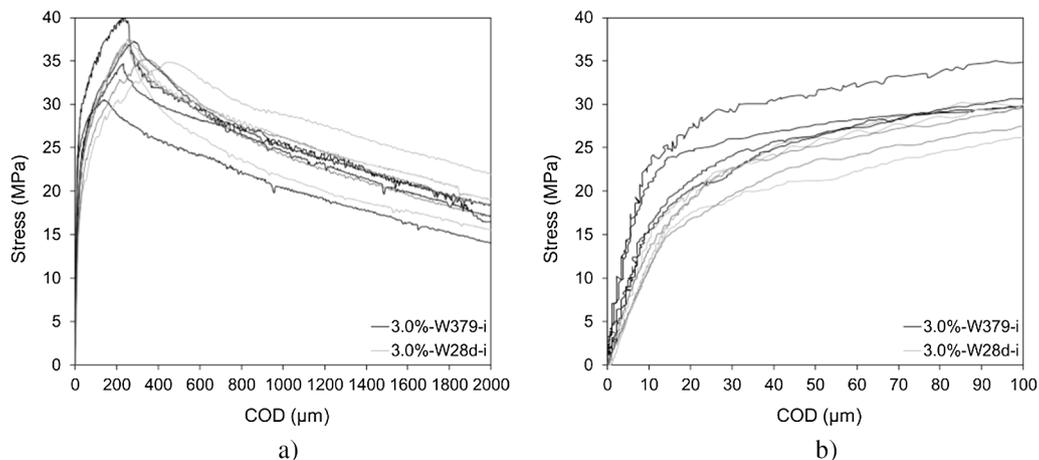
Fig. 12. a) Four-point bending load–displacement relationships for 28 and 379 old days up to softening area and b) Load-displacement curves zoom up to $COD = 100 \mu m$.

The individual load–displacement curves for all the valid UHPFRC specimens are presented in Fig. 12. A valid result was considered when, after peak loaded is reached, the macro-crack occurs inside the measuring length covered by the LVDTs (exemplified in Fig. 11). For each testing age, 28 and 379 days, five specimens were tested, and valid four and five were considered valid results, for 28 and 379 days, respectively. Average results, i.e., average peak load (F_{max}), Strenght (Stress) and COD at F_{max} (COD_{Fmax}) are summarised in Table 5 (2nd and 3rd lines for “3.0%-W28-i” and “3.0%-W379-i” specimens, respectively) and Table 6 of Appendix B, which contains detailed results. As shown in Fig. 12, flexural hardening behaviour occurred in UHPFRC mixtures with 3% steel fibres.

both in terms of peak load (see Fig. 13-a) and initial stiffness (see Fig. 12-b).

- Cracked-unloaded specimens “3.0%-350-i” and “3.0%-400-i” showed similar average peak loads (see Fig. 13-a) but lower stiffness compared to “3.0%-0-i” specimens (see Fig. 12-b).

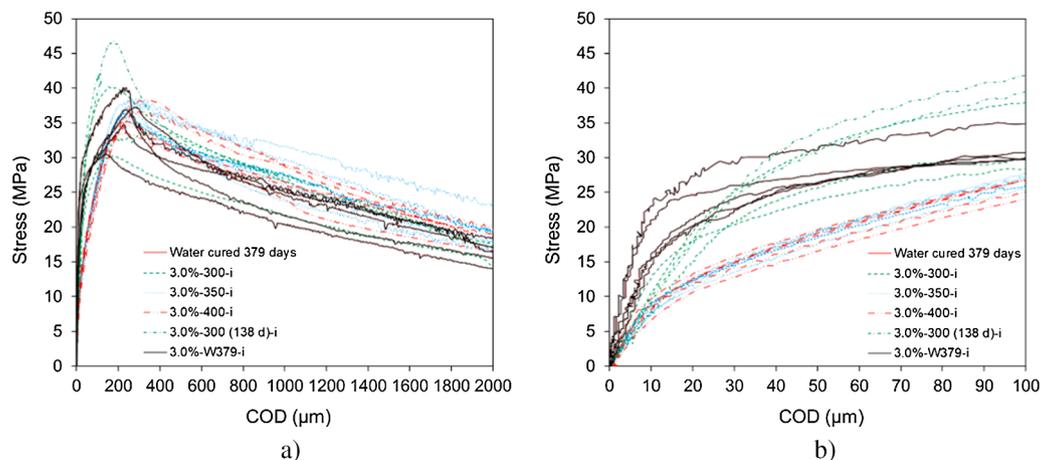
Fig. 13. a) Four-point load–displacement relationships for all valid specimens tested at the end of chlorides cycles and b) Load-displacement curves zoom up to COD = 100 µm.

After wetting-drying cycles, the specimens “3.0%-300-i” was removed from the frame and kept at 20 °C and HR = 65% controlled environment for one week before being re-loaded to failure under four-point bending test. The remaining specimens, 3.0%-0-i, 3%-350-i, 3%-400-i, were also kept in the same conditions for one week before mechanical tests. Fig. 13 presents curves of re-loading to failure for the different tested series.

- Non-cracked specimens (“3.0%-0-i”) showed similar average peak loads to the cracked specimens (see Fig. 13-a); however, their initial stiffness is, in general, higher (see Fig. 13-b).
- Cracked-loaded specimens (3.0%-300-i) presented similar or improved bending behaviour compared to “3.0%-0-i” specimens,

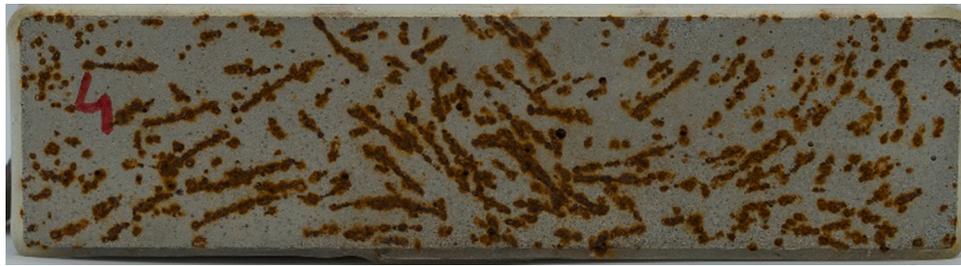
Fig. 14. Exposed specimen surface after wetting–drying cycles (3.0%-0-4).

All specimens were in excellent condition after the chloride cycles with no evidence of surface scaling, material loss or additional cracking, which corroborates previous findings [32]. However, corrosion on fibres close to the exposed surface was generally observed, as shown in Fig. 14. In fact, fibre located up to 3 mm from the exposed surface, usually suffers severe corrosion. On the other hand, those fibres fully embedded inside of the concrete, remained free from corrosion [49–51].

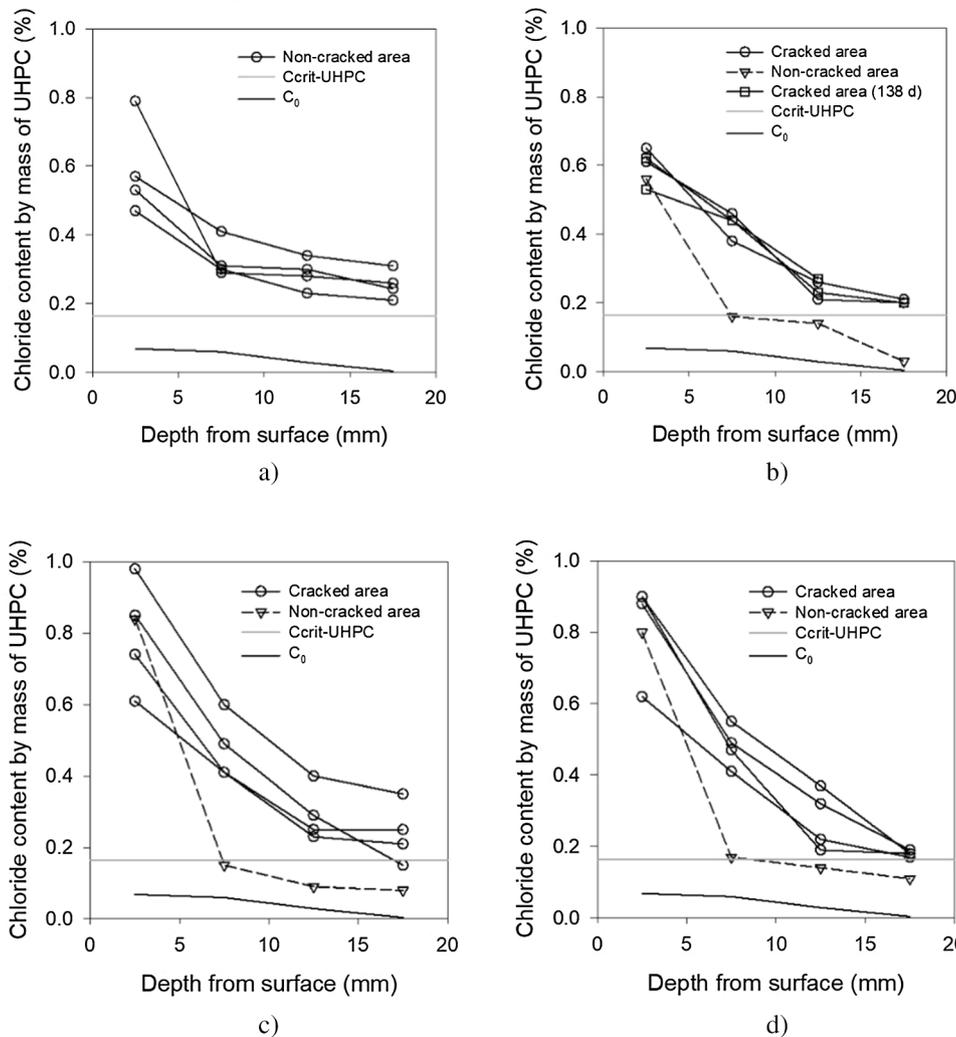
Fig. 15. Chloride profiles for UHPFRC series: a) 3.0%-0-i; b) 3.0%-300-i; c) 3.0%-350-i and d) 3.0%-400-i specimens;

Fig. 15 presents the chloride profiles and chloride content values for each specimen at different depths (detailed data can be found in Table 7 of Appendix B). The chloride content is expressed as the percentage of chloride ions by mass of the sample (without steel fibres – UHPC). Fig. 15 also depicts the C_0 (blue line in Fig. 15-a, b, c and d).

The non-cracked specimens (3.0%-0-i) showed a high chloride concentration close to the specimens surface, decreasing towards the specimens inner. These results are in agreement with the colourimetric analysis with silver nitrate. The maximum chloride content varied between 0.47 and 0.79% at a depth ranging from 0 to 5 mm, then, between 5 and 10 mm depth, the chloride content drastically decreased (around 50%) for values between 0.26% and 0.41%, see Fig. 15-a. Afterwards, chloride profiles kept decreasing with an asymptotic shape converging to 0.20% as depicted in Fig. 15-a.

On cracked specimens, samples taken near a macro-crack and non-cracked areas were analysed and depicted in Fig. 15-b, -c and -d, using full and dashed lines, respectively (chloride profiles data is also compiled in Table 7 of Appendix B). Generally, chlorides profiles appear to be similar despite the different COD_{load} applied. In fact, on cracked-unloaded specimens, 3.0%-350-i and 3.0%-400-i, the chlorides could penetrate inwards more rapidly due to the induced macro-crack.

Non-cracked specimens (Fig. 15-a) presented significant chloride content, higher than $C_{crit} = 0.16\%$ up to 20 mm depth. Regarding non-cracked areas of cracked series specimens, 3.0%-300-i, 3.0%-350-i and 3.0%-400-i, the surface chloride content (considering 5–10 mm [52]), was about 0.16% of UHPC mass (Fig. 15-b, -c and -d). On the other hand, chloride content assessed on the main (and visible) crack revealed that up to a depth of 20 mm the chloride content was above 0.16%. Though, it shows a decreasing tendency for higher depths.

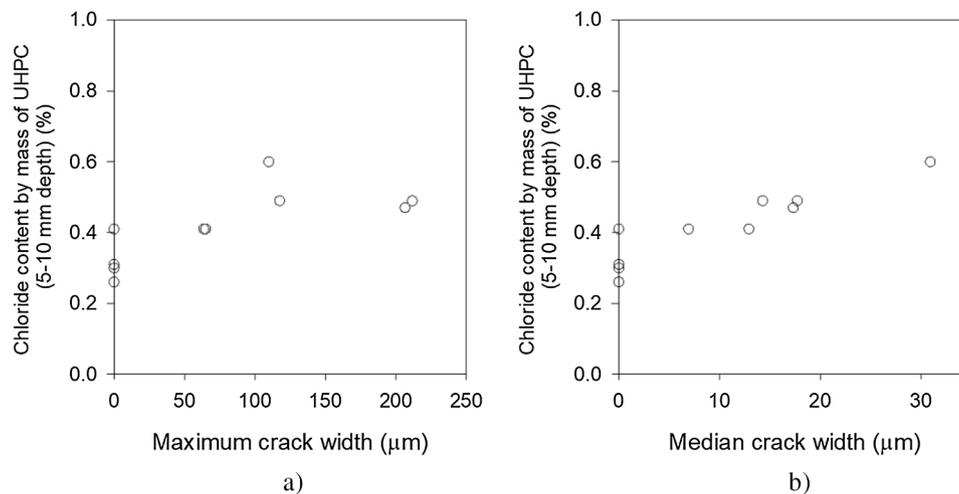
Fig. 16. Relationship between chloride content (5–10 mm depth) on a) maximum crack width and b) median crack width.

As can be observed in Fig. 16 -b, it seems higher median crack width gave rise to higher chloride content. On the other hand, chloride content did not show any tendency regarding maximum crack width, as shown in Fig. 16-a. This seems to make sense since up to a particular value of crack width, the suction capacity should be dominant. It should be noted that it is common practice to discard the first mm of a chloride profile

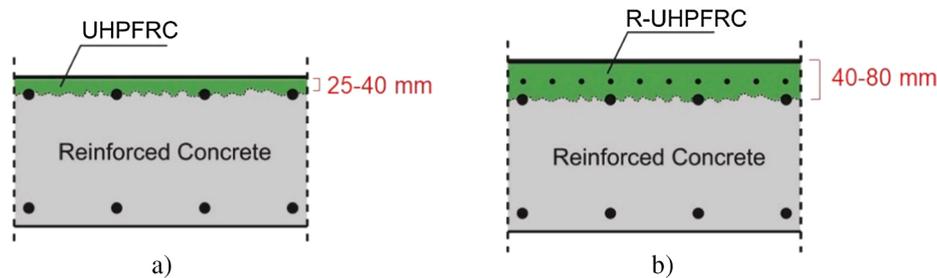
Fig. 17. Configuration of composite structural elements combining R-UHPFRC and conventional RC: a) UHPFRC layer (thickness 25–40 mm) has a protective function only; b) R-UHPFRC layer (thickness of 40–80 mm or more) has both structural resistance and protective features [57].

Based on these experimental campaign results, one can conclude that a minimum of 20 mm cover to reinforcement might be necessary to avoid rebar corrosion. This would be feasible considering the typical thickness of new reinforced UHPFRC layers, of 40–80 mm, as suggested in Fig. 17 [57].

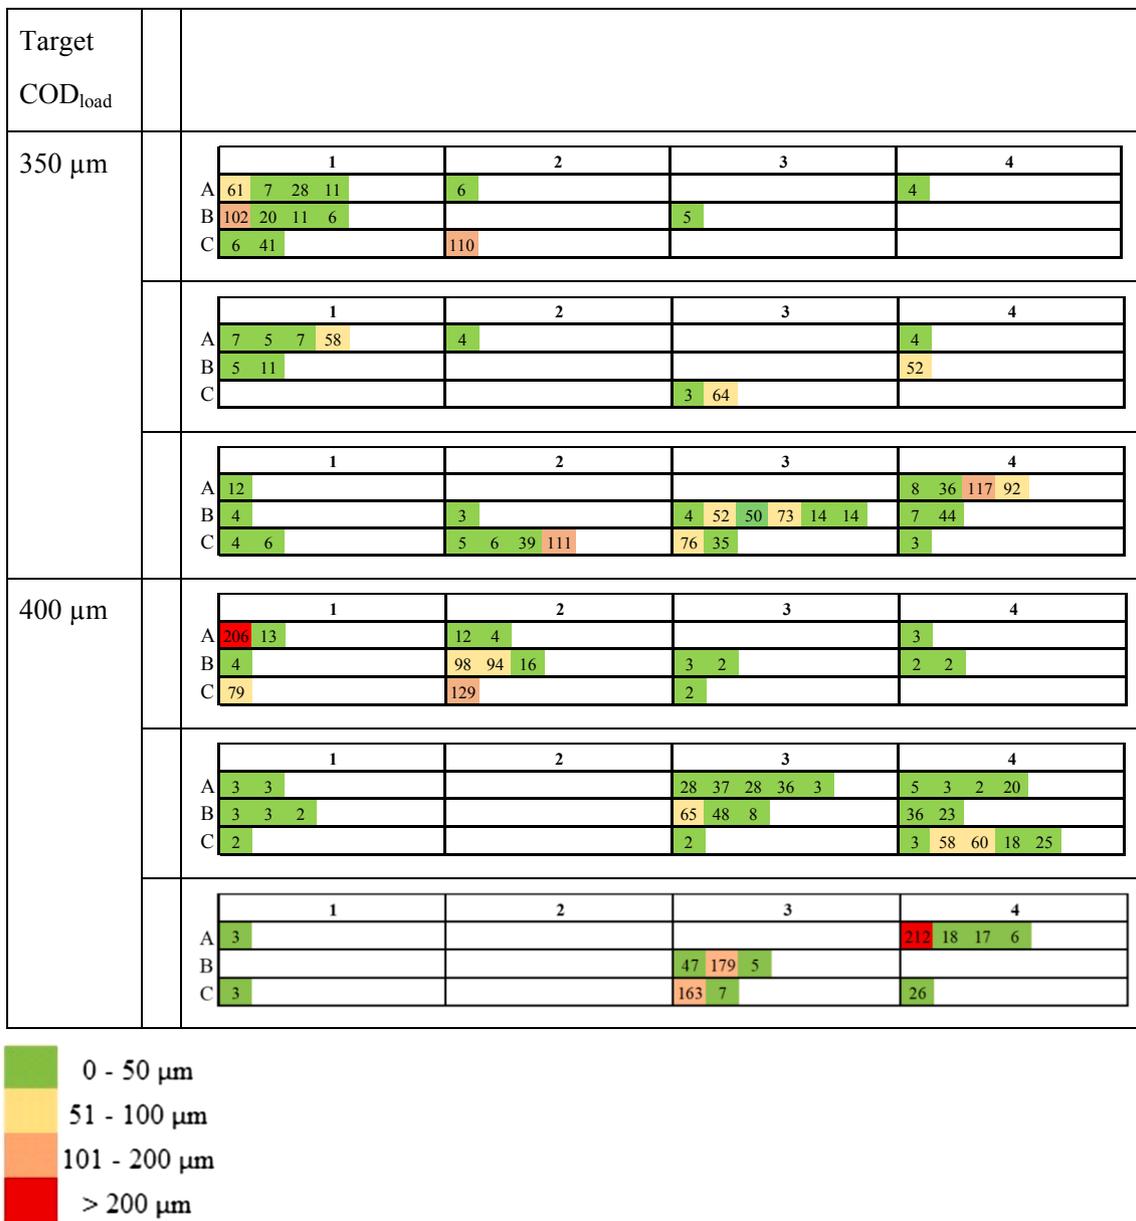
Fig. 18. Localisation of cracks observed in UHPFRC specimens and corresponding crack widths (in μm).

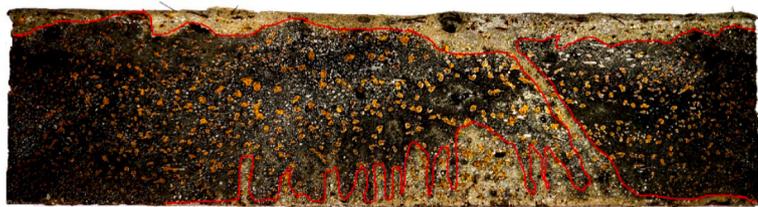
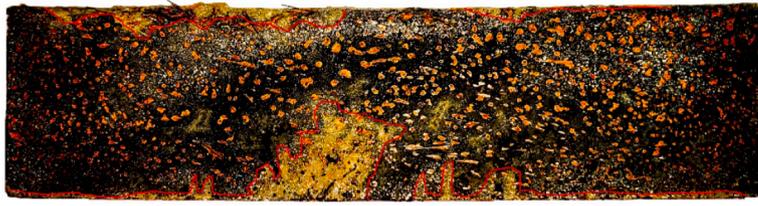
Specimen	3.0%-300-i
3.0%-300

Fig. 19. Chlorides ingress of 3.0%-300-i specimens (penetration depth of chloride ions in lighter part).

chloride penetration pattern was observed, since these specimens present mainly micro-cracking, instated of an evident macro-crack as observed in series 3.0%-350-i and 3.0%-400-i. These micro-cracks promoted suction of aqueous chloride solution, giving rise to small penetration through them, as can be seen in Fig. 19 of Appendix C. The maximum chloride penetration depth was 18–19 mm, while in the non-cracked zone was 2 mm. It must be noted that, in 3.0%-300-i specimens, some chloride condensation occurred in the loaded surface of the specimens (see Fig. 19 of Appendix C), since it was not possible to protect this surface with the waterproof tape.

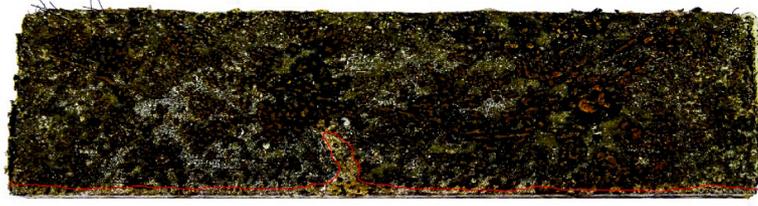
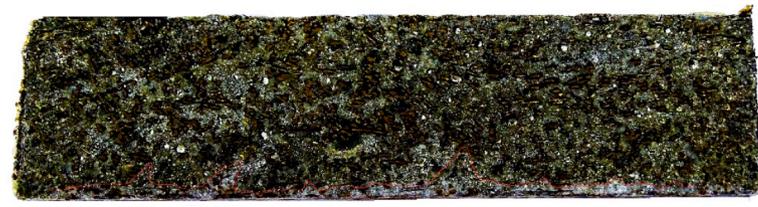
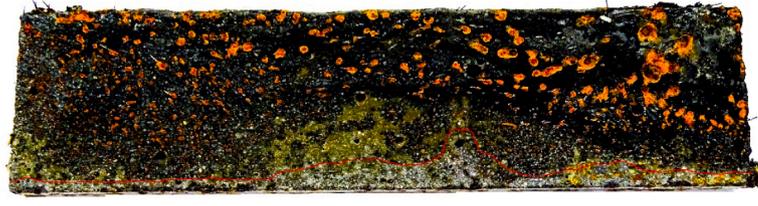
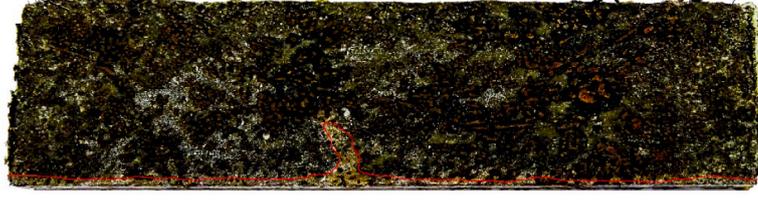
Specimen	3.0%-350-i
3.0%-350-4

Fig. 20. Chlorides ingress of 3.0%-350-i specimens (penetration depth of chloride ions in lighter part).

Maximum chloride content takes place close to the surface and then decreases as the penetration depth increases. The maximum chloride content, near the surface, varied between 0.61 and 0.98% and 0.62–0.90% for 3.0%-350-i and 3.0%-400-i specimens, respectively. Regarding the non-cracked area, maximum chloride content, near the surface, was 0.84% and 0.80% for 3.0%-350-i and 3.0%-400-i specimens, respectively. The main difference between crack and the non-cracked area is that the chloride content drastically reduced after 5 mm from the surface of specimens and it keeps nearly constant up to 20 mm depth. These findings corroborate with colourimetric analysis with silver nitrate, in which penetration front is different in non-cracked and cracked areas (see Appendix C, Figs. 19–21, for 3.0%-350-i 3.0%-400-i, respectively).

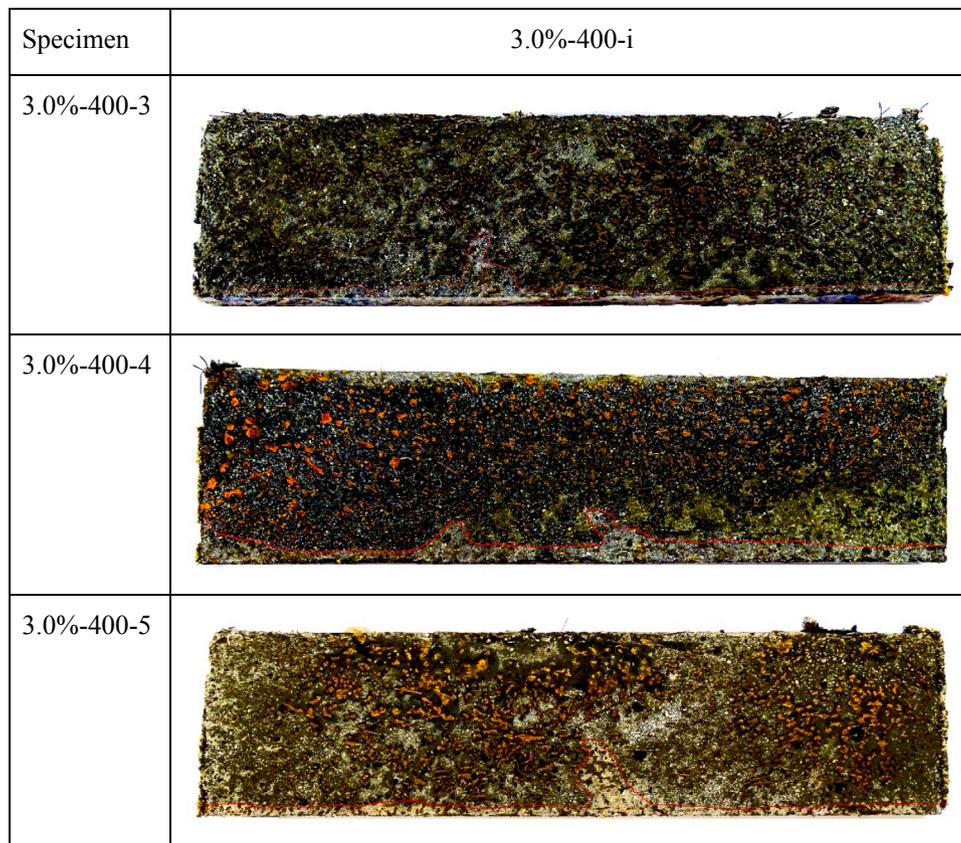
Fig. 21. Chlorides ingress of 3.0%-400-i specimens (penetration depth of chloride ions in lighter part).
