Statistical analysis of the stability of rock slopes

Journal of Marine Science and Engineering

Statistical Analysis of the Stability of Rock Slopes

Abstract: Physical model tests were performed in a wave flume at Deltares with rock armoured slopes. A shallow foreshore was present. At deep water, the same wave conditions were used, but by applying different water levels, the wave loading on the rock armoured slopes increased considerably with increasing water levels. This allowed an assessment of the effects of sea level rise. Damage was measured by using digital stereo photography (DSP), which provides information on each individual stone that is displaced. Two test series were performed five times. This allowed for a statistical analysis of the damage to rock armoured slopes, which is uncommon due to the absence of statistical information based on a systematic repetition of test series. The statistical analysis demonstrates the need for taking the mean damage into account in the design of rock armoured slopes. This is important in addition to characterising the damage itself by erosion areas and erosion depths. The relation between damage parameters, such as the erosion area an

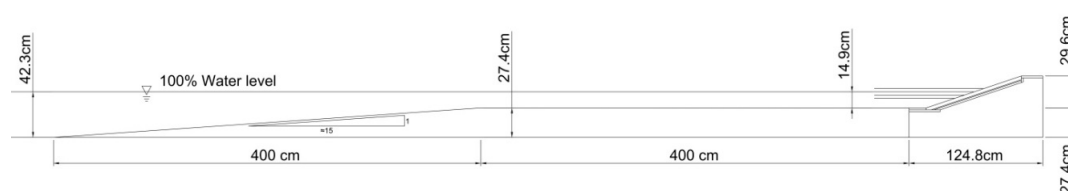
Figure 1 shows the cross-section of the test set-up in the flume. A horizontal shallow foreshore was present in front of the structure. The length of the horizontal foreshore (4 m) is long enough to ensure that the depth-limited waves that reach the structure are adapted to the (shallow) water at the base. Therefore, the foreshore is representative of other shallow foreshores, where the incident wave conditions at the base (as applied in most existing design guidelines for rock slopes) are adapted to the local water depth. The transition slope from deep water to this shallow horizontal foreshore was close to 1:15. Five structure configurations were tested. One with a straight slope (see Figure 2) and four with a berm (see Figure 3): A narrow (0.08 m, i.e., a width of 5 stone diameters: $5 D_{n50}$) and a wide berm (0.16 m, i.e., $10 D_{n50}$), each at two different levels. The tested structures consisted of an armour layer of rock with a D_{n50} of 0.0163 m, a grading of $D_{n85} / D_{n15} = 1.25$, density of $\rho_s = 2710 \text{ kg/m}^3$ and a layer thickness of two diameters, a filter layer of rock with D_{n50} of 0.0094 m, and a layer thickness of two diameters, on a 1:3 slope with an impermeable core. The crest level was fixed at 0.296 m above the base of the structure (non-overtopped). The statistical analysis in the present research focuses on the structure configuration with a straight 1:3 rock slope. The tests investigated the range of damage levels that is also relevant for other structure configurations with rock armour layers (i.e., $S < 12$). The actual damage levels depend, for instance, on the slope and permeability of the structure, but the variation in the damage levels is assumed not to depend on the slope and permeability of the structure; the statistics of the 1:3 slope are considered representative for rock slopes with damage levels of $S < 12$.

Figure 1. Foreshore and structure geometry in the wave flume.

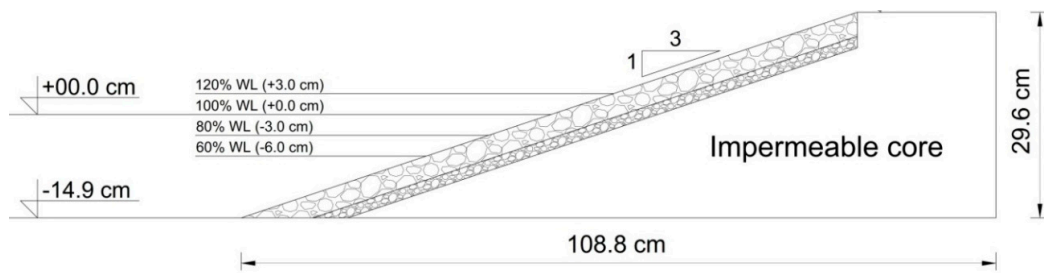
Figure 2. Structure geometry with a straight slope.

Six test series were performed, Series S1 and S2 with the structure in Figure 2, and Series S3 to S6 with one of the berm configurations in Figure 3. Except for Series S2, all series consisted of four increasing water level conditions (see Table 1) without any repair of the slope after each test, thus the resulting damage values are cumulative damage values. Series S1 with a uniform slope was performed five times. In Series S2 only the 100% condition was tested, which enabled a comparison of the results with (Series S1) and without (Series S2) milder conditions prior to the design condition. This test was also performed five times. Damage to the rock armoured slope was measured using the digital stereo photography technique (DSP) as described in [7,8]. With this measurement technique, all displaced stones can be identified by comparing the images (i.e., a 3D digital representation of the slope) after a test run with the images of the initial slope, see Figure 4. Based on this technique, all required parameters characterising the damage can be determined.

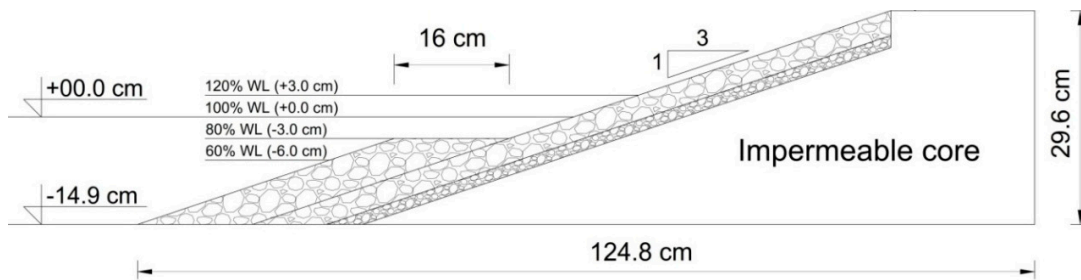
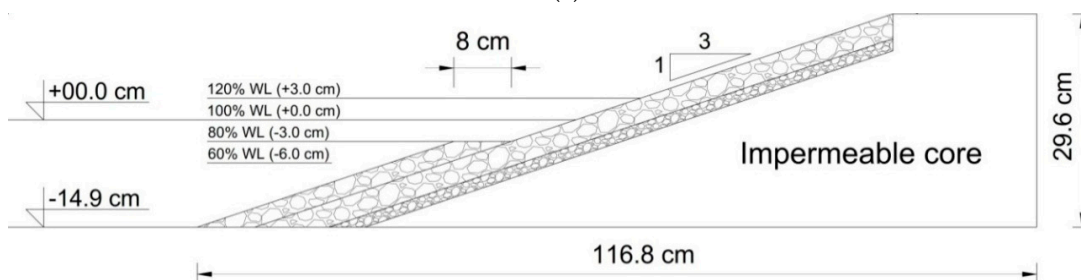
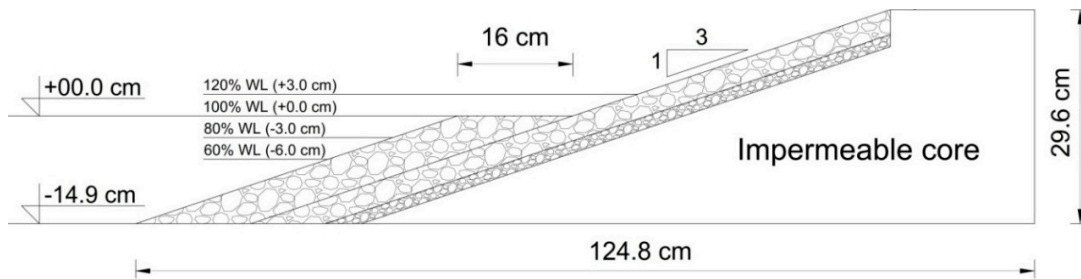
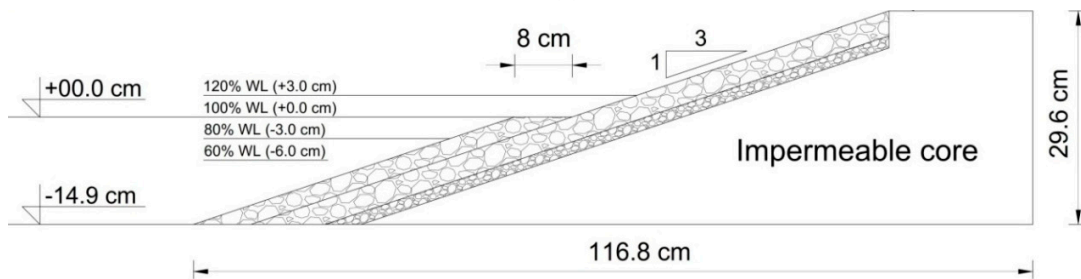
Figure 3. Structure geometries with berms (a): Wide berm at a level of “80% of the 100% Water level (WL)”; (b): Narrow berm at “80% of the 100% WL”; (c): Wide berm at a level of the “100% WL”; (d): Narrow berm at the “100% WL”.

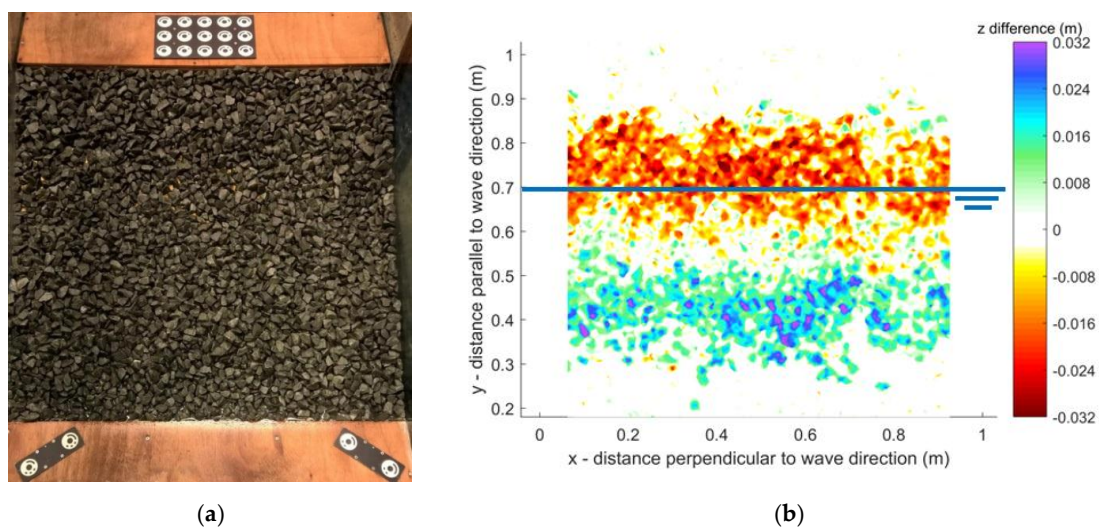
Figure 4. Image of the rock armoured slope (a) and an example of the measurement (compared to the initial situation) of the distribution of damage using digital stereo photography (DSP), where the warm colours denote erosion and the cold colours denote accretion (b).

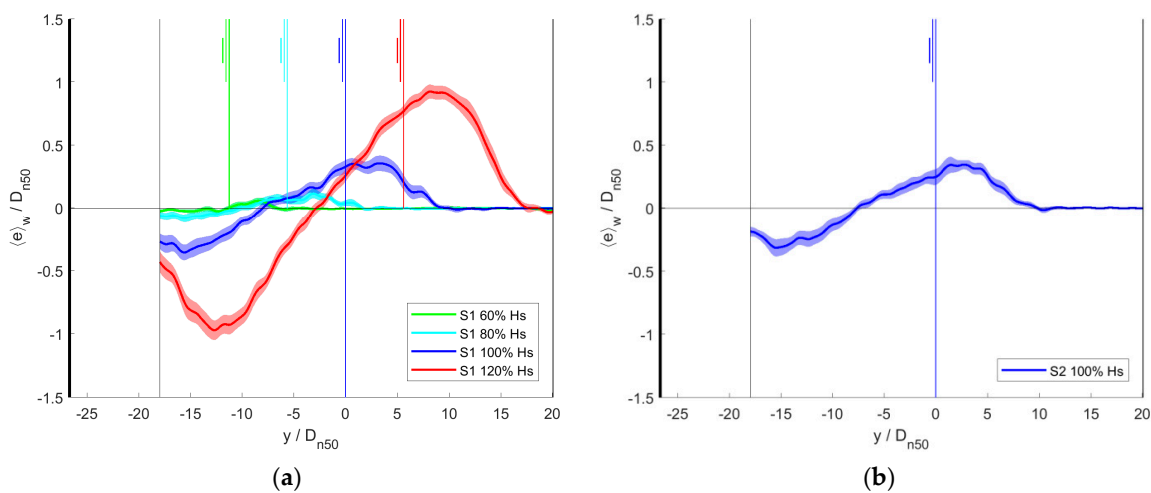
Figure 5 shows the non-dimensional erosion and deposition profiles for Series S1 and S2, averaged over five tests, including the 90% confidence intervals. On the horizontal axis, y/D_{n50} denotes the intersection of the original profile of the armour and the still water level for the 100% condition. For all conditions, erosion occurs around the still water level, with the maximum erosion depth slightly above the still water level.

Figure 5. Non-dimensional erosion (positive values) and deposition (negative values) profiles averaged over five tests (a) Series S1, for four different water levels; (b) Series S2 for the 100% water level), including the 90%-confidence interval.

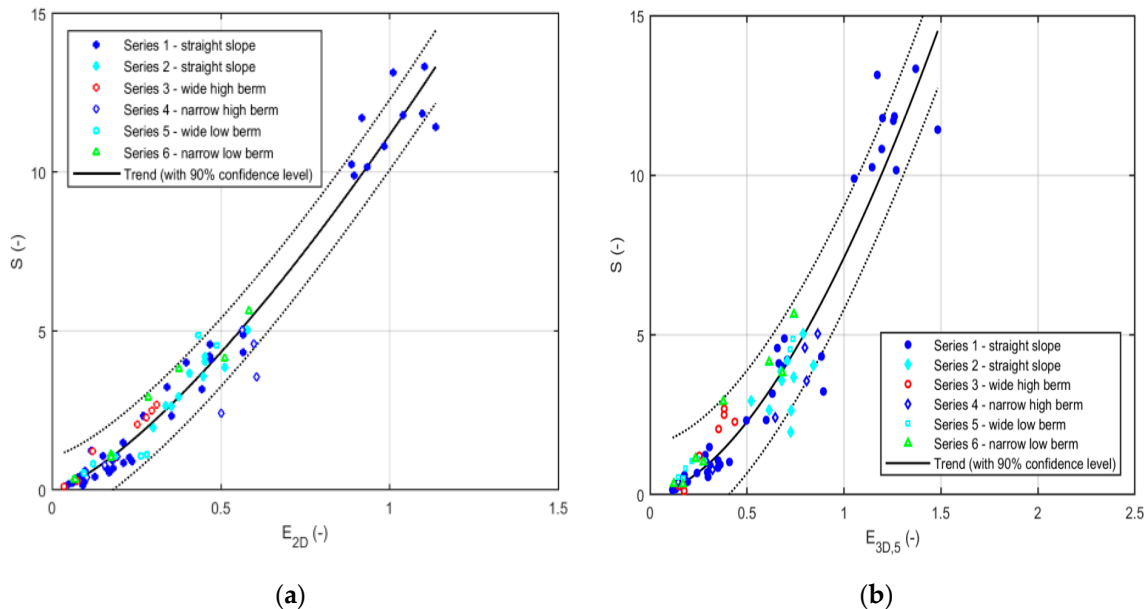
Figure 6a shows the measured damage values, S (based on the eroded area), versus E_{2D} (based on the erosion depth). This figure shows a clear trend between these two parameters. The relevant range of damage is often between the start of the damage ($S = 2$) and failure ($S = 12$); within this range, the trend can be simplified to $S = 10 E_{2D}$ for the tested configurations (1:3 slopes, with and without a berm). Figure 6b shows the measured damage values, S (based on the eroded area), versus $E_{3D,5}$. This figure also shows a clear trend between these two parameters. Within the relevant range of damage, this trend can be simplified to $S = 8 (E_{3D,5})^2$ for the tested configurations (1:3 slopes, with and without a berm).

Figure 6. (a) Measured damage values, S (based on the eroded area) versus E_{2D} (based on the erosion depth); (b) damage values, S (based on the eroded area) versus $E_{3D,5}$ (characterisation width 27 stone diameters).

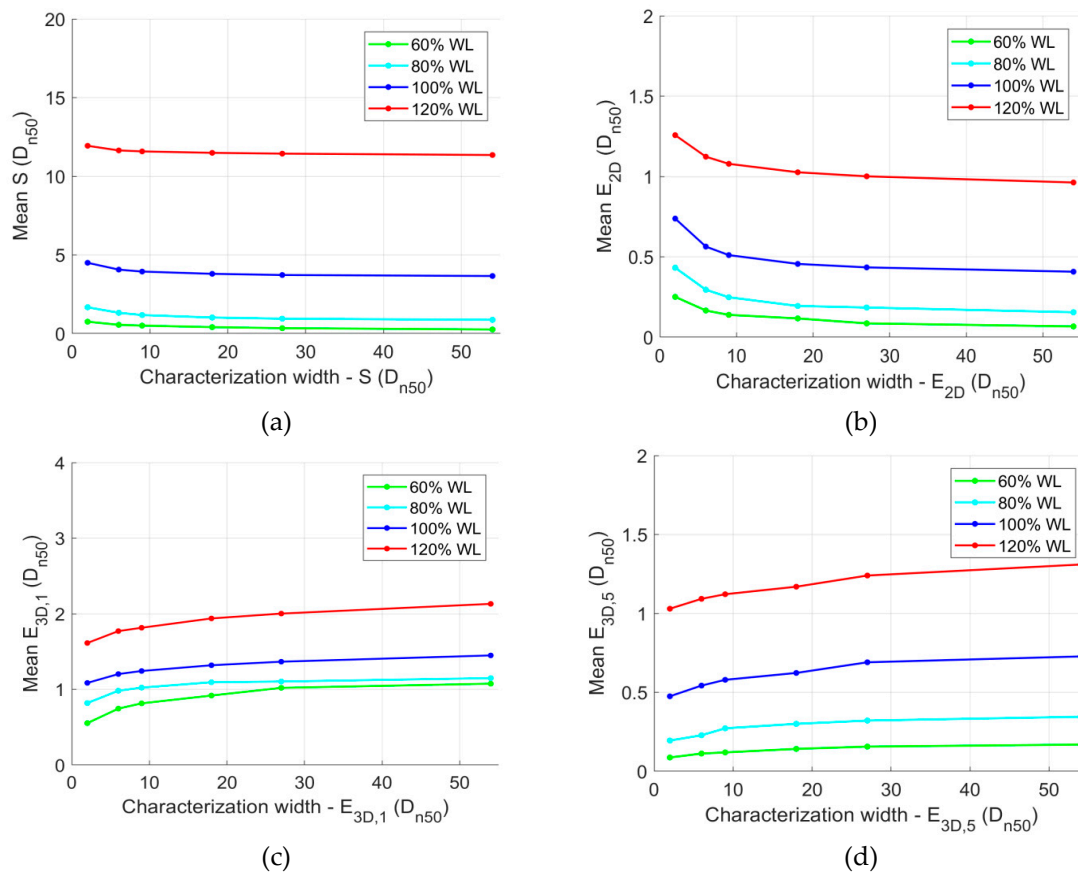
Figure 7. Mean damage values versus the characterisation width, i.e., the width over which the damage is determined (for Series S1); in each panel, another damage parameter was used. (a) S parameter; (b) E_{2D} parameter; (c) $E_{3D,1}$ parameter; (d) $E_{3D,5}$ parameter.

In the present tests, the damage was determined over a width that is equivalent to 54 stones of 0.0163 m (i.e., somewhat less than the width of the flume due to the use of markers close to the glass walls of the flume for the digital stereo photography technique). Series S1 was performed five times. Therefore, the mean damage values, the standard deviations, and the variations (i.e., the standard deviation, σ , divided by the mean values, μ) could be determined over the width of 54 stones. The statistical analysis can also be performed over a smaller width of the test section, for instance, over 10×27 stones instead of 5×54 stones ($S(54)$ means that the mean and standard deviations of the damage are determined over a width of 54 stones, and $S(27)$ means that the mean and standard deviations of the damage are determined over a width of 27 stones, etc.). The influence of the width of the test section (characterisation width) on the statistical values was analysed. Figure 7, Figure 8, and Figure 9 show, respectively, the mean damage values, the standard deviations, and the variations as a function of the width over which the damage was determined. These figures illustrate that the damage values were affected by the width over which the damage was determined. This is not only valid for the present tests, but for all physical model tests with rock slopes.

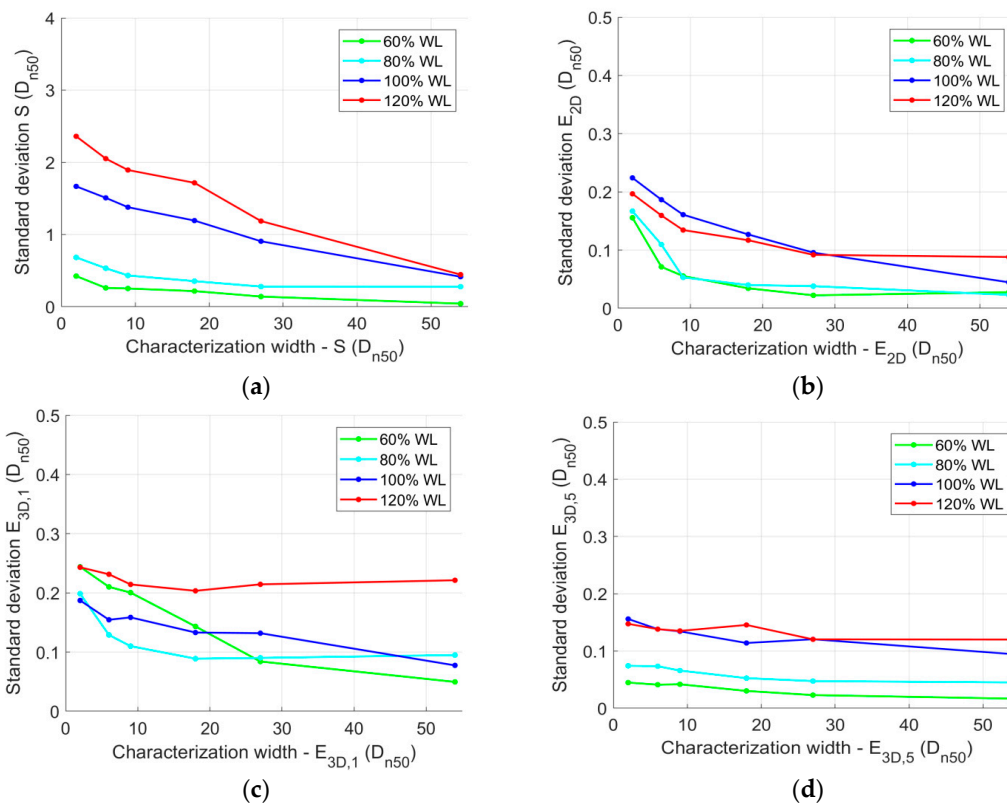
Figure 8. Standard deviations of the damage values versus characterisation width, i.e., the width over which the damage is determined (for Series S1). (a) S ; (b) E_{2D} ; (c) $E_{3D,1}$; (d) $E_{3D,5}$.

Figure 8 shows that the width over which the damage is obtained (i.e., the characterisation width) also affects the standard deviations of the damage parameters. Figure 8a shows that for the damage parameter, S , the standard deviations were highly affected by the width of the section over which the damage was determined. Figure 8b,d show that the standard deviations of the parameters, E_{2D} and $E_{3D,5}$, are more or less constant for a section with a width of 25 stones or more. Figure 8c shows that for the parameter, $E_{3D,1}$, there is not a clear trend; for some conditions, the values decrease for wider sections while for other conditions, the values are constant for wider sections.

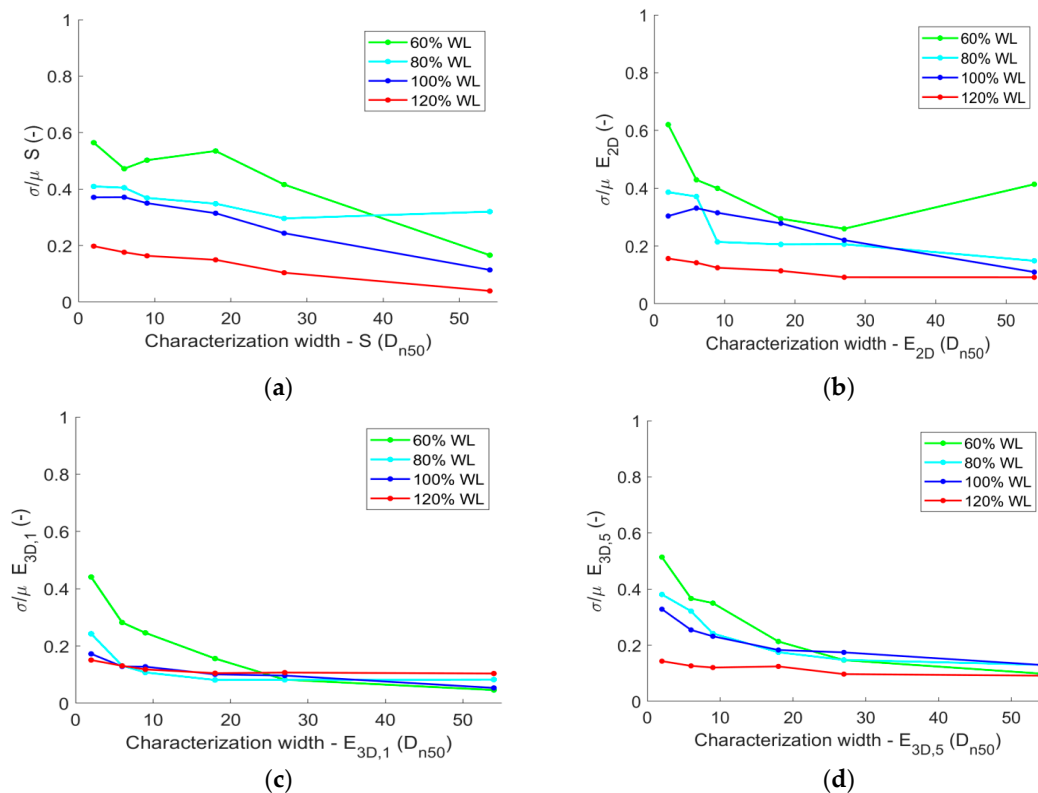
Figure 9. Variation (i.e., standard deviation divided by mean) in the damage versus characterisation width, i.e., width over which the damage is determined (for Series S1). (a) S ; (b) E_{2D} ; (c) $E_{3D,1}$; (d) $E_{3D,5}$.

Figure 9 shows the variation as a function of the width over which the damage was obtained. For the lower damage values (i.e., at the 60% and 80% water levels), the variability of the damage parameters, $E_{3D,1}$ and $E_{3D,5}$, was less than for the damage parameters, S and E_{2D} . For the higher damage values (i.e., at the 100% and 120% water levels) and the largest width of the test section (e.g., a width of 54 stones), there was no clear difference between the variation values of the various damage parameters. Figure 9 shows that the variation of the damage parameters, $E_{3D,1}$ and $E_{3D,5}$, does not vary significantly for various widths over which the damage was obtained, as long as the width was about 25 stones or more. Note that for $E_{3D,1}$ and $E_{3D,5}$, the mean values increase for a larger width, such that for equal values of the spreading, the variations decrease for a larger width. As also discussed in [13,14], it is recommended that damage is determined in a wave flume over a width of about 25 stones.

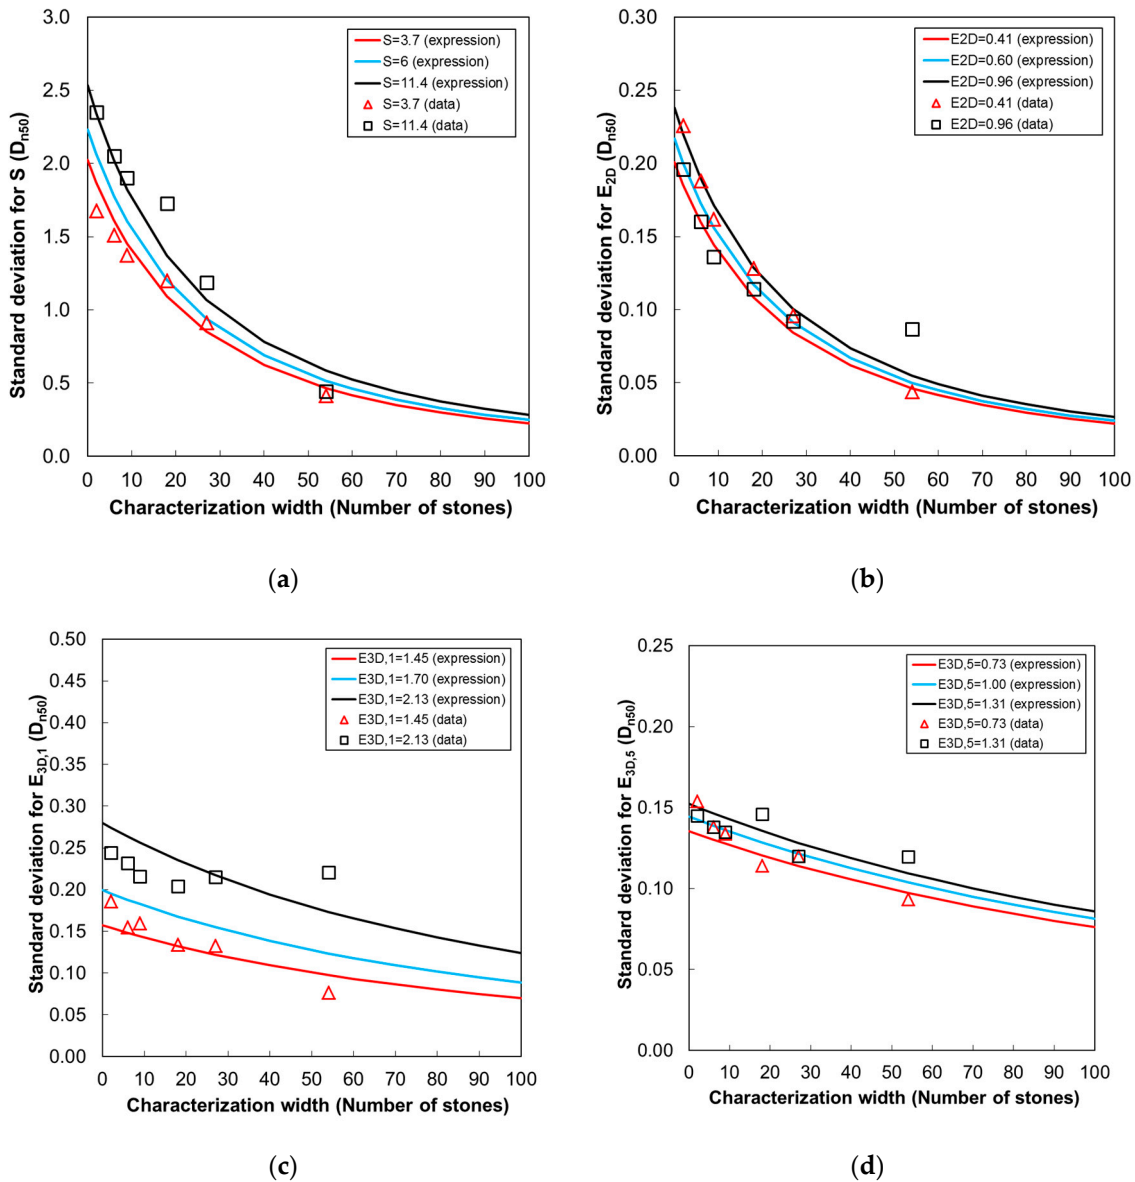
Figure 10. Fit (Equations (3a)–(3d)) to the obtained standard deviations from the measurements (standard deviations versus the number of stones over the width of the test section). (a) S parameter; (b) E_{2D} parameter; (c) $E_{3D,1}$ parameter; (d) $E_{3D,5}$ parameter.

If a model test is performed without any repetitions, the standard deviation, σ , can be estimated based on the present tests. The standard deviation and variation (σ/μ , where $\mu = S_m$) appeared to be dependent on the amount of damage and on the width of the test section (i.e., the number of stones, N_{st} , within the width of the test section). For the four different damage parameters' standard deviations obtained from the tests (see Table 2 and Figure 8), a simple fit can be used for the damage levels between the start of the damage and failure (i.e., for S between $2 < S < 12$). These fits are given in Equations (3a)–(3d) and Figure 10. Note that these expressions for the standard deviations include not only the damage level, but also the number of stone, N_{st} , within the width of the test section. The latter influence was not included in [10].

These expressions (Equations (3a)–(3d)) lead to variations (σ/μ) that decrease for larger damage values using S , E_{2D} , or $E_{3D,5}$ or increase for larger values using $E_{3D,1}$. Note that [6] also derived estimates of the spread depending on the amount of damage, but those were based on individual damage profiles and not on average damage profiles.
