Iterative Prototyping of Aircraft Tire Wear Measurement using Laser Profilometer

Michiel J. Schuurman* and Roger M. Groves†

Delft University of Technology, Faculty of Aerospace Engineering, Delft, 2629HS, The Netherlands

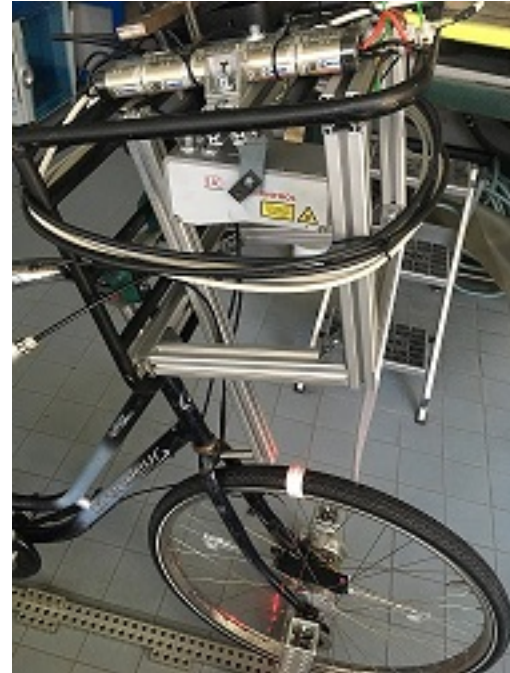
Fig. 1 Bicycle test stand.

(a) Test setup bicycle.

(b) Close up laser setup on bicycle.

The first step in the profilometer system development was to source and connected components together for prototyping. The objective in this first phase was to integrate the system and allow data to be recorded for later analyses. For this phase, an off-the-shelf Dutch city bicycle was procured. The bicycle was equipped with a five speed internally geared rear hub with 28 inch front and rear wheels with used tires. The front bicycle wheel tire tread would be measured. By attaching a purpose-built aluminum rack to the steering column the laser could attached and pointed downwards at the tire treads for measurement. For static testing a stand was built which would elevate the front wheel axle and allow the front wheel to rotate freely. The bicycle test setup used for static testing is shown in Fig. 1a.

This static test stand enabled data collection of the front bicycle wheel treads using the profilometer system connected to a computer and normal main power supply. Using a cordless drill the front wheel was rotated at a constant speed, and data could be collected and recorded for later analyses. The static unit data was subsequently analyzed and assessed. During these stationary tests, the power requirement of the system was measured in order to size the battery pack for the next iteration.

Following static testing the system components, including at the time a properly sized battery pack were packaged into a 'mobile system'. The purpose-built aluminum rack, to which the scanCONTROL laser unit was already connected, was re-used to carry all the required components on board the bicycle. With the system integrated, dynamic testing was conducted on TU Delft campus. The now mobile system on the bicycle was driven across the campus bicycle pathways while recording data. The dynamic scanCONTROL data was subsequently analyzed and assessed.

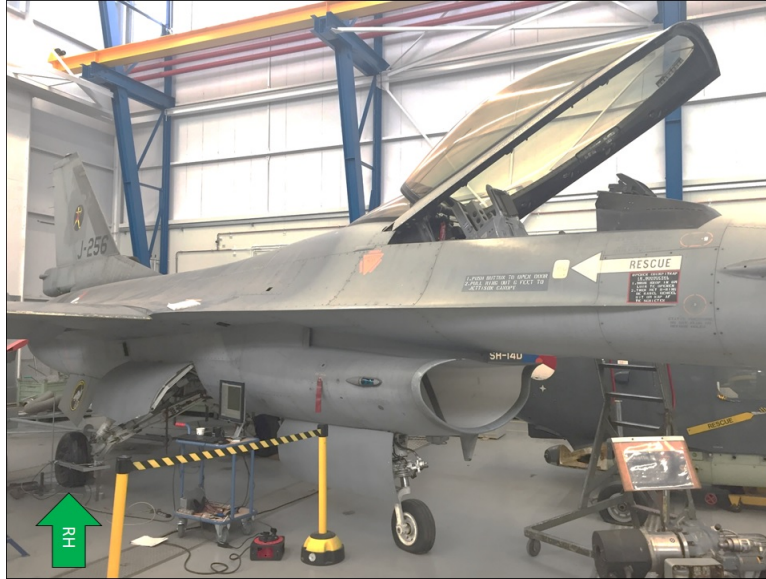
Fig. 3 F-16 profilometer Ground Test, main landing gear tires (right hand main wheel shown with green arrow).

In order to get a more representative tire measurement it was decided to make use of the available aircraft on static display at the Faculty of Aerospace Engineering. In the faculty hanger, a F-16 (Fig. 3) was available which is fitted with Goodyear 25.5x8.0-14, 20-ply aircraft tires (NSN 2620011426461) having a width of 200 mm. The main left and right hand tire were chosen as they were at both ends of their service life.

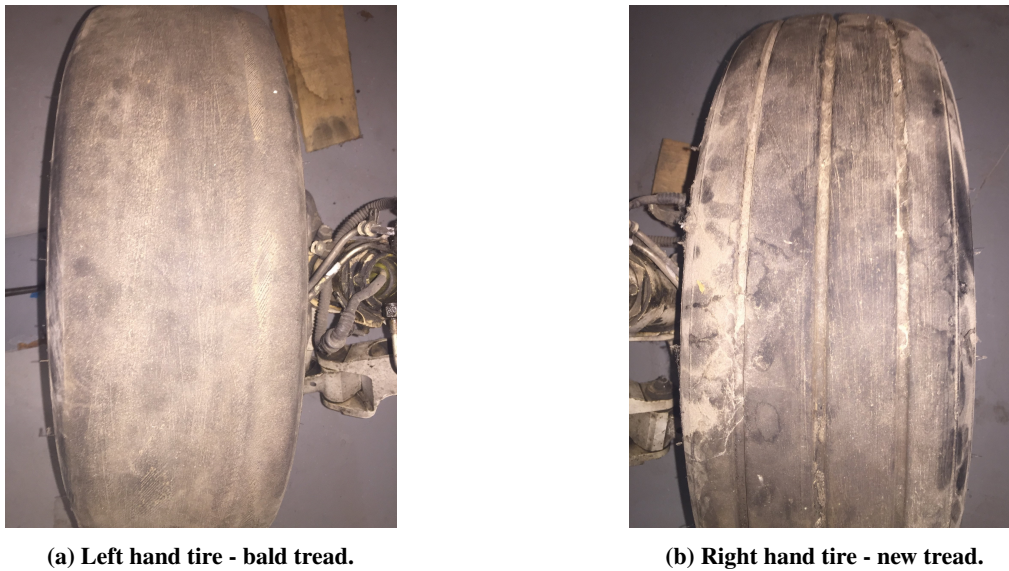
Fig. 4 F-16 main landing gear tires.

The left hand tire (Fig. 4a) was bald and in one area the ply was visible, which meant this tire was well beyond its operational service life. The right hand tire (Fig. 4b) on the other hand, was new and showed no signs of wear, which meant it was at the beginning of its operational service life. Despite efforts, equipment was not available which would allow the F-16 up to be hoisted in the air or jacked-up to allow for free rotation of the tires. Therefore a purpose-built armature attached to the wheel axis was built that could be rotated around the tire circumference for an almost full tire tread sweep (290° angle). Because the armature with the laser unit was rotated around the tire axis, a comparison could be made between the two tire tread measurements.

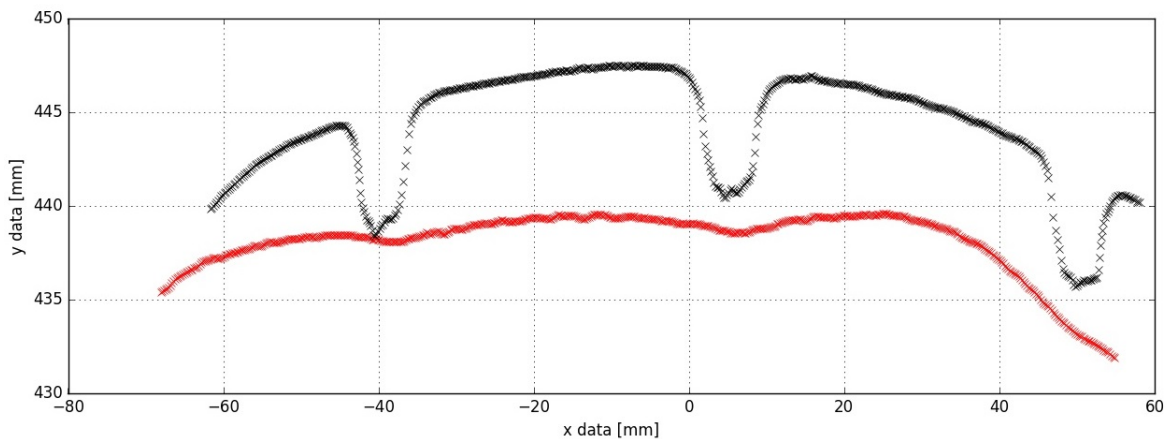
Fig. 5 F-16 Tire cross section comparisons between a new right hand (black) and left hand bald (red).

Analysis between the left and right hand F-16 tire data shows a distinct difference. Fig. 5 depicts the right main landing gear tire (top trace) and the left main landing gear tire (bottom trace) cross-section. Clearly, the three treads are detected in the right hand tire, but are not present for the left hand tire. The delta between the two traces shows the tire wear. Further analysis also shows that in one area (right side) the left hand tire wear is past the two bottom grooves of the right hand tire. This suggests the tire ply should be visible at that location, which was already noted before. The 110 mm scan width of the measurement system was not sufficient to detect the full 200 mm width of the tire, as no information is captured on the state of the tire shoulders.

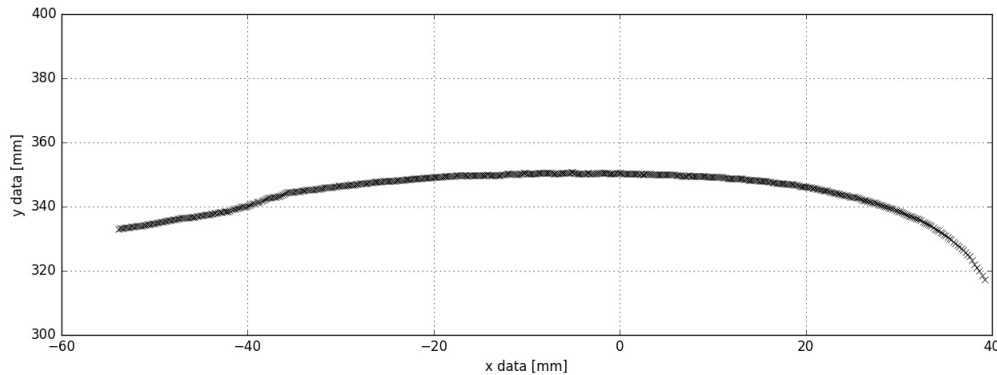
Fig. 7 Profilometer plot showing cross section A350 Main Landing gear tire.

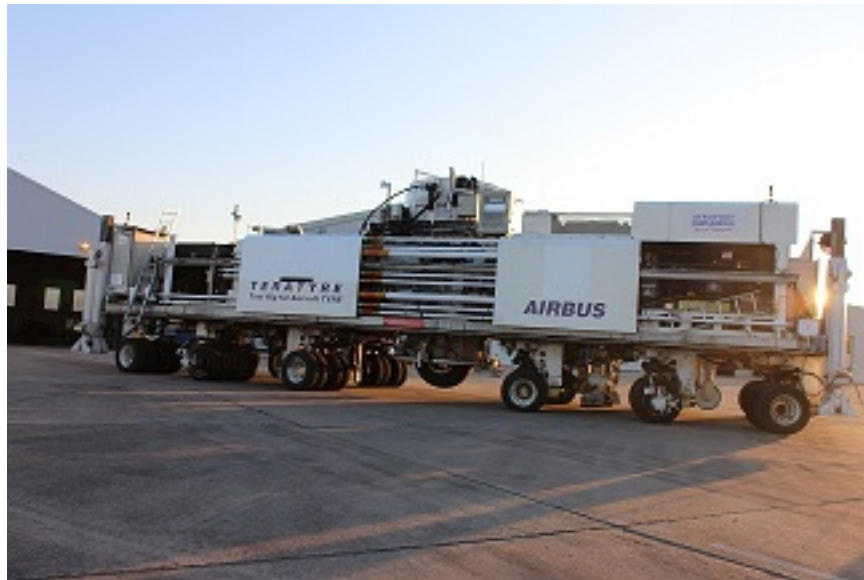
Fig. 8 Test Rig for Aircraft Tires (TeraTyre) at Châteauroux Airport with in the centre the aircraft tire being tested.

The developed tire test rig can rotate the tire at a high slip angles which normal dynamo-meters cannot do. The TeraTyre test rig has overall dimensions of 14.5 x 4.5 meters and is 5 meters tall. The rig weighs 115 metric tons and is powered by a 1500 horsepower engine which allows the rig to reach a maximum speed of 90 km/h. The TeraTyre test rig can move and test one aircraft tire at a time along a linear or curved trajectory. With its pneumatic turret system the tire can be loaded to different weights. Due to the high slip angle capabilities, the aircraft tire is tested to its limits and well beyond ordinary wear seen in normal service life operation. With the extreme conditions to which TeraTyre is testing tires, the profilometer capability can be investigated and aircraft tire wear can be evaluated.

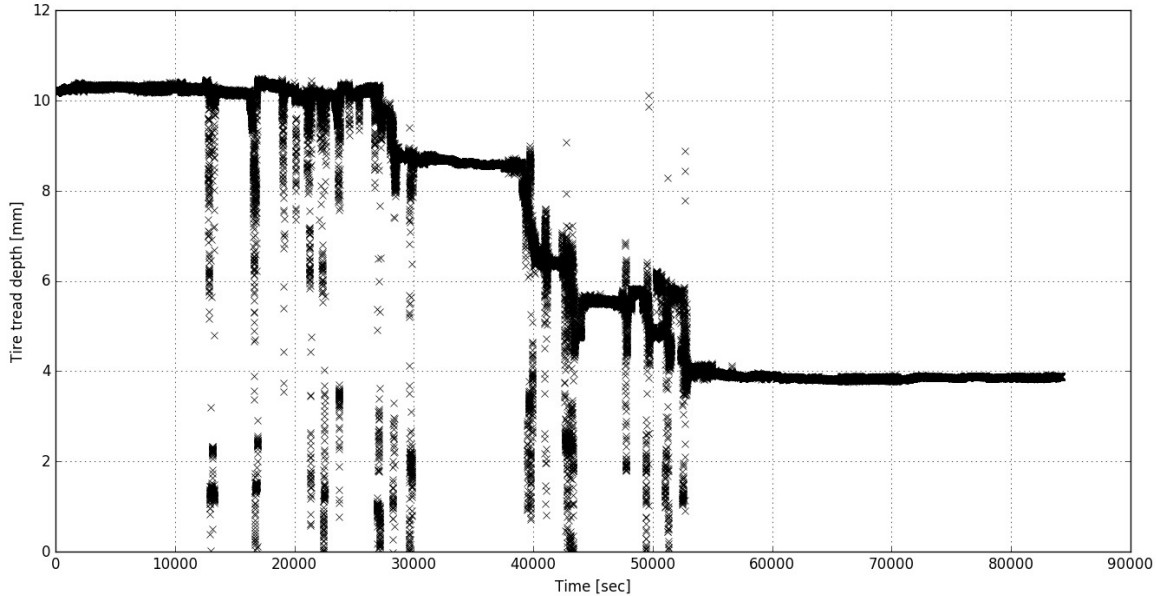
Fig. 9 TeraTyre Profilometer tire wear plot result Test wheel 9.

Fig. 9 shows an unfiltered data set for Test wheel 9. The data is for a single measurement point which was in the field of view, the tread depth is calculated by subtracting the profile measurement of the valley and the groove. At the start of the test, the detected tread depth was ten mm, which is reduced by the end of testing to four mm. Depending on the test profile speed, slip angle and weight differences a distinct difference in the data traces and amount of wear. The preliminary data analyses showed a decrease in tire tread depth, which demonstrates wear was detected by the profilometer system. In a follow-up paper, the test results will be discussed in more detail.
